Structural Inspection

August 23, 2018

For: Chantelle Meyers
126 Nottingham Drive
Slidell, La.

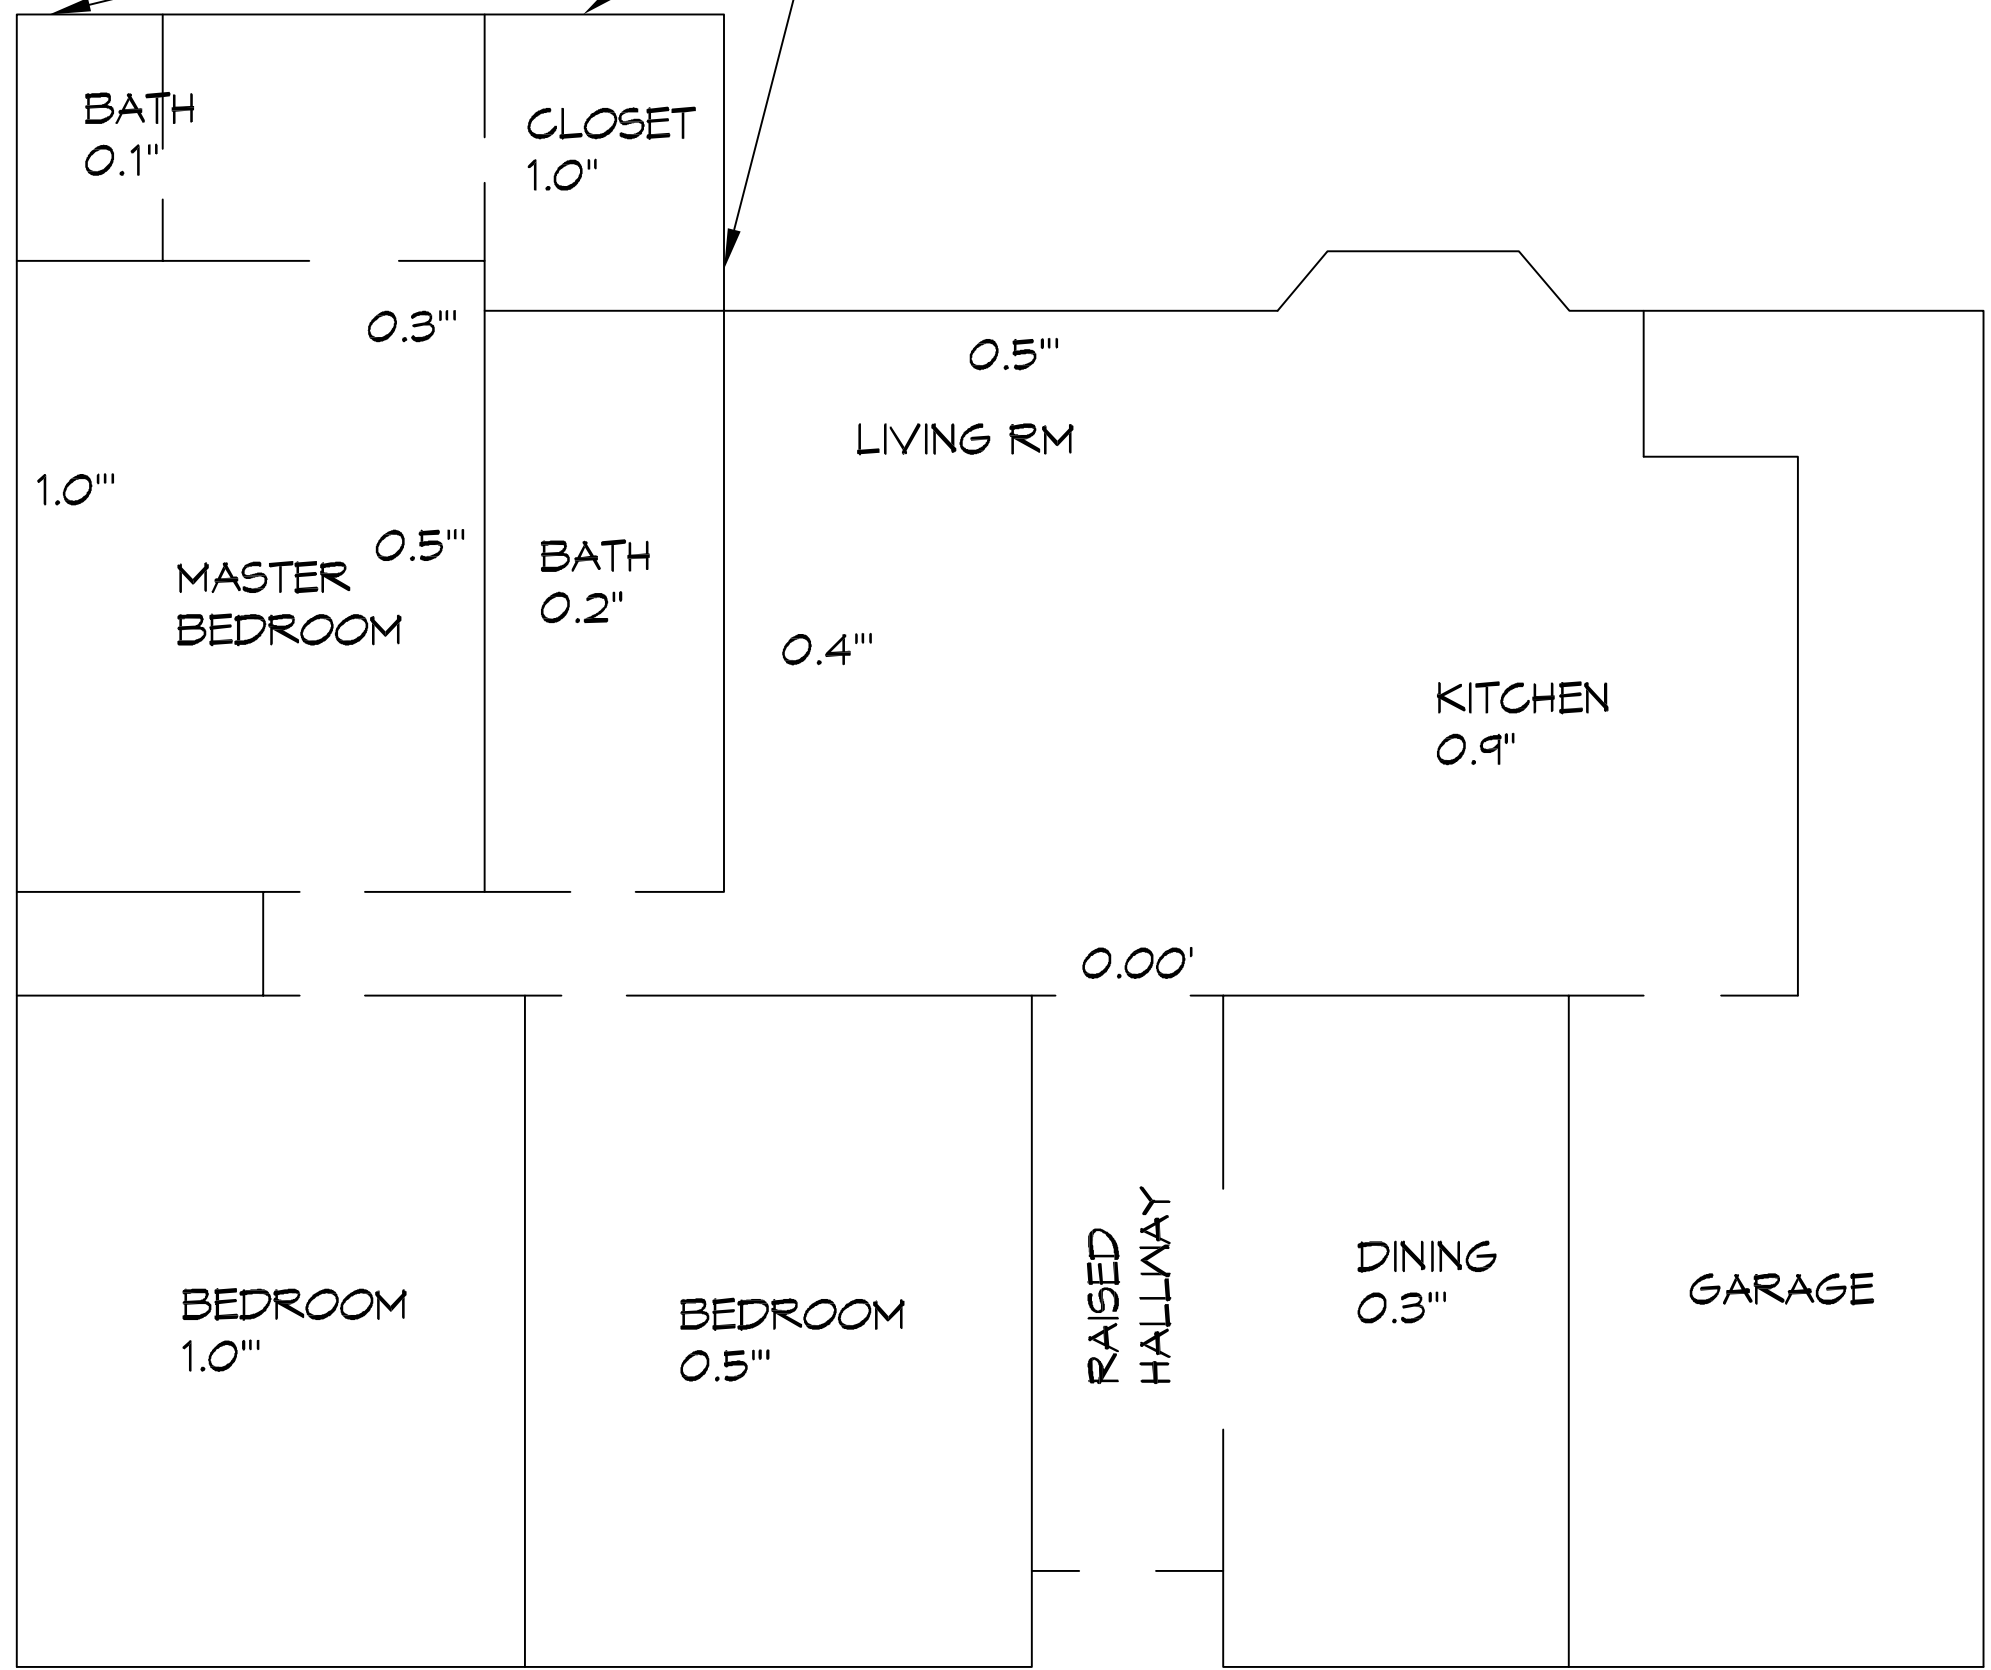
The rear yard of the home (near master bedroom closet) is holding water around the foundation and does not allow the rain water to flow away from the foundation causing settlement/erosion and mildew to grow on the brick veneer.

HOLDING WATER
AROUND FOUNDATION

- 1) Seal the cracks in the brick veneer and foundation with a non-shrinking grout, to prevent insects from entering the home.
- 2) Gutters and down spouts are needed to direct the rainwater away from the foundation.
- 3) The yard should be re-graded to allow for proper drainage of rainwater away from the foundation.
