Structural Inspection

December 10, 2018

Ref: 129 Nottingham Drive
Slidell, La.

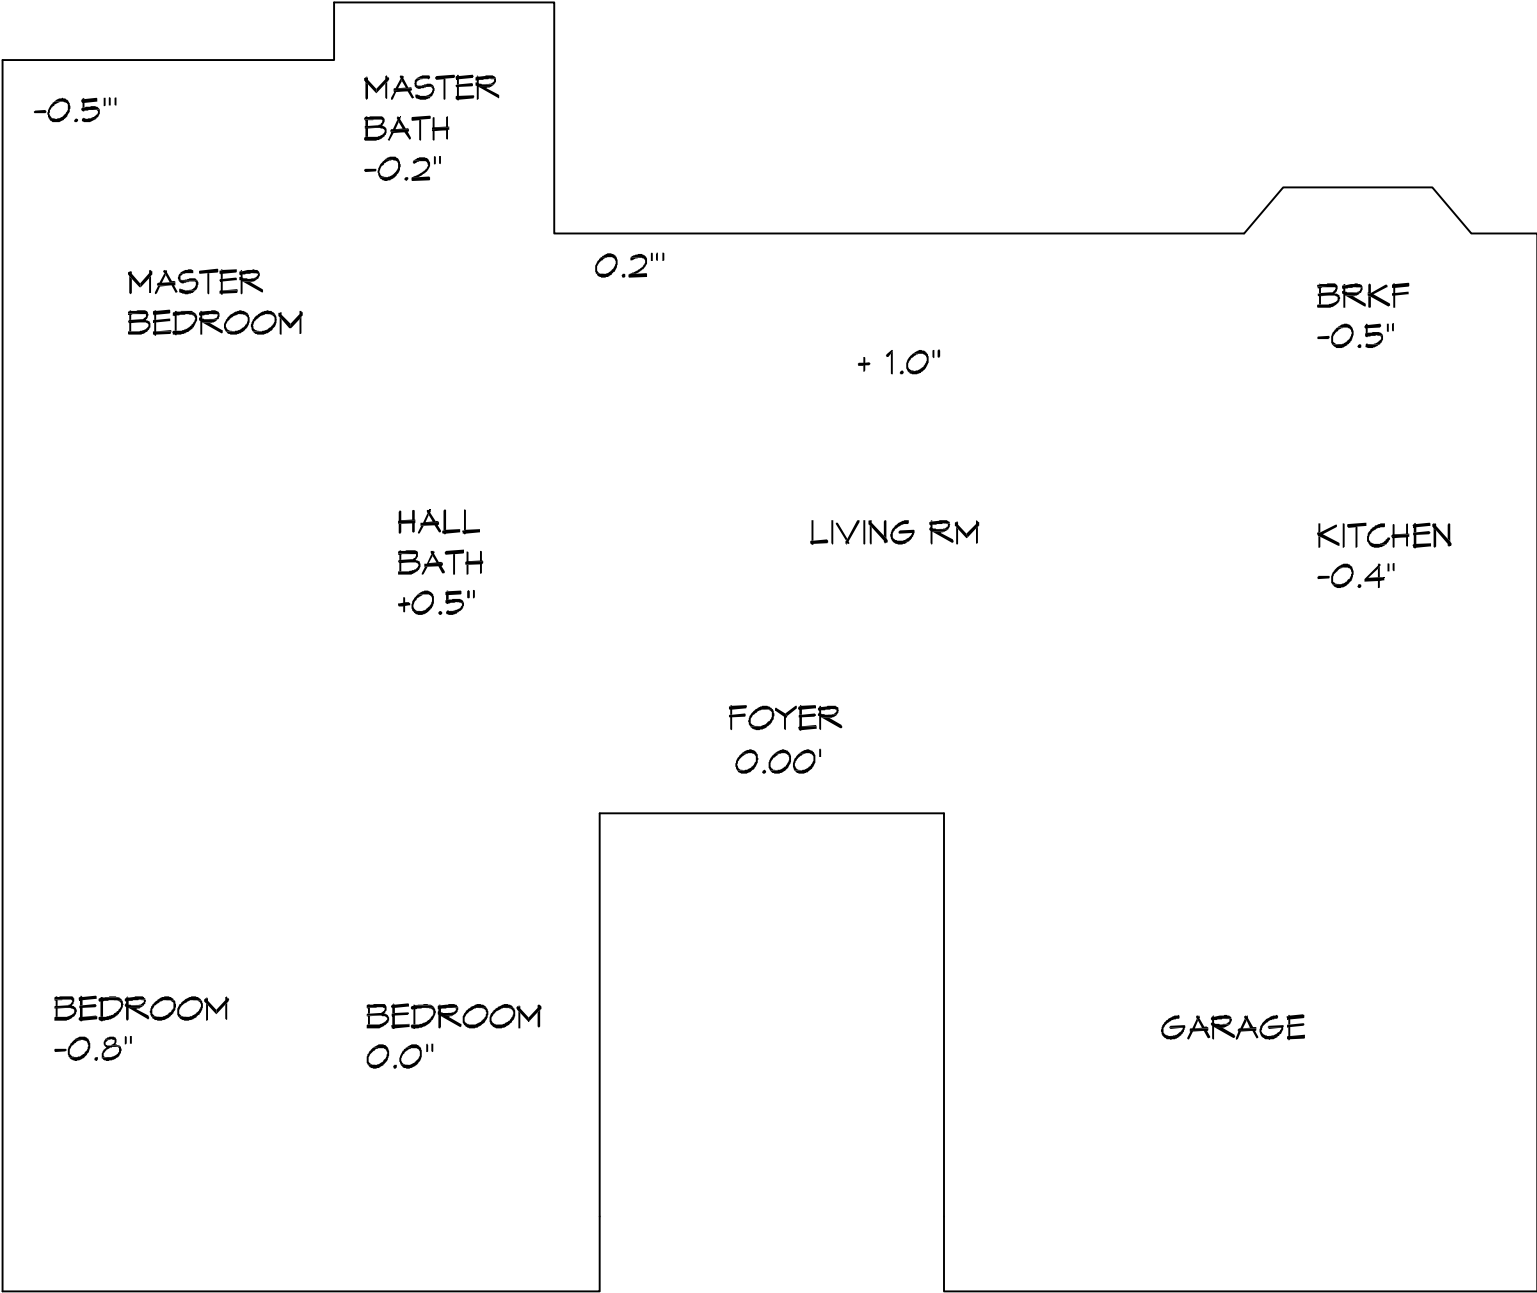
Upon inspection, a zip level was used to verify the floor height conditions. The level was set up at the front of the living room at zero inches and measured throughout the home. It is important to note that all floor height conditions vary due to ceramic height and wood flooring height.
