Structural Inspection

April 24, 2019

Ref: 1309 Seville Dr
NOLA

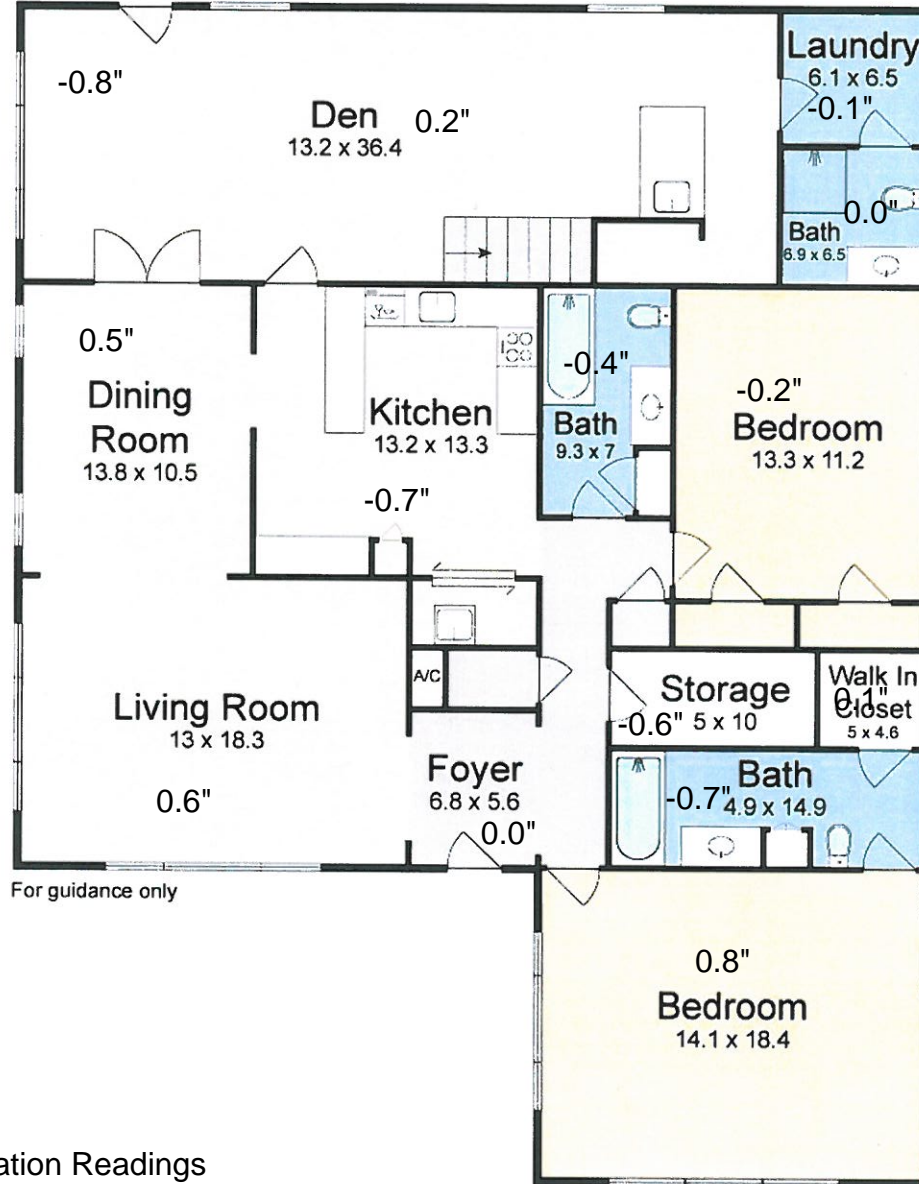
Elevation Readings

Upon inspection, a zip level was used to verify the existing floor height conditions. The level was set up at the front foyer at zero inches and measured throughout the home. It is important to note that all floor height conditions vary due to ceramic flooring and wood flooring.

The heights varied throughout the home range from 0.8" in the front bedroom to -0.8" in the left rear of the Den. Overall it slopes to the rear of the home less than one inch.
