Home Inspections of Louisiana, LLC

1347 Greenlawn Street
Slidell, LA 70460

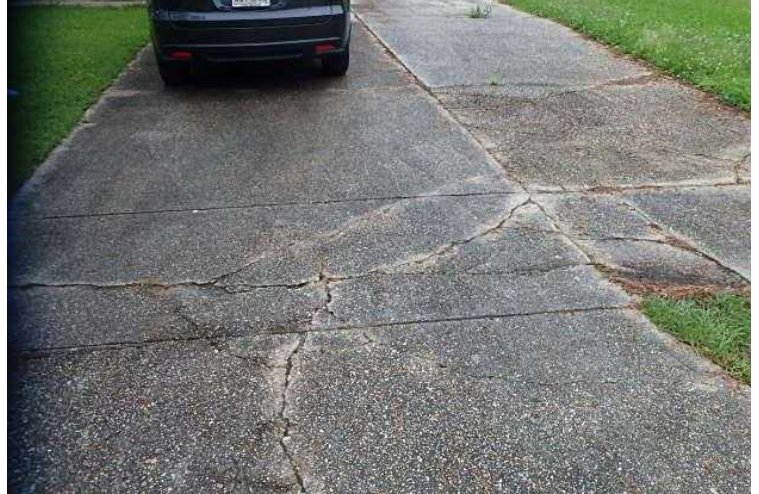
#2 Concrete driveway. Cracking and some settlement present.

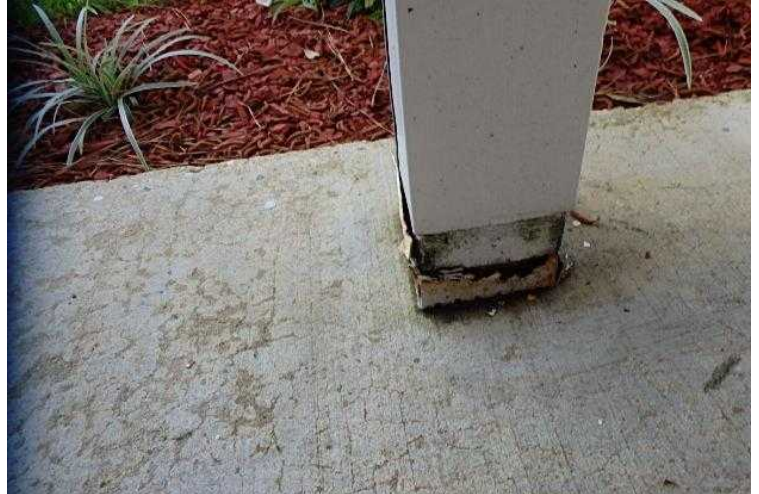
#6 Metal covering rusting along the bottom of the column.

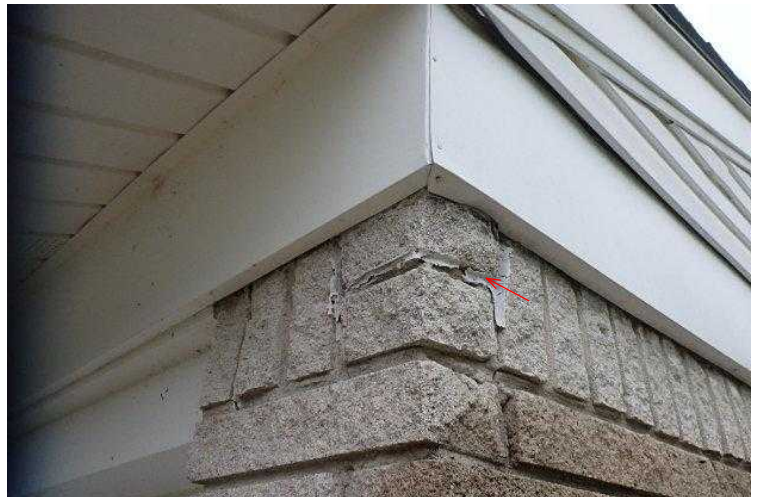
#12 Loose bricks in the upper right corner.
Brick veneer is non-structural.

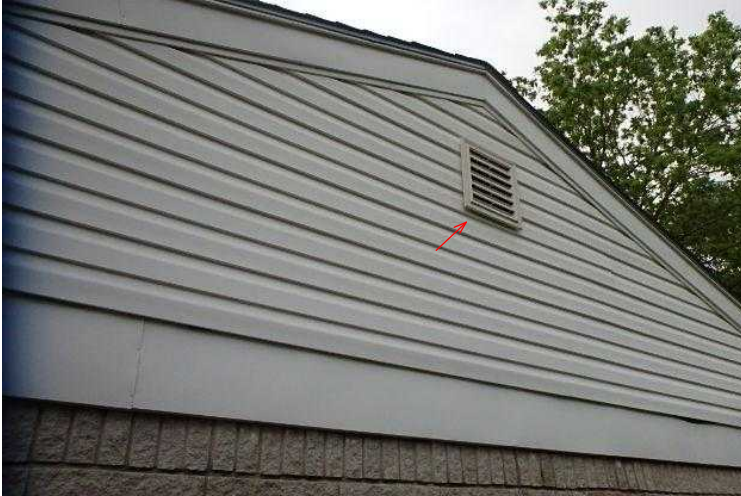
#13 Gable vents on each side.

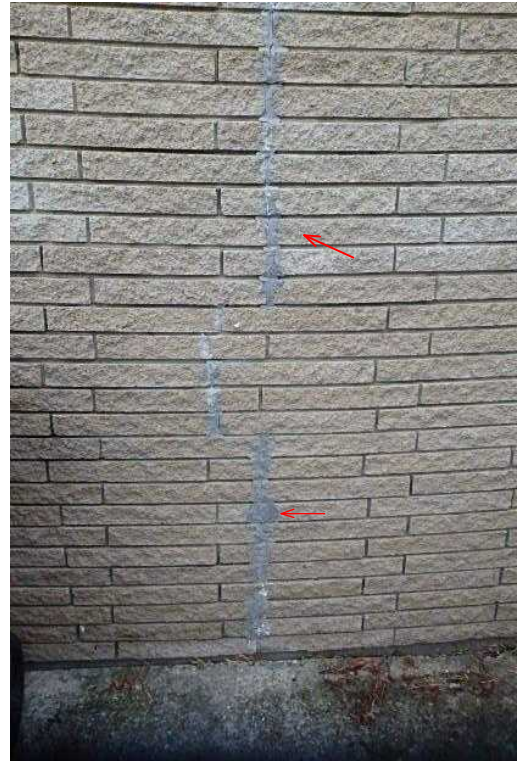
#14 Brick crack on the right side was filled with mortar.

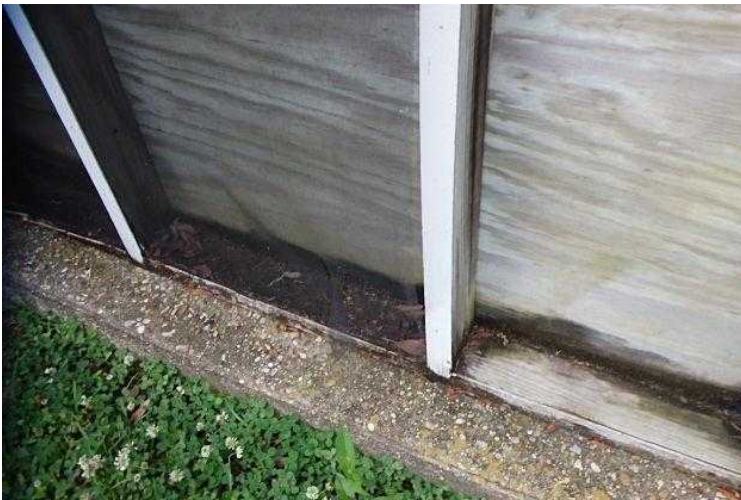
#23 Plywood added on the inside with hold moisture at the sill plate.

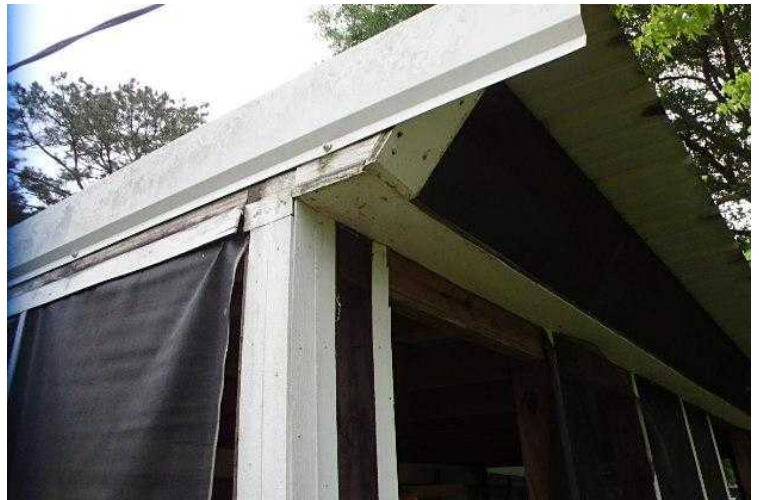
#24 Exposed wood around the top. Keep painted.

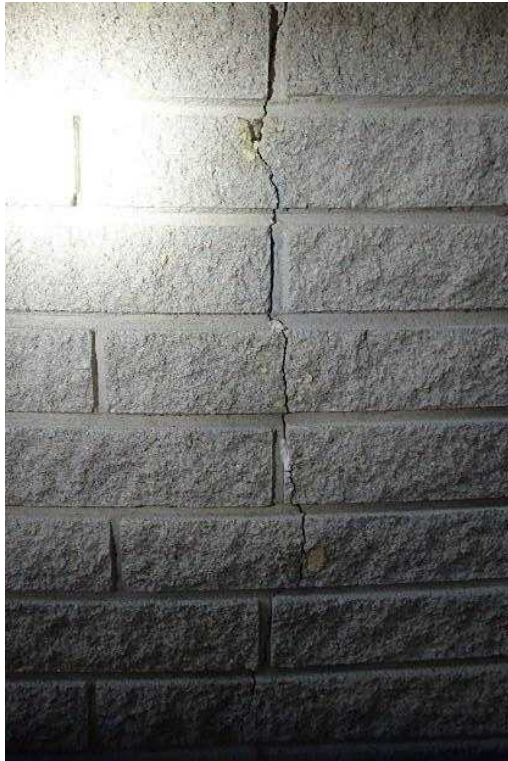
#33 Crack in the rear brick.

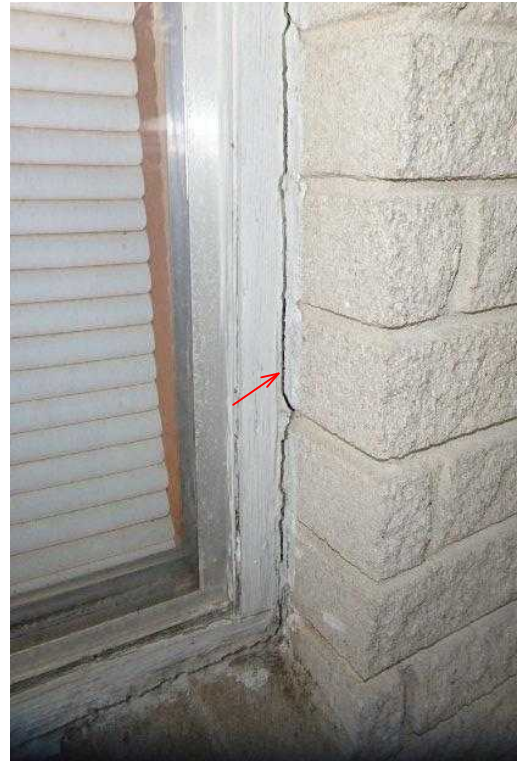
#34 Wood trim around the bathroom window. Open joint indicates some movement.

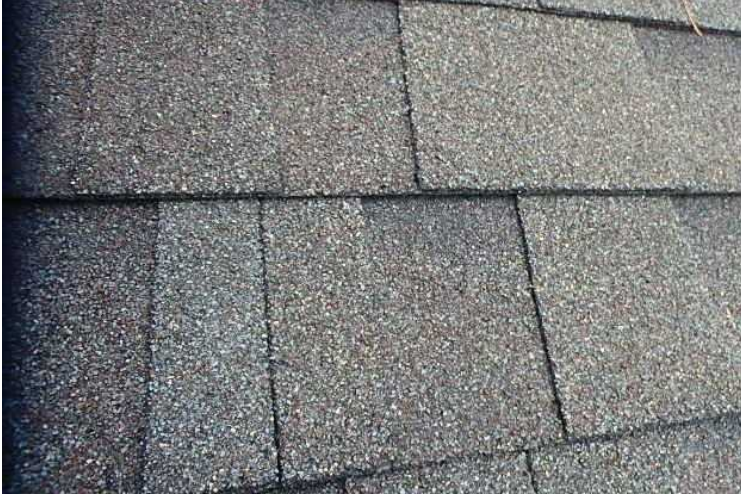
#37 Roof shingles. No granule loss noted.

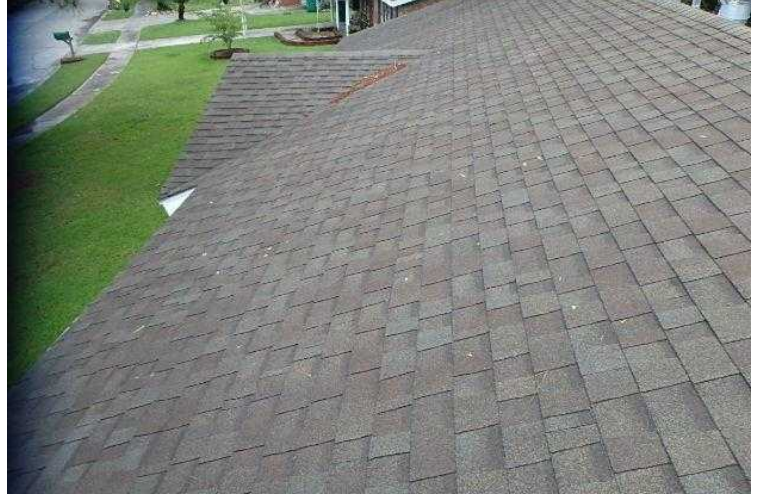
#38 Front roof view with center gable.

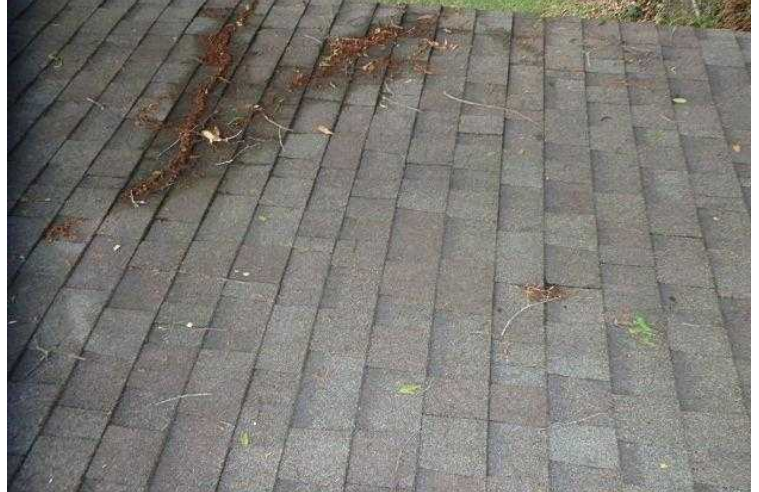
#42 No damage to the shingles from fallen branch.

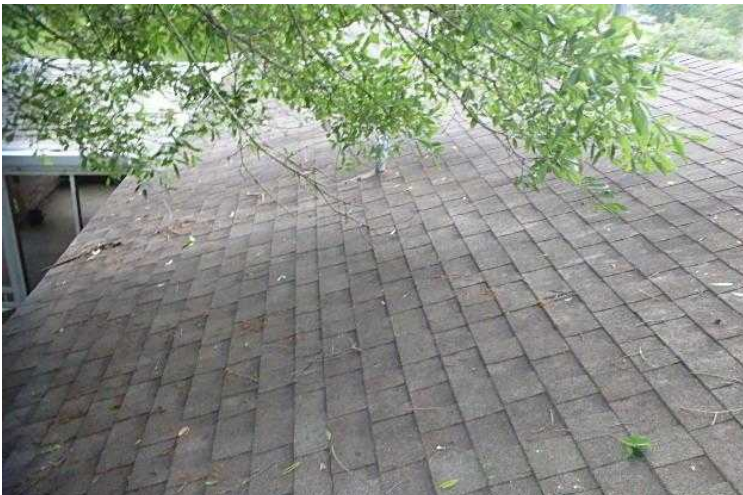
#43 Rear roof. Cut back tree branches soon before damage results.

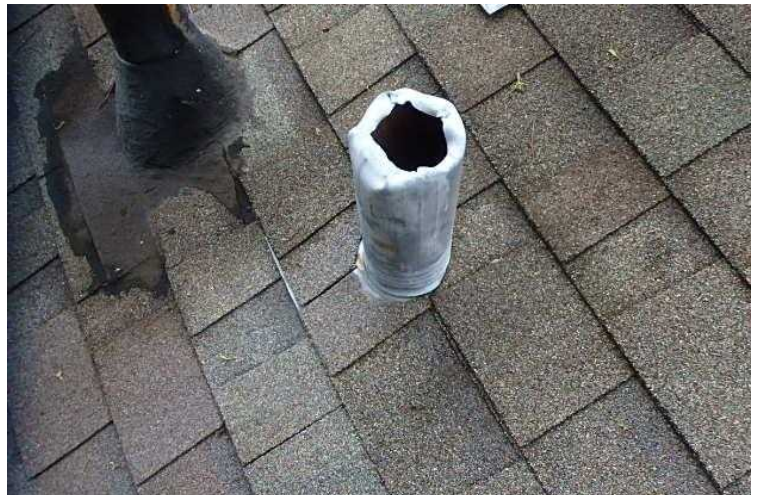
#44 Cast iron and galvanized vent pipes with lead vent flashings.

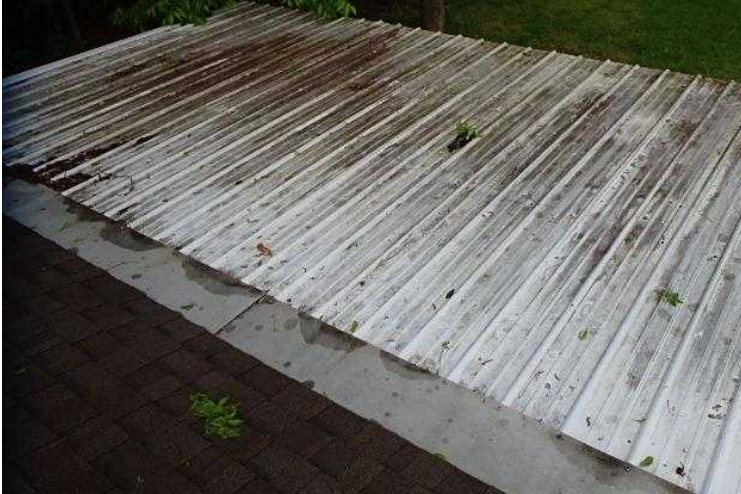
#49 Patio metal roofing. Some rusting present.

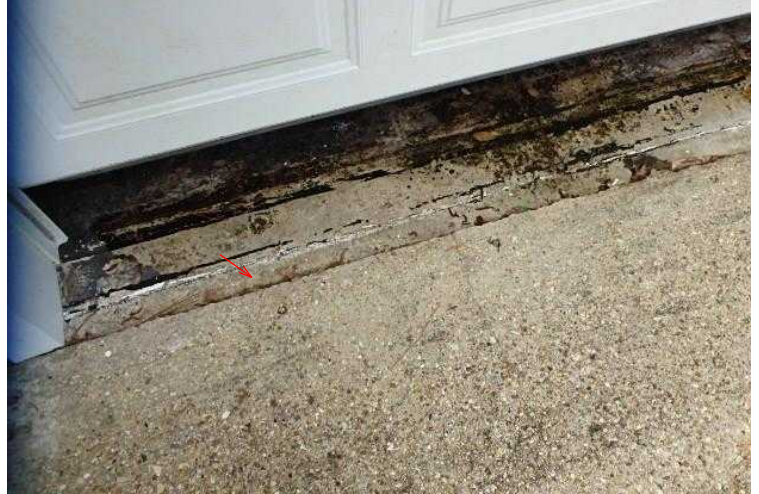
#50 The driveway is higher than the garage on one side.

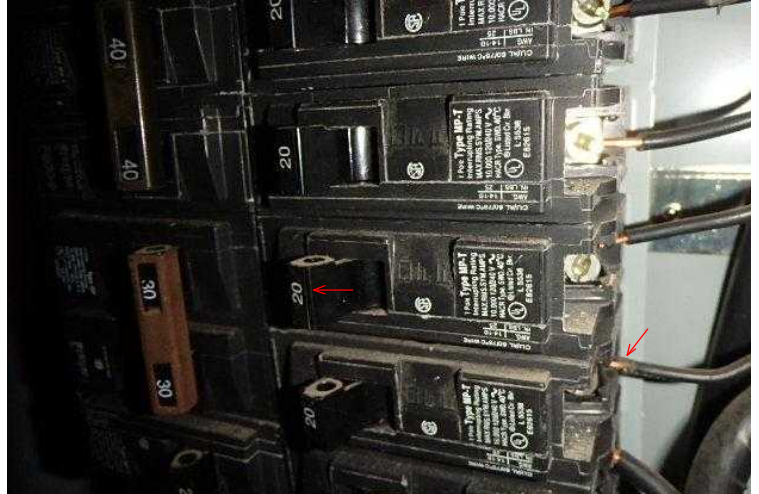
#66 Some of the breakers are oversized. Fire hazard.

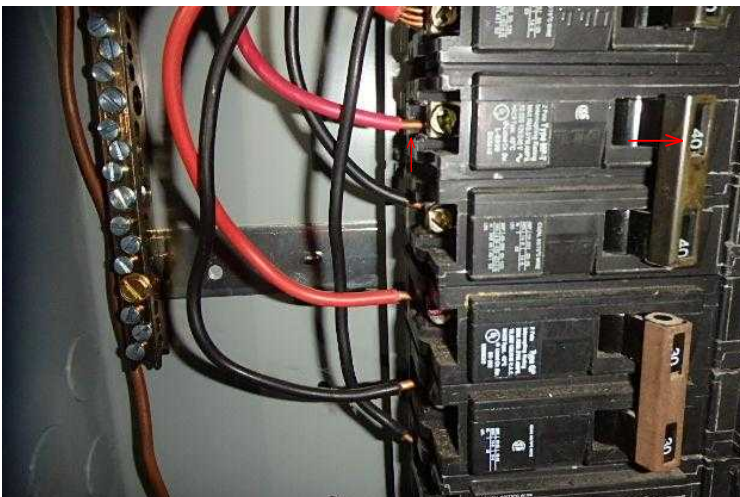
#67 Breaker should be 30 amp.

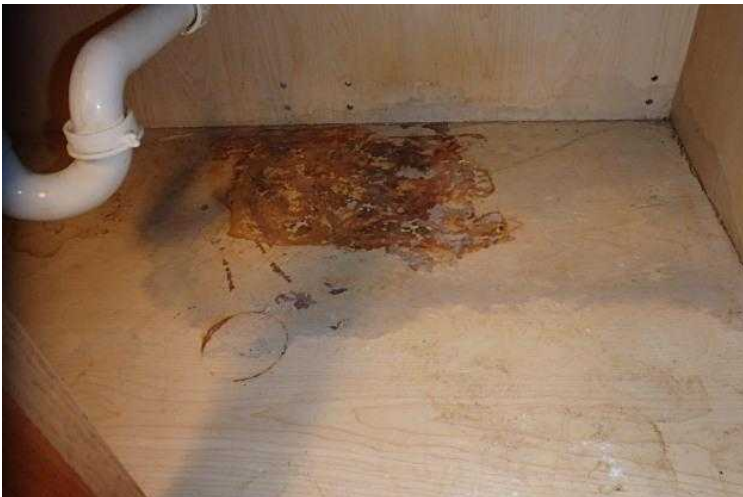
#75 Past leaks present.

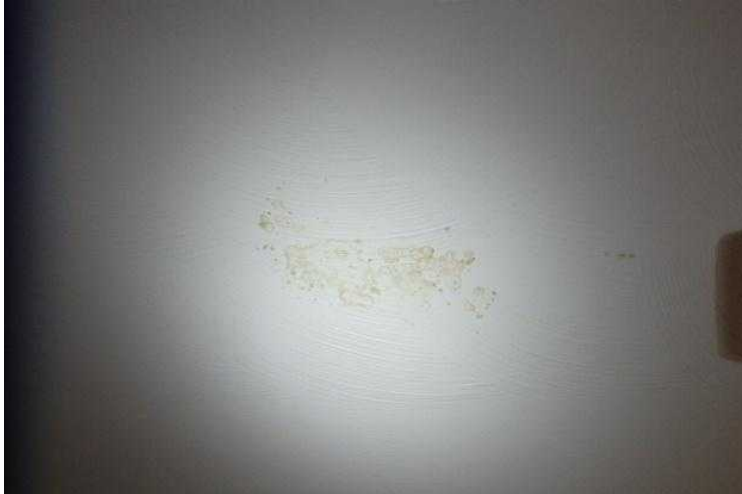
#89 Stain on the ceiling.

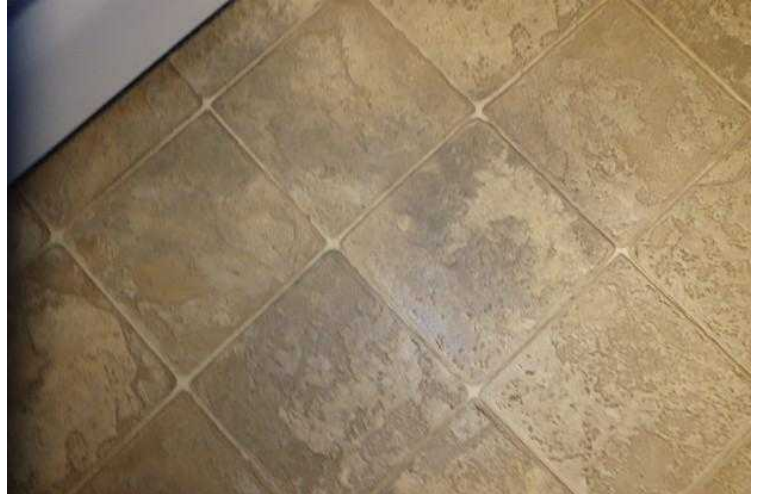
#90 Stains on the flooring in the kitchen.

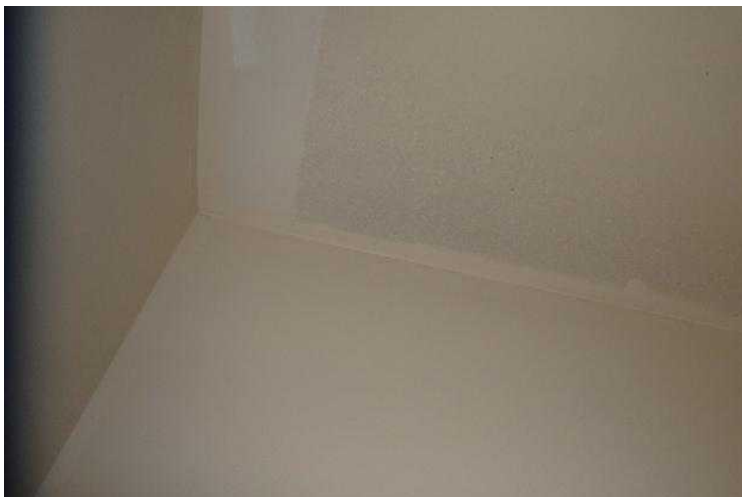
#91 Den closet ceiling not painted.

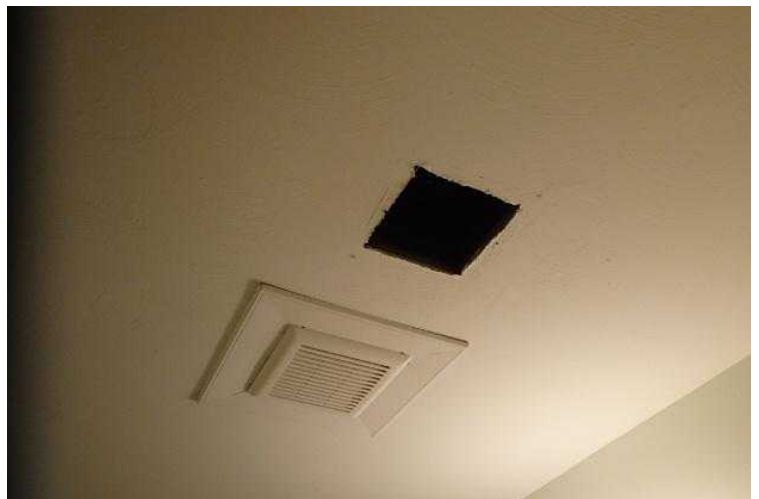
#96 Ceiling register missing.

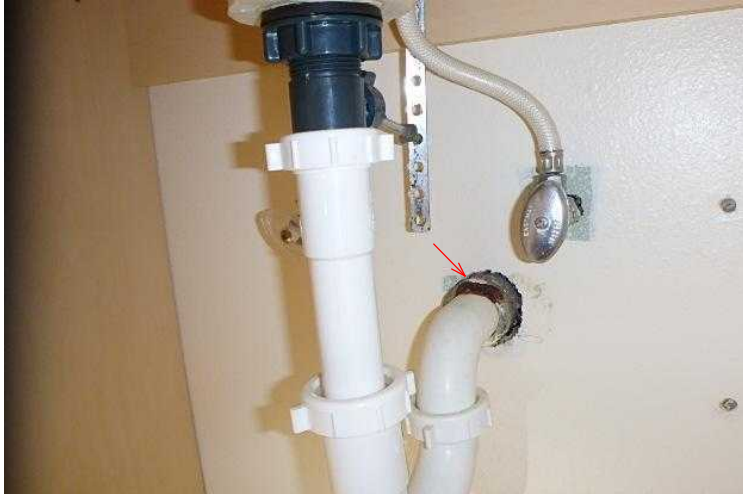
#97 Galvanized drain pipe in the wall.

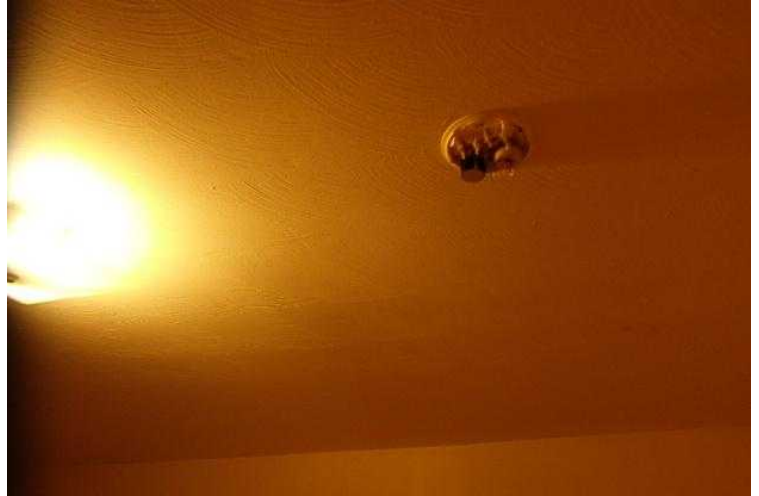
#102 Smoke detectors should be replaced and installed in the bedrooms and hallways.

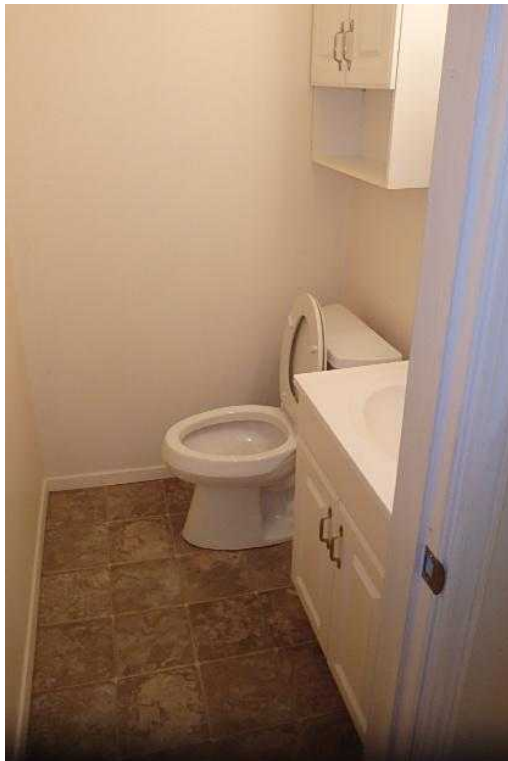
#103 Master 1/2 bath.

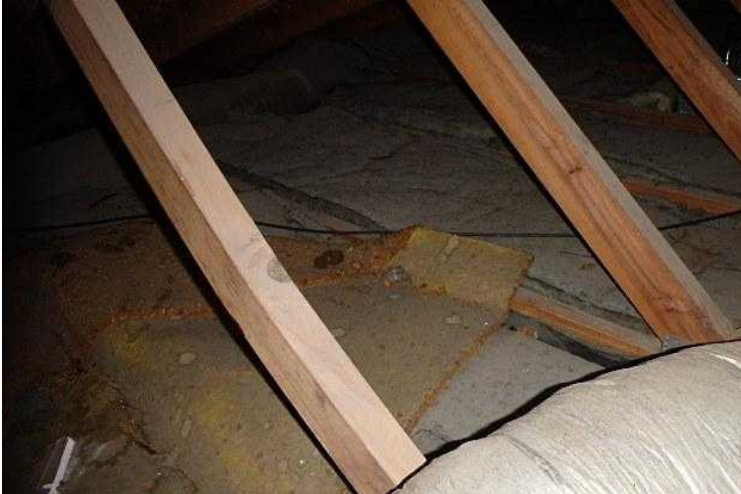
#109 The original insulation was improperly installed with the paper side facing up.

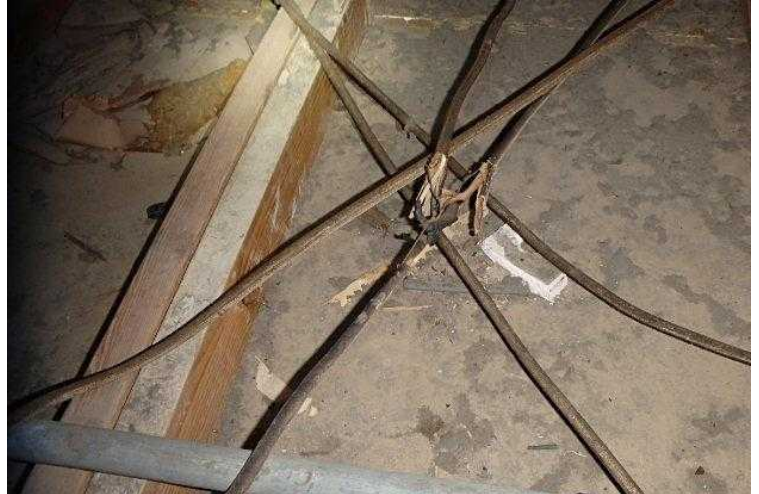
#110 Open wire splices should be in junction boxes.

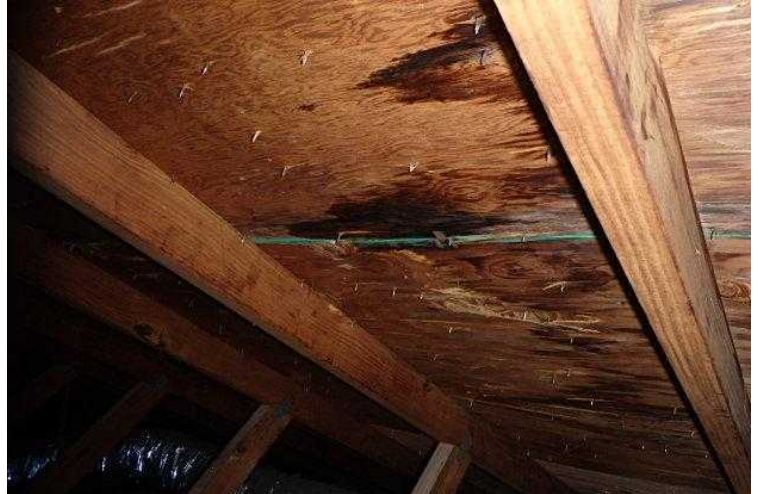
#114 Moisture stains present. These may be old.

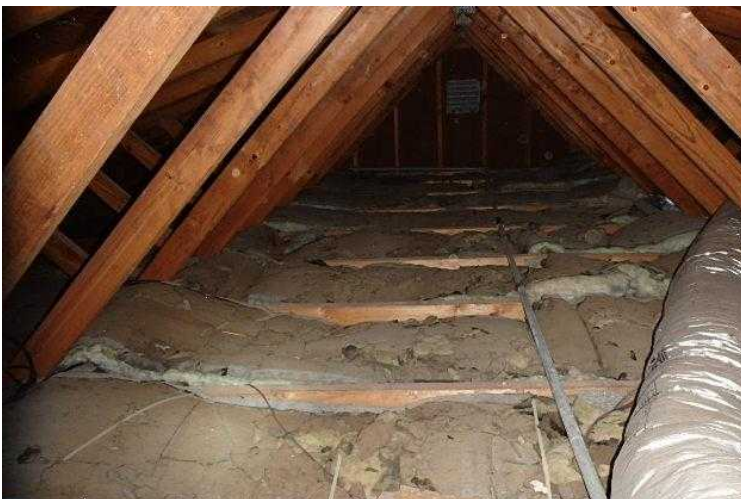
#115 Left attic view.
