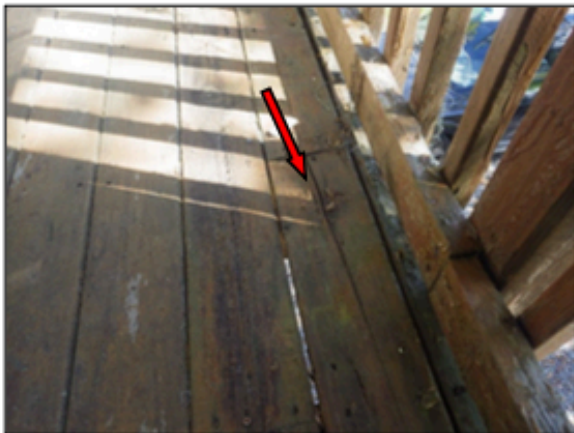
Photo 6:1

Support Pier: Concrete Wood Steel
Floor Material: Concrete Wood Flagstone Pebble aggregate Brick
Condition: Satisfactory Marginal Poor
 Wood rot (at planks - see Photo 6:1) Moisture damage
 Loose/damaged handrails (see red arrow in Photo 6:2) Safety hazard
 Loose planks
 Sagging (at corner - see yellow arrow in Photo 6:2)
 Lack of adequate support (see red arrow in Photos 6:3 & 6:4)
 Moisture staining (see yellow arrow in Photo 6:4)
 Recommend contractor evaluate and repair as needed

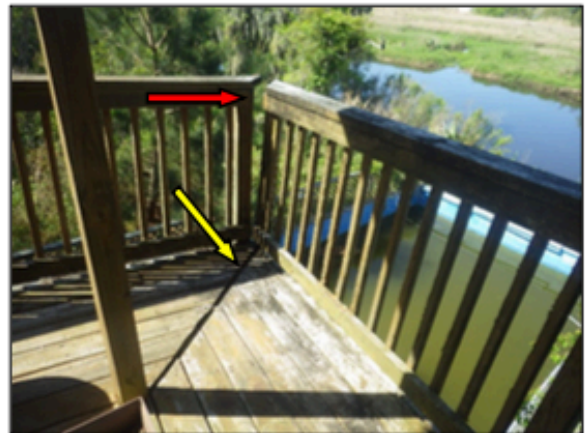
Photo 6:2

- The handrail is loosely attached at multiple locations around the porch. It is recommended that a contractor evaluate the entire porch railing system.
