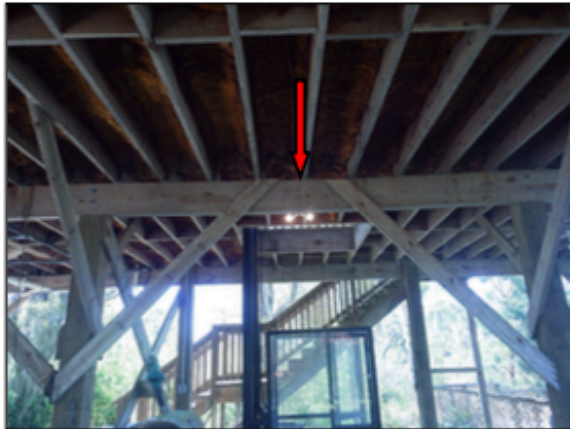
Photo 21:1

- Material:** Steel Wood Concrete block Brick
- Condition:** Satisfactory **Marginal** (2) Poor
- Sagging (beams – see Photo 21:1)
- Moisture stains (see Photo 21:2)

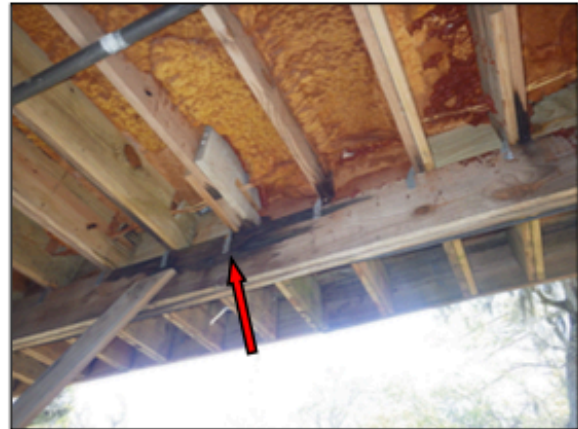
Photo 21:2

This issue is consistent at the same locations on all of the support beams.
