Structural Inspection

September 14, 2021

For: Todd Seal
1937 Grace Street
Slidell, La. 70458

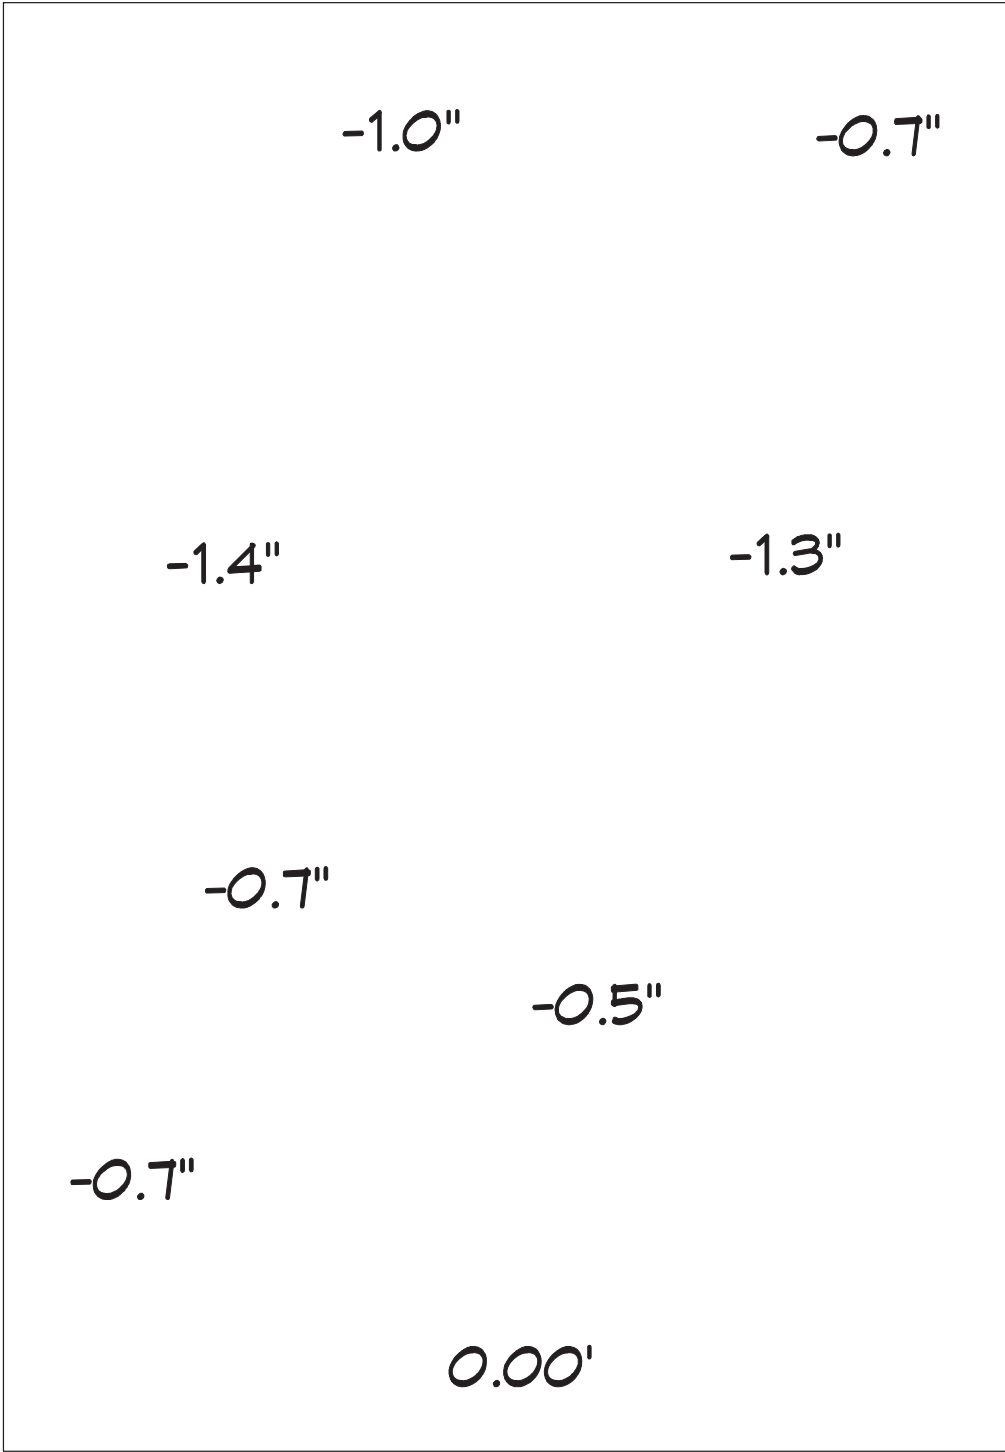
FRONT OF HOME

A zip level was used to verify the floor height conditions inside the home. The level was set up in the foyer area at zero inches and measured throughout the home; there is a 1' difference from the foyer to the rear back bedroom. From the foyer to the 2nd bedroom on the left there is 1.4' difference in elevation. See the attached floor plan with spot elevations.
