Structural Inspection

October 24, 2017

Ref: 212 Melody Lane
Slidell, La. 70458

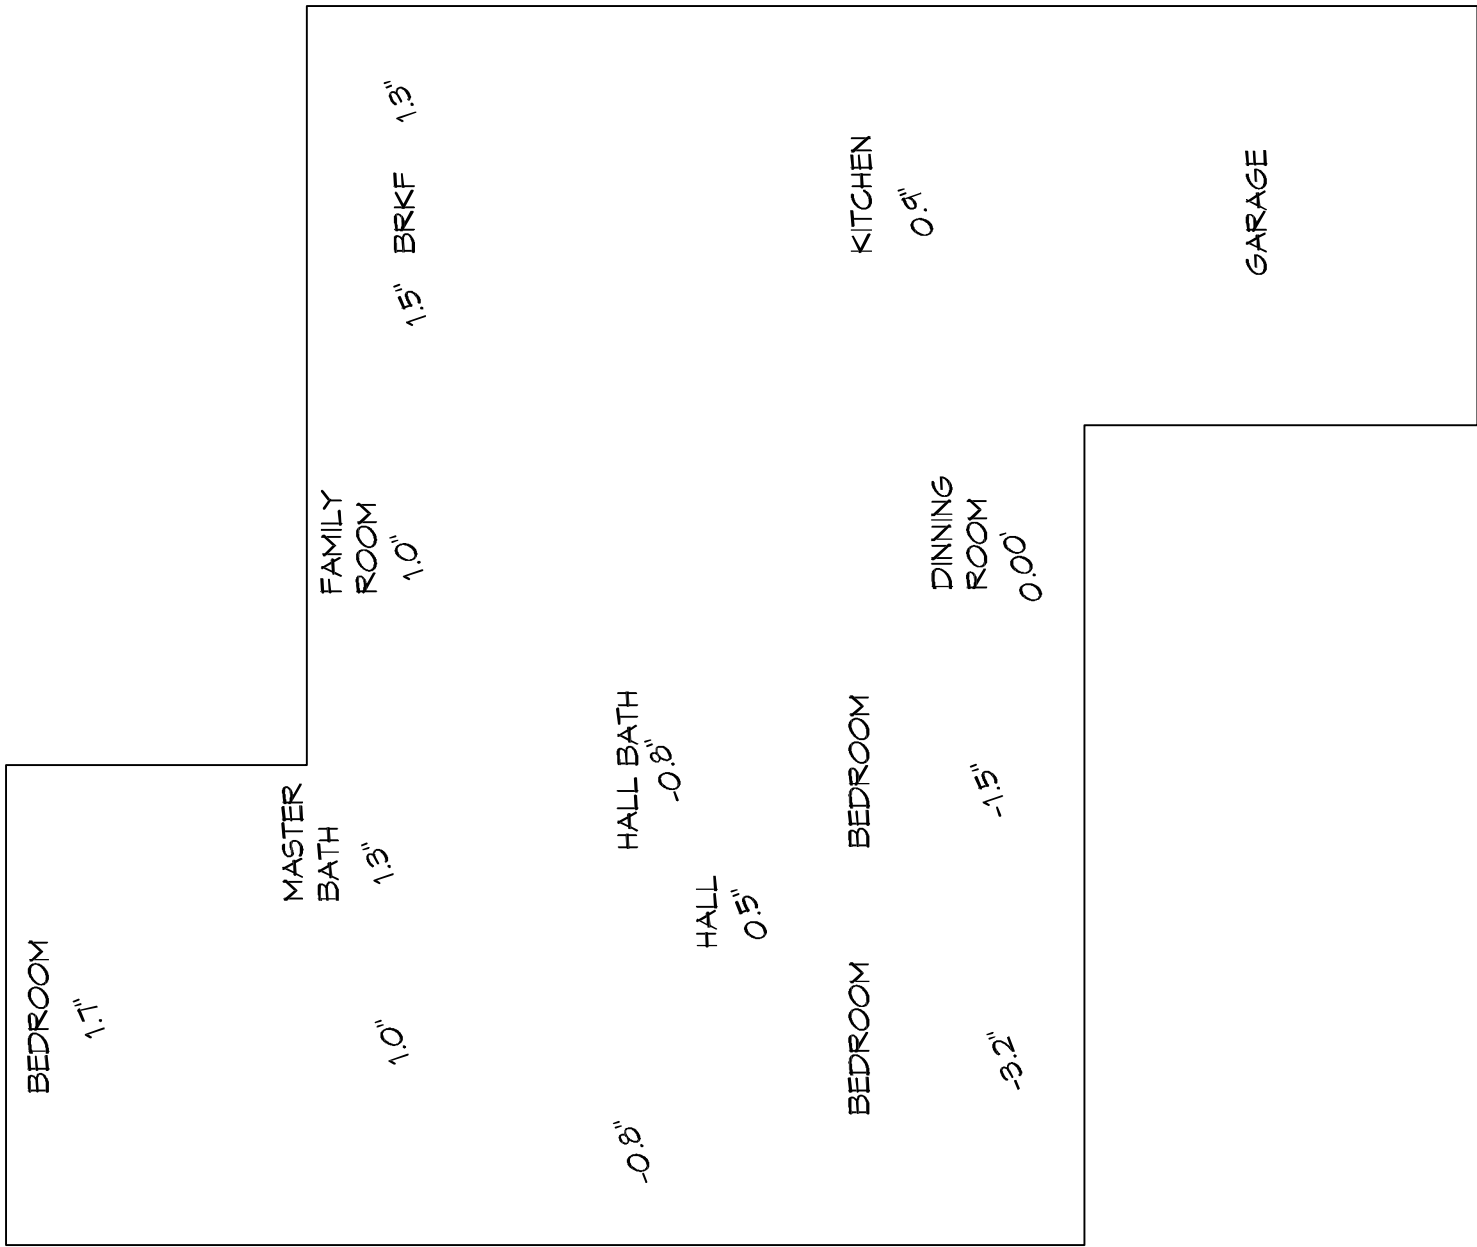
Upon inspection, a zip level was used to verify the floor height conditions. The level was set up at the front of the home near the dining room. The slopes range in the house from 0.0" to -2.3" in the main areas. The area in question (bedrooms), from the back of the master bedroom to the front bedroom has a combined slope of -4".

4" SLOPE TO FRONT

It is recommended when there is more than a 3” elevation difference (tripping hazard) to have the home stabilized with screw pilings.
