# STRUCTURE

212 Melody Lane, Slidell, LA October 17, 2017

Report No. 1231

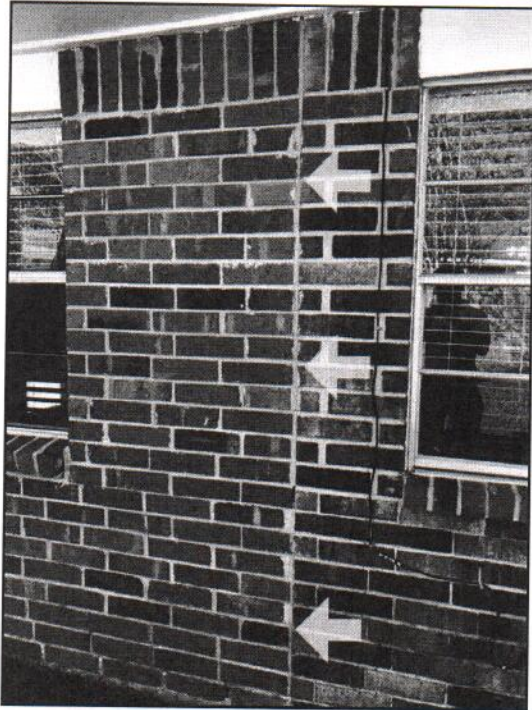
**15. Condition:** • Prior repairs

**Implication(s):** Weakened structure

**Location:** Rear Exterior Wall

16. Prior repairs

**Task:** Further evaluation Request disclosure

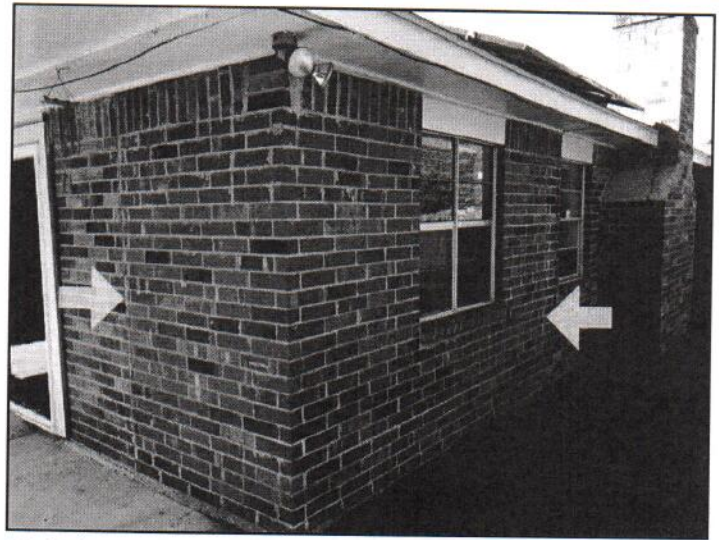
17. Prior repairs

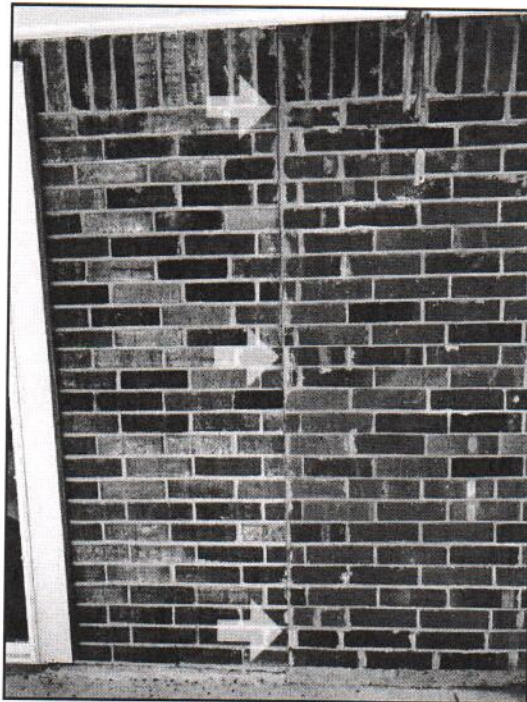
18. Prior repairs

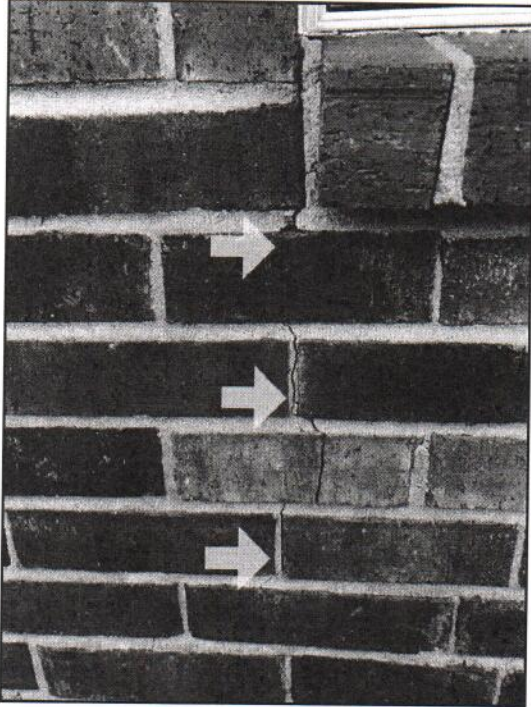
16. Condition: • Cracked

Implication(s): Weakened structure

Location: Throughout Exterior Wall

19. Cracked

**13.** • For all recommendations concerning brick work, I recommend contacting a licensed masonry contractor for further evaluation.

**Task:** Further evaluation

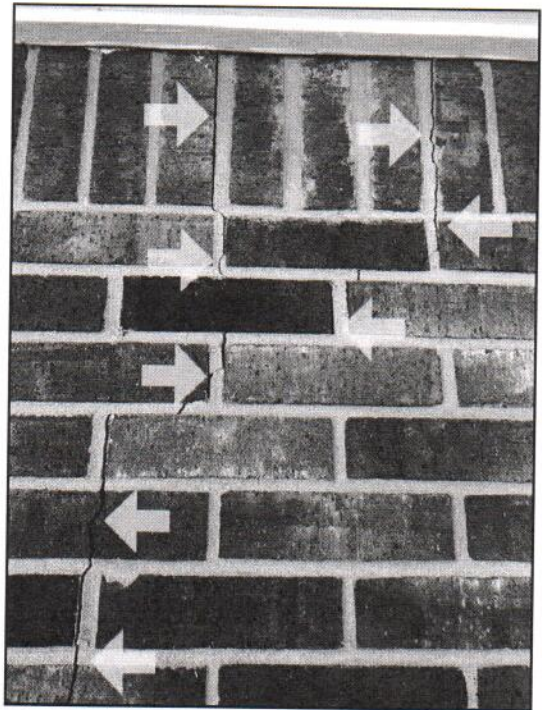
20. Cracked

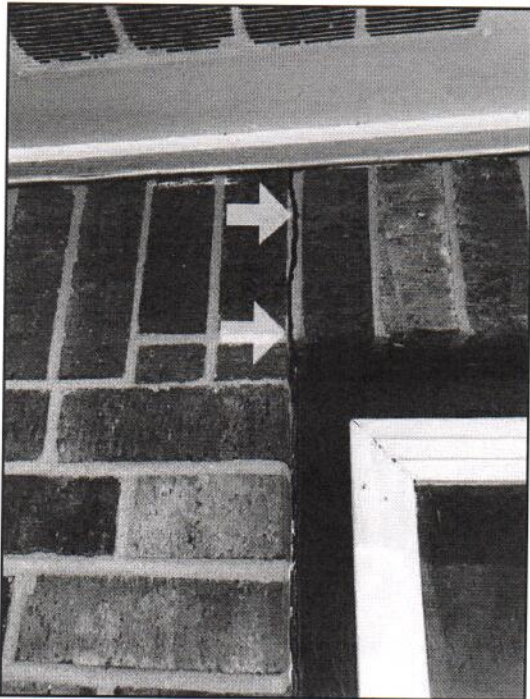
21. Cracked

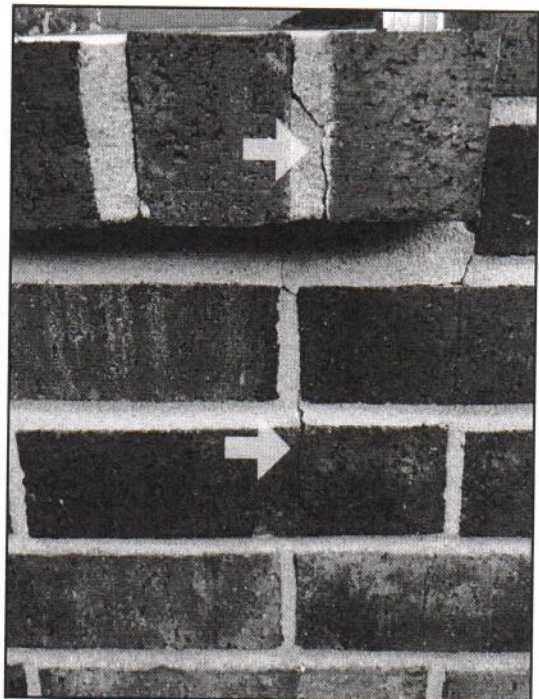
22. Cracked

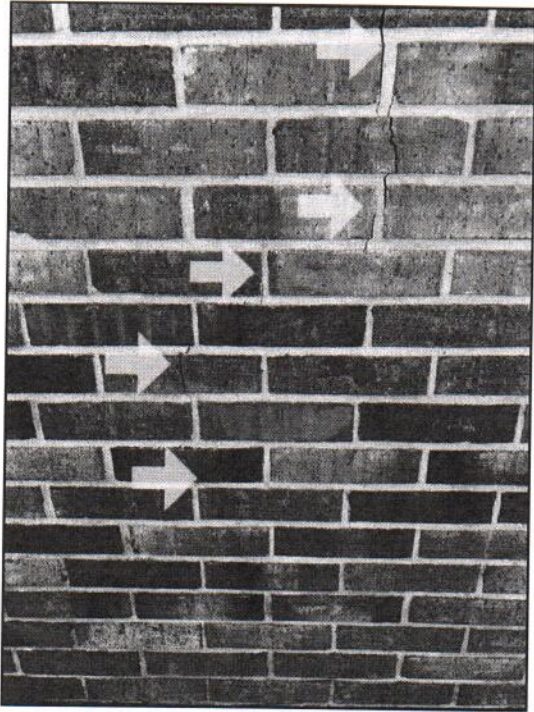
23. Cracked

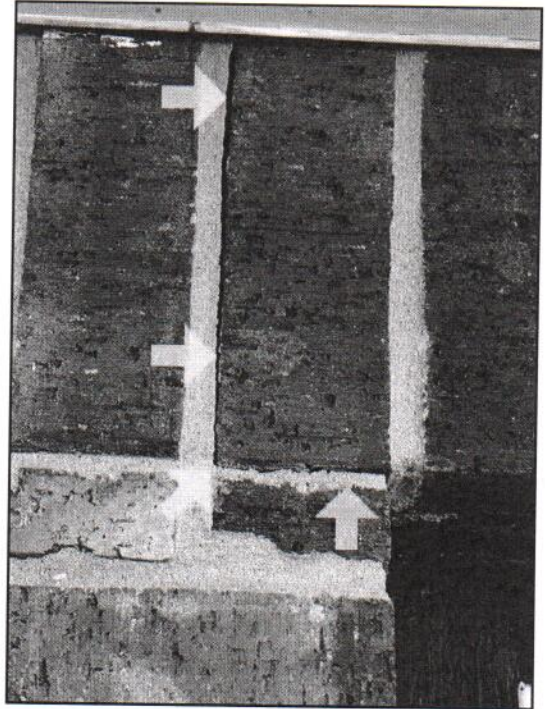
24. Cracked

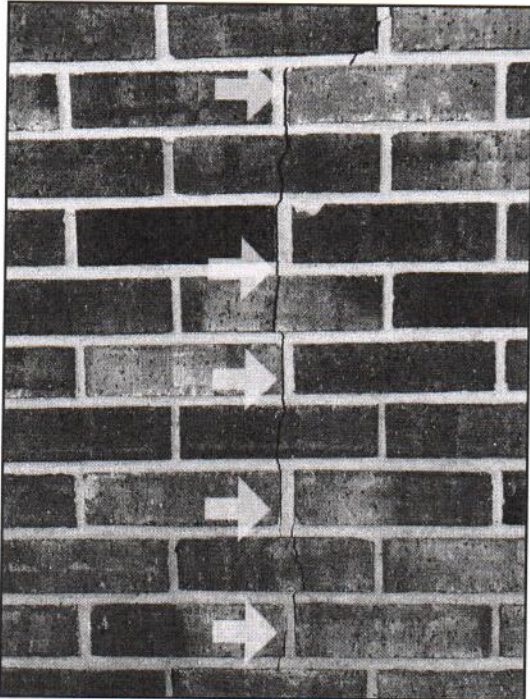
25. Cracked

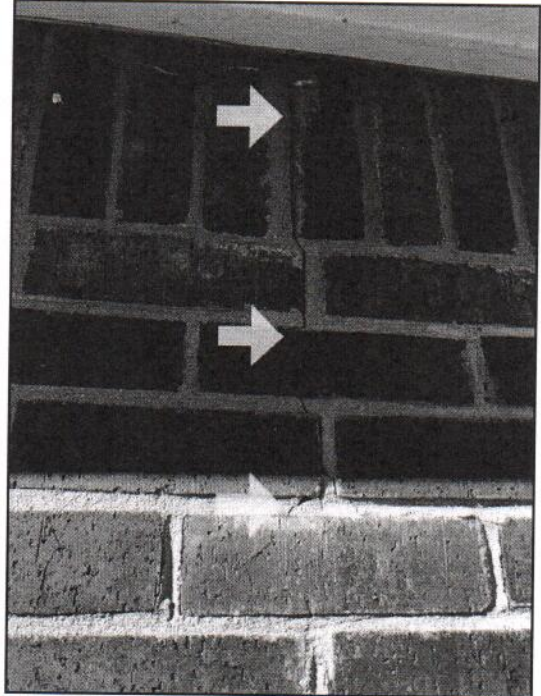
26. Cracked

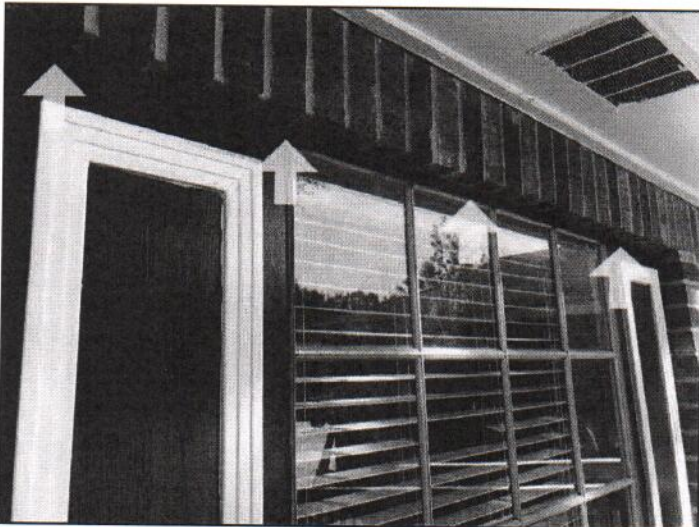
17. Condition: • Rust

Implication(s): Weakened structure | Chance of structural movement

**Location:** Front Exterior Wall

27. Rust

**Task:** Repair Further evaluation

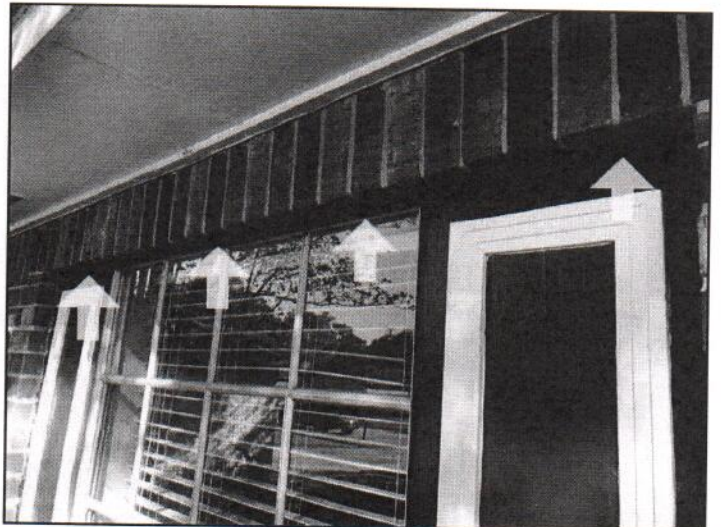
28. Rust
