7.17.18

2228 2nd St
Slidell, LA 70458

House Call Home Inspection
Paul Fortmayer LA LHI # 10899
C(985) 237-8292 F(270) 717-7361
PFortmayer@HouseCallUSA.net

INSPECTION CONDITIONS

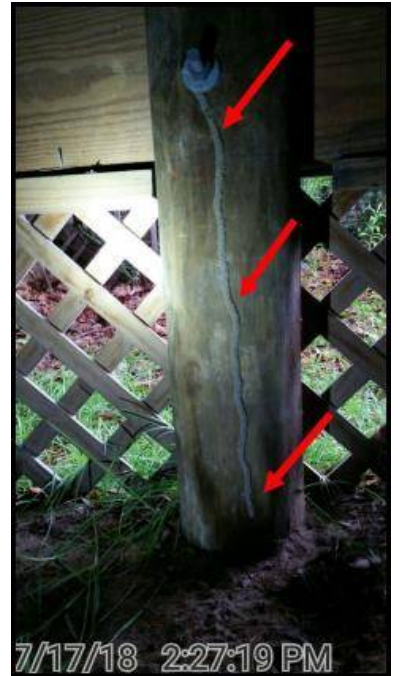
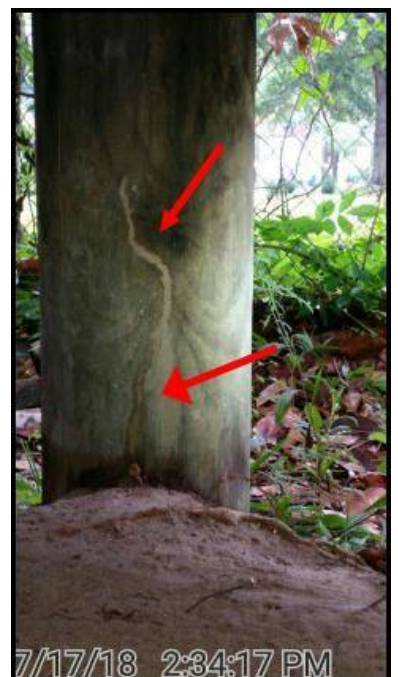
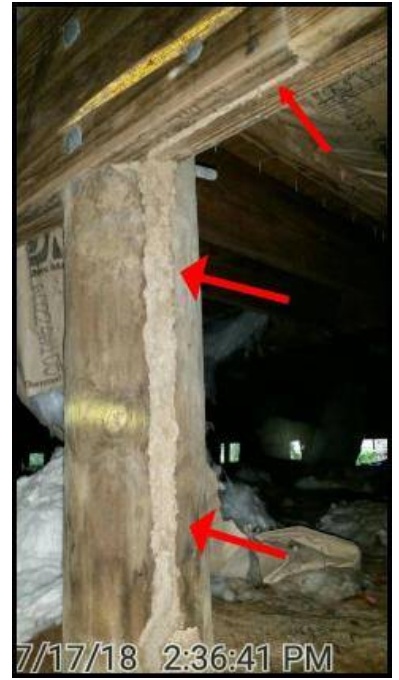
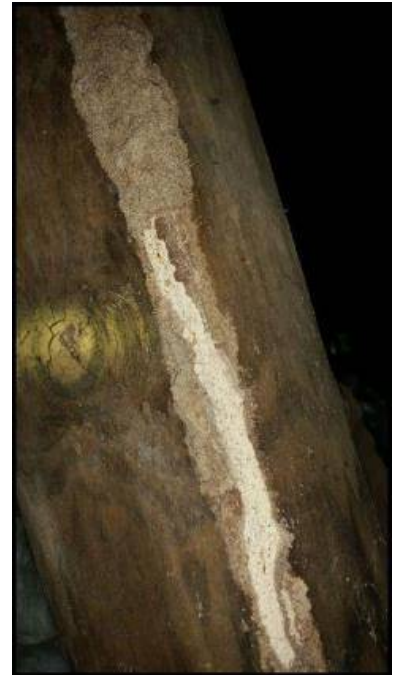
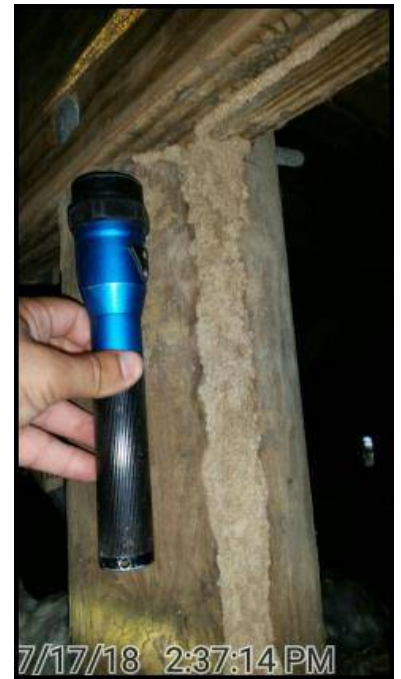
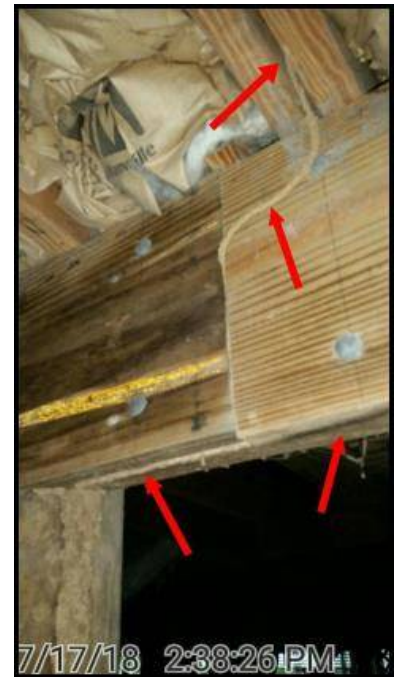
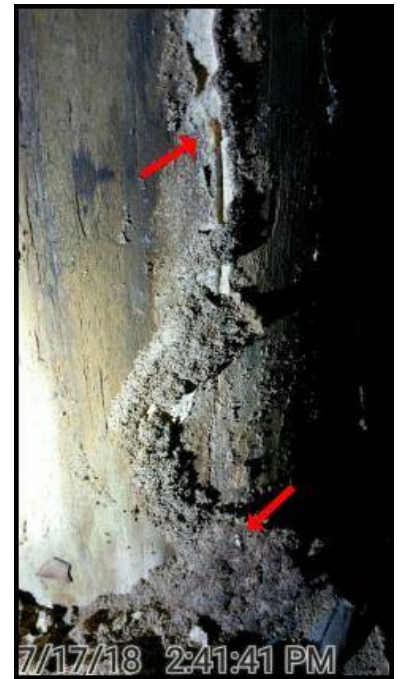
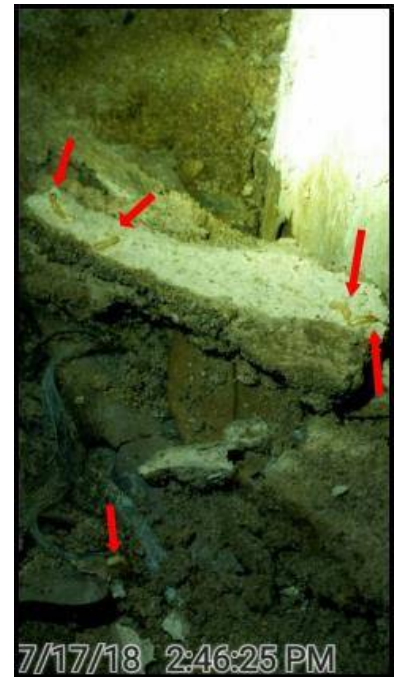
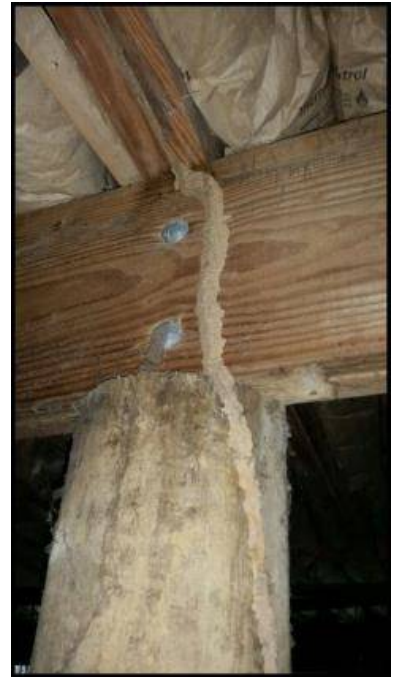
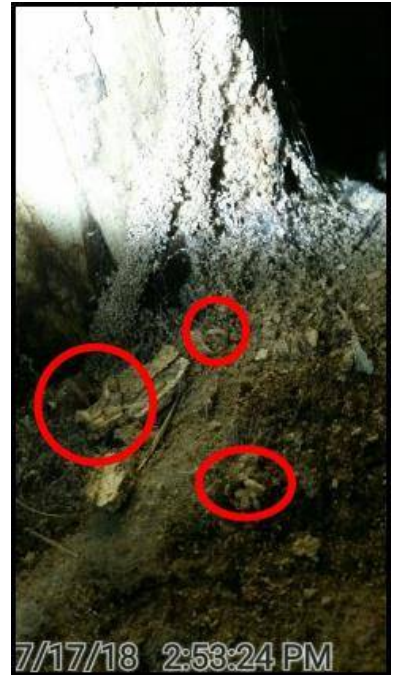
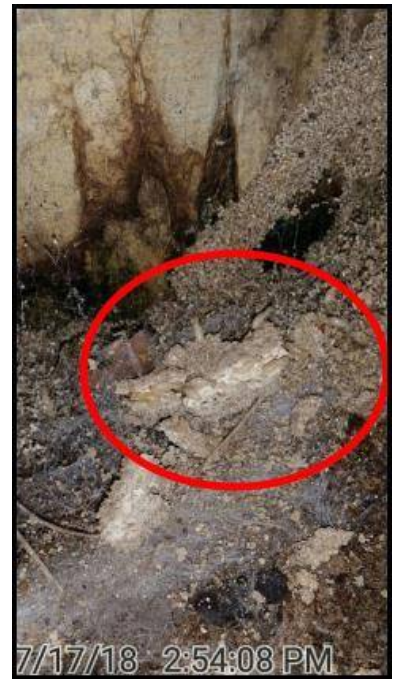
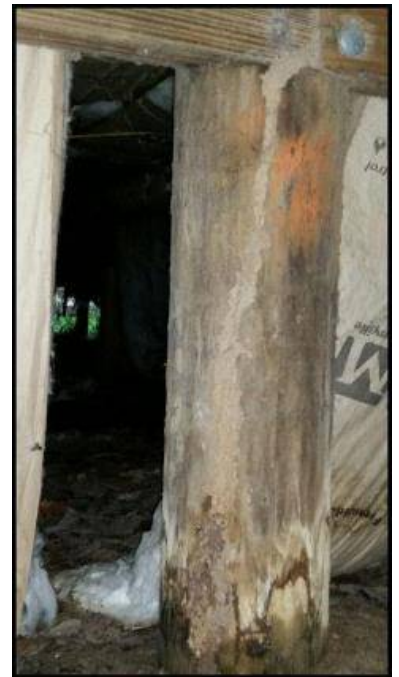
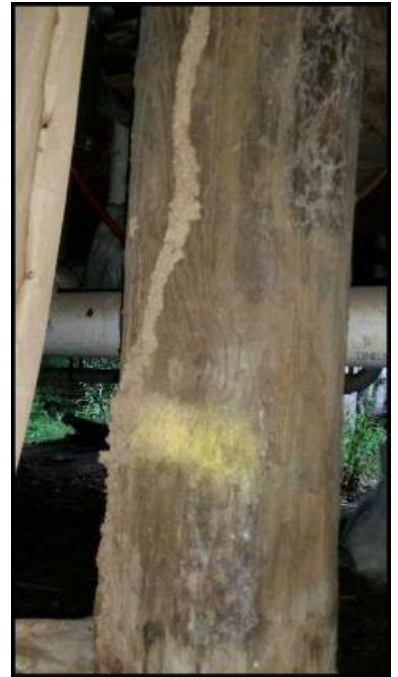
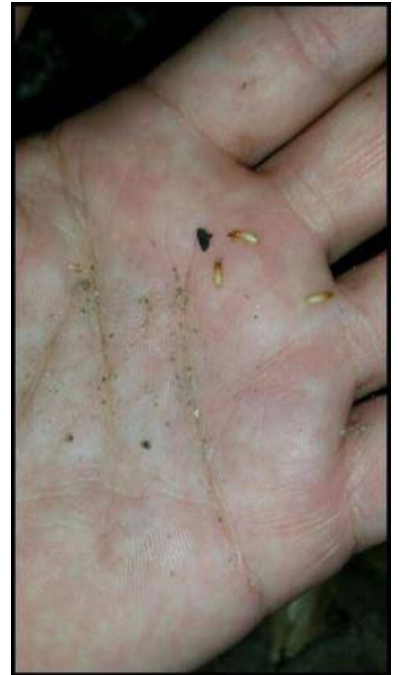
Termite shelter tubes noted in multiple locations throughout the crawlspace. The shelter tubes are noted on the wooden piers, the structural support members, and the subfloor. Damage and active termites noted.

The following photos show the some of the shelter tubes, damage and termite activity found.

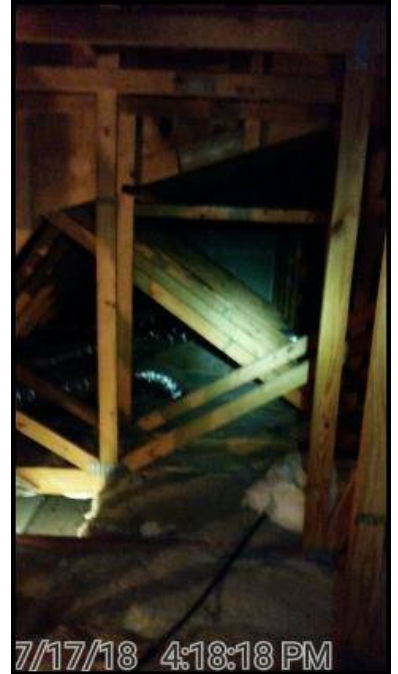
Restricted access due to attic design. Only partially entered/partially inspected.

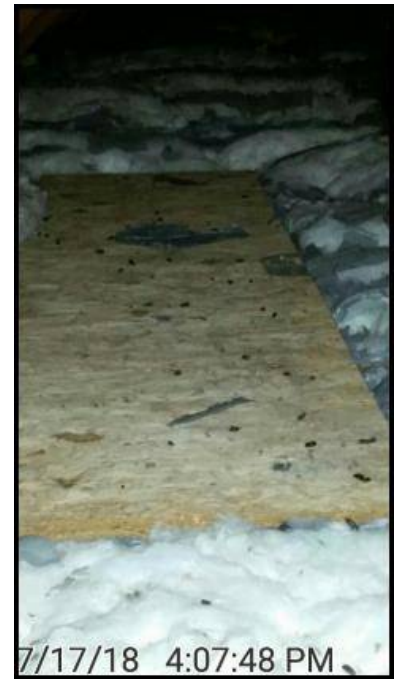
More rodent droppings noted.

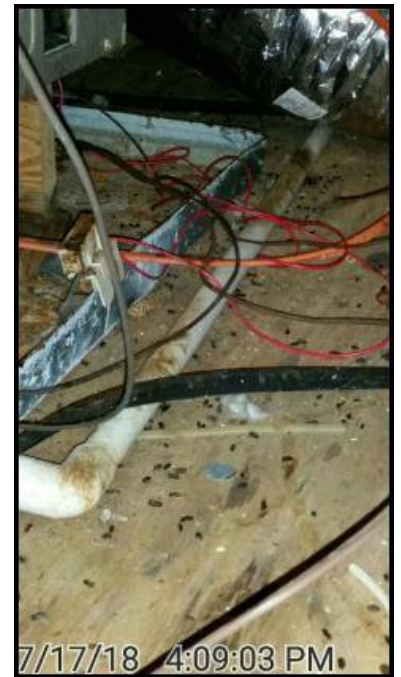
More droppings noted and grease runs noted.

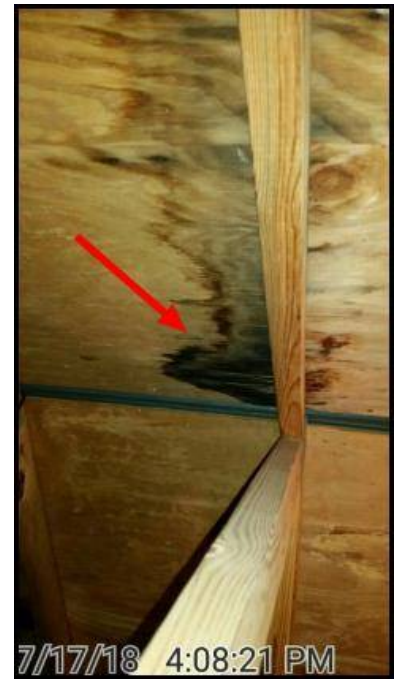
The following concerns were noted at the attic:
Significant staining is noted in the rear right attic space.

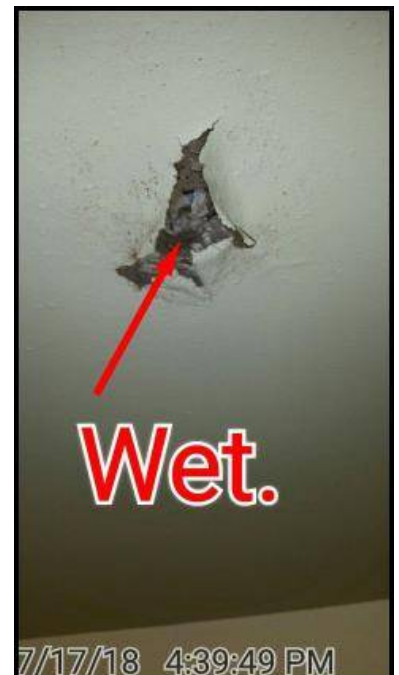
The following concerns were noted at the attic:
Active leakage noted at the right side front hall.
This area of the attic was not accessible. Further evaluation recommended by a qualified licensed roofing contractor and repair as needed.

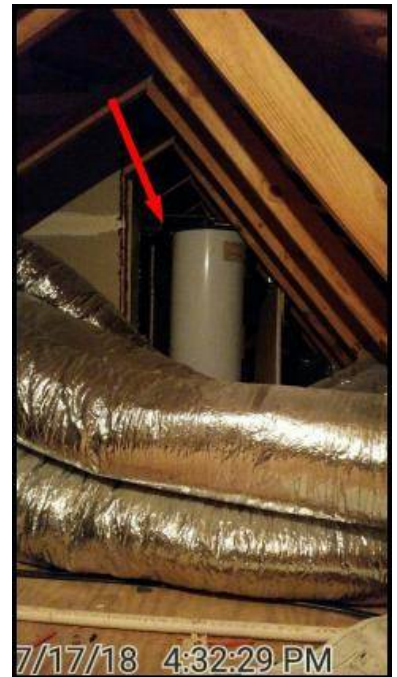
WATER HEATER CONCERNS: Improper serviceable access. There should be secure and sturdy walk boards, clear of obstruction and trip hazards, with a minimum 30"x30" platform at the unit's serviceable side for safe access.

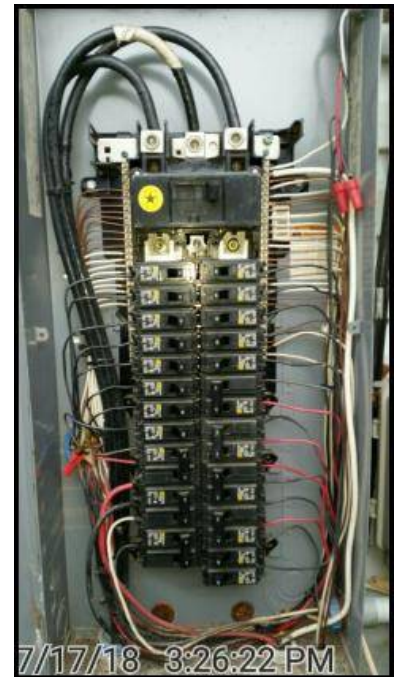
- * Panel is outdated by today's standards
- * White wire used as hot circuit not properly marked (Should be painted/taped black).

- * No AFCI (arc fault circuit interrupter) breakers were visible. Recommend installing AFCI breakers to comply with current safety standards.

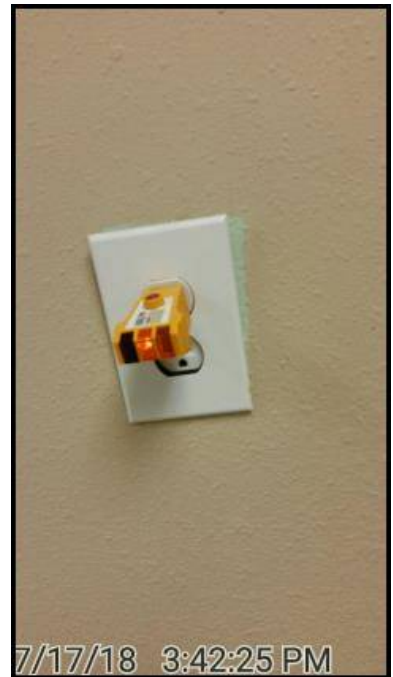
The following concerns were noted with the switches and outlets: Miswired outlets noted, Damaged outlets are viewed, Loose outlet noted, Possible loose wiring noted at outlet, Worn outlets/switches noted. This is usually the result of normal wear, and upgrading is recommended, Recommend evaluation by a qualified licensed electrician and repair or replace as needed.

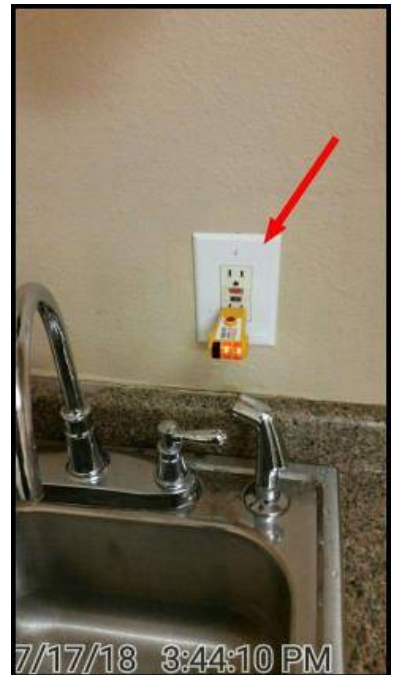
The following concerns were noted with the switches and outlets: GFCI not operational, Recommend evaluation by a qualified licensed electrician and repair or replace as needed.

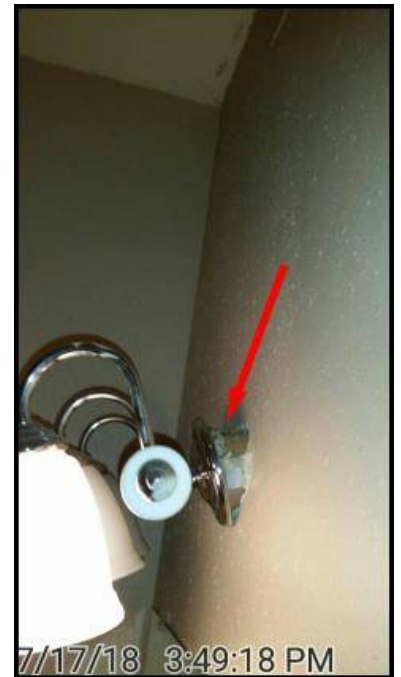
The following concerns were noted with the lights:
Bath light is loose at the wall.

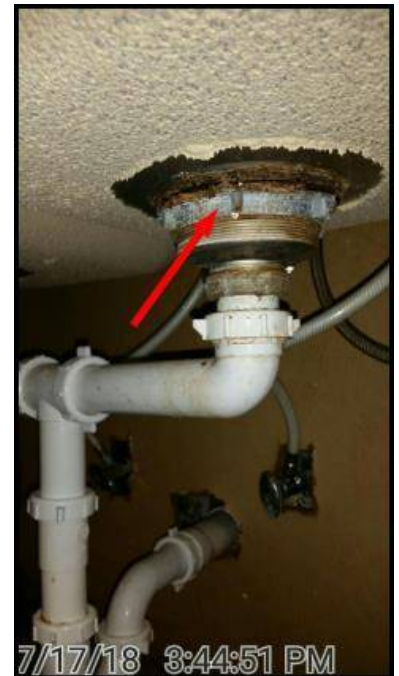
The following concerns were noted with the kitchen sink: Leakage is present, noted at the drain line.

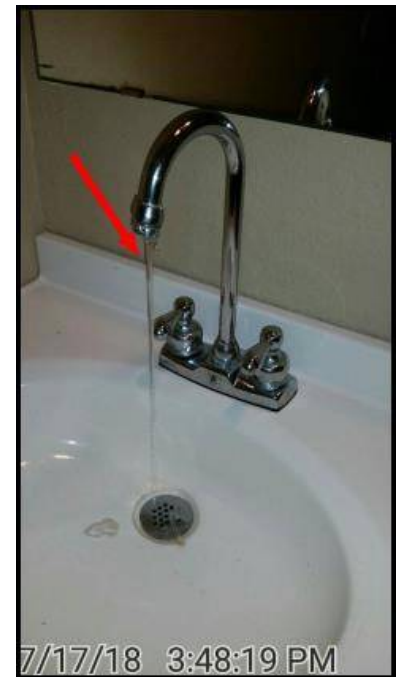
The following concerns were noted at the bathroom sink: Low water volume is noted. Further evaluation recommended by a qualified licensed plumbing contractor.

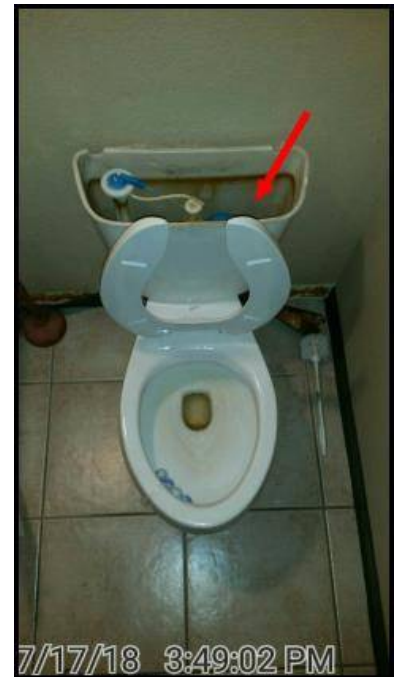
The following concerns were noted at the toilet:
Toilet is not working. The water is off. Inspectors
are not allowed to turn on any equipment that is off.
Verify reason with seller and repair or replace as
needed.
