## Structural Inspection

May 24, 2022

James Kevin Curley  
2800 Gause Blvd.  
Slidell, La. 70461

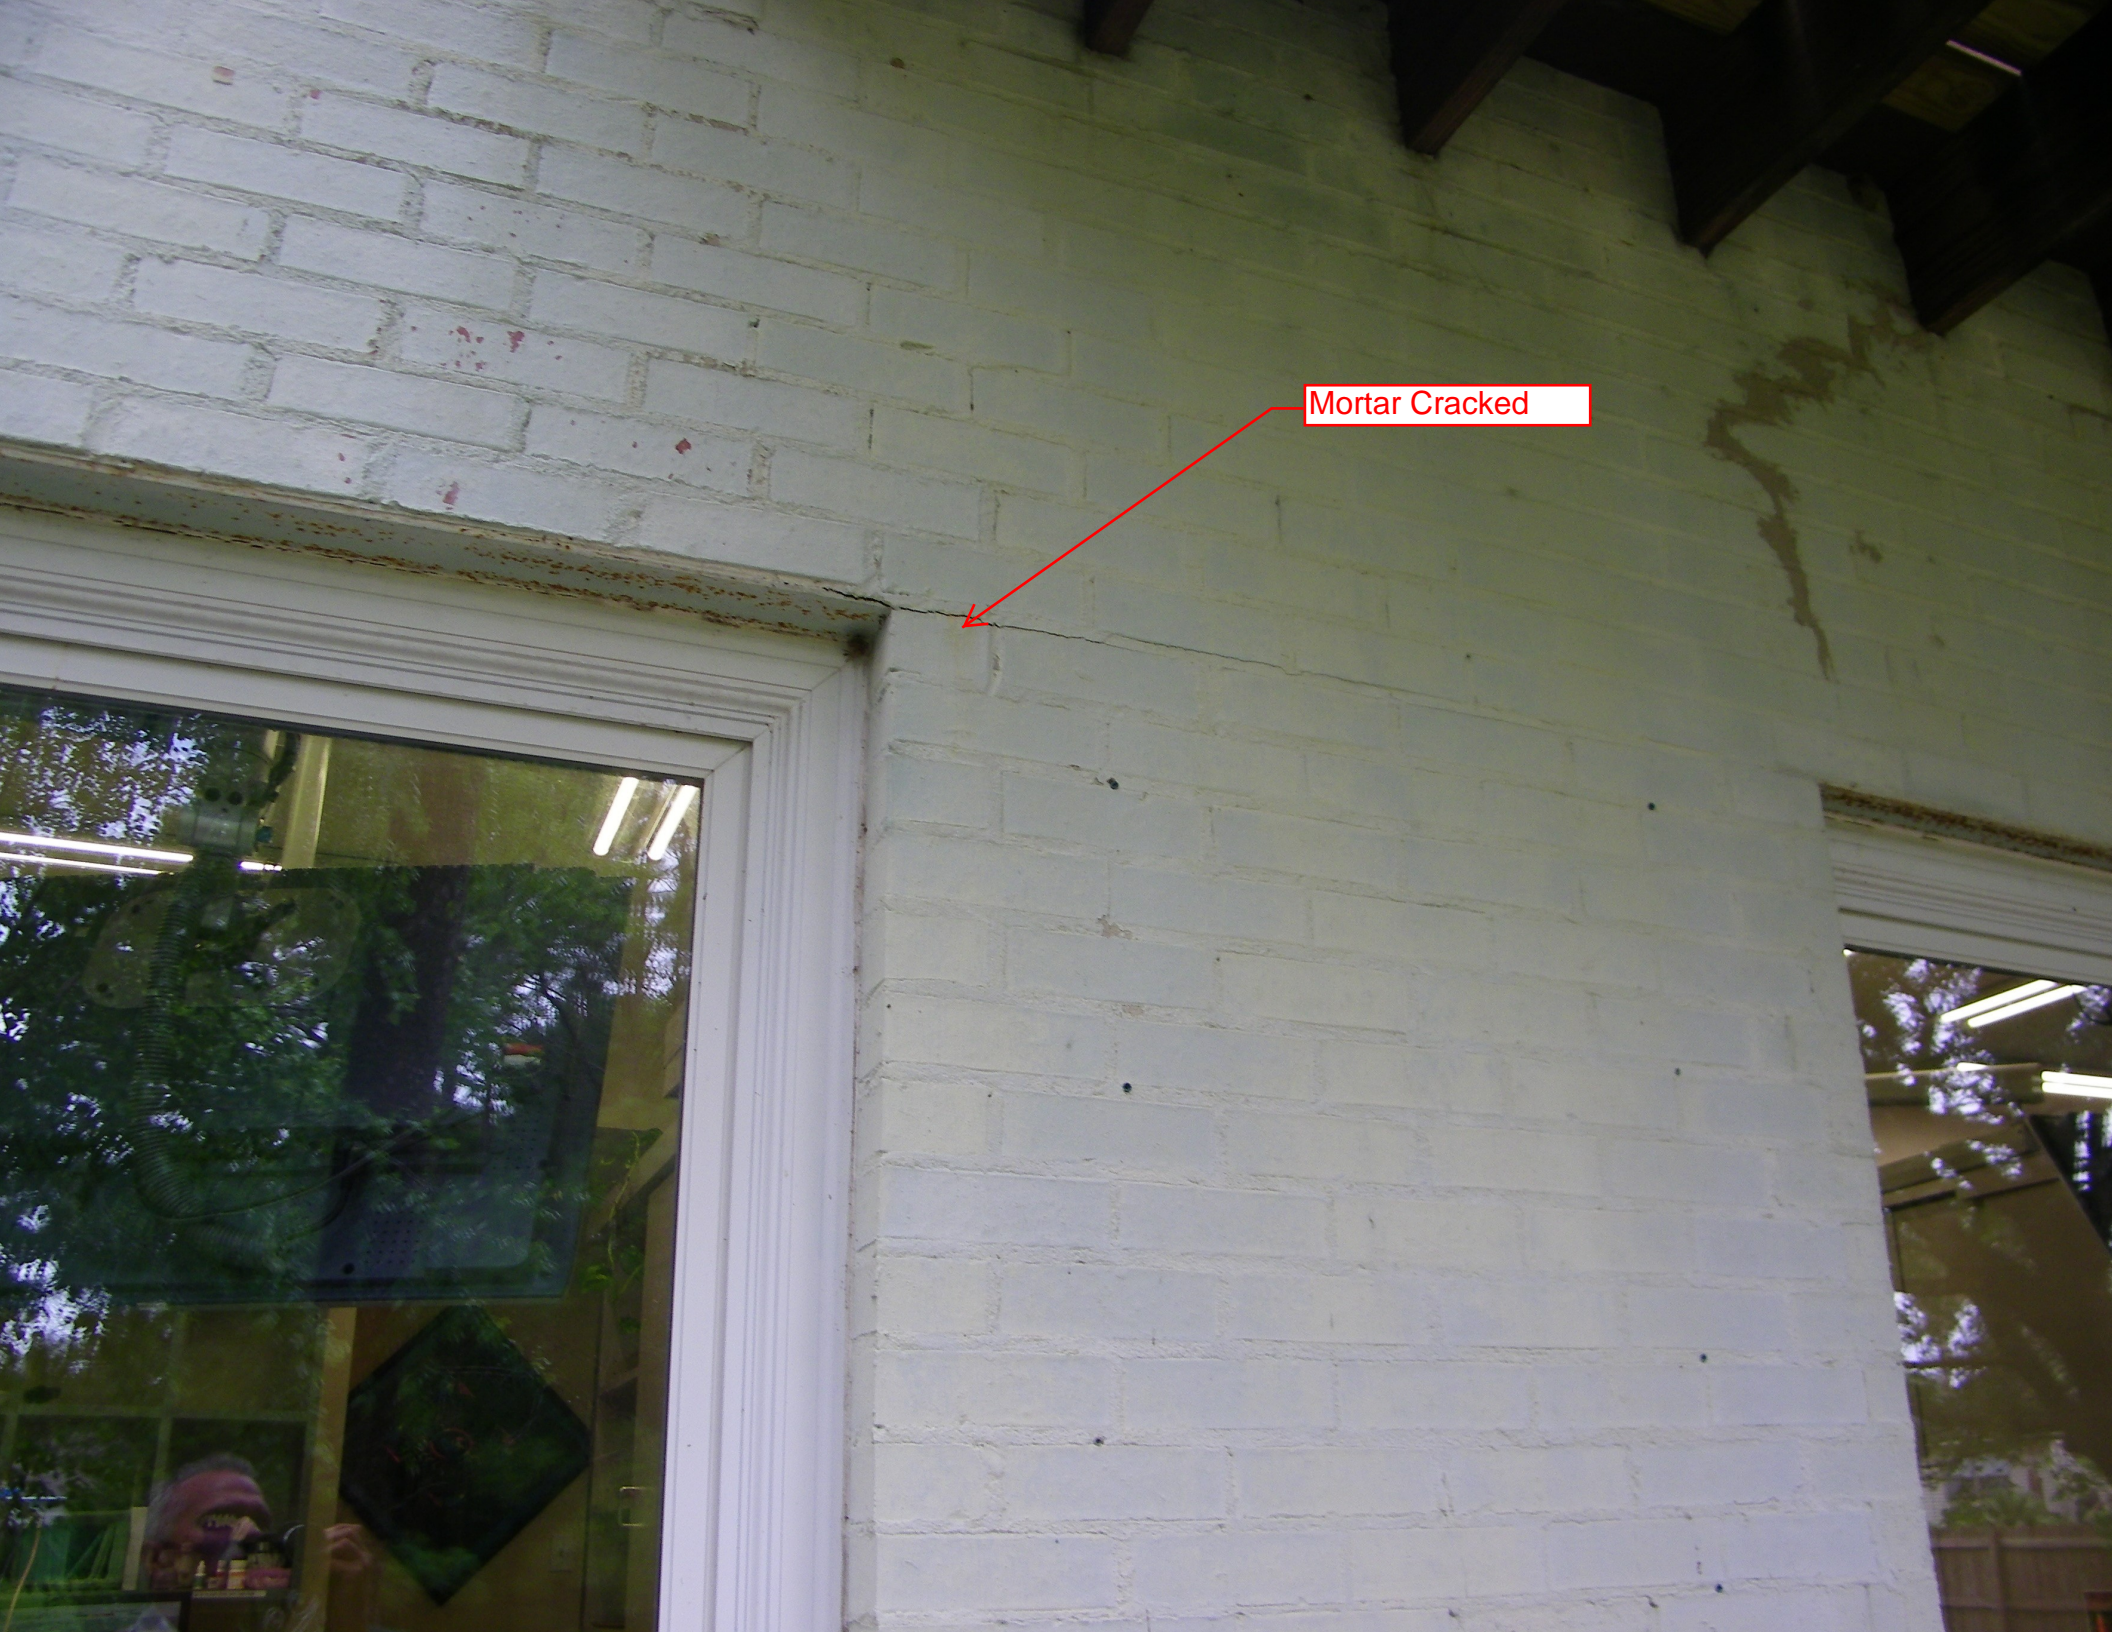
- 1) There are some bricks that have cracked mortar around them horizontally and vertically; the cracks in the brick veneer do not show up in the foundation.
- 2) Two down spouts at the corners of the bldg are not lined up to flow onto the backsplash blocks.

Mortar cracked

Mortar Cracked

- 1) Seal the cracks in the brick veneer with a non-shrinking grout, to prevent insects from entering the building.
- 2) Align downspouts on back of building to flow onto the backsplashes provided.

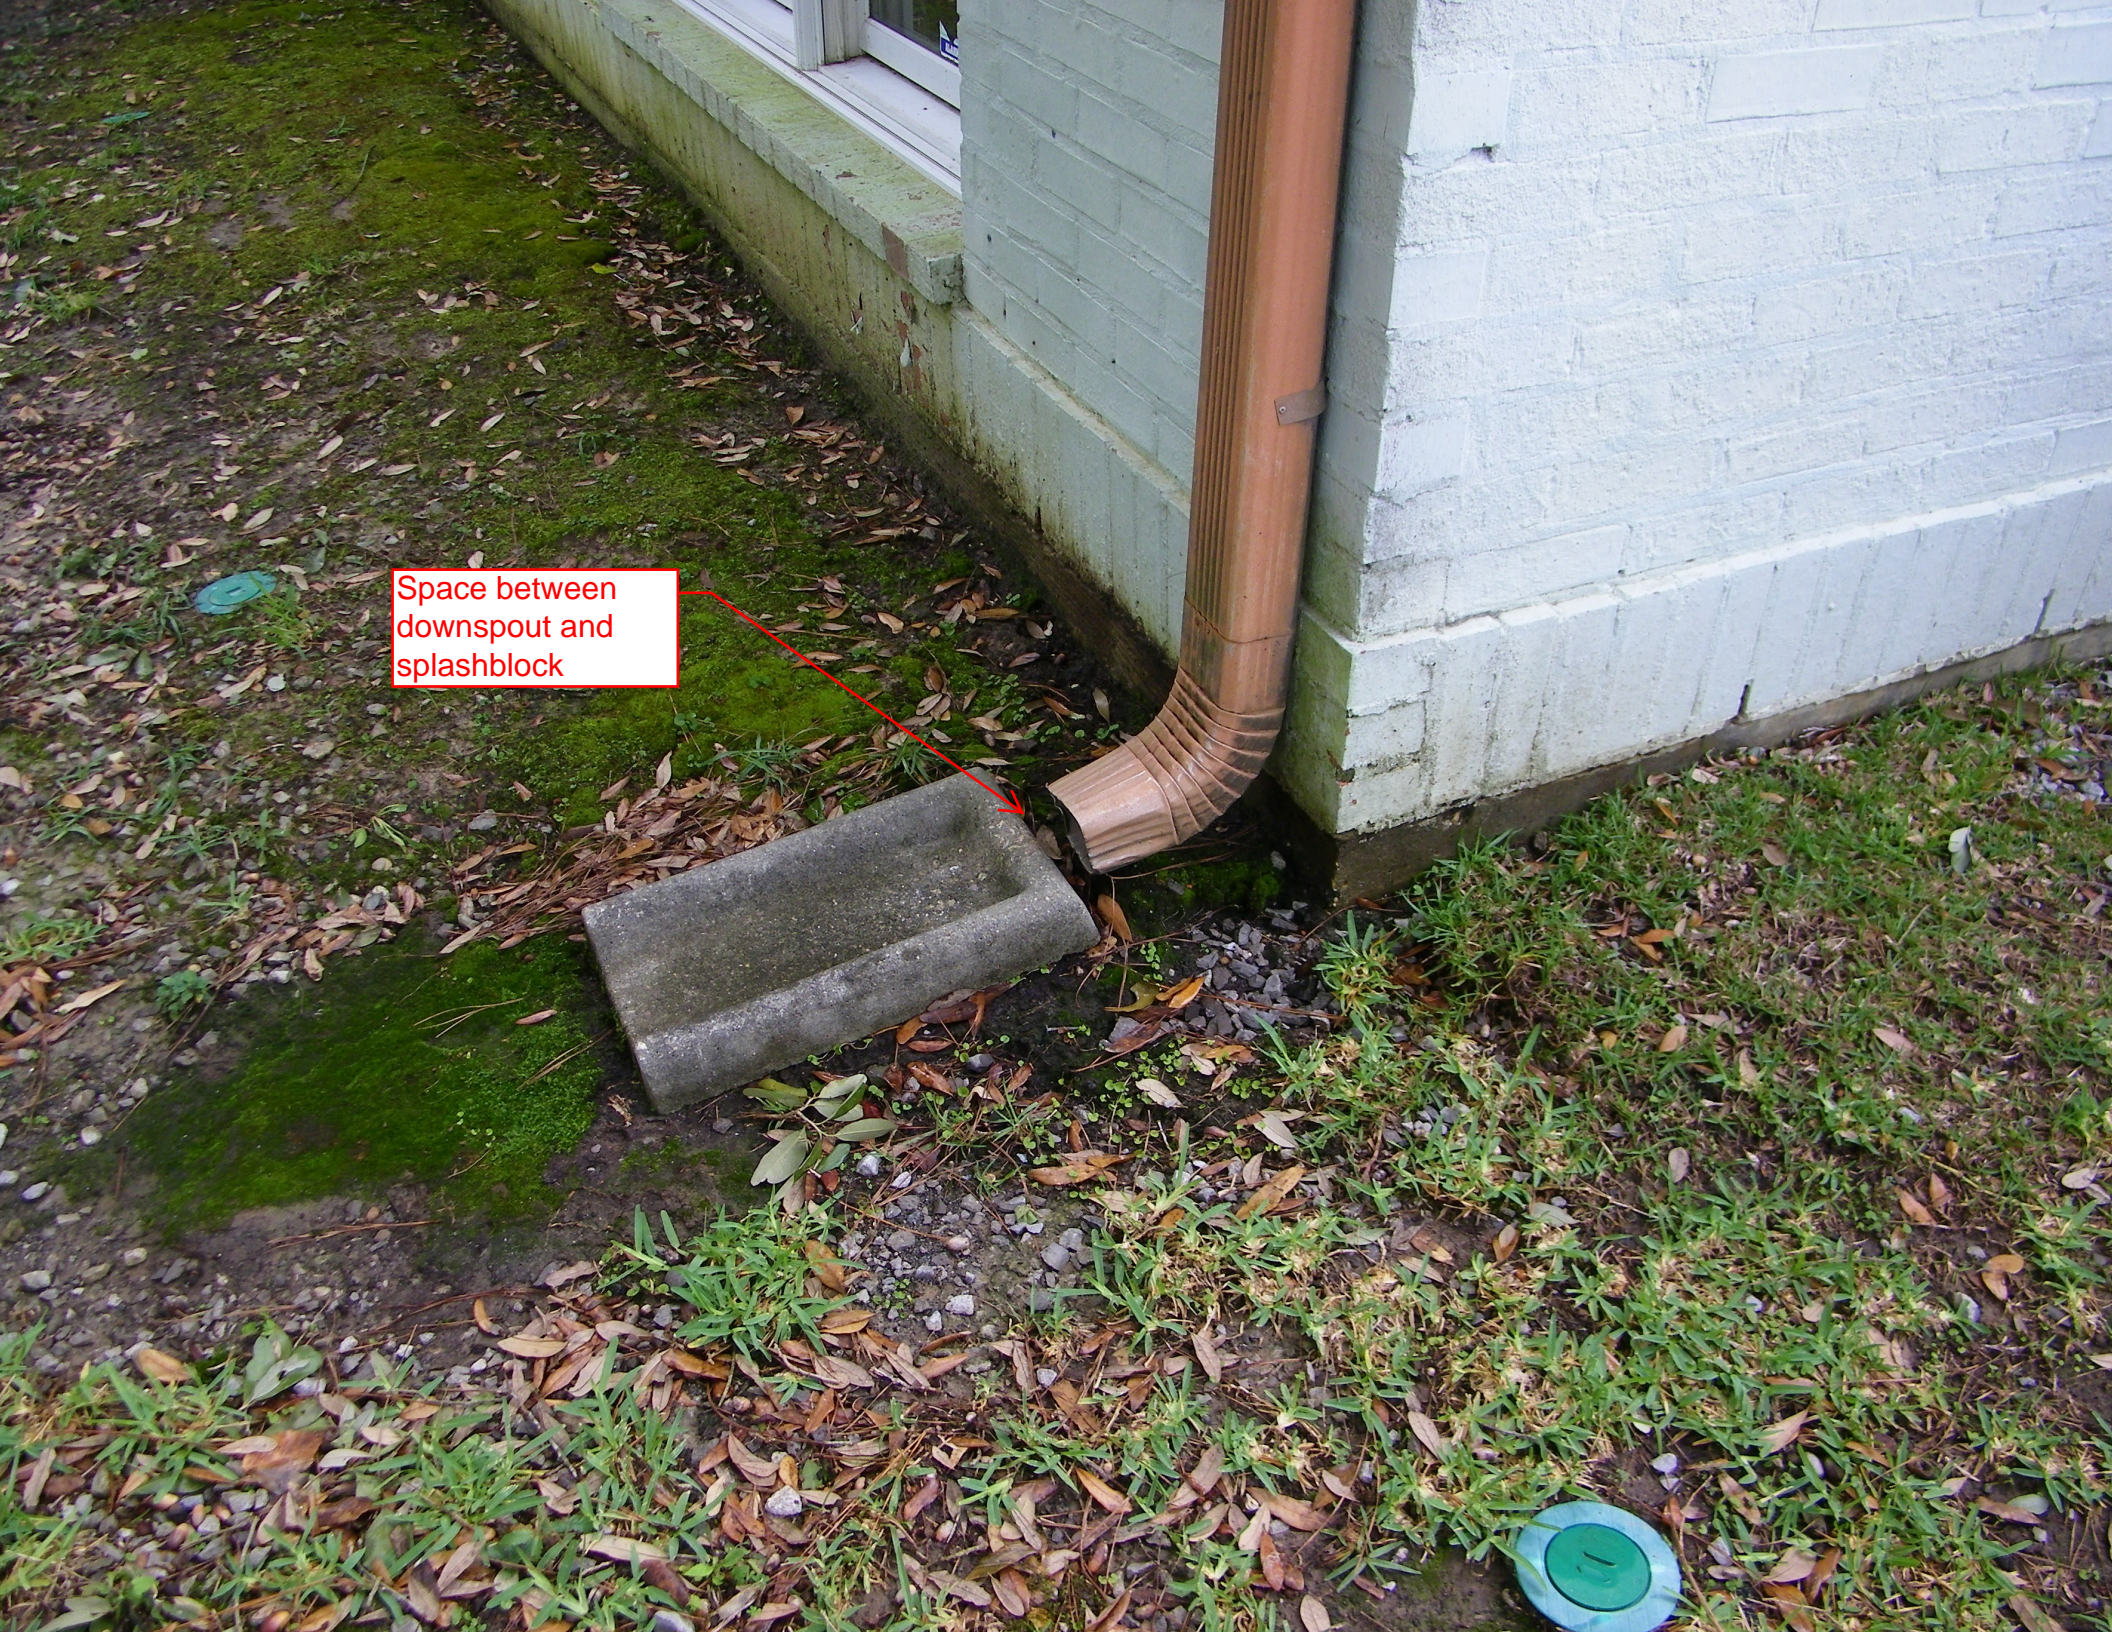
Space between  
downspout and  
splashblock
