Structural Inspection

February 17, 2017

Ref: 301 River Landing Road
Slidell, La. 70461

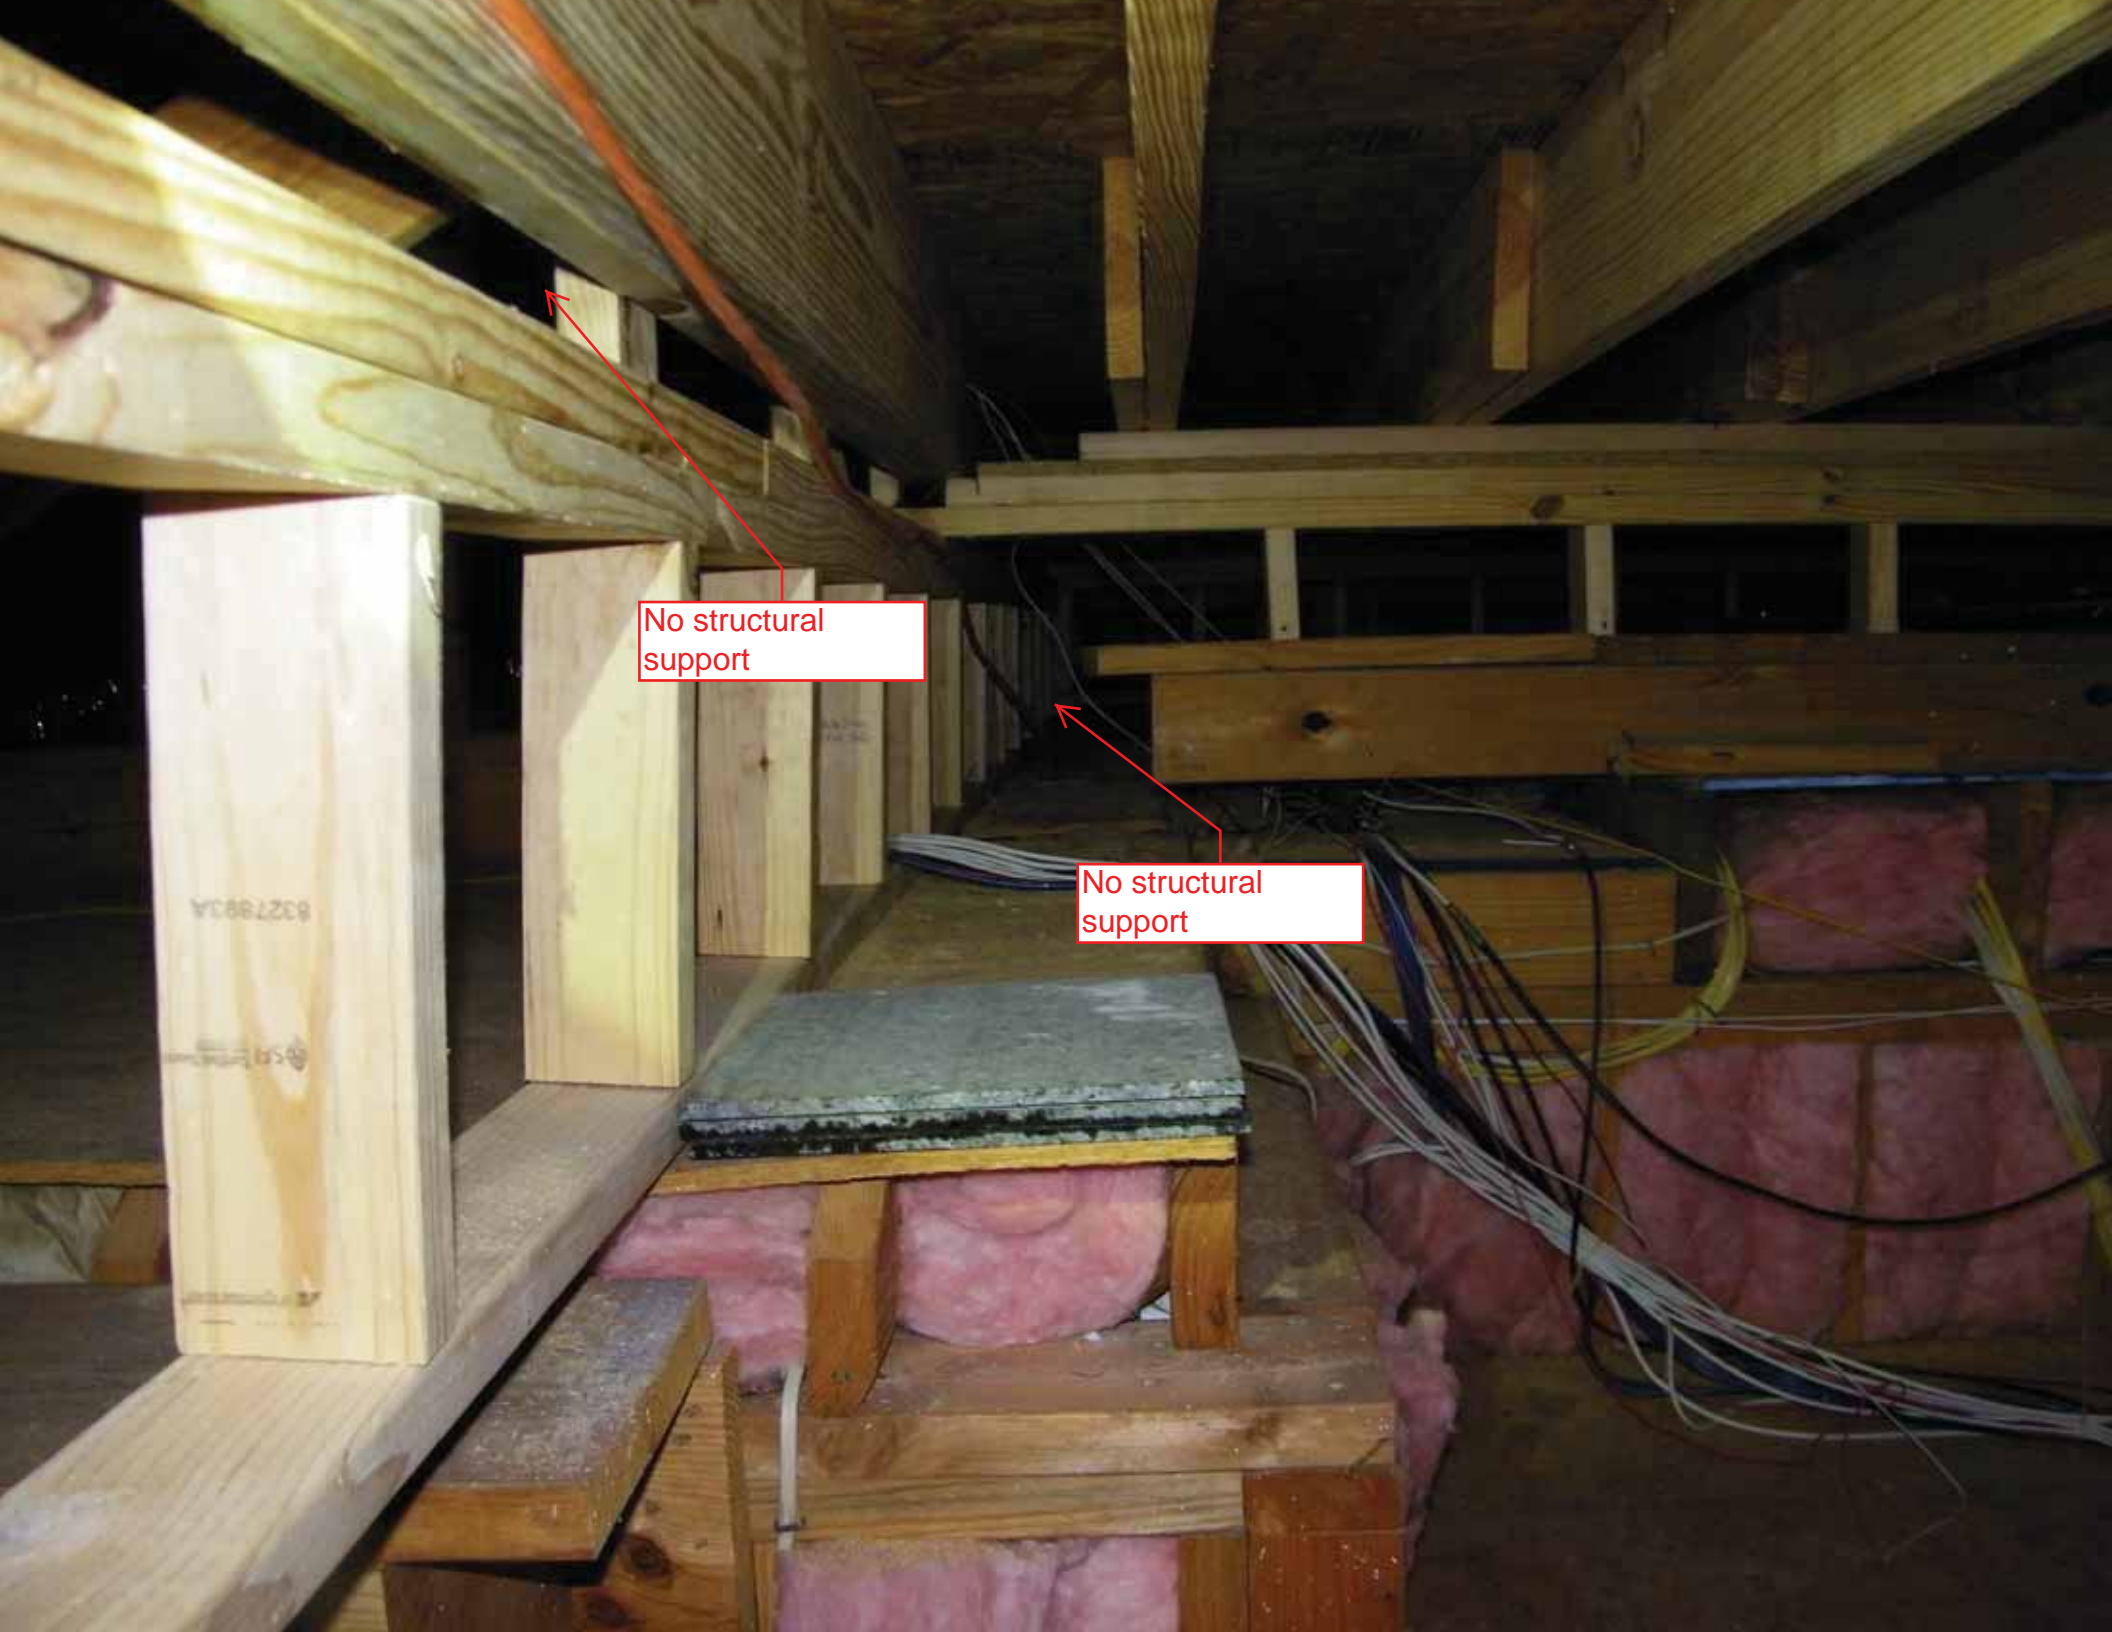
No structural support

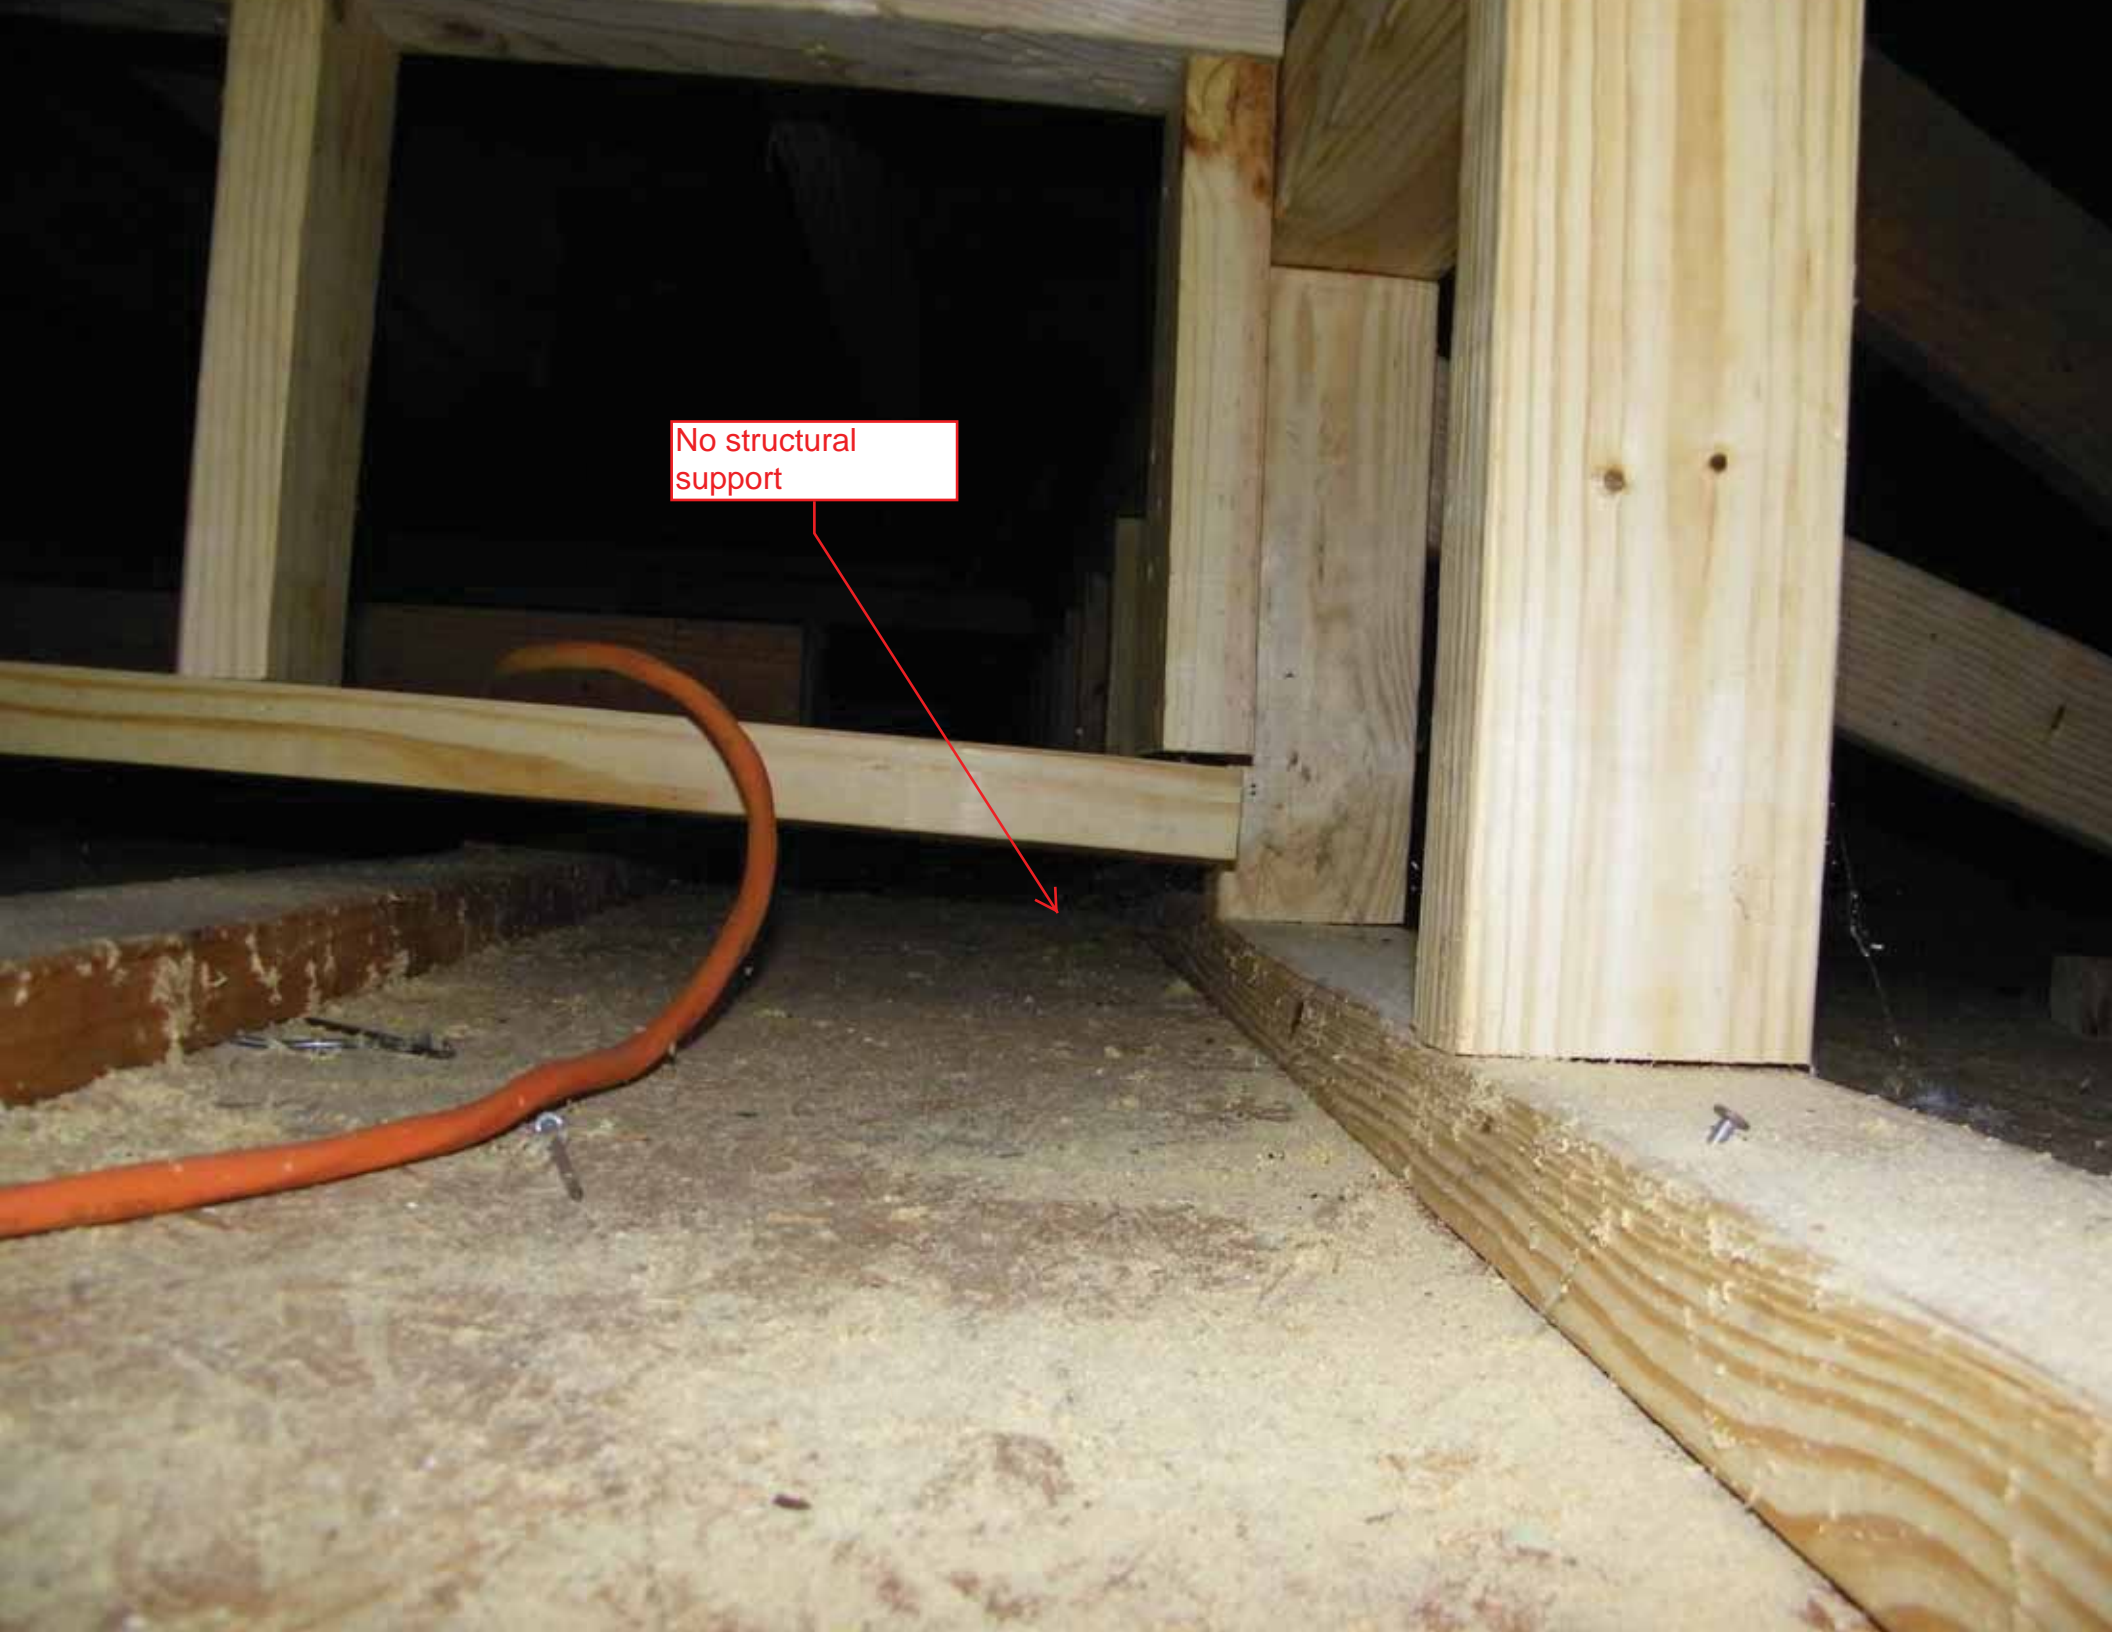
No structural support

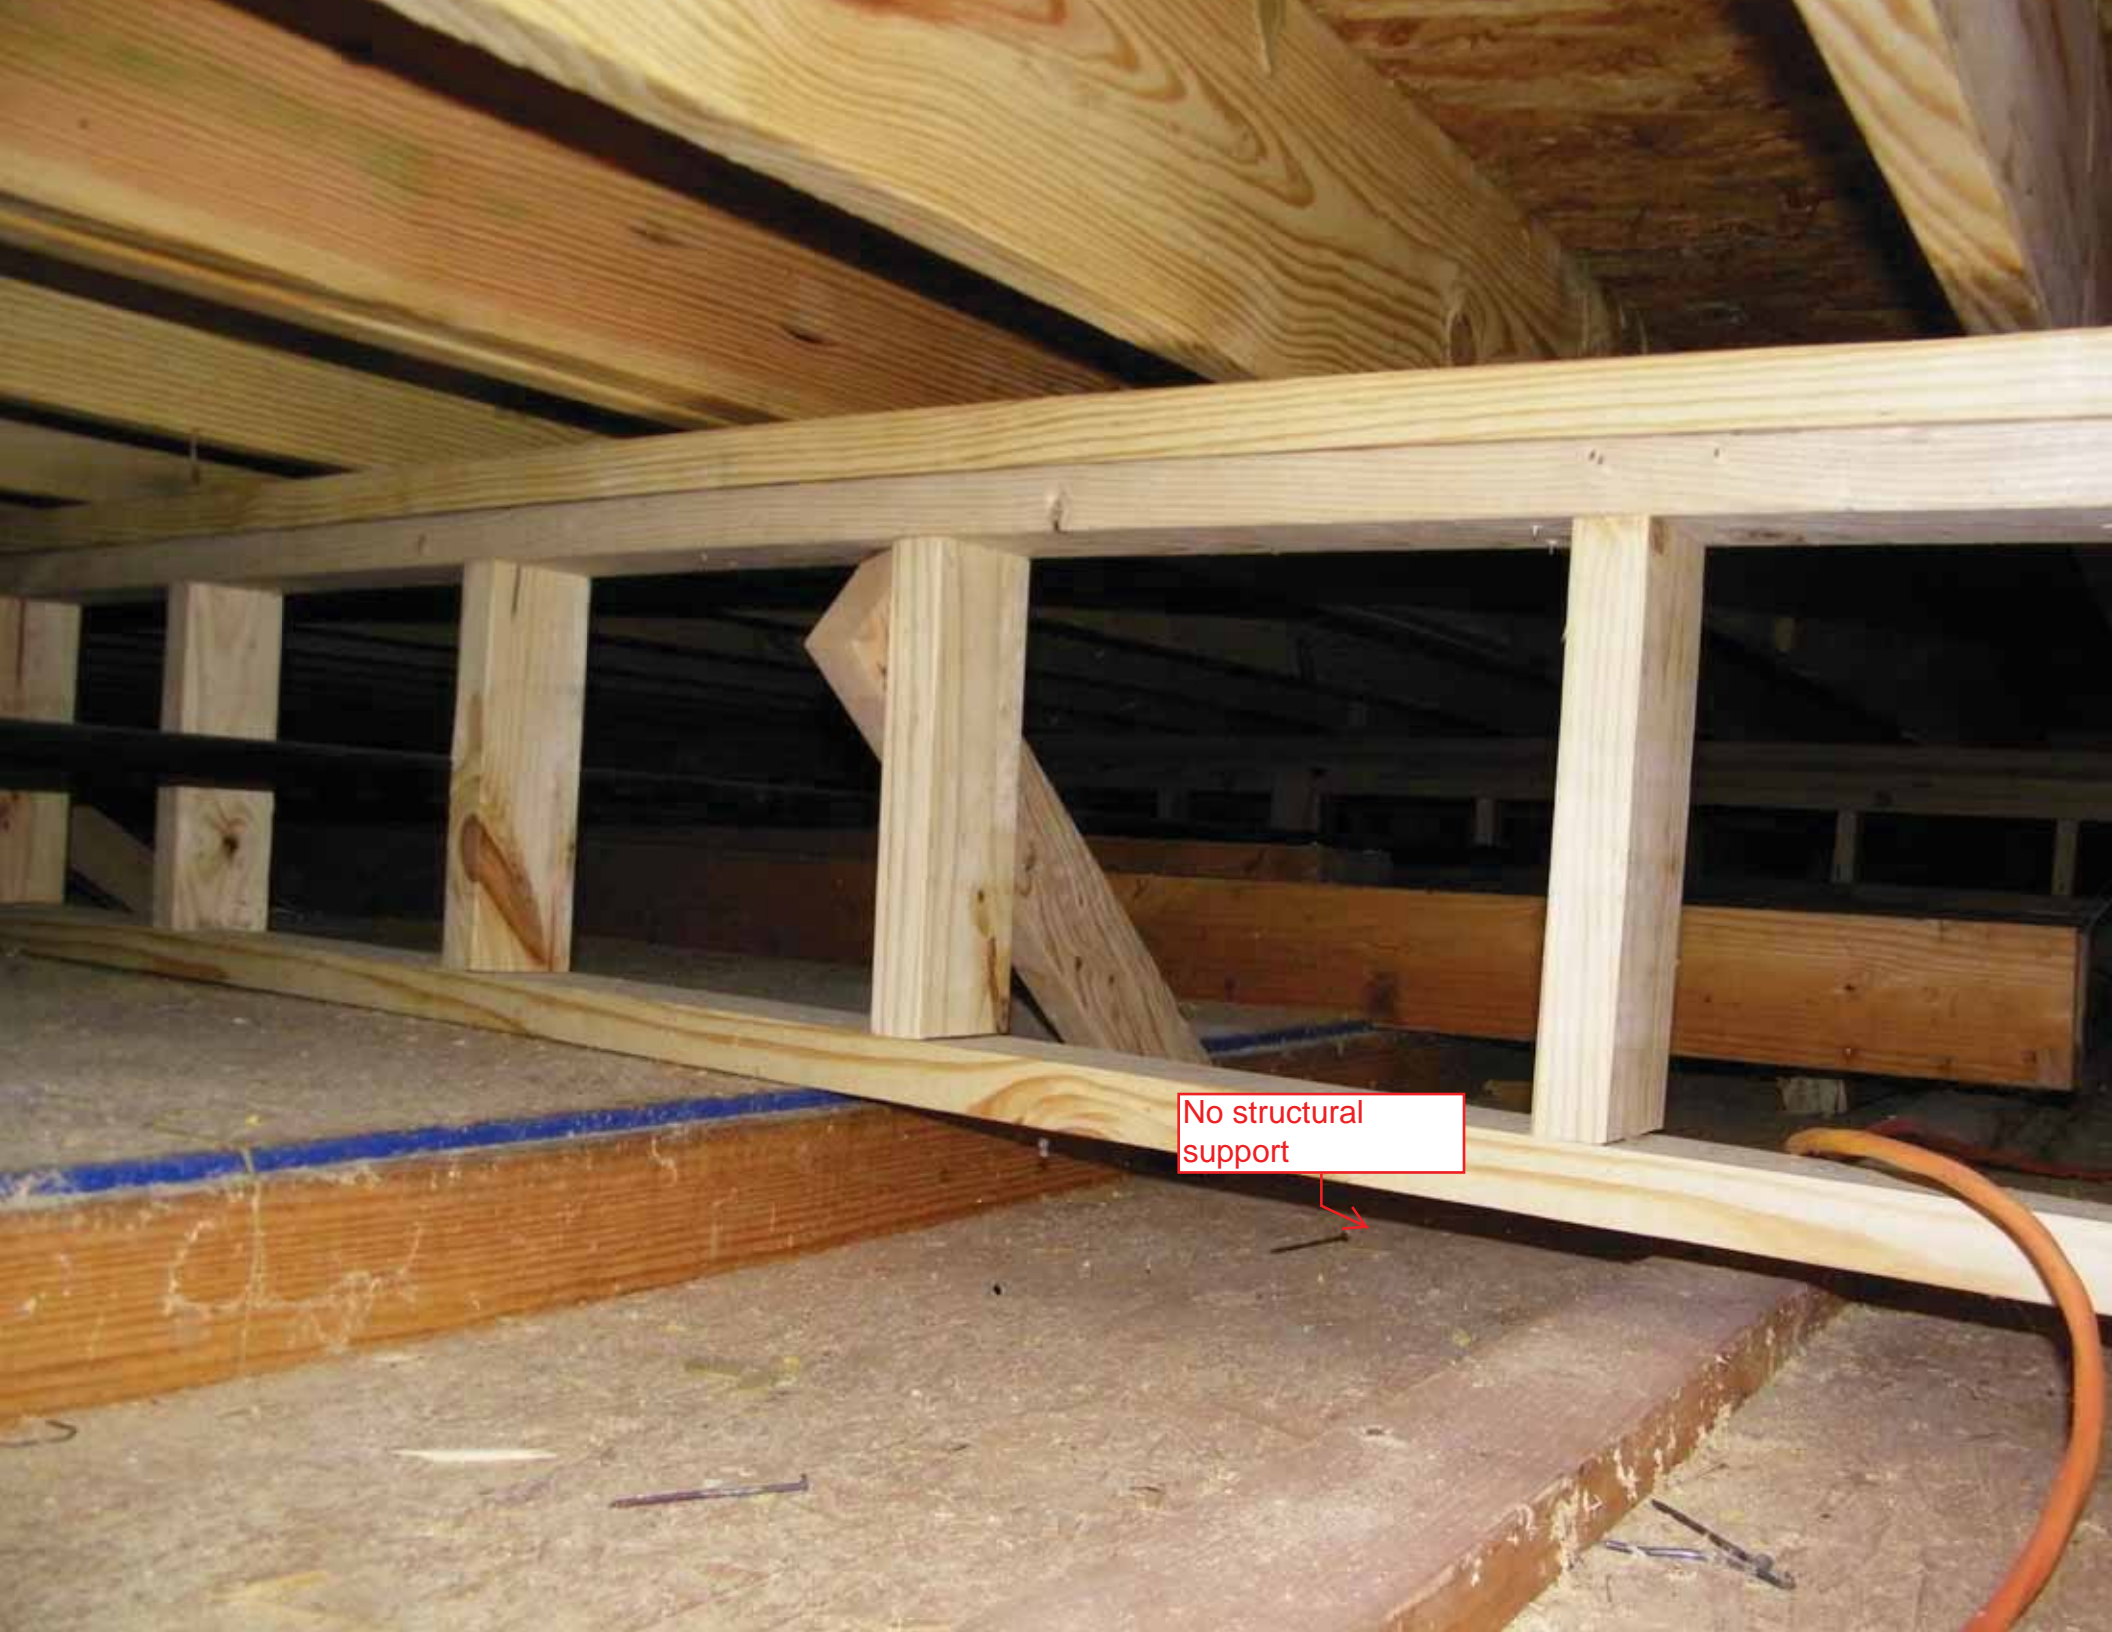
No structural support
