## Structural Inspection

September 8, 2022

Anthony Ficarra  
3201 Range Ct  
Mandeville, La. 70448

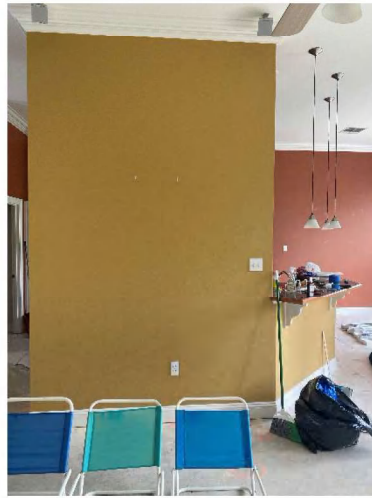
Island Wall

Upon inspection, it was noted that the wall in question is a load bearing wall. It supports not only the ceiling over the kitchen but also portions of the roof.

Since this wall is load bearing it cannot be easily removed. If a portion of this wall was to be removed a header over the opening would need to be designed.

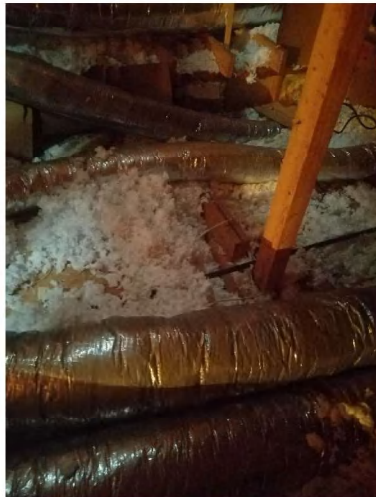
This column is over the End Wall

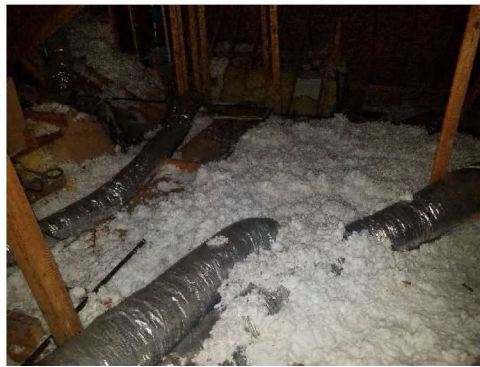
The kitchen ceiling is supported by Island Wall

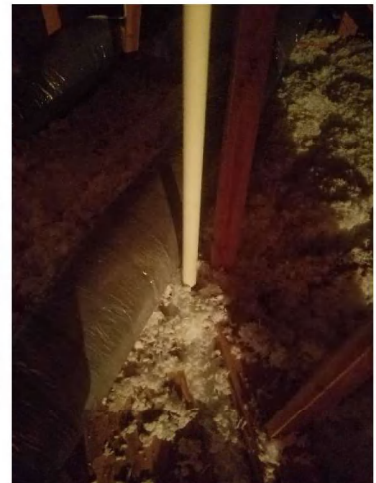
This roof support is supported by the end of the Island Wall
