Structural Inspection

September 28, 2016

For: Steven Burke
Patricia Burke
350 Sandy Brook Circle
Madisonville La. 70447

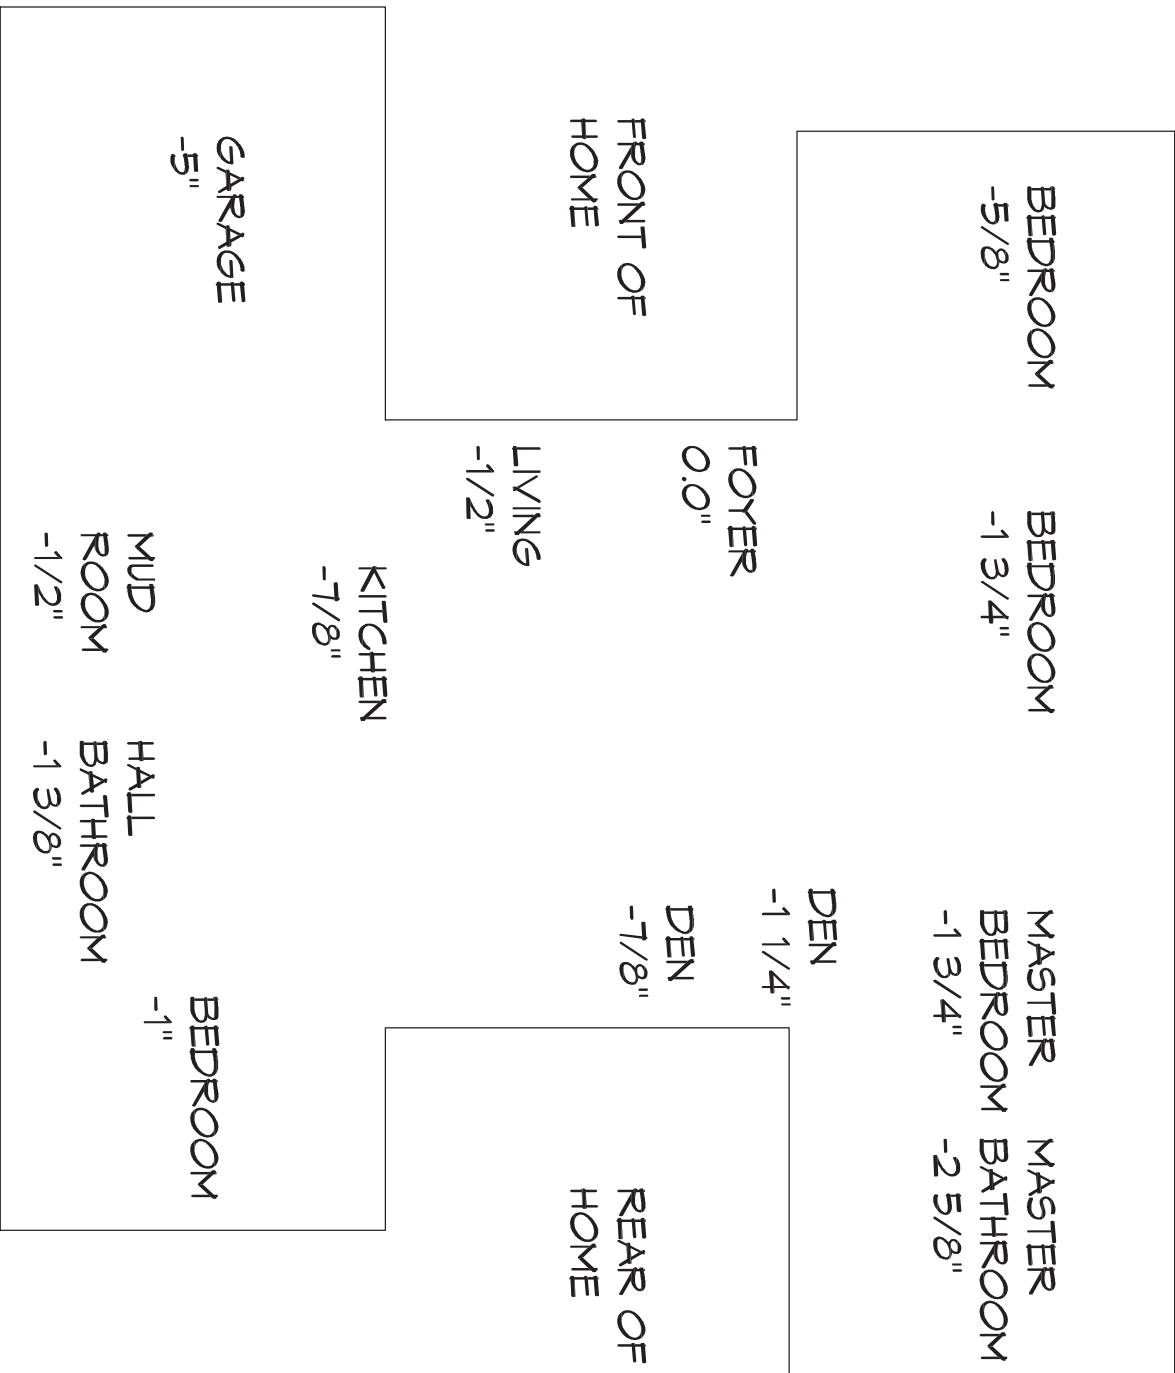
Upon inspection, a zip level was used to verify the floor height conditions. The level was set up at the front door at zero inches and measured throughout the home, there is a - 2 5/8 inch difference noted to the rear of the home in the master bedroom. The master bedroom floor appears to have the most notable slope. There appears to be a crown in the entrance/living room area (middle of home) and the floor slopes in either direction as noted in the attached sketch.

This home should be shored up to level and be stabilized. All repairs should be made as identified in the above line items. Proper drainage should be installed in the front flower bed as not to cause erosion under the house.
