## Structural Inspection

September 28, 2016

For: Steven Burke  
Patricia Burke  
350 Sandy Brook Circle  
Madisonville La. 70447

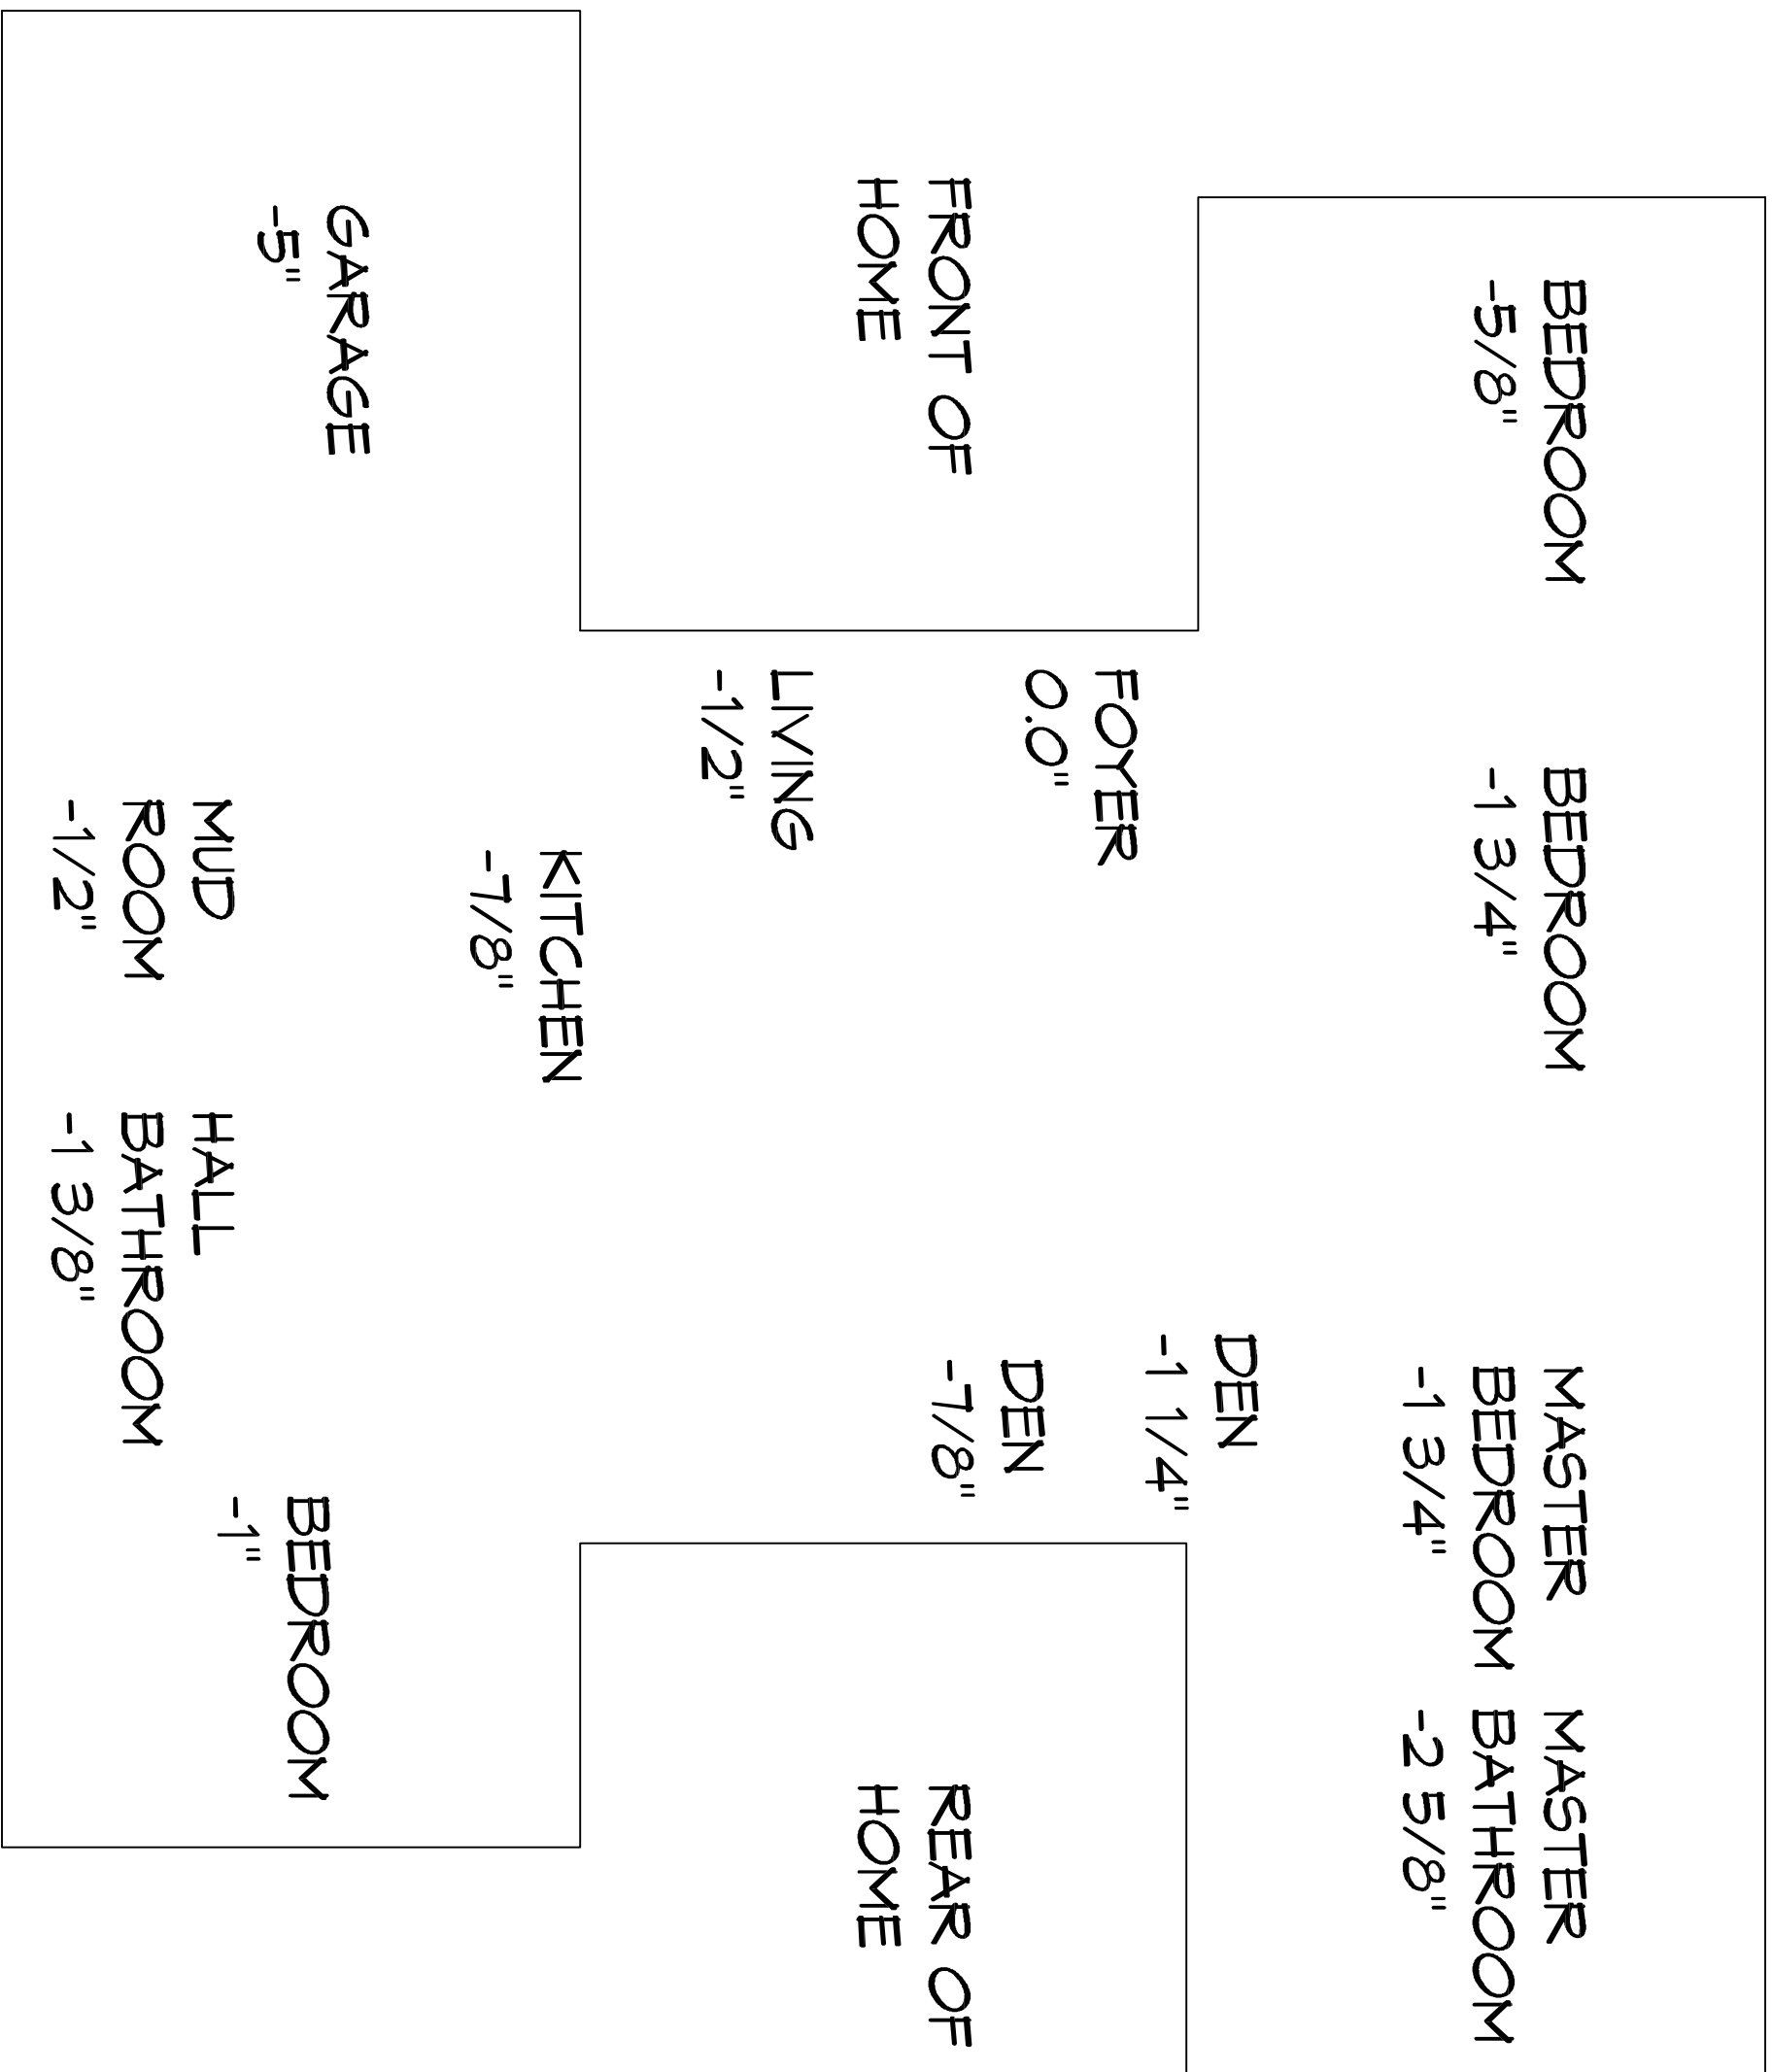
Upon inspection, a zip level was used to verify the floor height conditions. The level was set up at the front door at zero inches and measured throughout the home, there is a - 2 5/8 inch difference noted to the rear of the home in the master bedroom. The master bedroom floor appears to have the most notable slope. There appears to be a crown in the entrance/living room area (middle of home) and the floor slopes in either direction as noted in the attached sketch.
