# Your Inspection Report

443 Pine Cone Lane  
Slidell, LA 70458

**INSPECTION DATE:**  
Tuesday, September 26, 2017

RE: Report No. 1336  
443 Pine Cone Lane  
Slidell, LA  
70458

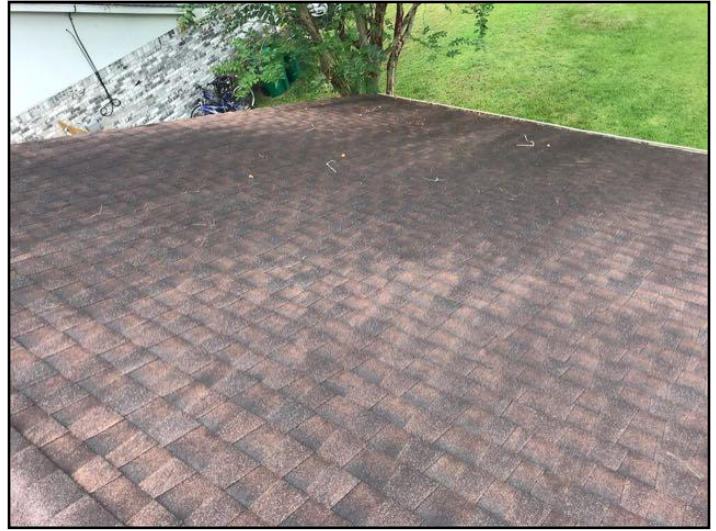
**2. Condition:** • Discoloration/algae observed at the roofing surface. Recommend professional cleaning by a qualified tradesman.

5. *Discoloration/algae observed at the roofing...*

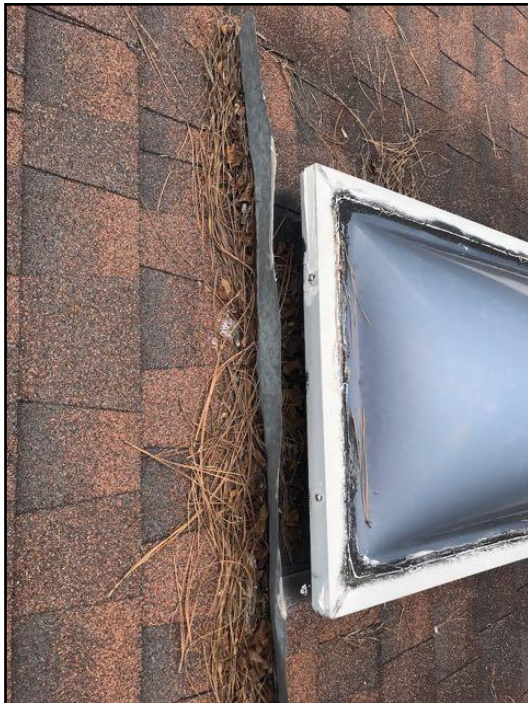
**4. Condition:** • Debris build-up at the roof surface may negatively impact the life expectancy of the shingles.

6. *Debris build-up at the roof surface may...*

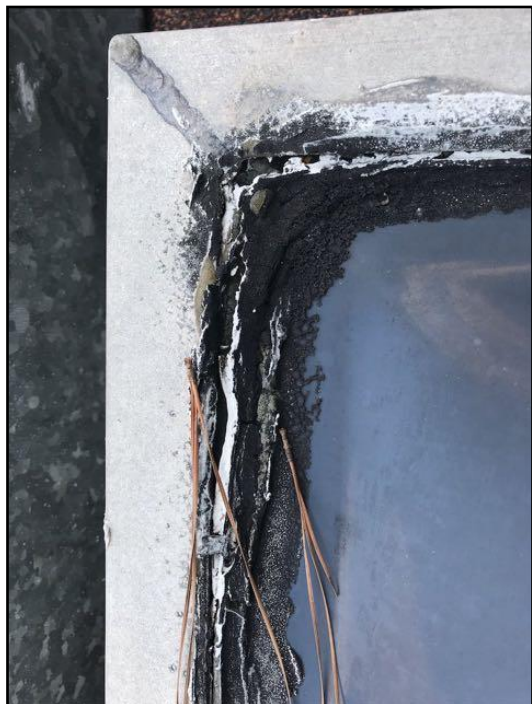
Previous repairs noted at skylights. Patched/sealed areas are deteriorated and cracked. Recommend further evaluation by a licensed contractor and repair/replace as needed.

10. *Damage, patched*

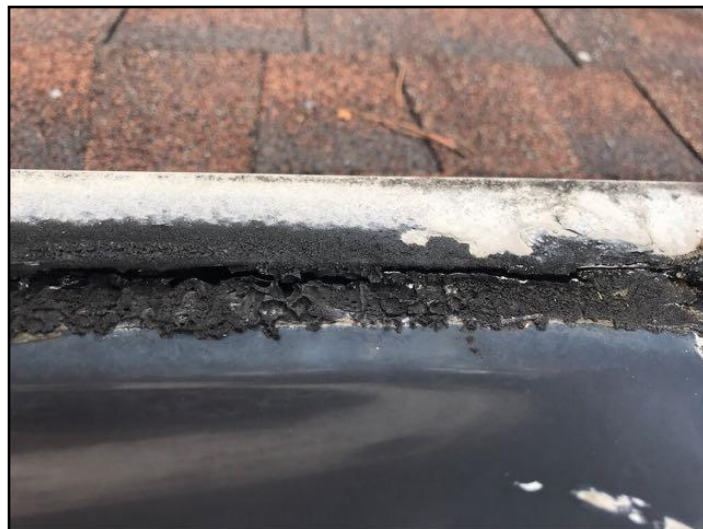
11. *Damage, patched*

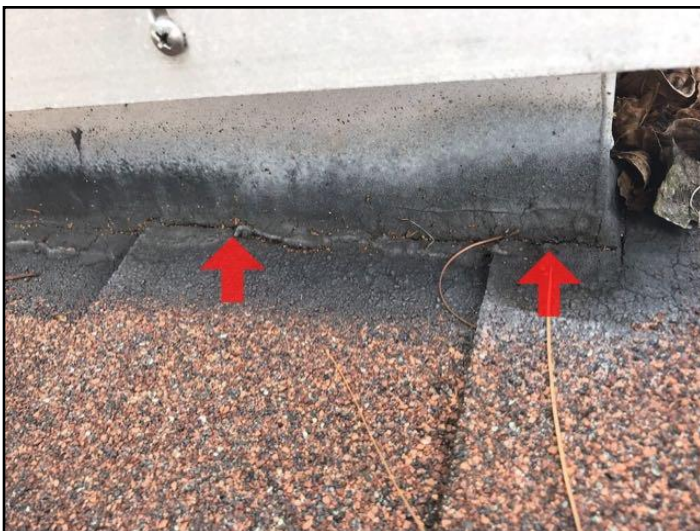
12. *Damage, patched*

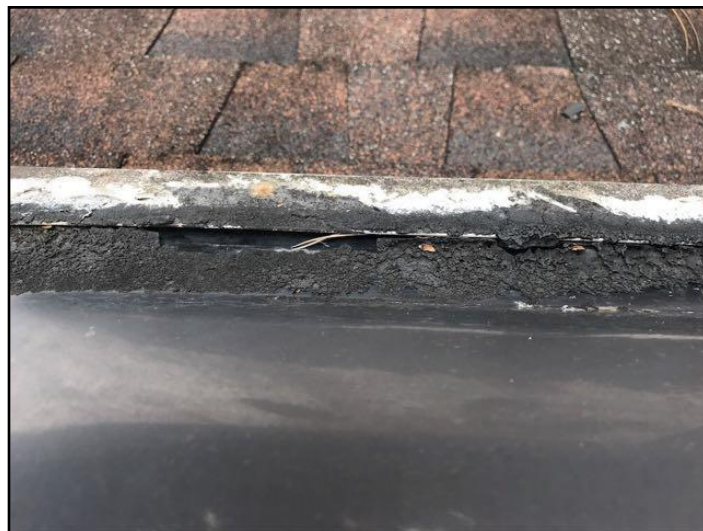
13. *Damage, patched*

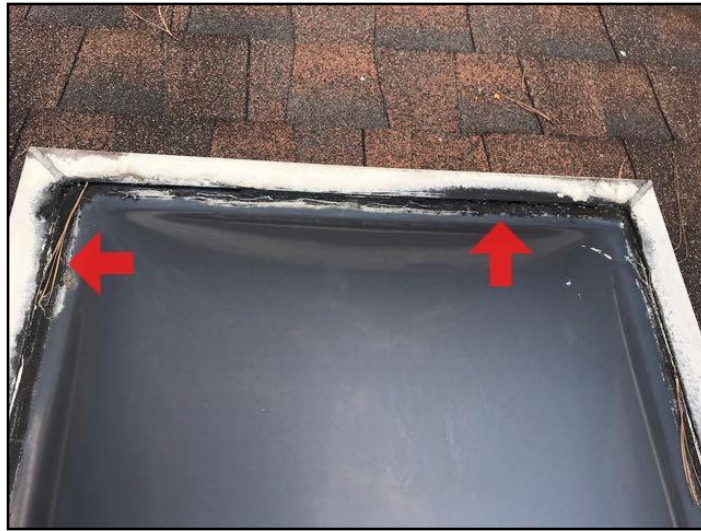
14. *Damage, patched*

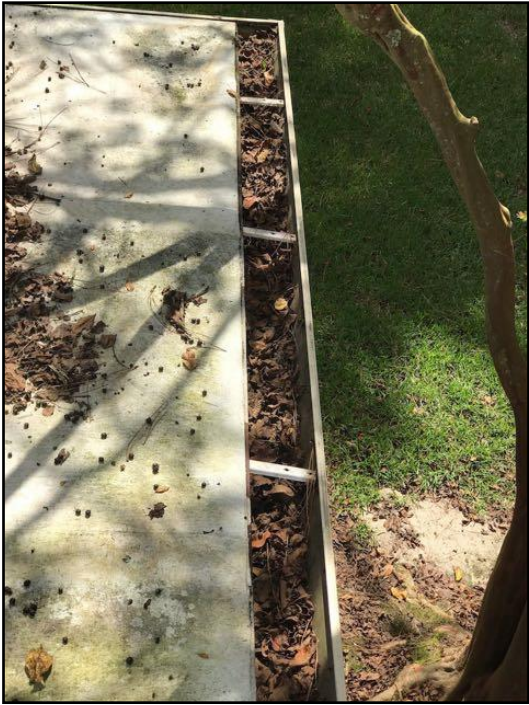
15. Clogged

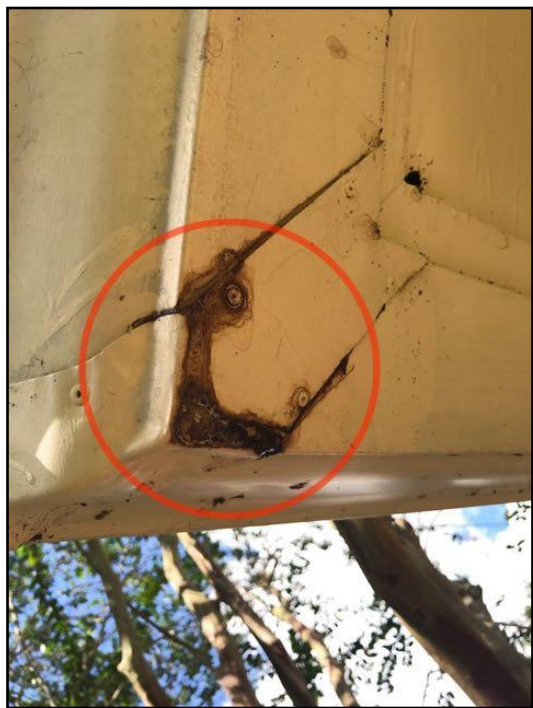
16. Leak

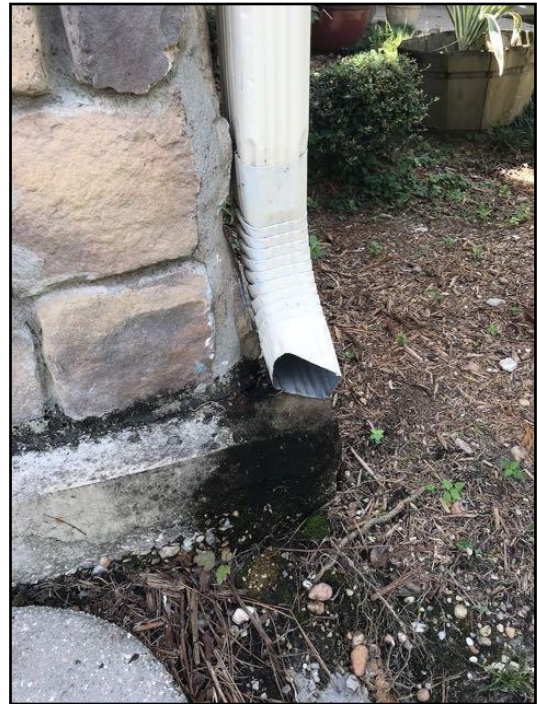
18. Downspouts discharge too close to building

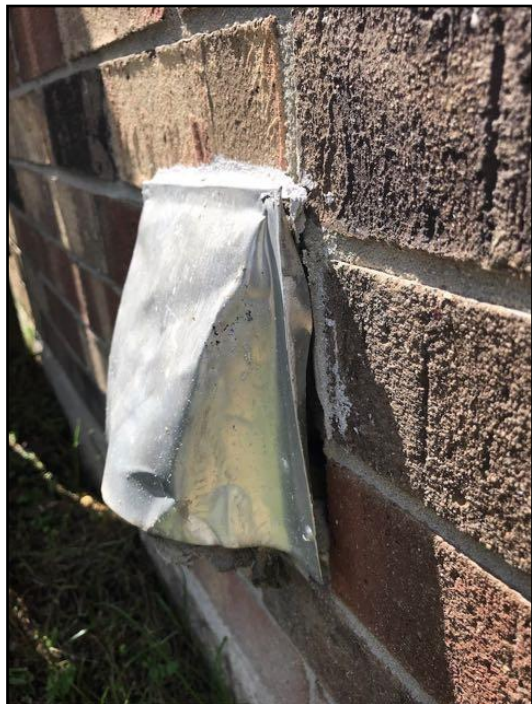
**17. Condition:** • Recommend caulking/sealing the intersections of dissimilar building materials.

19. Recommend caulking/sealing the intersection...

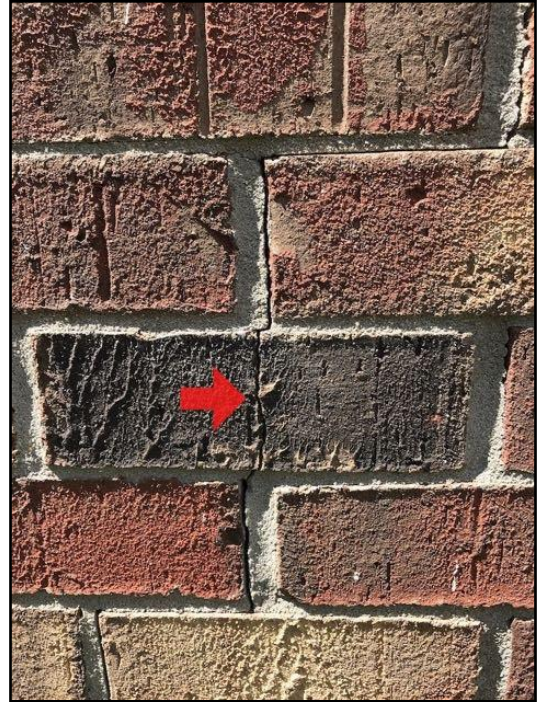
Cracking noted through mortar and face of brick. You may wish to seek further evaluation by a structural engineer. Monitor for any changes and/or problems.

24. Cracked

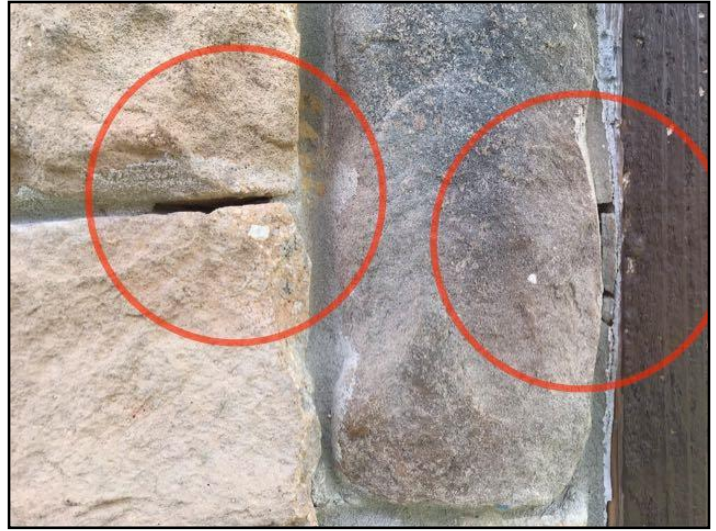
27. Mortar deterioration

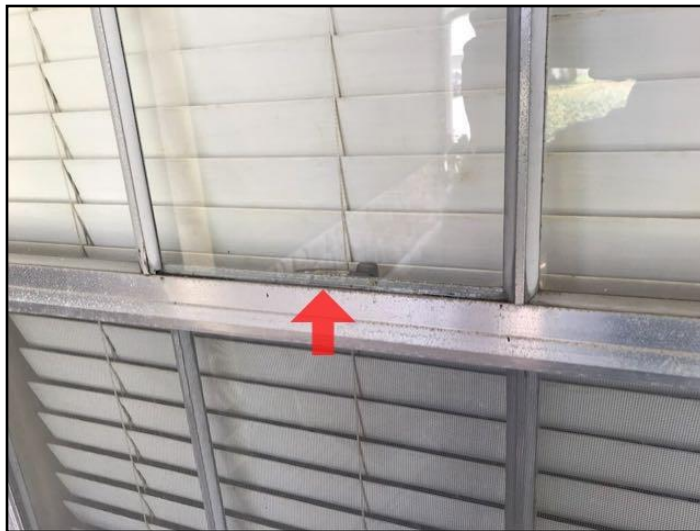
29. Missing or loose pieces

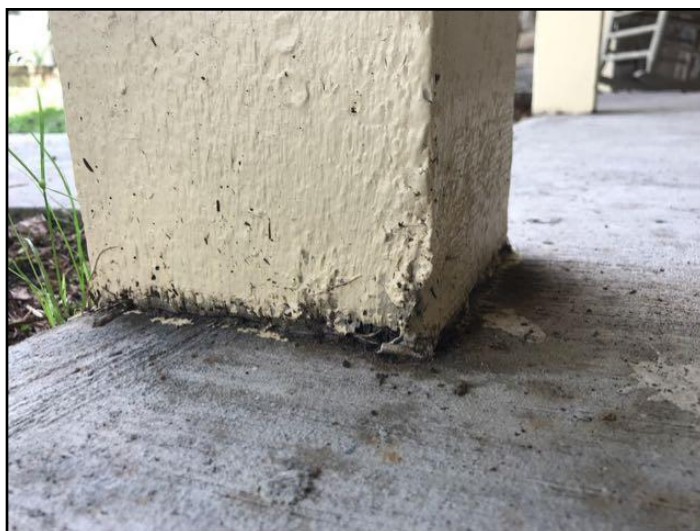
26. Condition: • Minor damage/deterioration at the base of columns.

30. Minor damage/deterioration at the base of...

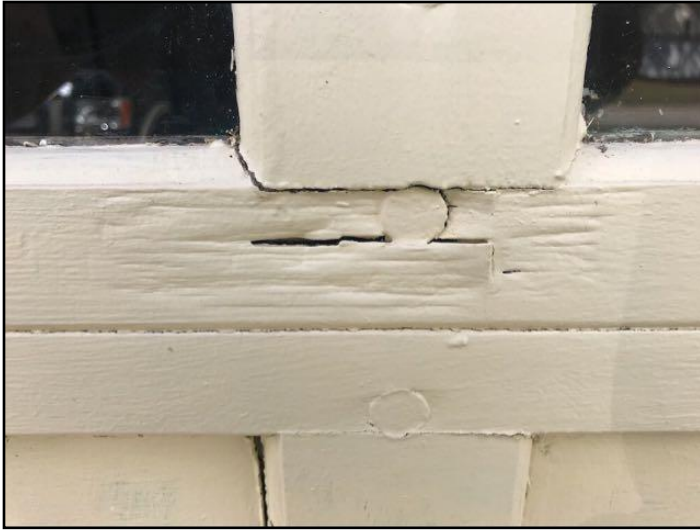
32. Rot

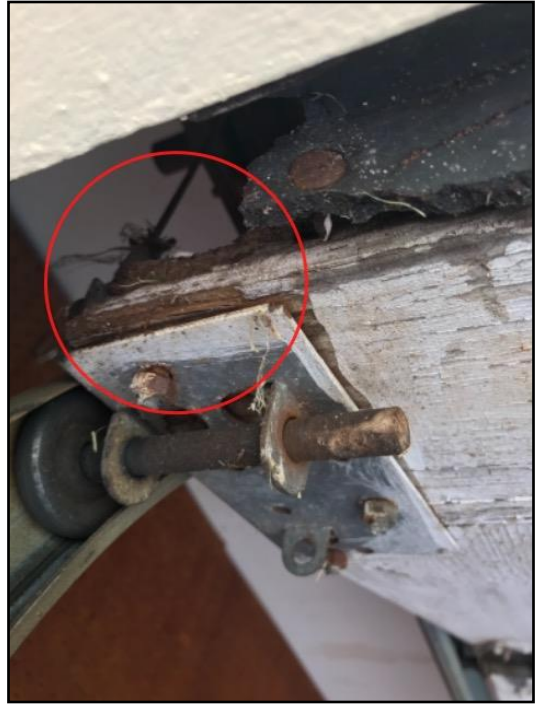
33. Rot

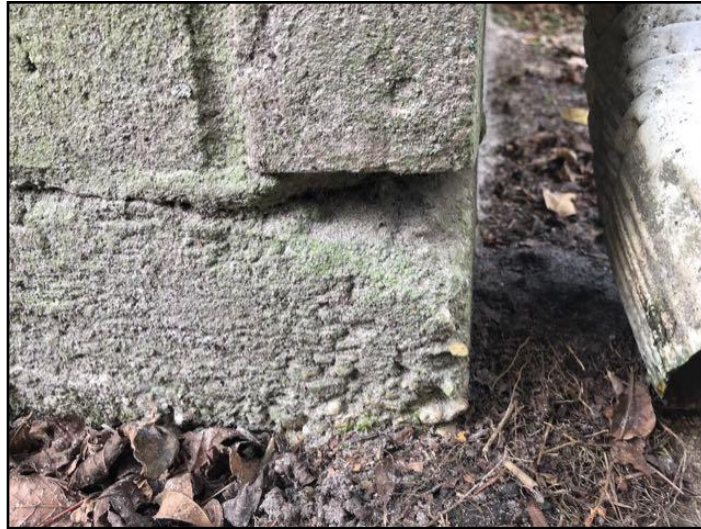
**35. Condition:** • Typical corner cracks noted at slab

*37. Typical corner cracks noted at slab*

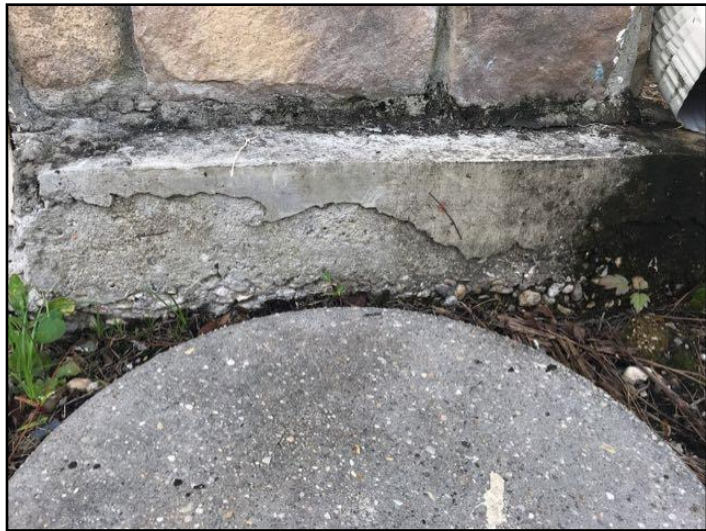
38. Spalling, crumbling or broken material

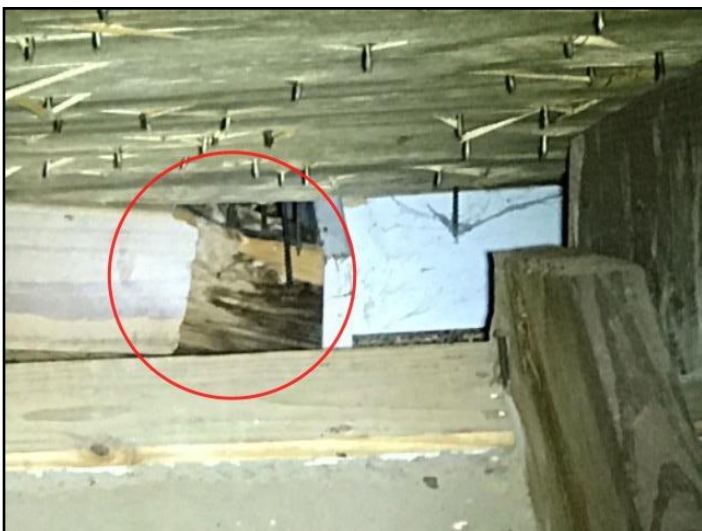
39. Rot

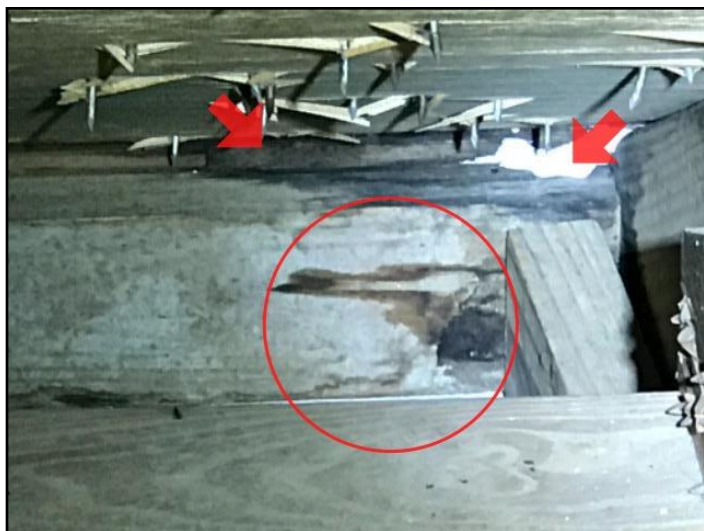
40. Rot

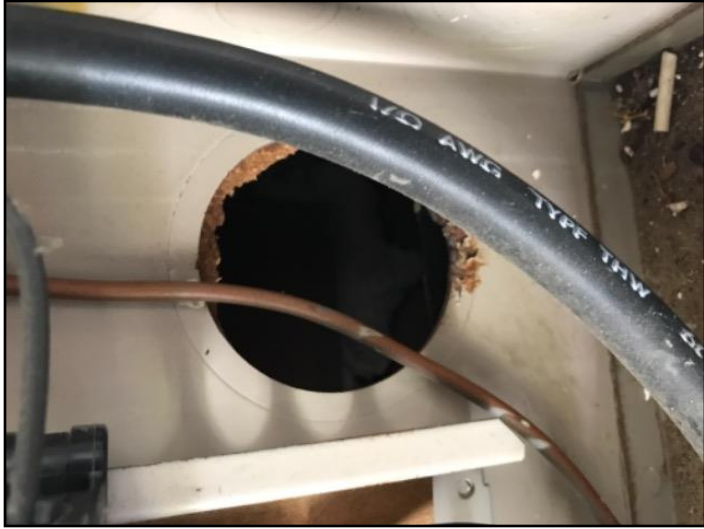
45. Openings in panel

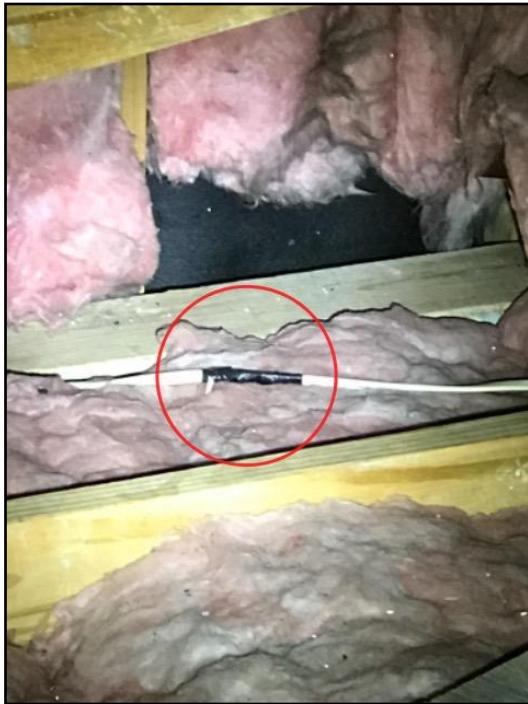
50. Missing

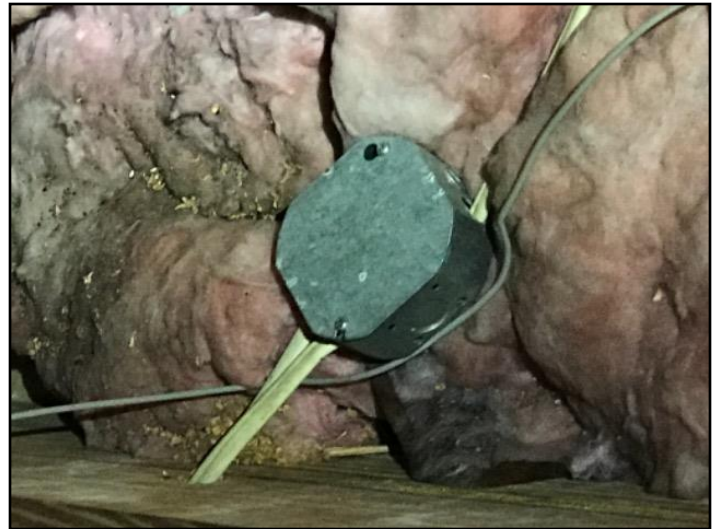
51. Loose

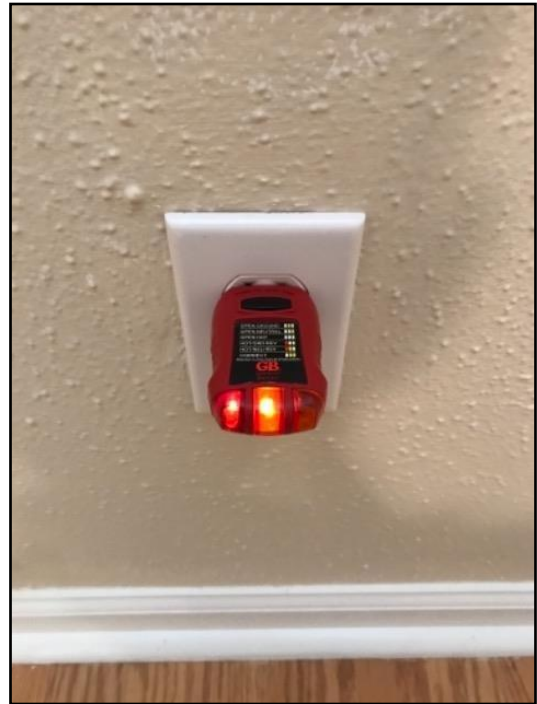
54. Reversed polarity

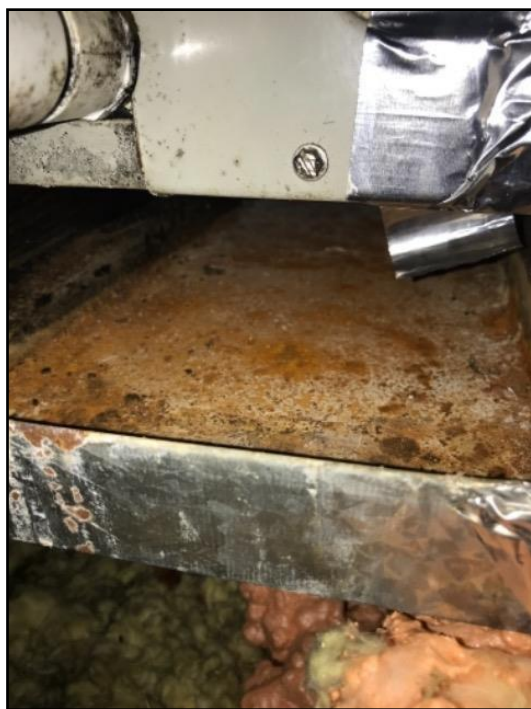
Rusting noted at the overflow drain pan.

66. Rust in pan

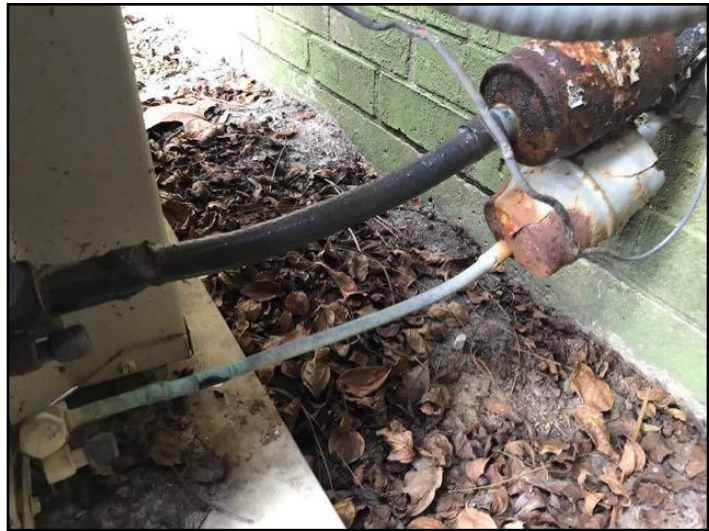
69. Insulation - missing

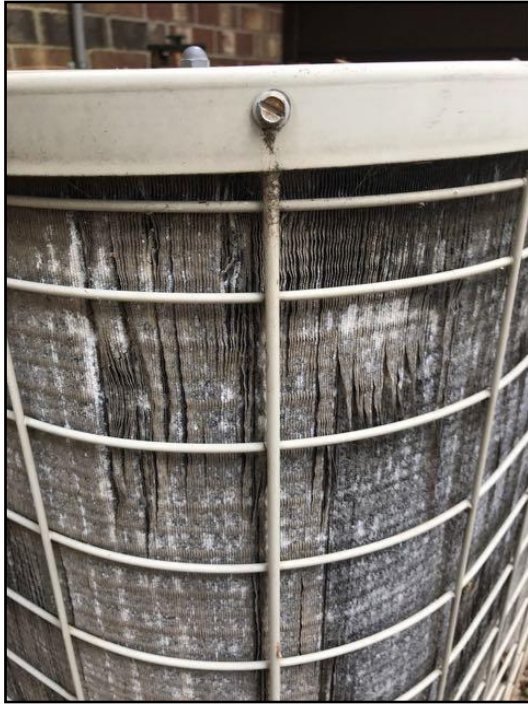
70. Damaged fins on condenser

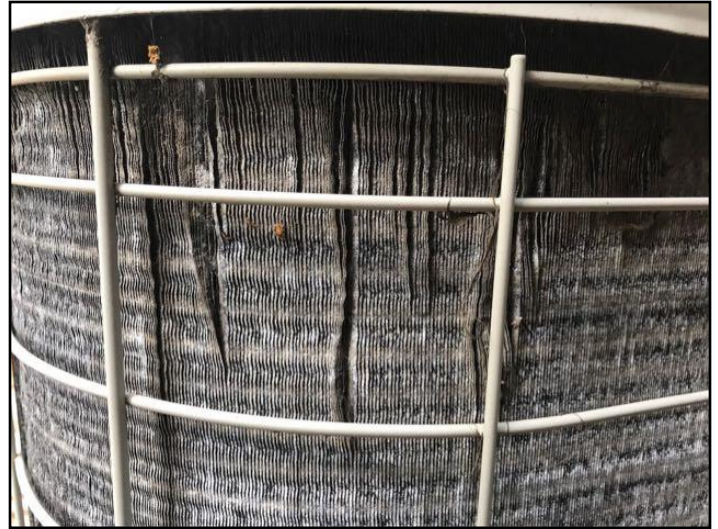
71. Damaged fins on condenser

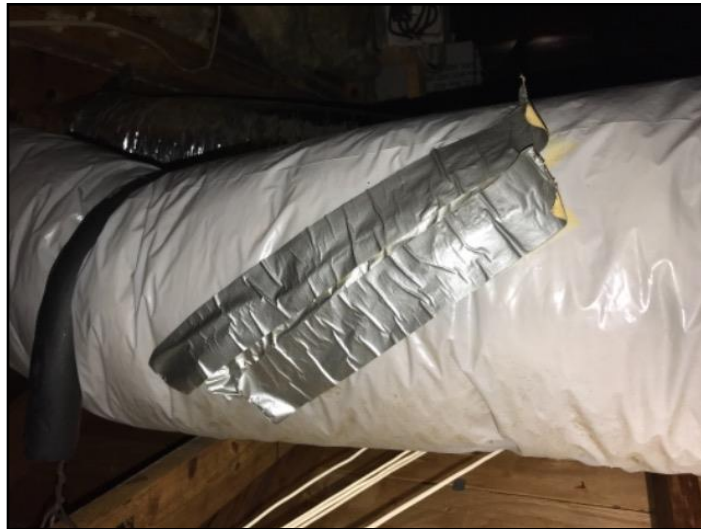
**Condition:** • Duct tape used on the HVAC system. This is not recommended. Properly seal with foil tape and duct mastic to prevent air leaks.

73. Duct tape used on the HVAC system. This is...

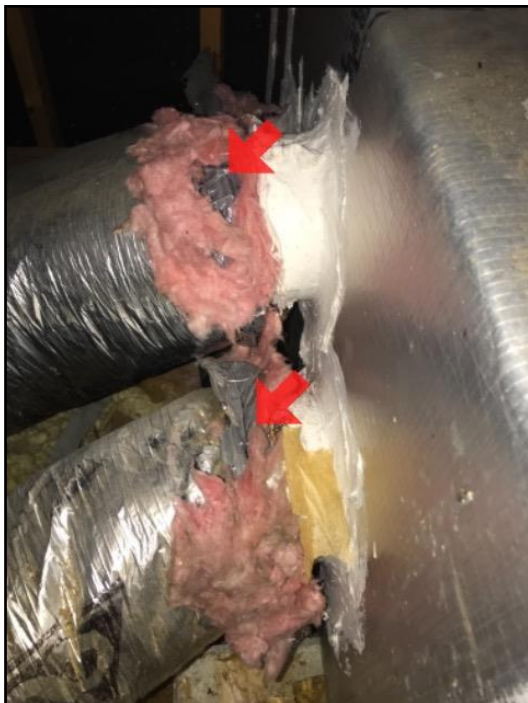
74. Damaged insulation on ductwork

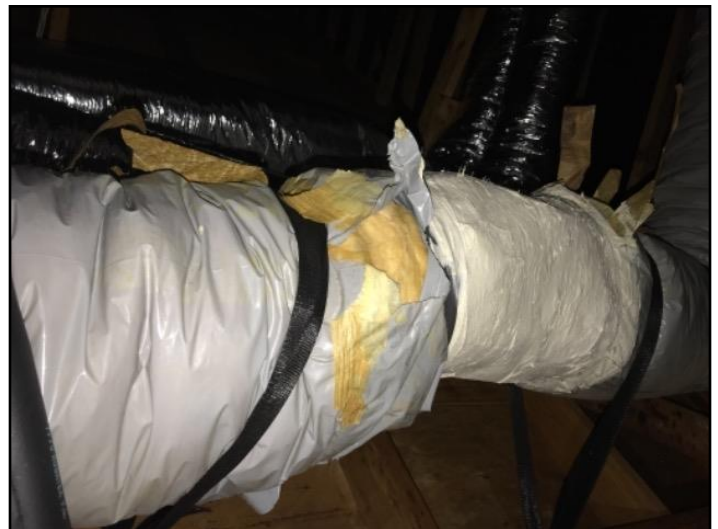
75. Damaged insulation on ductwork

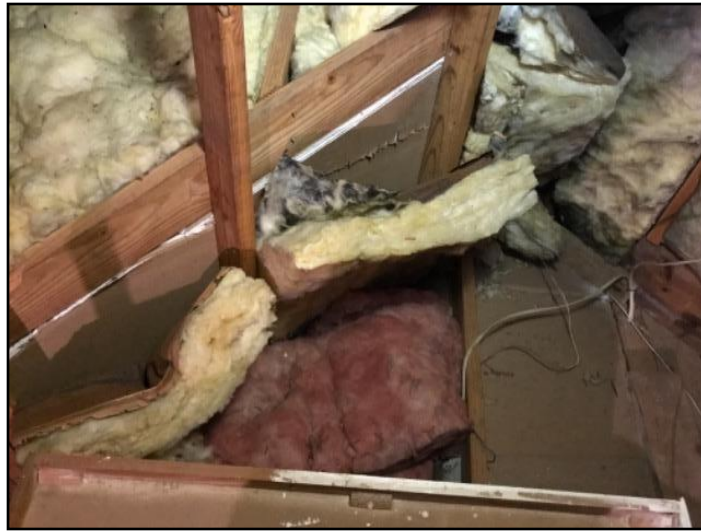
77. Worn and/or falling insulation noted at..

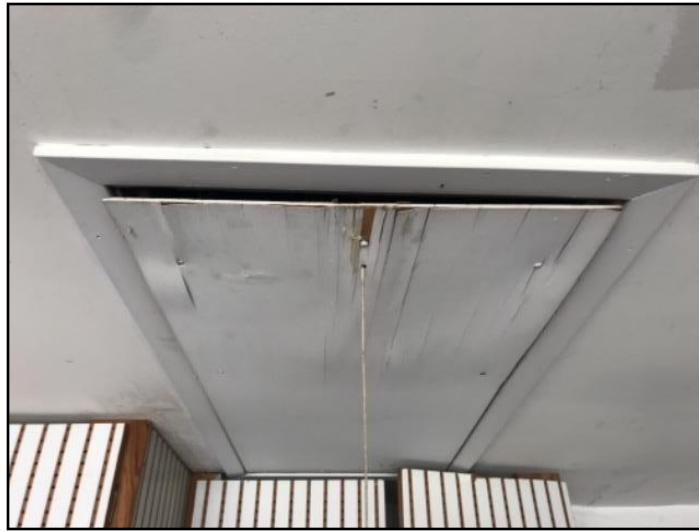
**79.** Attic access does not fully close

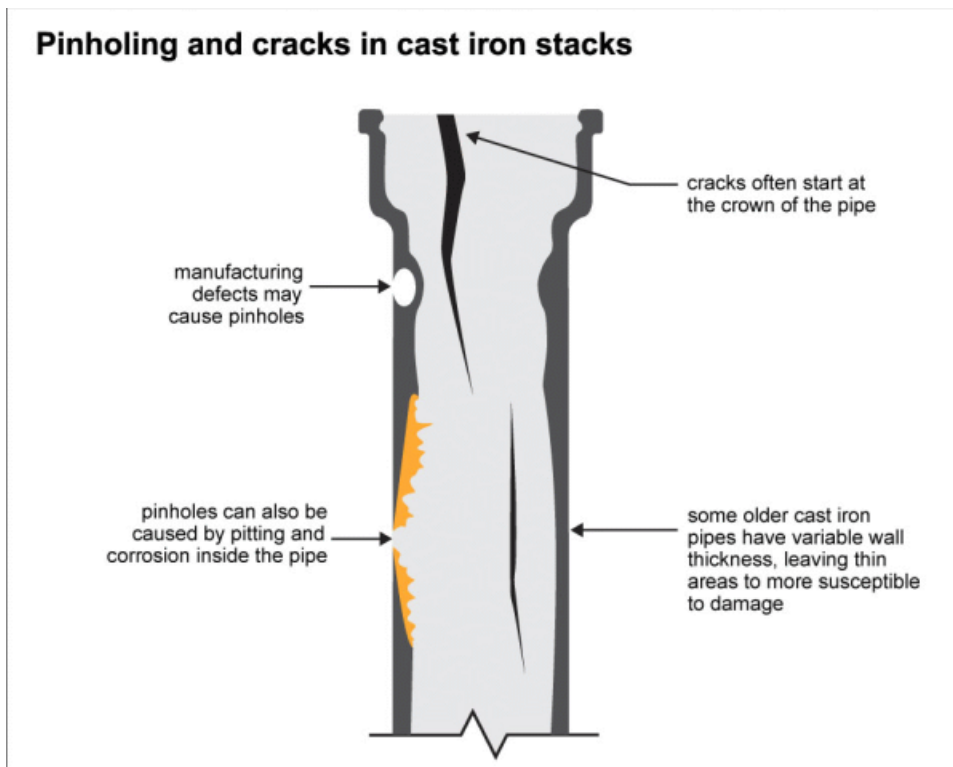
85. *Rust*

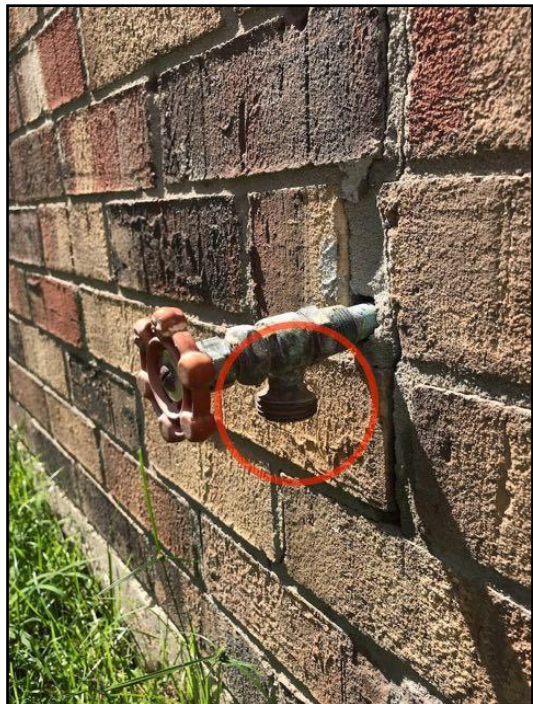
86. Backflow prevention missing

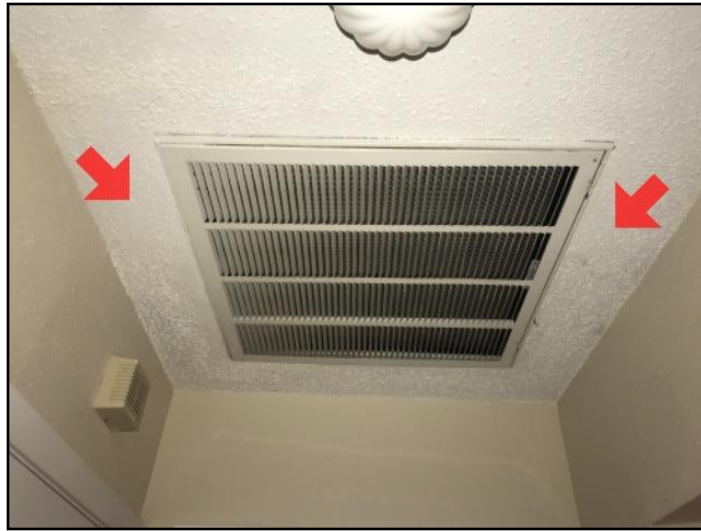
101. Previous repairs noted. Recommend verifying...

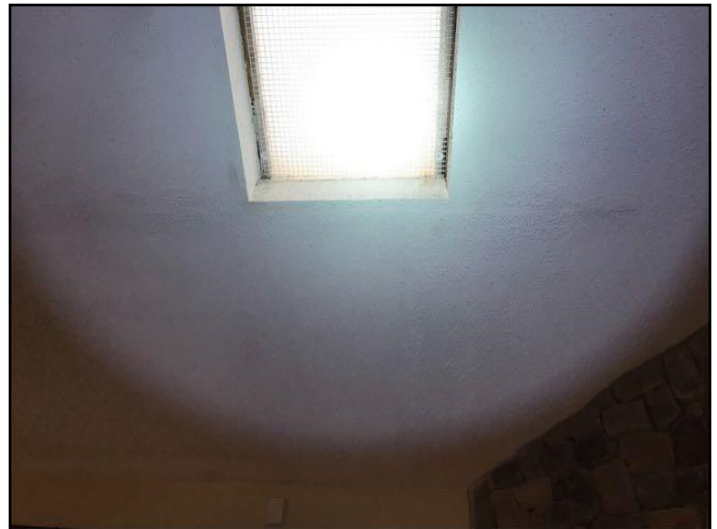
103. Water stains

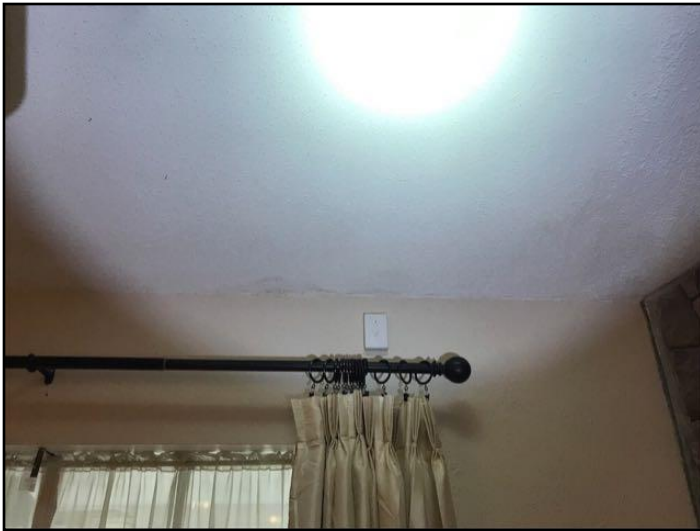
104. Water stains

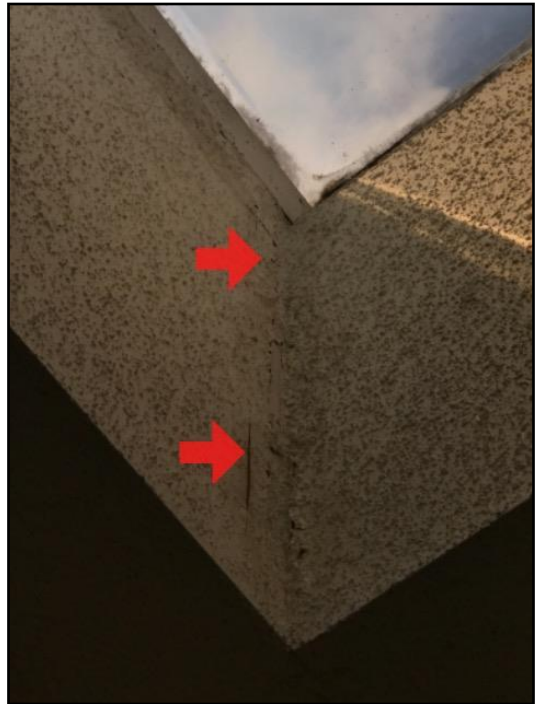
105. Water stains

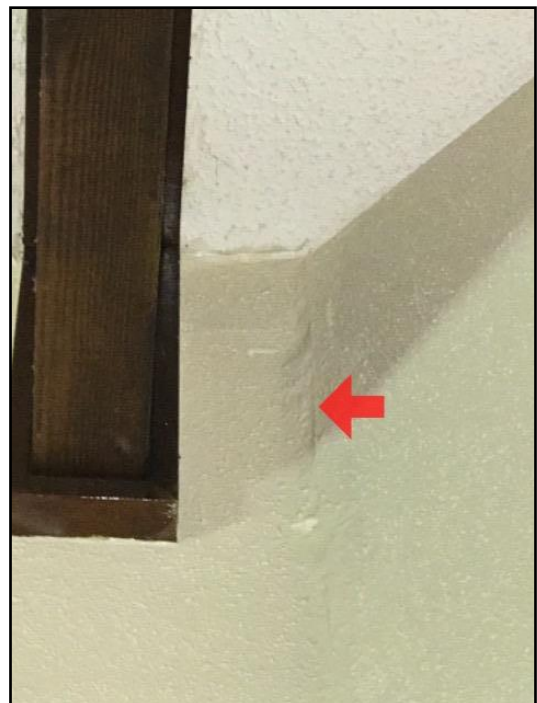
**109.** Previous repairs

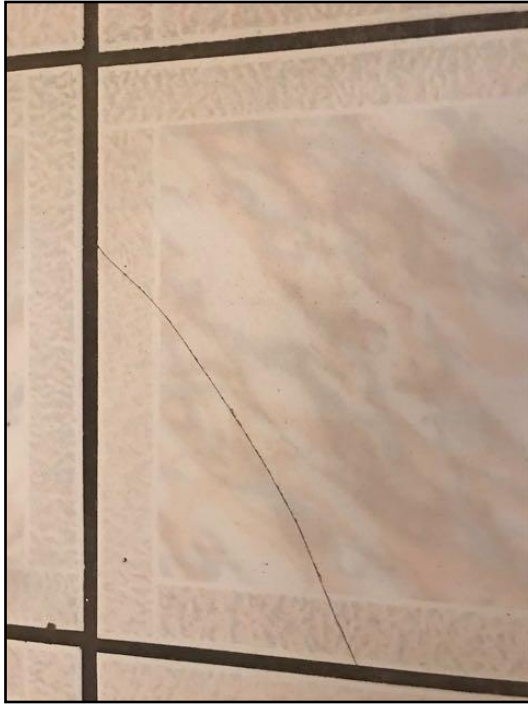
110. Tiles cracked

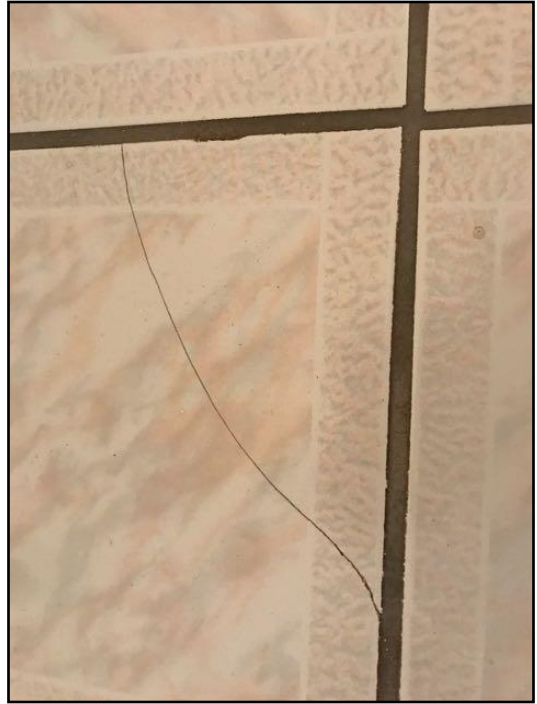
111. Tiles cracked

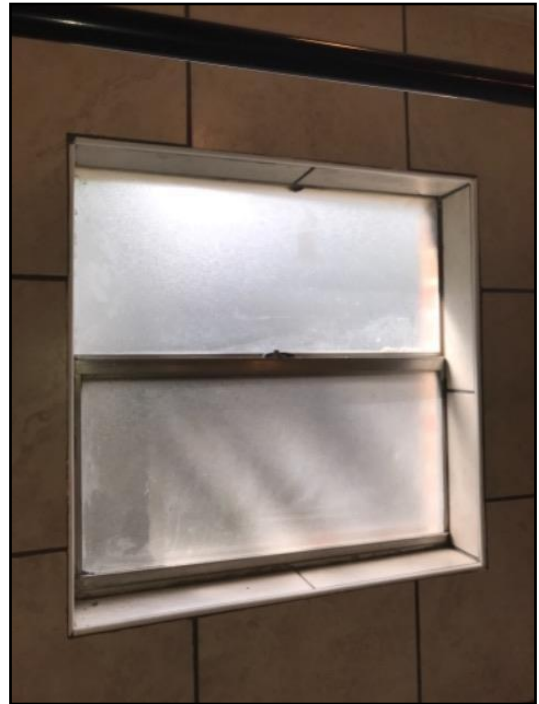
113. Difficult to operate

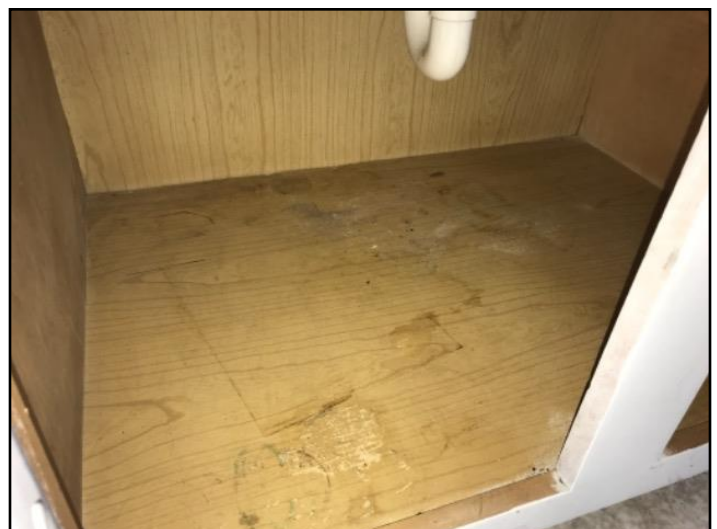
115. Stained, worn, damaged
