INSPECTION CONDITIONS	3
EXTERIOR - FOUNDATION - BASEMENT	6
GROUNDS	12
ROOF - FLASHING SYSTEMS	18
PLUMBING	22
ELECTRICAL	25
BATHROOMS	29
GARAGE - CARPORT	34
INTERIOR - ATTIC	37
KITCHEN - APPLIANCES - LAUNDRY - WETBAR	44
HEATING - AIR CONDITIONING	50

INSPECTION CONDITIONS

DATE OF INSPECTION: 7/3/2020.
START TIME OF INSPECTION: 2pm.
END TIME OF INSPECTION: 5pm.
CLIENT NAME: Steven Prince.
INSPECTION SITE: 445 Evergreen Ct.

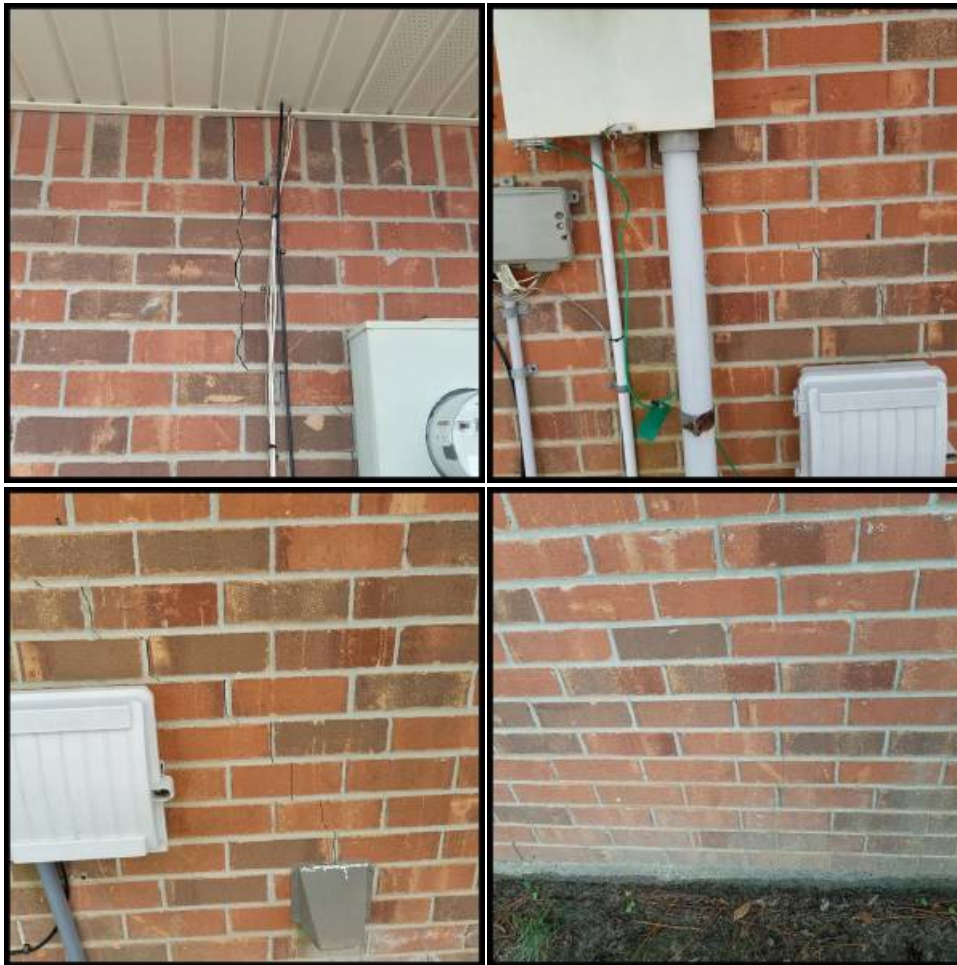
The following concerns were noted at the exterior walls:
Recommend caulking/sealing intersections between dissimilar building materials.
Cracks noted. Some cracking is to be expected in all exterior surfaces as the property settles with age. Recommend monitoring for any future changes
Significant cracks were noted on the right side of home. Structural issue may be present.
Recommend further evaluation and repair as needed.

Recommend evaluation by a qualified licensed contractor and repair or replace as needed.

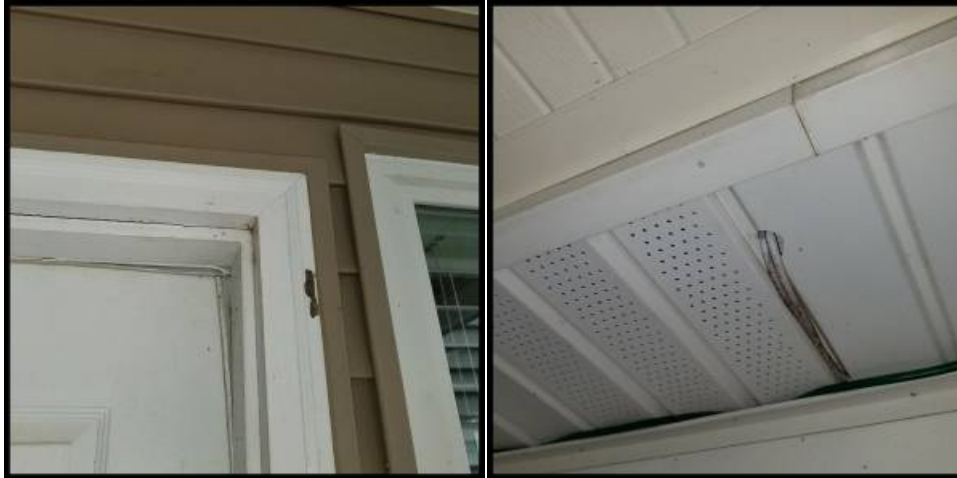
The following concerns were noted at the exterior trim:
Caulking recommended at intersections between dissimilar building materials.
Peeling paint noted around the front door frame. This may indicate water penetration issues.
Recommend painting or sealing to prevent further damage.
Pest entry points noted. Recommend sealing all penetrations to prevent access.

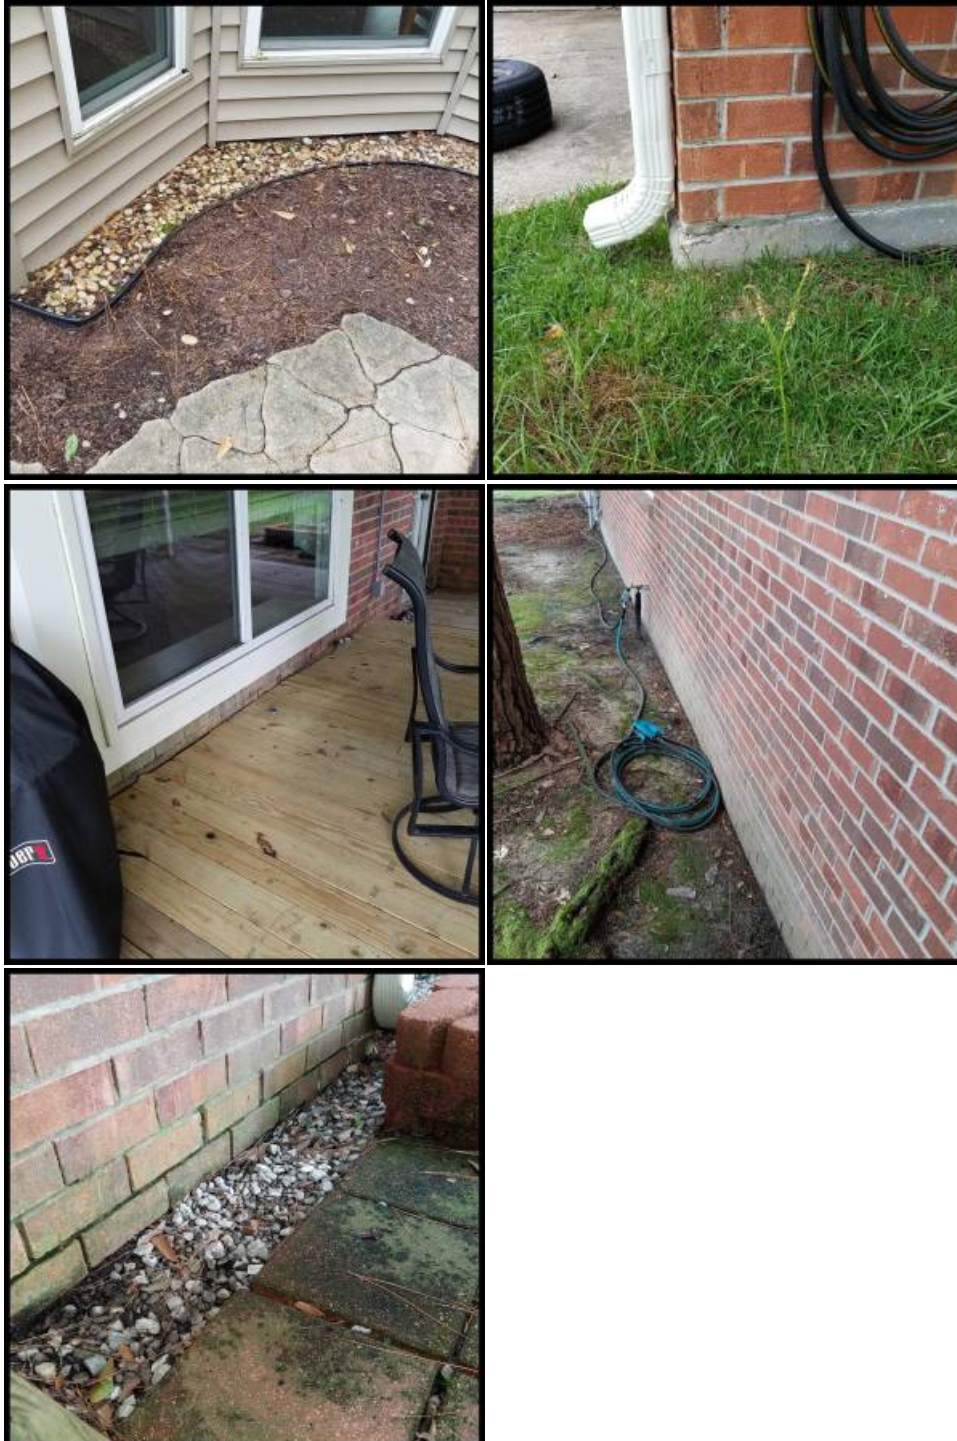
The following concerns were noted at the slab:
Typical cracks in slab noted. Some cracking is to be expected as the property settles with age. Recommend monitoring for any future changes.
Typical corner cracking noted. Monitor for problems and repair as needed.
Some areas of the slab were not visible for inspection due to the following reason, high soil levels and decking. Recommend lowering soil levels (sloping away from the house) to allow for periodic inspection of the slab.

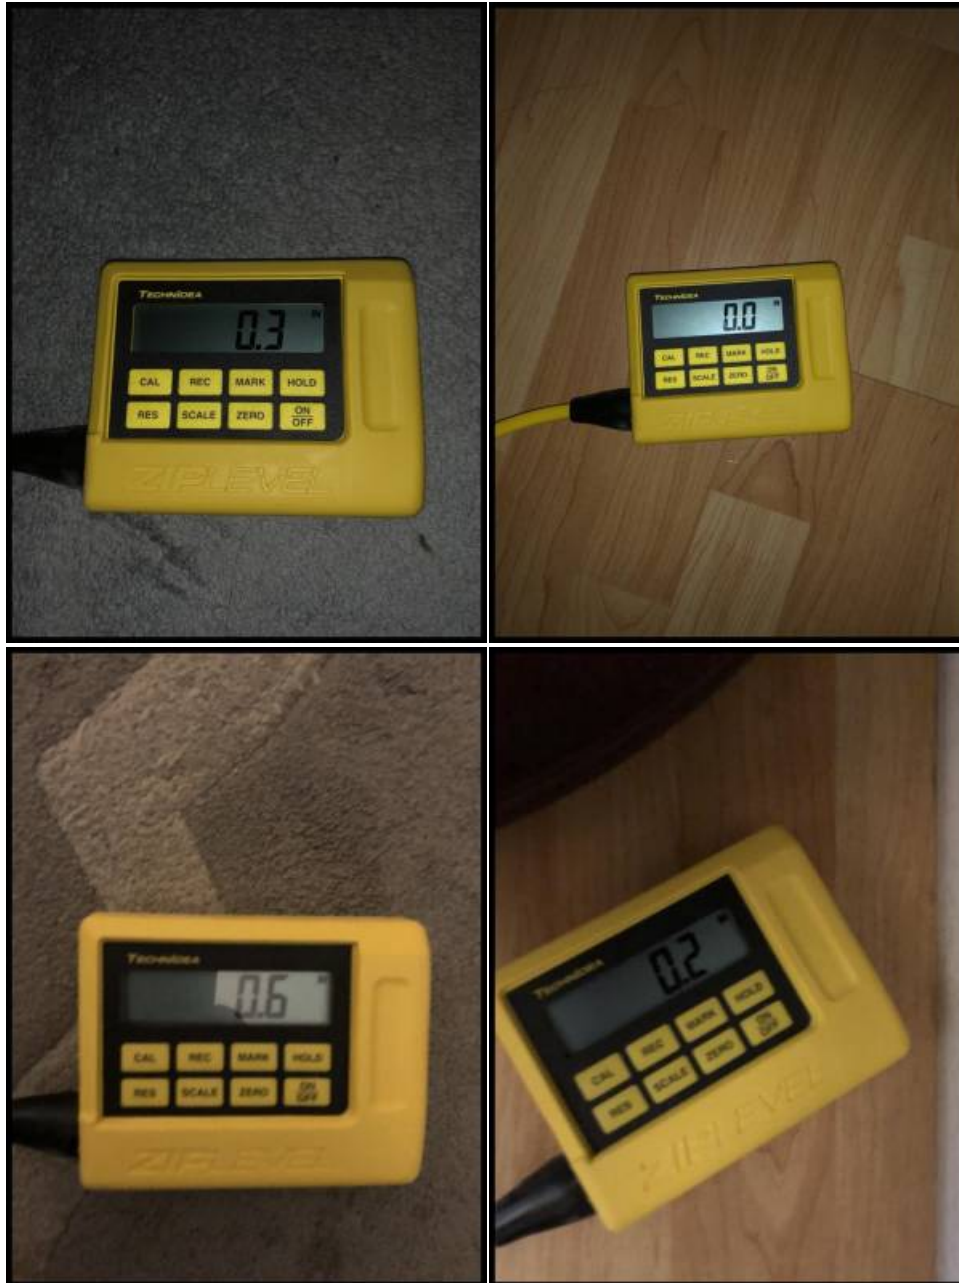
LEVEL SURVEY

A computerized level survey was performed, and the approximate differential measurement

indicated 1-2 inches of variance between survey points

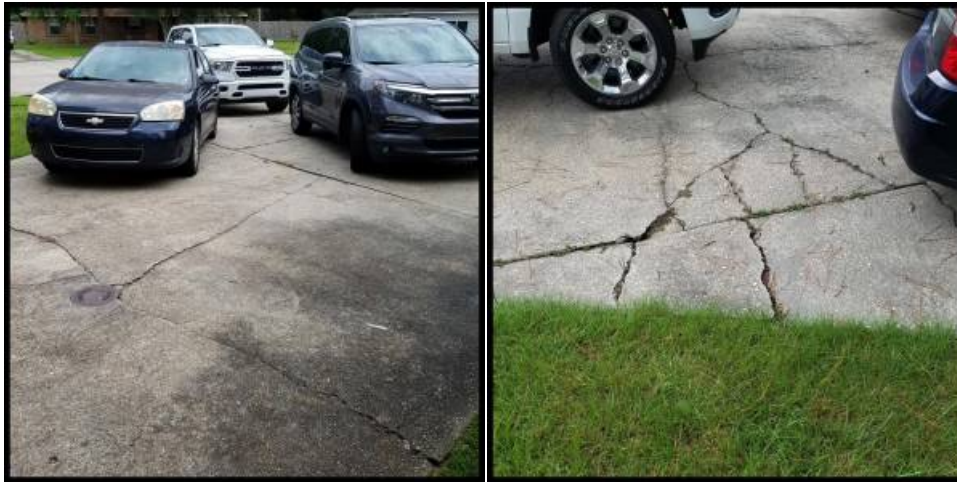
The following concerns were noted at the driveway:
Cracks noted. Some cracking is to be expected as the property settles with age. Recommend monitoring for any future changes.

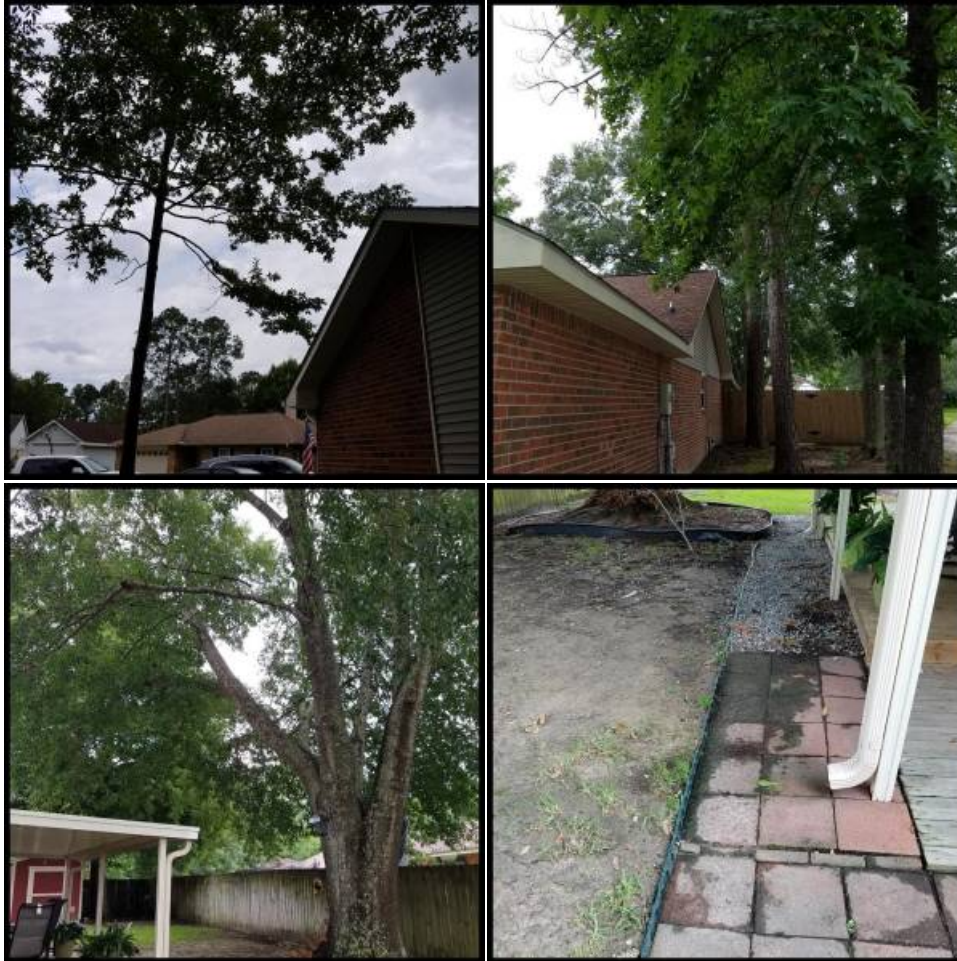
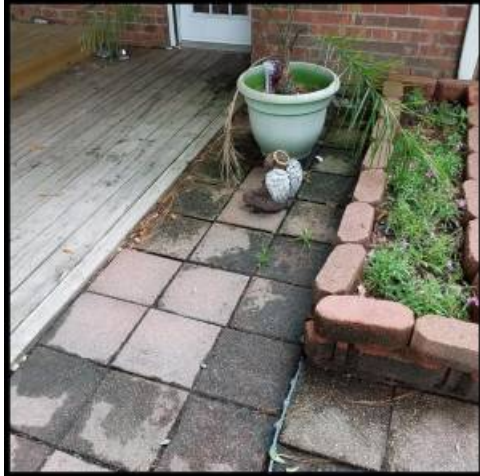
The following concerns were noted at the landscaping:
Large tree(s) located on the property. They may present problems (now or in the future) with site drainage, roof/structure damage, plumbing, and/or foundation conditions. Recommend monitoring the situation for problems and consult with an expert as needed.

Trees are touching/over-hanging the roof. Damage is possible.
Trim plants and trees away from structure to help prevent damage and pest intrusion.

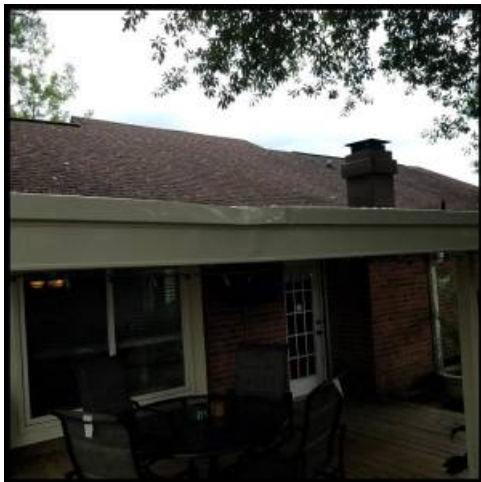
The following concerns were noted at the patio/porch cover:
Damage noted to the back side of the awning. Monitor for problems and repair as needed.

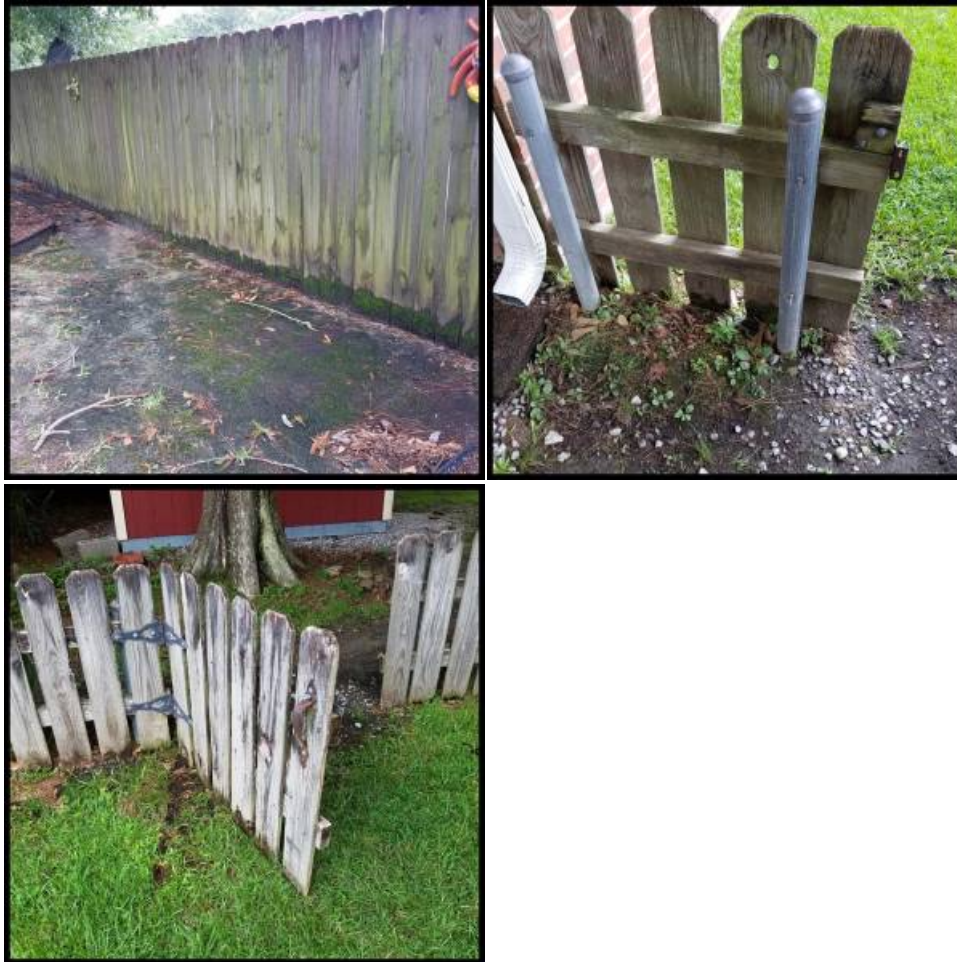
The following concerns were noted at the fence:
Moisture damage noted.
Left Gate needs repair or adjustment.

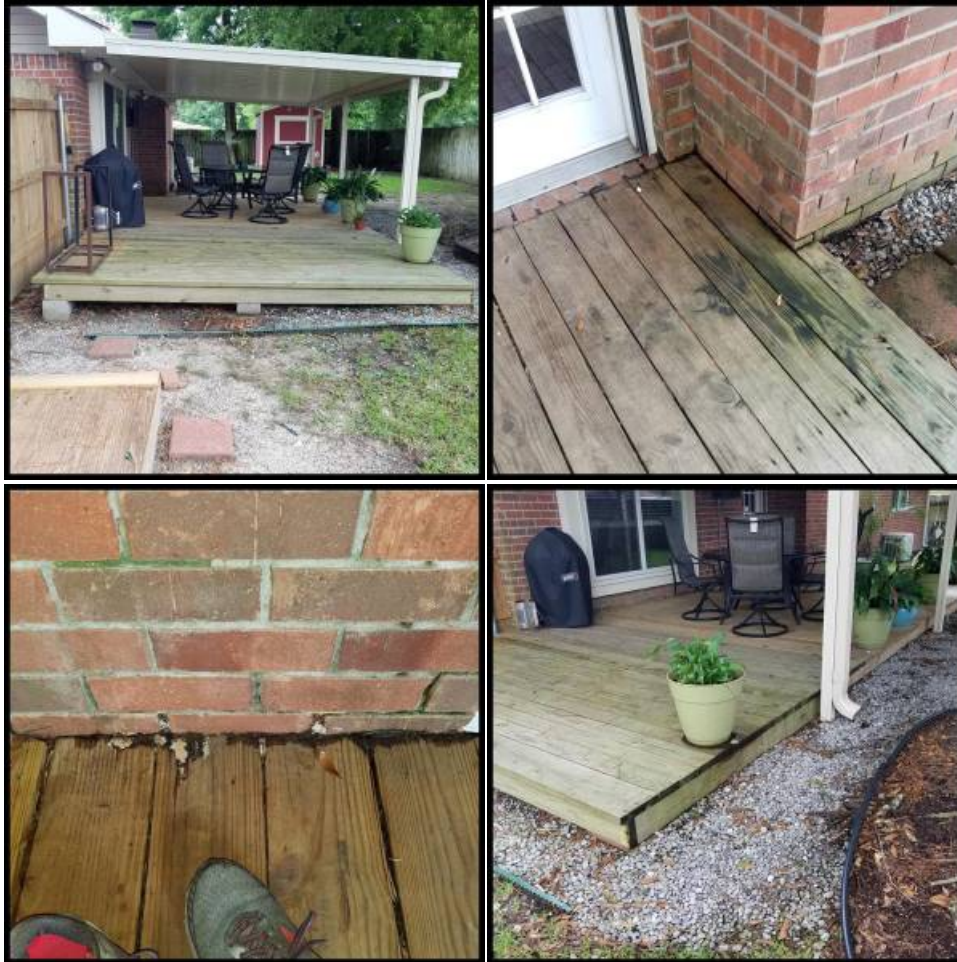
Wood to ground contact noted. Monitor for problems and replace or repair as needed.

Moisture staining noted to rear deck next to the rear door. Monitor for problems and repair as needed.

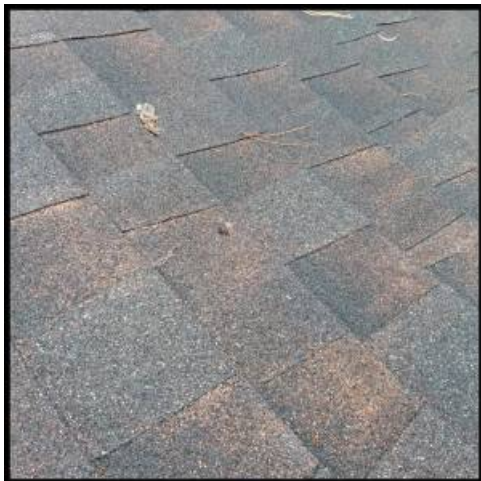
The following concerns were noted at the roof:
Nails/Fasteners are exposed. Sealing is recommended.

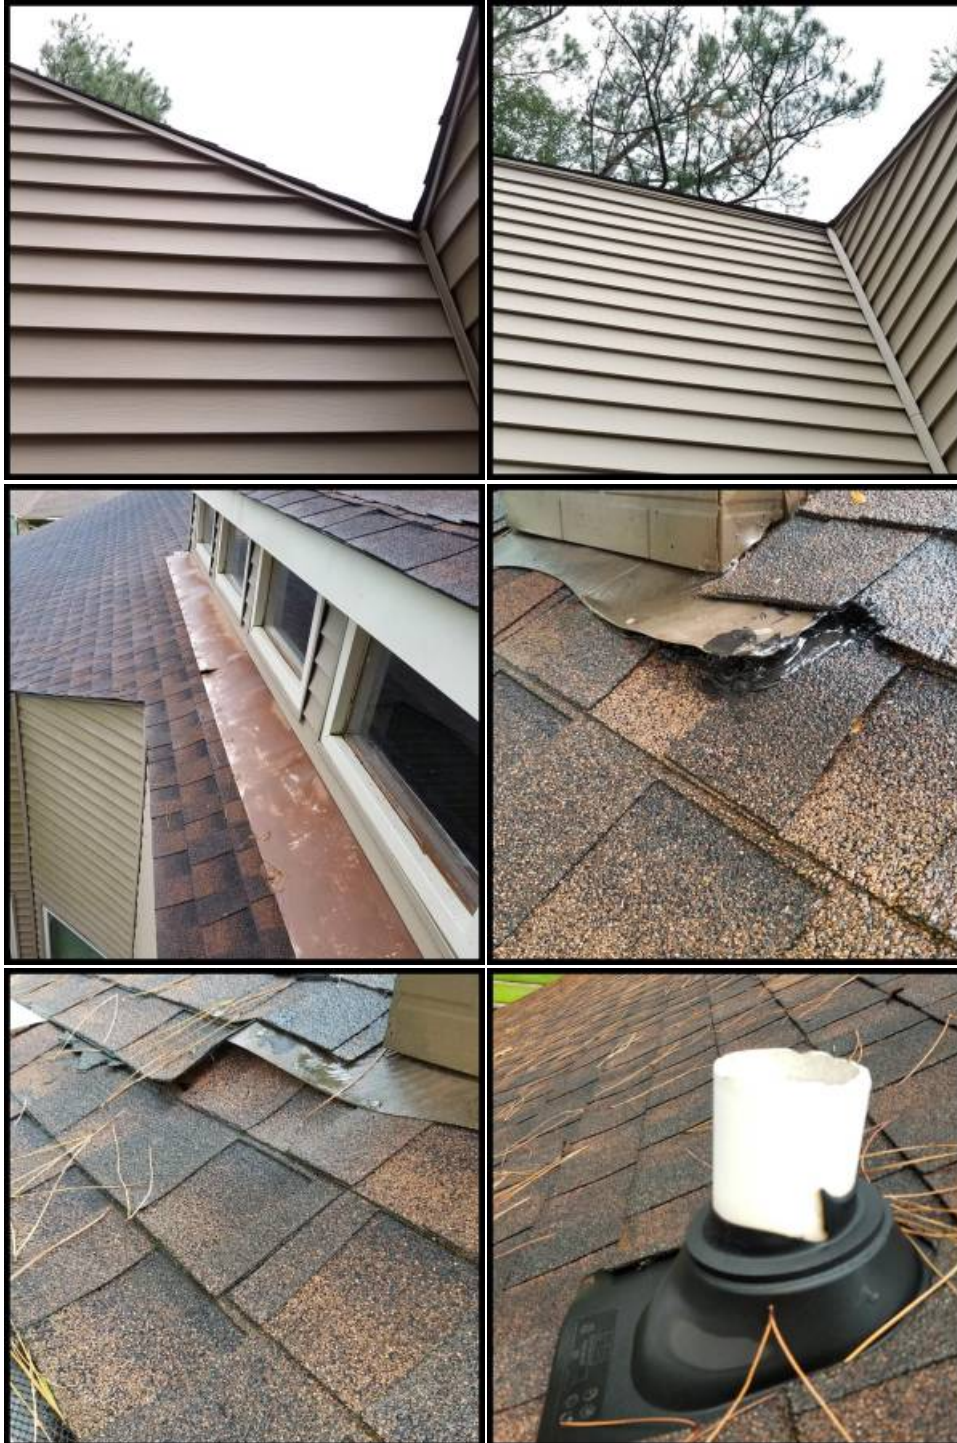
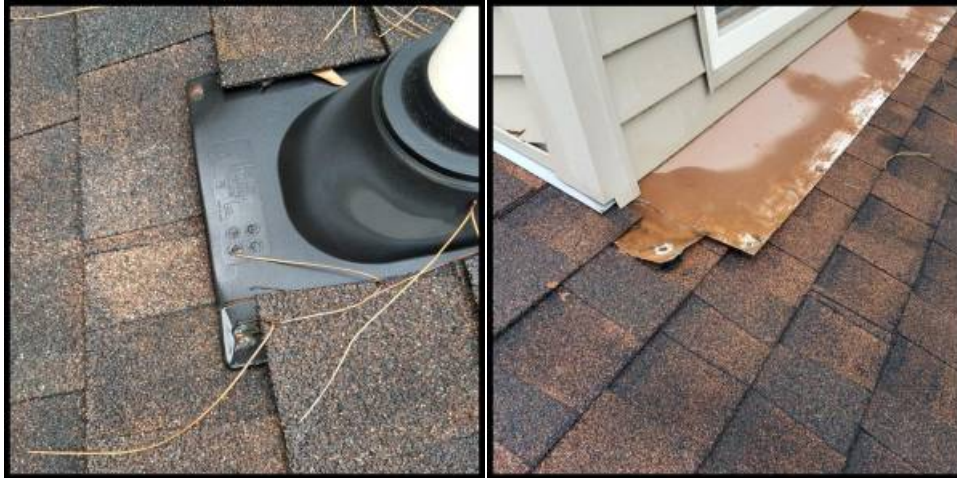
The following concerns were noted at the flashings:
No visible drip edge flashing noted at edges of roof in the front court yard. While this flashing is not required, it is recommended to divert water away from the soffit and fascia, helping to decrease the likelihood of moisture damage to the structure.
Torn boot noted on the back left of home. Monitor for problems and replace as needed.
Lifting flashing noted. Recommended securing to prevent any further damage.

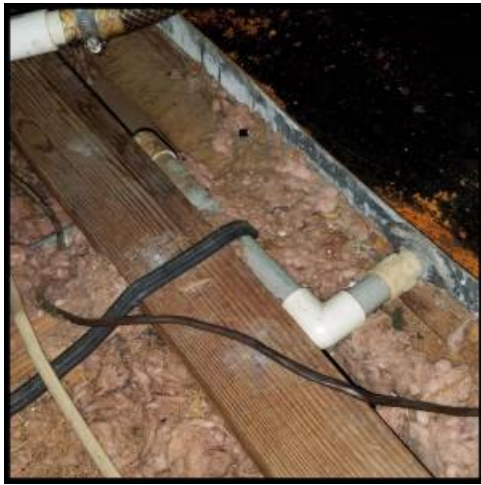
ABS to PVC contact noted on the AC drain line. Glue may not properly adhere and openings may result. Monitor for problems and replace as needed.

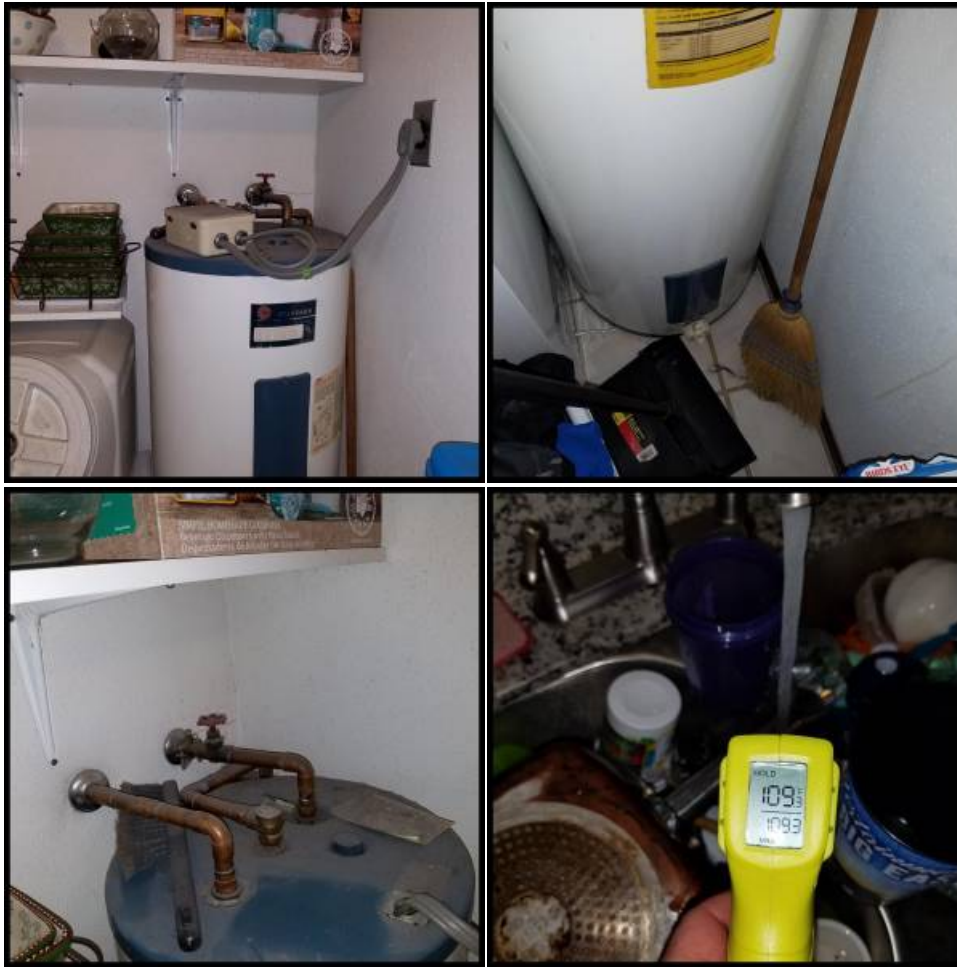
The following concerns were noted at the water heater:
Recommend installing an overflow drain pan with an exterior routed drain line.

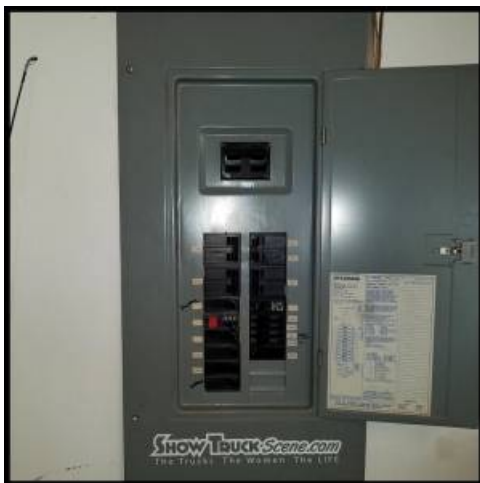
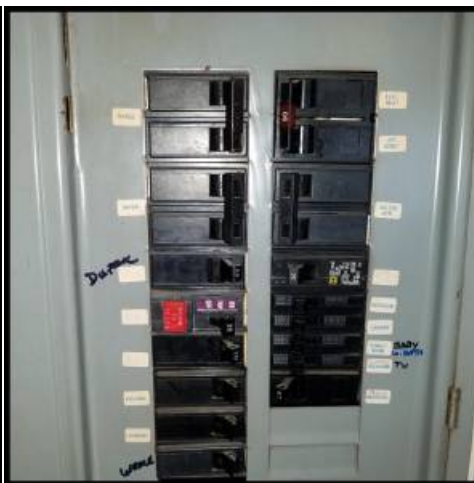
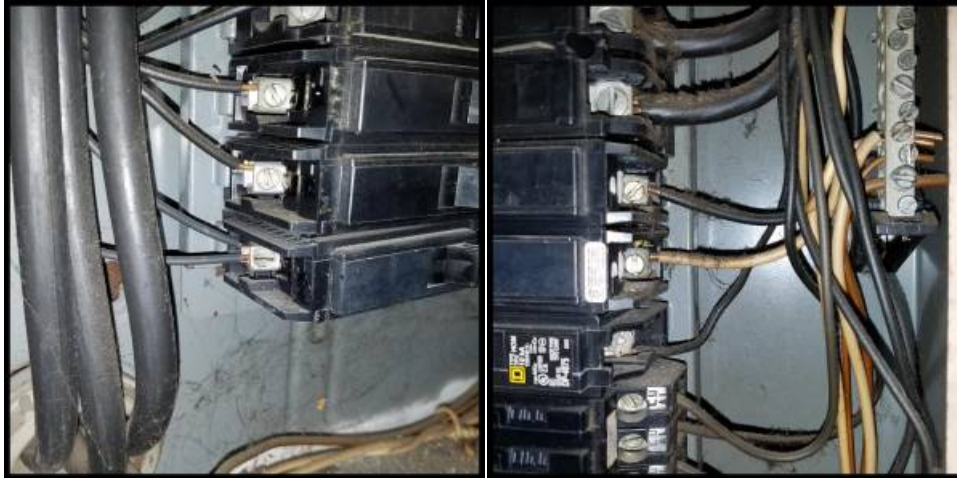
The following concerns were noted at the main electrical panel:
White wire used as hot circuit not properly marked (Should be painted/taped black)
Improper screws noted at panel cover. Replace with proper screws.

The following wiring concerns were noted:
Multiple wires are connected to a single lug on a circuit breaker where generally only one wire should be connected. Further evaluation is recommend and correct as needed.

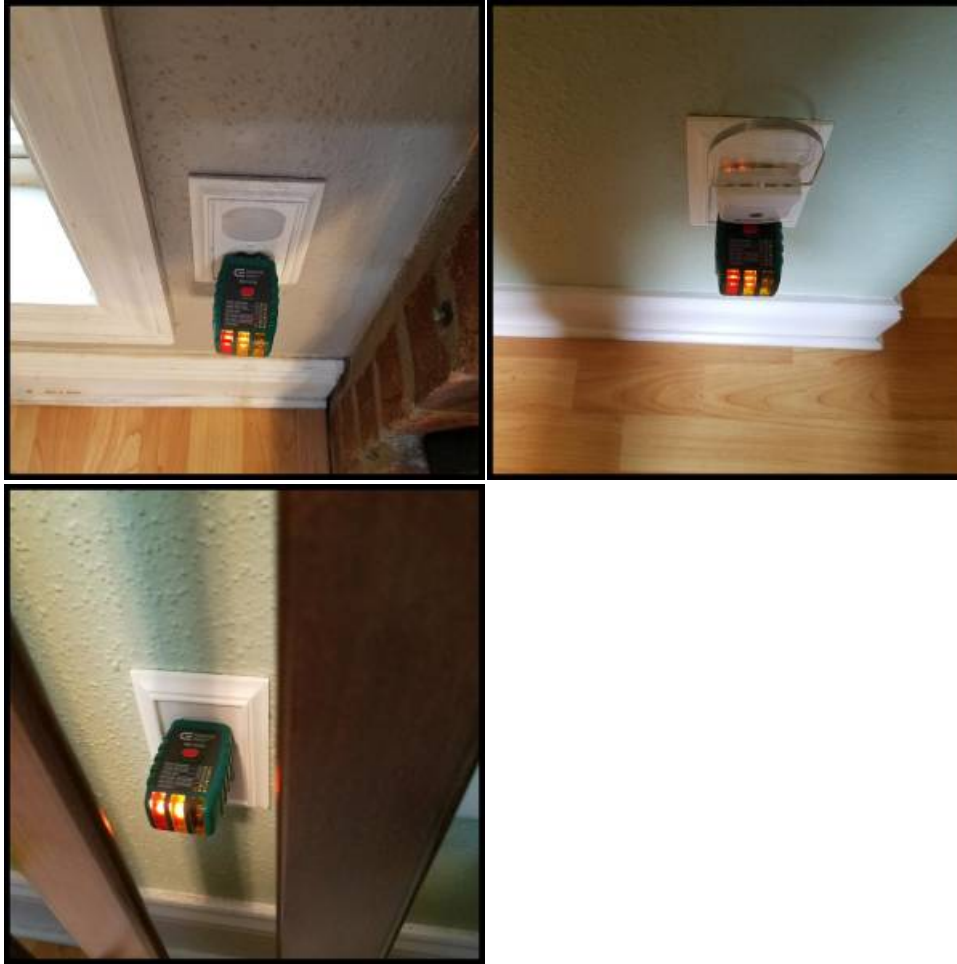
The following concerns were noted with the switches and outlets:
Reverse polarity outlet is noted in the living room to the left of the fire place, in the front right bedroom back wall and left wall. Further evaluation is recommended and repair or replace as needed.

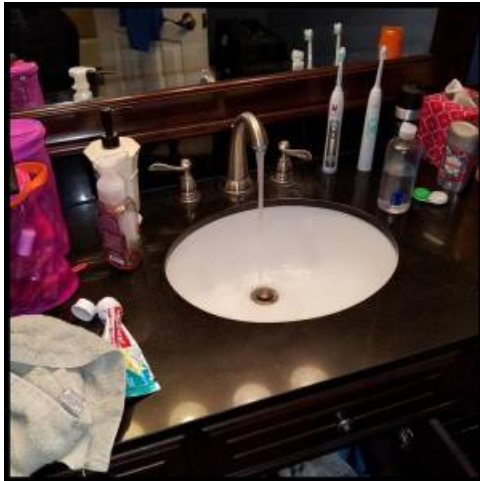
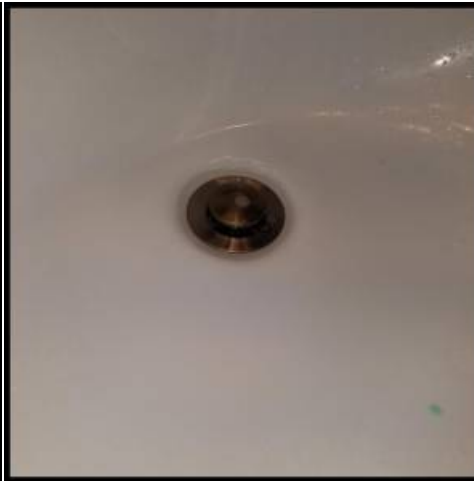
Stopper missing/did not operate properly. Repair or replace as needed.

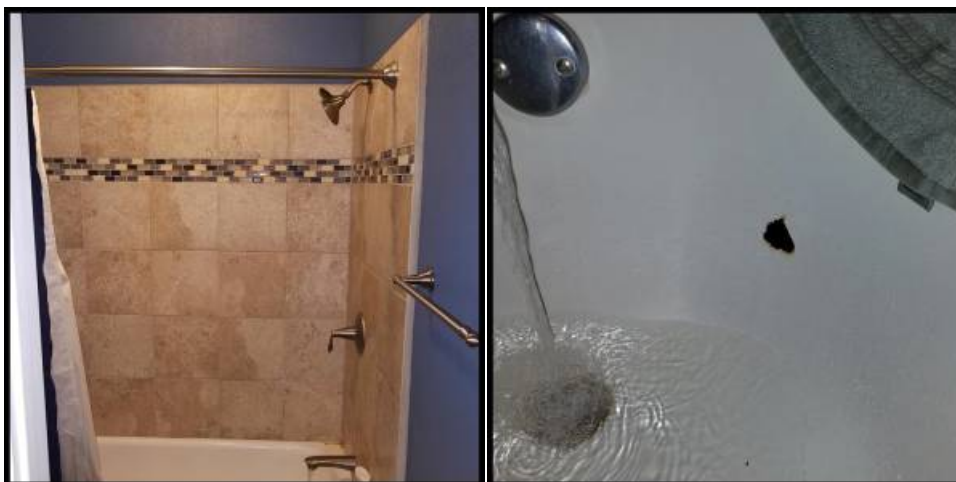
Damage/Deterioration noted at tub on the right side. Monitor for problems and repair or replace as needed.

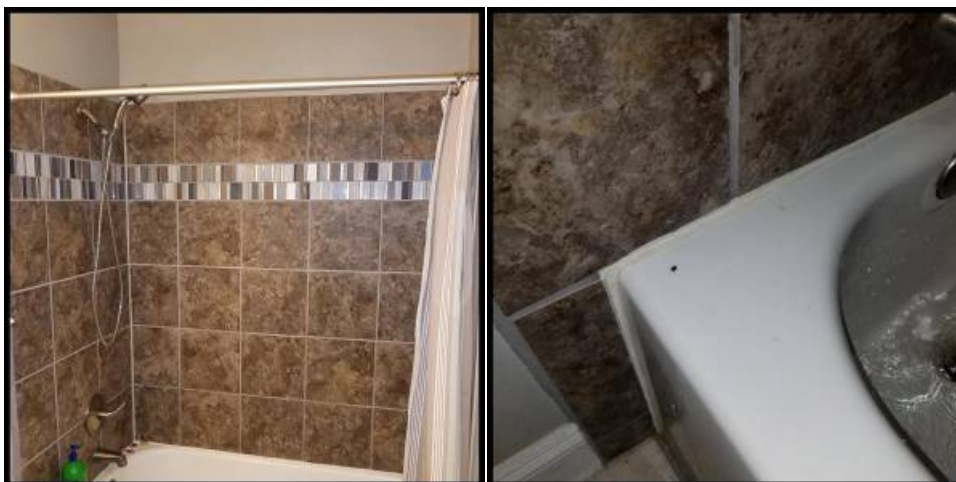
Damage/Deterioration noted at tub on the top left side. Monitor for problems and repair as needed.

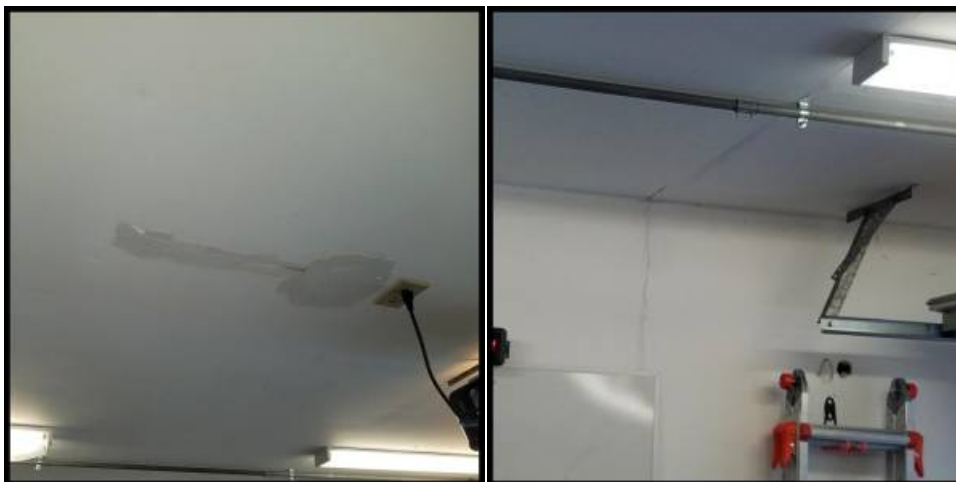
The following concerns were noted at the walls/ceiling:
Typical cracks noted. Some cracking is to be expected in all interior surfaces as the property settles with age. Recommend monitoring for any future changes
Restricted access due to personal belongings. Unable to fully inspect. Perform a thorough inspection prior to closing after personal items have been removed and call your inspector if any concerns arise.
Peeling paint noted on the ceiling. Repair and paint as needed.
Non-professional repairs noted on the ceiling. Monitor for problems and repair as needed.

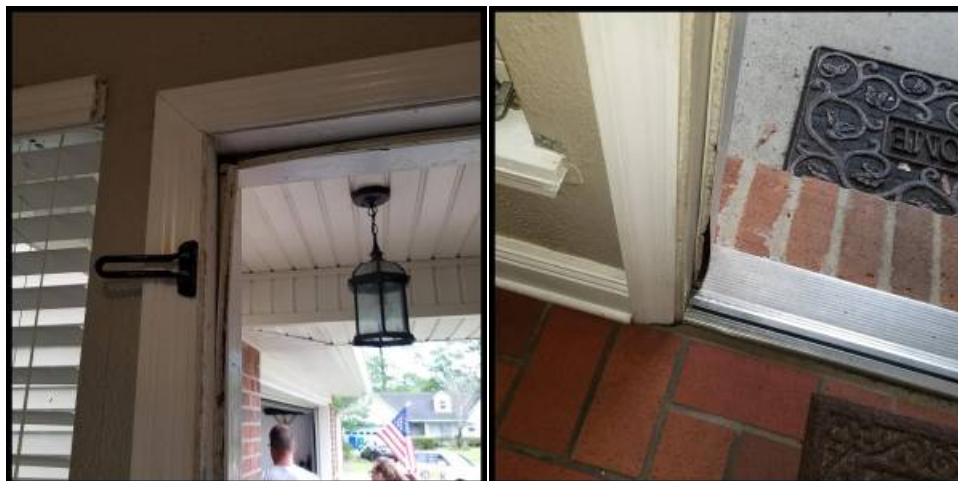
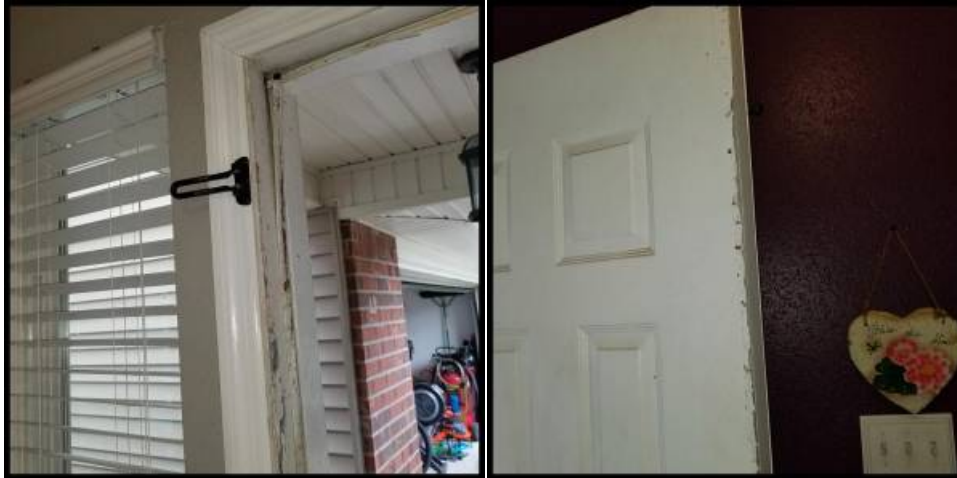
Damaged weatherstripping noted. Replace as needed.

Peeling paint noted on the door and door frame. Paint as needed.

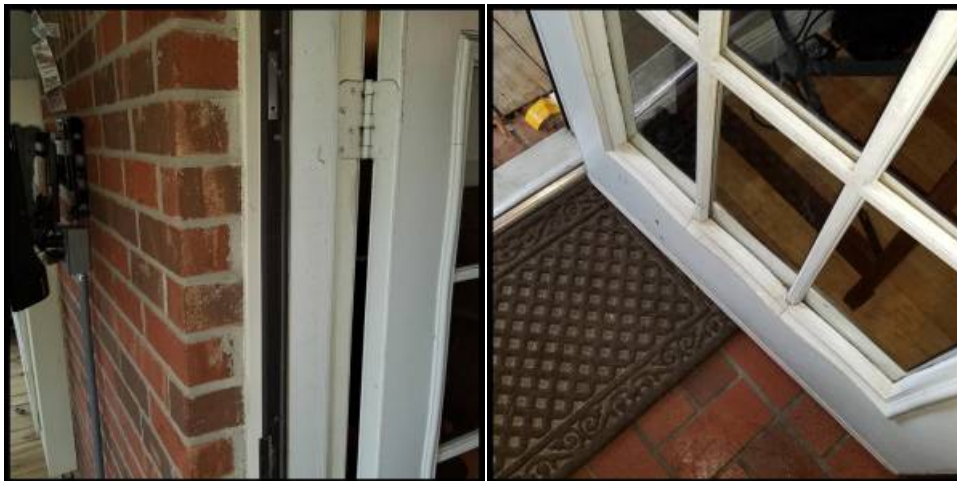
The following concerns were noted at the exterior doors:
Missing exterior storm door noted. Replace as needed.
Moisture damage noted to the trim on the door around the windows. Monitor for problems and repair as needed.

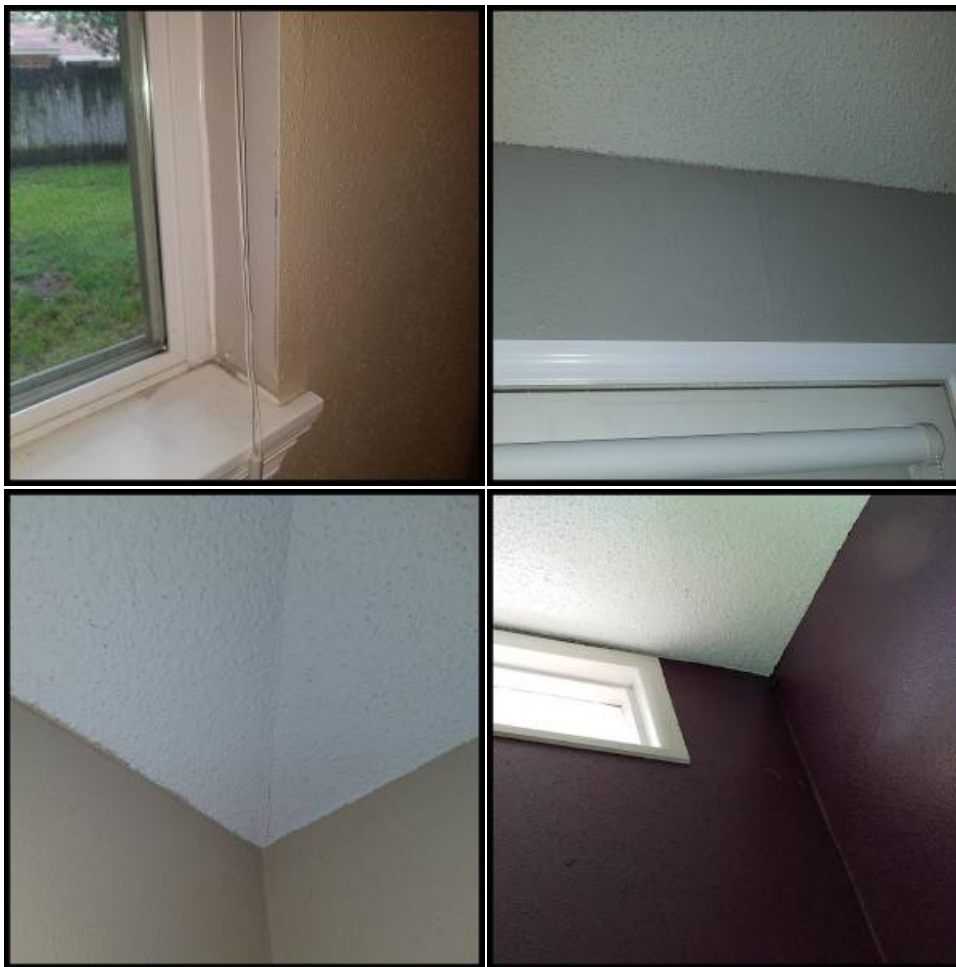
Typical cracks noted. Some cracking is to be expected in all interior surfaces as the property settles with age. Recommend monitoring for any future changes.

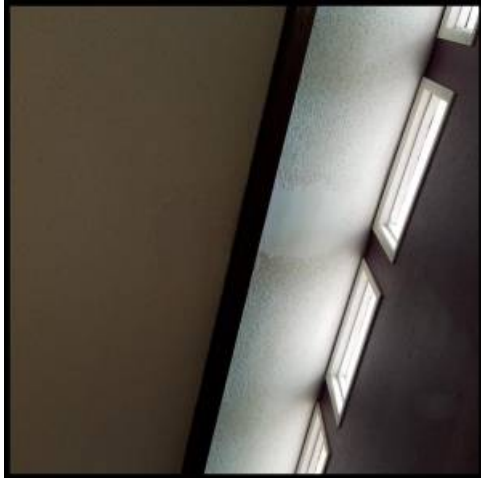
Previous repairs noted, monitor for problems. Verify reason with seller and monitor the area for on-going or future problems and repair as needed.

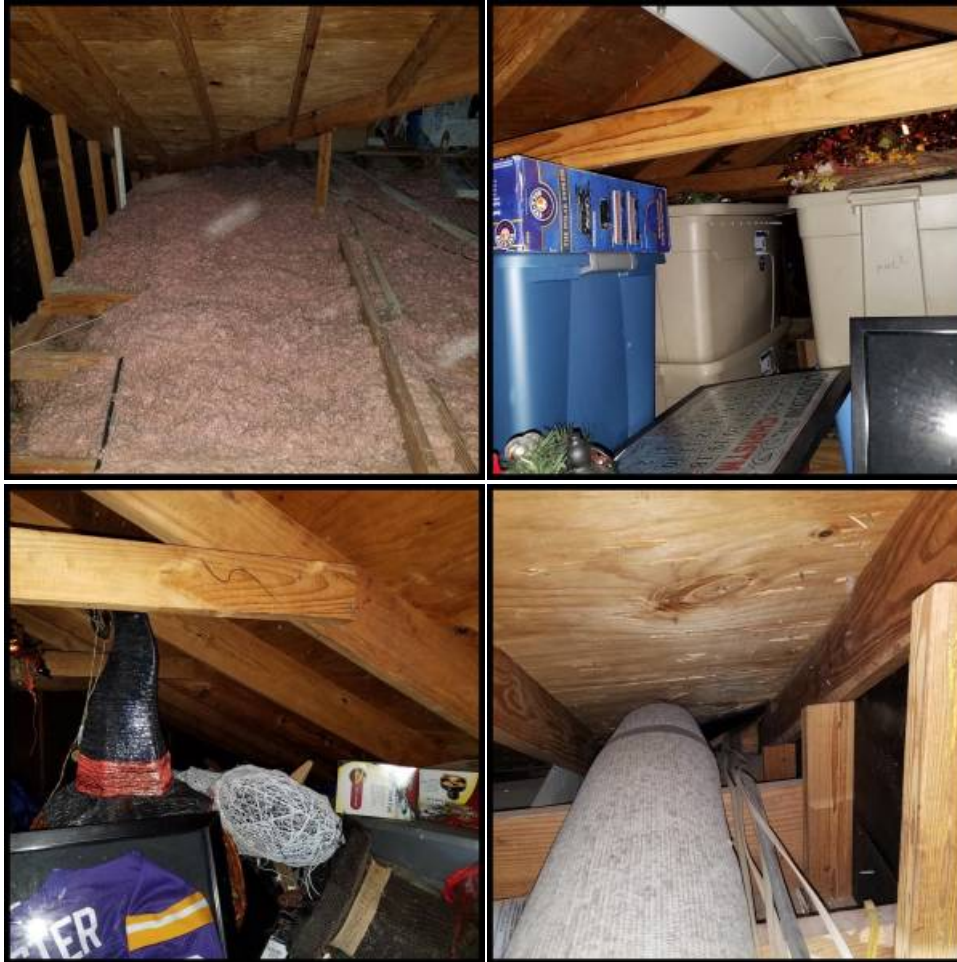
Restricted access to attic due to personal belongings. Only partially entered/partially inspected.

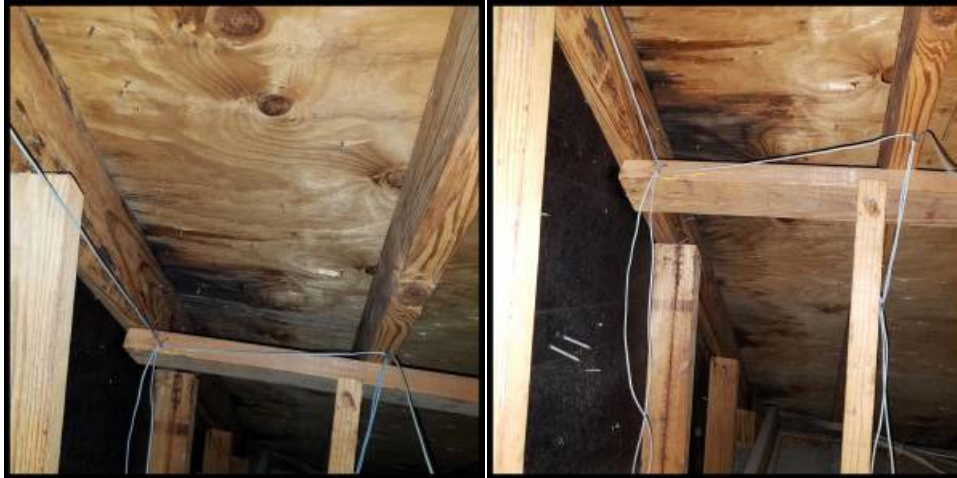
Staining is noted on the front side to the left of the garage and front right of the doorway, Unable to determine the status of the stains.

Active leakage may be present. Further evaluation is recommended. Repair as needed.

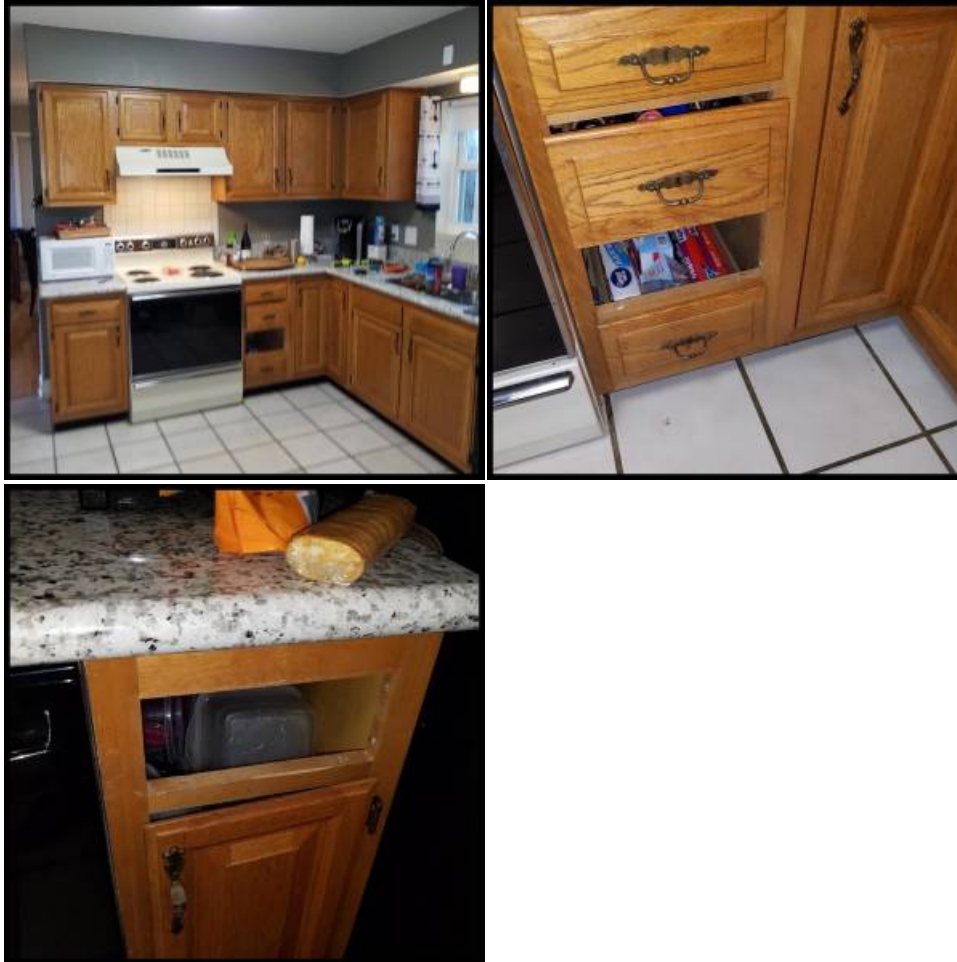
The following concerns were noted at the kitchen cabinets/counter tops:
Minor wear was noted. Monitor for problems and repair or replace as needed.
Missing drawers noted. Third drawer to the right of the oven and top drawer to the right of the dishwasher. Recommend replacing.
Viewing below sink, cabinets, and drawers is restricted due to personal belongings. Recommend inspecting prior to closing.

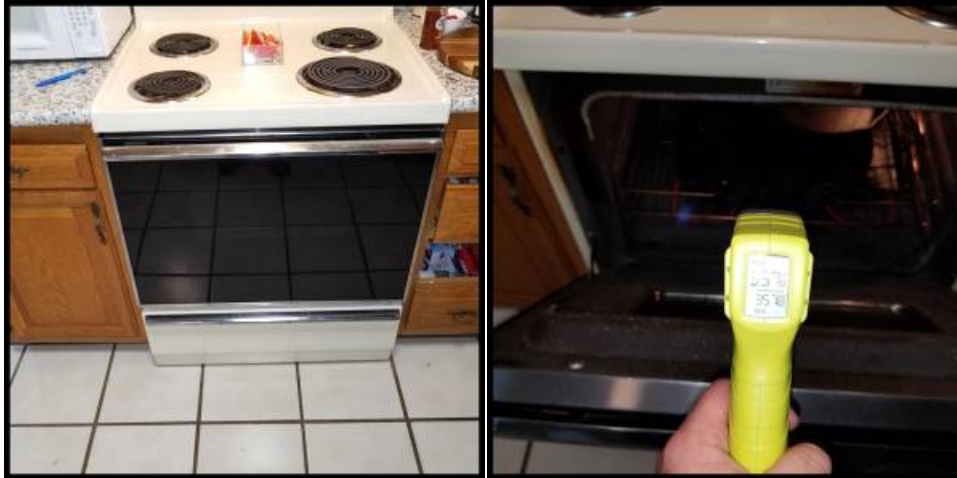
The following concerns were noted at the range/cook top and oven:
No anti-tip device was installed on the free-standing oven. Recommend installing for additional safety.

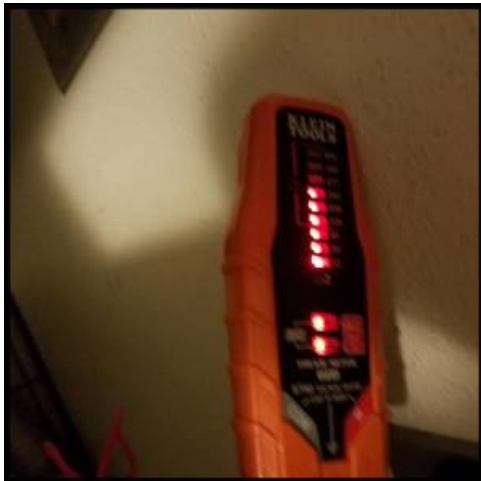
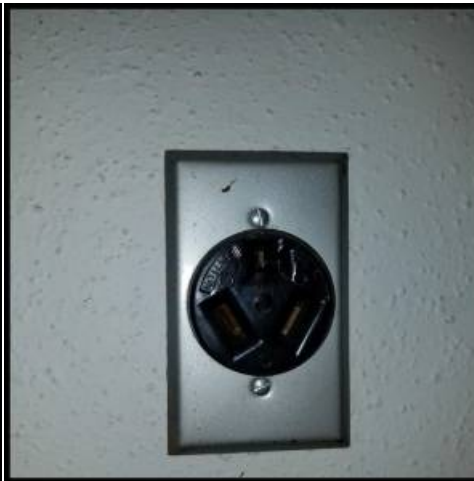
240V Service-operational, 3 prong outlet provided. Recommend upgrading to a 4 prong outlet if possible.

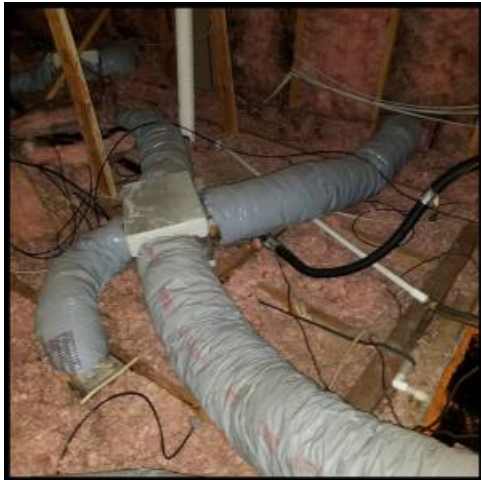
Gray vinyl covered ducts noted. Some manufacturers of these ducts have experienced product failure in residential use. Recommend monitoring for future problems.

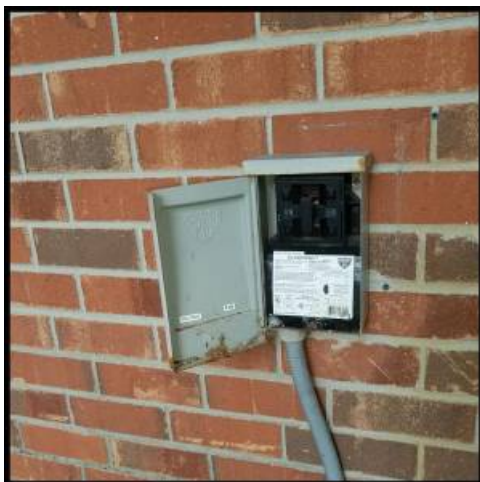
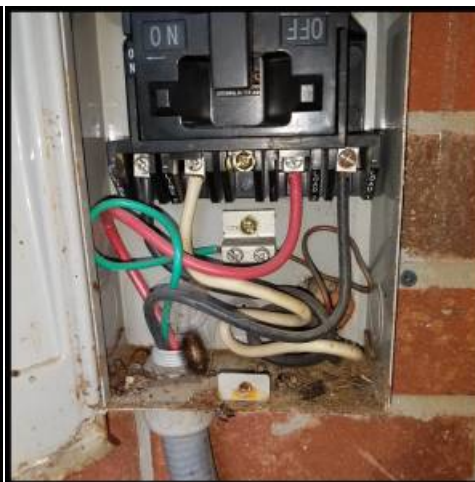
The following concerns were noted at the power source:
Panel appears to be without the benefit of protective grommet. Add as needed to protect the wiring.
