INSPECTION CONDITIONS	3
EXTERIOR - FOUNDATION - BASEMENT	6
GROUNDS	12
ROOF - FLASHING SYSTEMS	18
PLUMBING	22
ELECTRICAL	25
BATHROOMS	29
GARAGE - CARPORT	34
INTERIOR - ATTIC	37
KITCHEN - APPLIANCES - LAUNDRY - WETBAR	44
HEATING - AIR CONDITIONING	50

INSPECTION CONDITIONS

DATE OF INSPECTION: 7/3/2020.
START TIME OF INSPECTION: 2pm.
END TIME OF INSPECTION: 5pm.
CLIENT NAME: Steven Prince.
INSPECTION SITE: 445 Evergreen Ct.

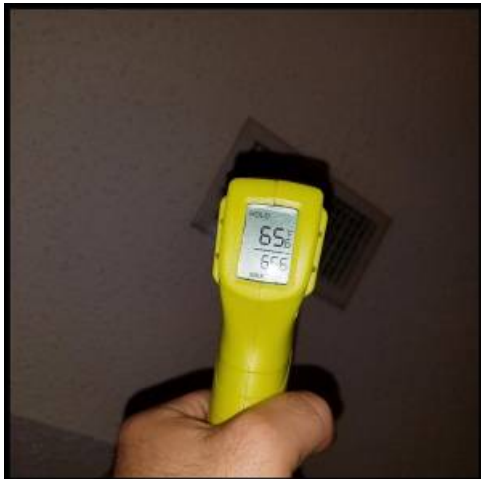
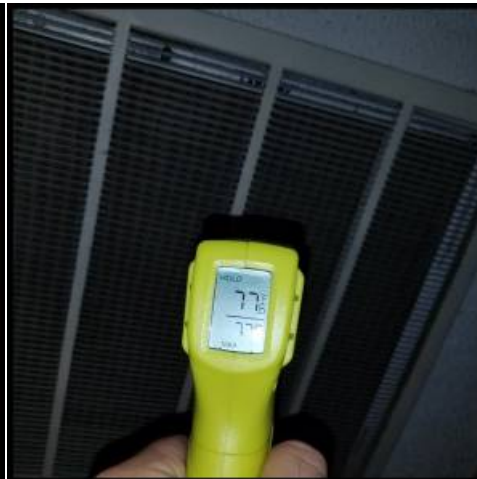
INTERIOR AIR TEMPERATURE DROP: 12-14 degrees F. Considered marginal operation.

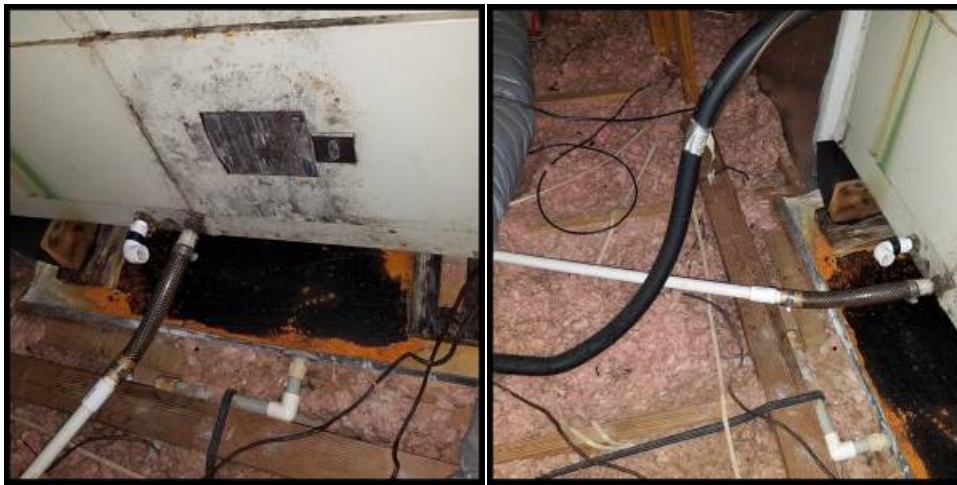
The following concerns were noted with overflow drain pan:
Damage/rusting noted at pan. Monitor for problems.
