## Structural Inspection

May 28, 2019

Ref: 524 Brakefield St  
Slidell, La.

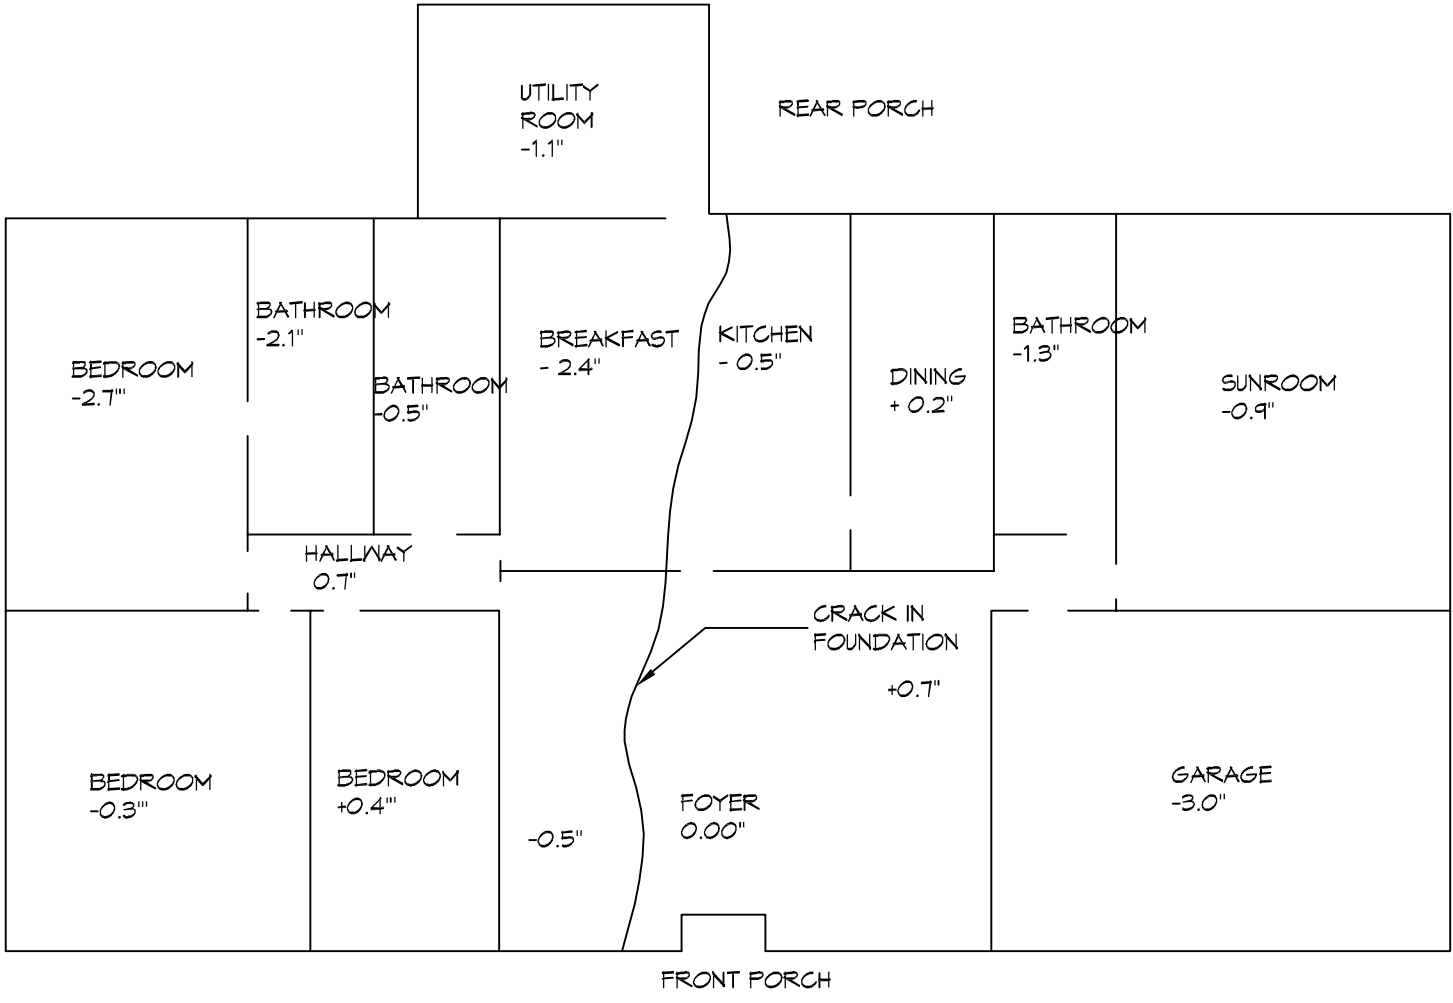
Upon inspection, a zip level was used to verify the floor height conditions. The level was set up at the front foyer/ living room at zero inches and measured throughout the home. It is important to note that all floor height conditions vary due to ceramic height and wood flooring height. See the attached elevation sketch.
