Structural Inspection

November 23, 2020

For: Brian Breaux
25356 Chef Menteur Hwy
New Orleans, La. 70129

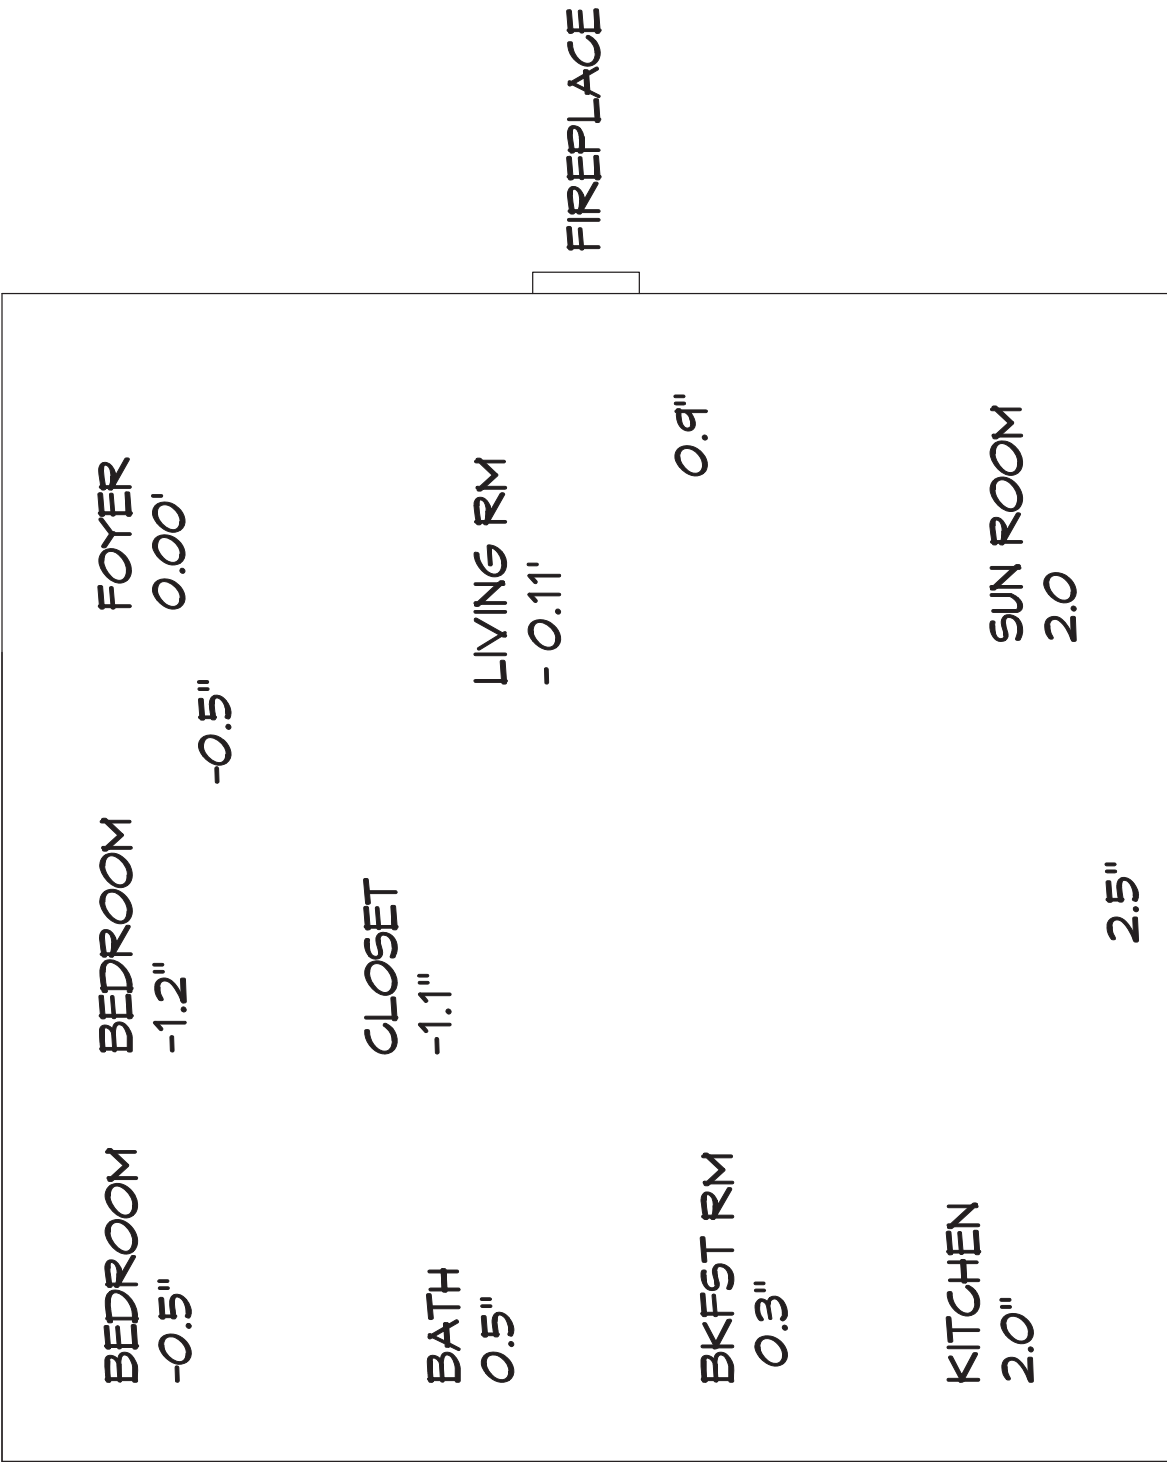
Upon inspection, a zip level was used to verify the floor height conditions. The level was set up at the front of the home in the foyer. The slopes range in the house from 0.0" to +2.5" to -1.3" throughout the home as noted in the attached layout.

- 1) It is recommended to level the home and secure it properly using current codes.
- 2) Replace torn felt and missing shingles to dry the home in.
- 3) Repair and patch sheetrock and paint to match.
- 4) Add cross bracing.

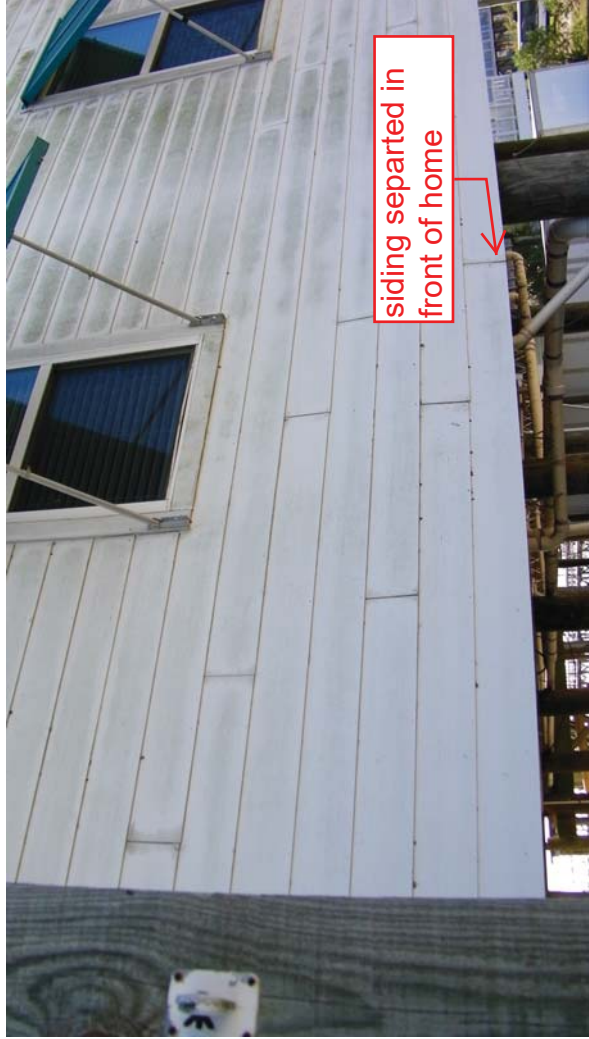
siding separated in front of home

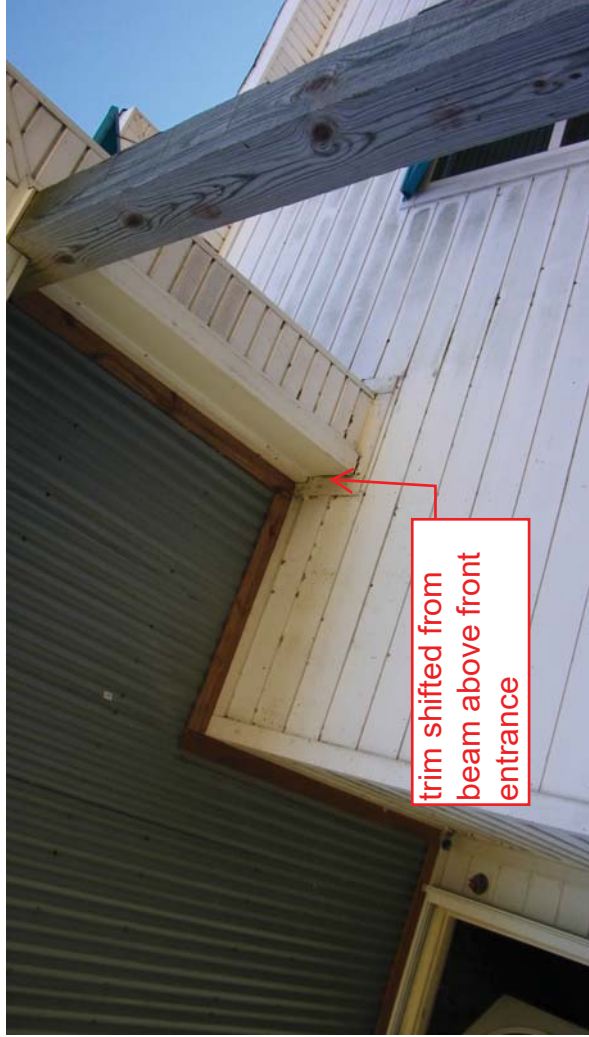
trim shifted from
beam above front
entrance

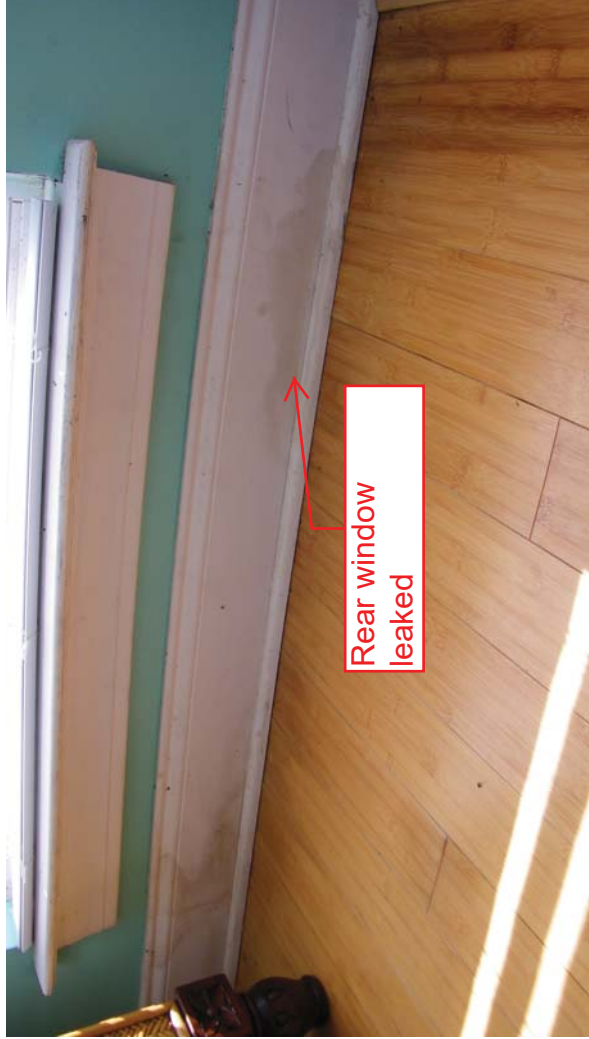
All the exterior doors are aged specifically the front door and that is where most of the sheet rock damage occurred in front and on both floors of the home. The rear window in the sunroom was noted to have water stains under the window on the molding. The exterior of the home was noted to have some siding and shingles missing. One of the skylights leaked water due to the shingles missing in that area.

Rear window
leaked

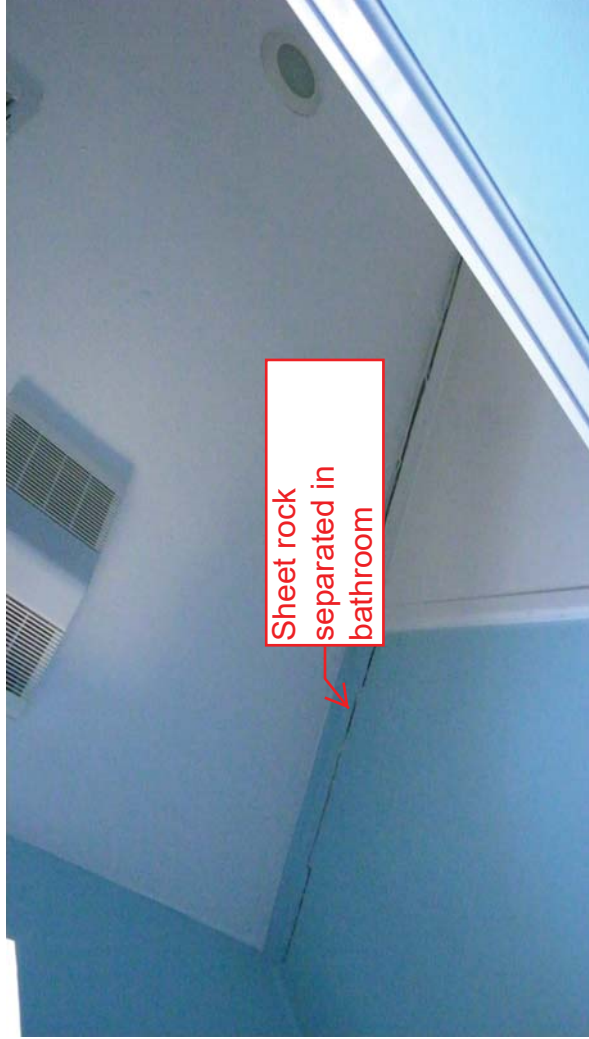
The wind as stated from the weather channel passed over this area and after the eye passed the North West wind hit the front of the home causing uplift and horizontal winds on the front porch area and wall causing shifting in the house which in turn caused all the sheet rock damage.

Sheet rock separated in bathroom

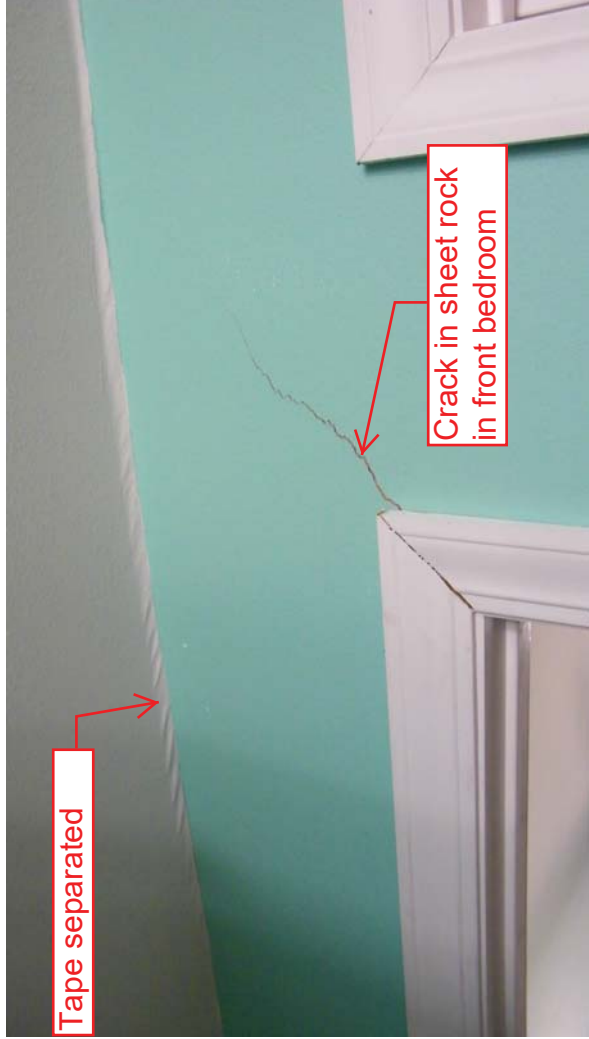
Tape separated

Crack in sheet rock
in front bedroom

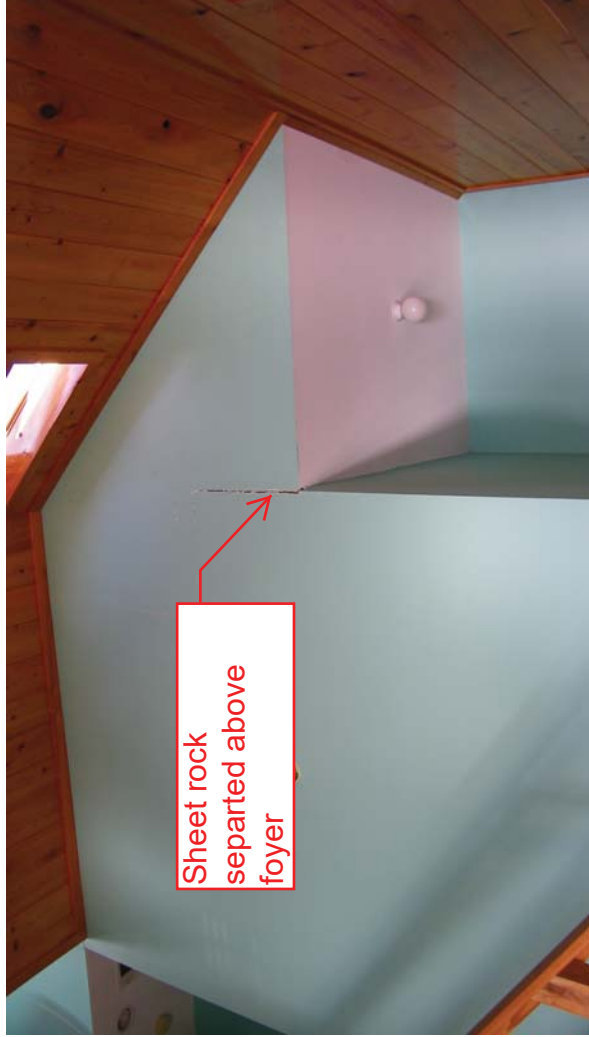
Sheet rock
separated above
foyer

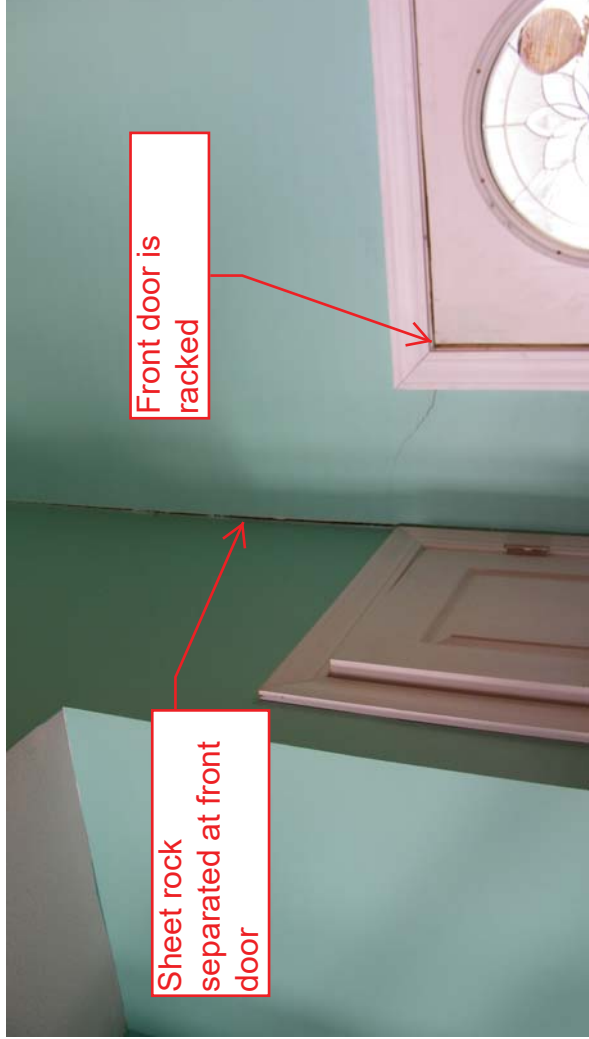
Front door is
racked

Sheet rock
separated at front
door

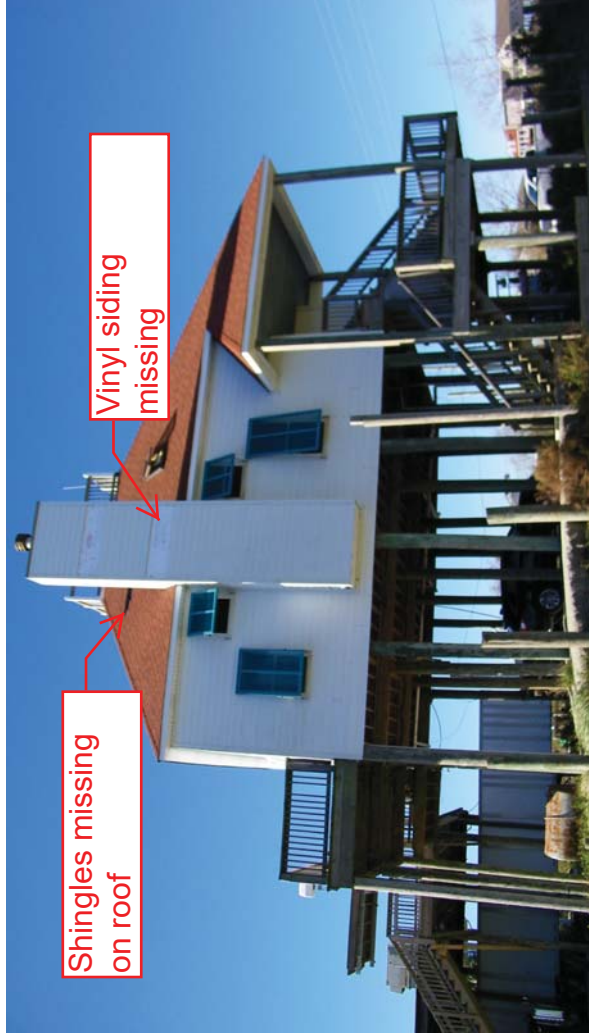
Shingles missing
on roof

Vinyl siding
missing
