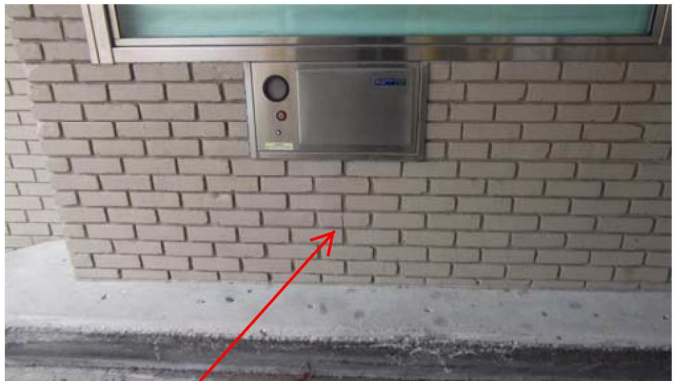
Crack in brick veneer.
