Structural Inspection

November 16, 2016

Ref: 550 Pontchartrain Blvd.
Slidell, La. 70458

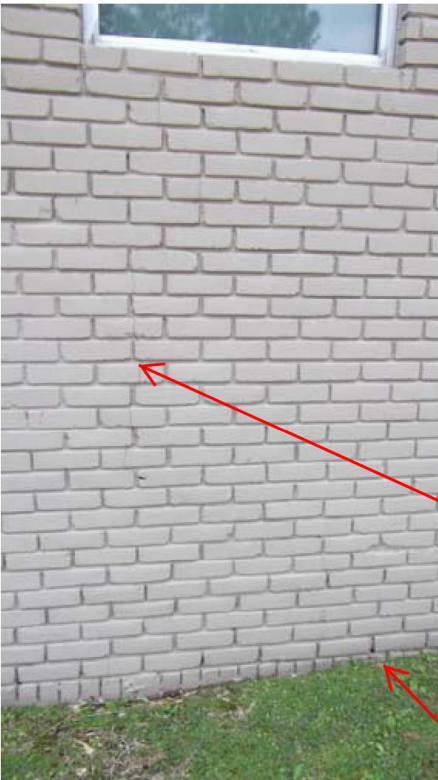
Two cracks in the exterior brick veneer at the rear of the building run from the ground level to the corners of the exterior windows. One crack in the brick veneer runs from the ground level to top of the wall and one crack below the teller window runs from the concrete up to the bottom of the teller window. The perimeter of the building has brick below the natural grade of property therefore the concrete foundation could not be seen without excavation. Most of the weep holes in the brick at the base have been covered with landscaping.

Crack in brick veneer.

1. The cracks in the brick veneer should be sealed.
2. The landscaping around the perimeter of the building should be corrected to expose the top of the foundation allowing water that forms behind the brick veneer to drain out through the weep holes.

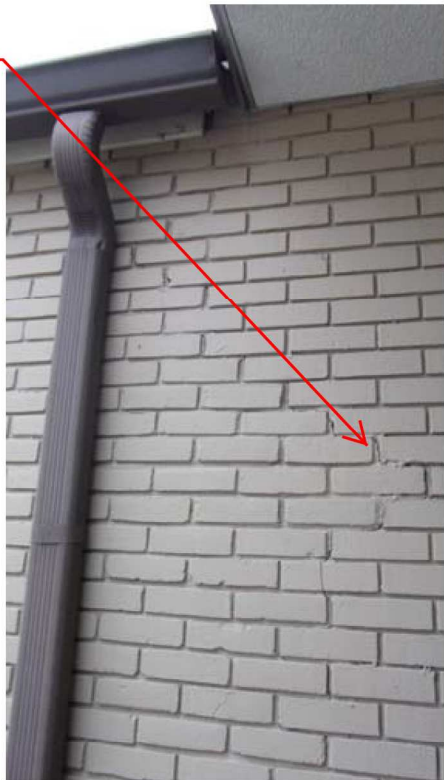
Crack in brick veneer.

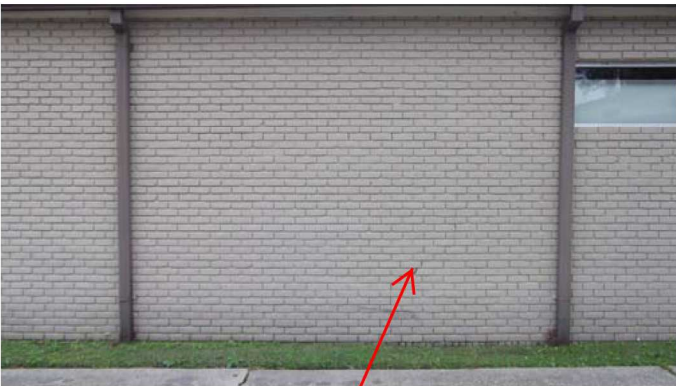
Weep holes covered by landscaping.

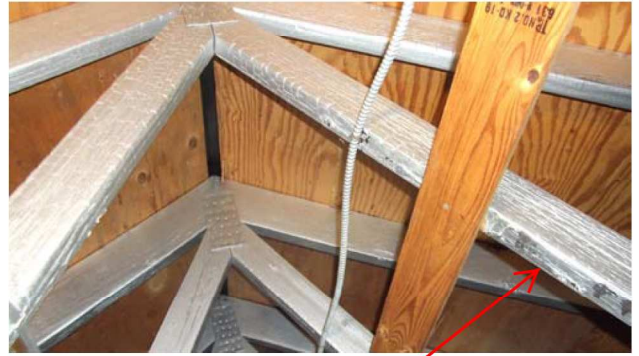
The roof is a gable roof supported at the exterior walls. Multiple rafters and web supporting members show signs of charring from a fire directly over the lobby area. All rafters, web supporting members and ceiling joist over the lobby area have been painted with a silver paint to seal the wood.

There was no evidence of any rafters, web supporting members or ceiling joists showing any signs of being stressed. Some of the paint no longer existing at some of the charred spots on the wood; however the wood fibers around these spots show no signs of fatigue with signs of cracks in the paint.

Roof framing members that have been painted.

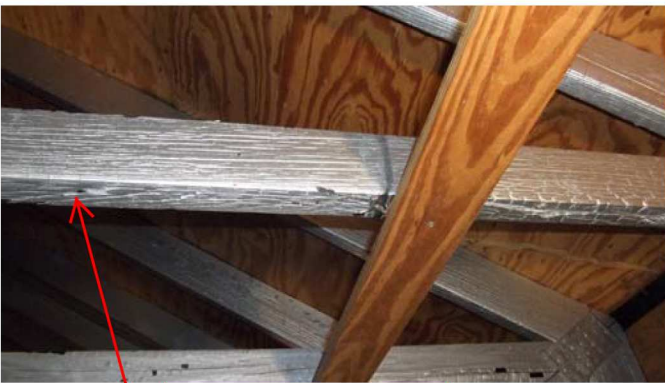
Roof framing members that have been painted.

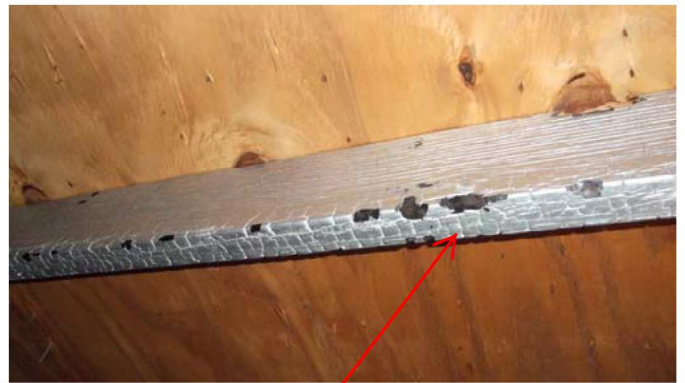
Roof framing member that has been painted.
