Structural Inspection

November 16, 2016

Ref: 550 Pontchartrain Blvd.
Slidell, La. 70458

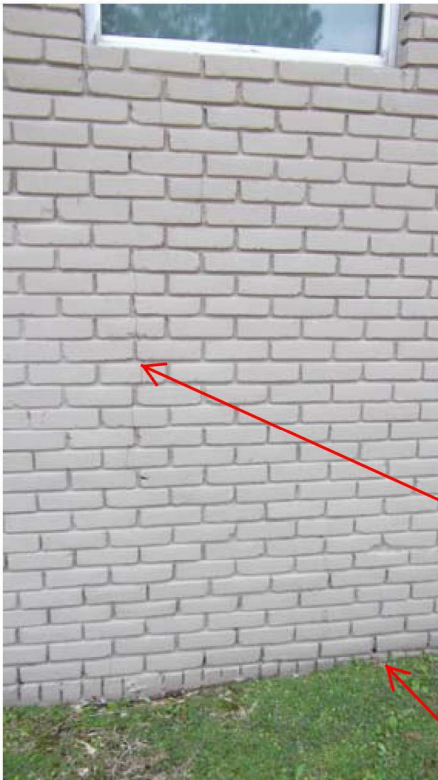
Two cracks in the exterior brick veneer at the rear of the building run from the ground level to the corners of the exterior windows. One crack in the brick veneer runs from the ground level to top of the wall and one crack below the teller window runs from the concrete up to the bottom of the teller window. The perimeter of the building has brick below the natural grade of property therefore the concrete foundation could not be seen without excavation. Most of the weep holes in the brick at the base have been covered with landscaping.

Crack in brick veneer.

1. The cracks in the brick veneer should be sealed.
2. The landscaping around the perimeter of the building should be corrected to expose the top of the foundation allowing water that forms behind the brick veneer to drain out through the weep holes.

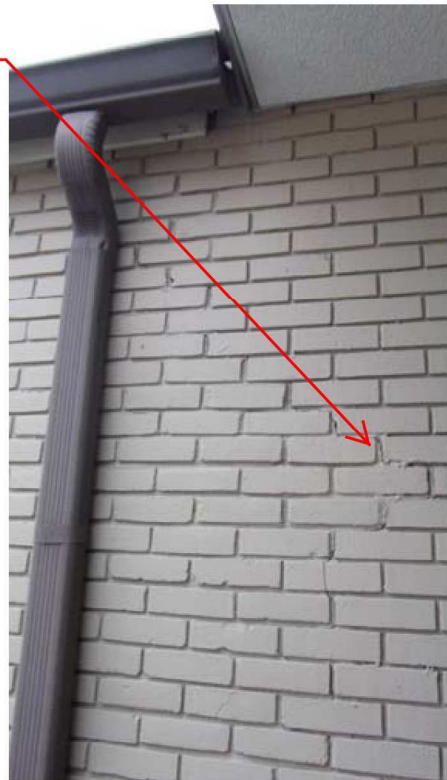
Crack in brick veneer.

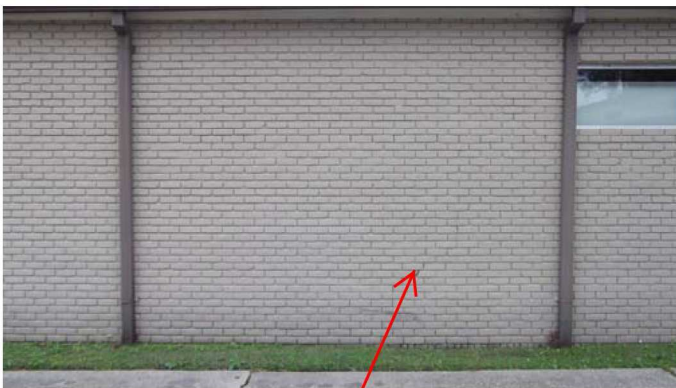
Weep holes covered by landscaping.

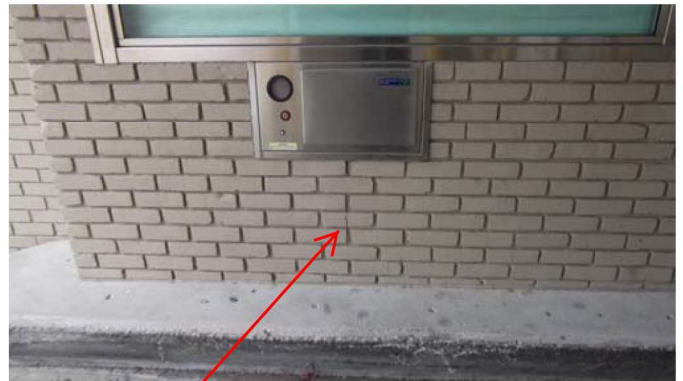
Crack in brick veneer.

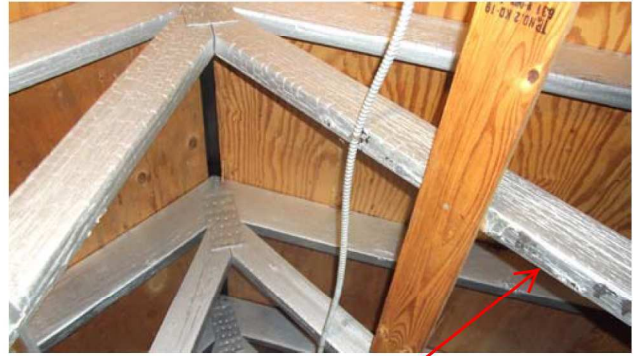
The roof is a gable roof supported at the exterior walls. Multiple rafters and web supporting members show signs of charring from a fire directly over the lobby area. All rafters, web supporting members and ceiling joist over the lobby area have been painted with a silver paint to seal the wood.

There was no evidence of any rafters, web supporting members or ceiling joists showing any signs of being stressed. Some of the paint no longer existing at some of the charred spots on the wood; however the wood fibers around these spots show no signs of fatigue with signs of cracks in the paint.

The silver paint used to seal the wood in the attic provides a means to reduce/eliminate odors from the char and smoke on the wood members. Char that forms on the surface of wood structural members is lightweight and brittle, it has little tensile, compressive or shear strength. Movement of any of the structural members would inevitably show signs of missing areas of char and cracks in the paint where the stress(s) would have occurred.

Roof framing members that have been painted.

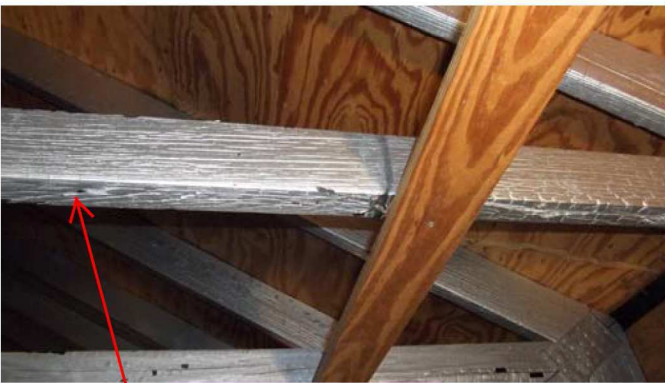
Roof framing members that have been painted.

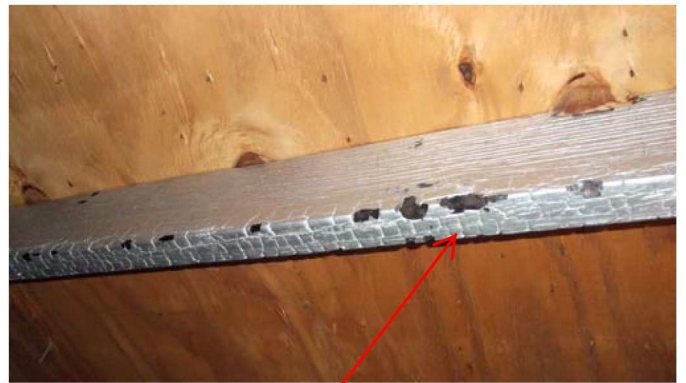
Roof framing member that has been painted.
