Structural Inspection

February 26, 2016

For: Brigid Deloach
5531 Sandlewood Ct.
Slidell, La 70460

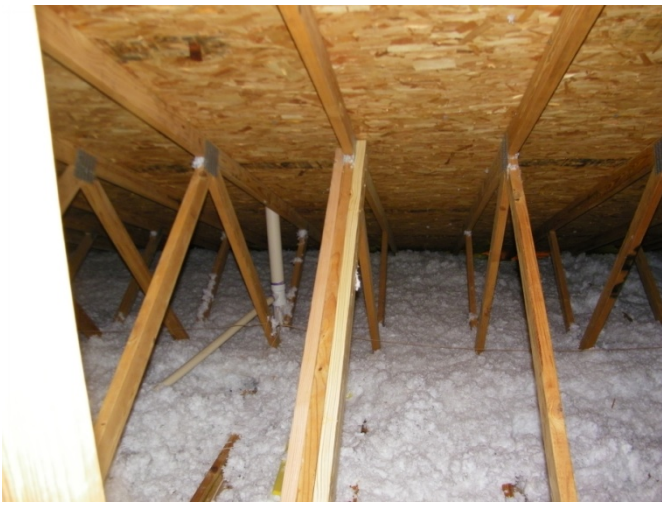
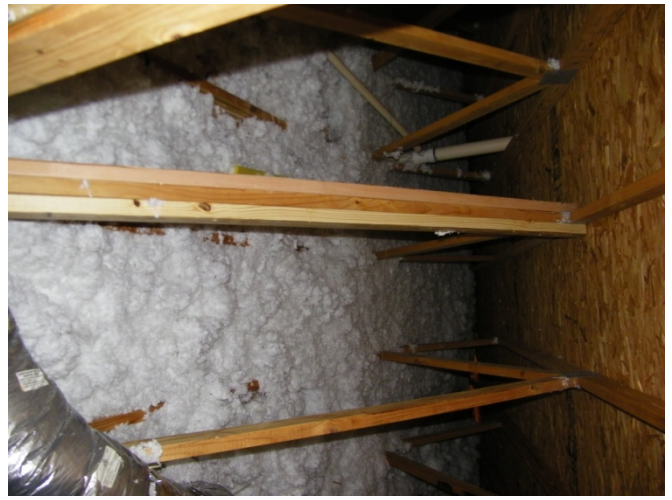
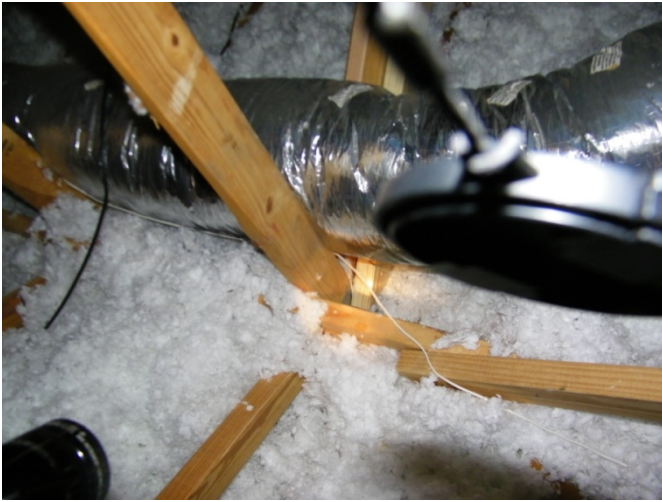
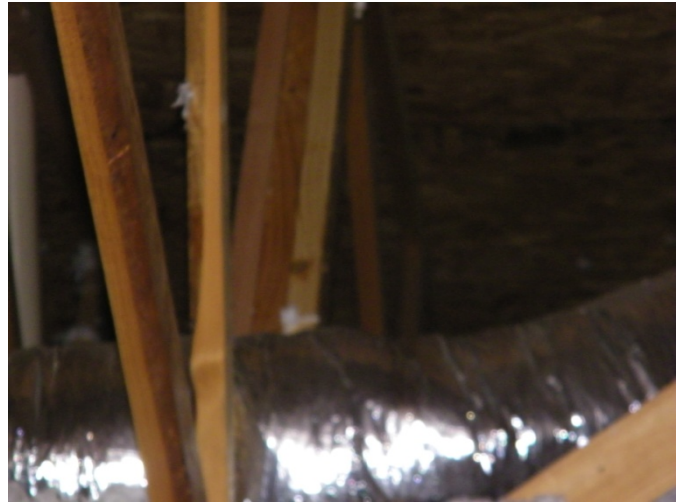
The roof is built with trusses @ 24" O.C. one of the roof truss in the rear of the home was cracked and has since been repaired by a contractor. The contractor installed bracing on either side of the broken truss and is equally strong now.

It is my opinion that this truss is currently structurally sound.
