# HOME INSPECTION REPORT

5531 Sandlewood Ct., Slidell , LA 70460

Tuesday, February 16, 2016

2162016-3

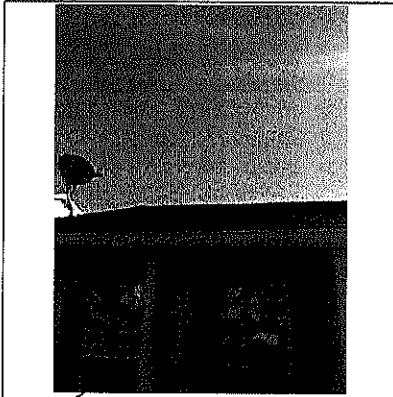
Repair: Ridge caps damaged in various areas and exposed nails in the roof. Professional roofer recommended for further evaluation and repairs.

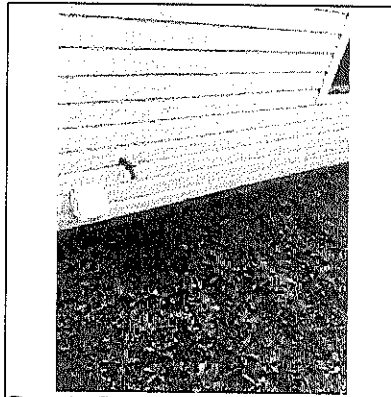
Repair: Damaged siding on the right exterior.

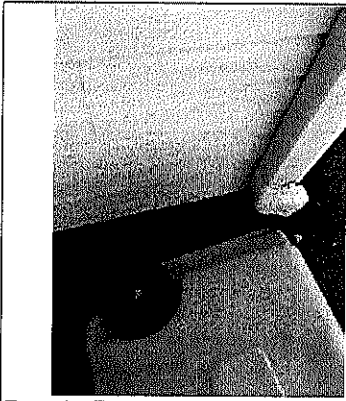
Repair: Damaged siding on the right front.

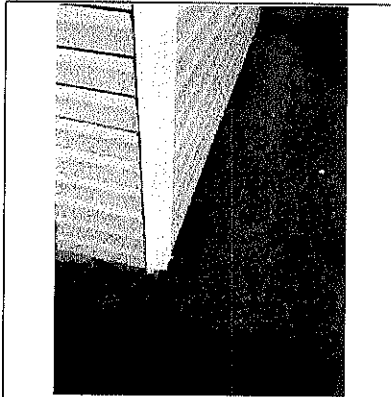
Repair: Right rear corner damaged.

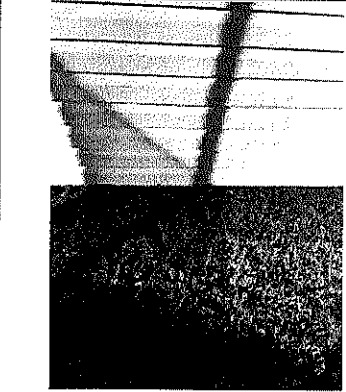
Repair: Lower siding on the home damaged in various areas.

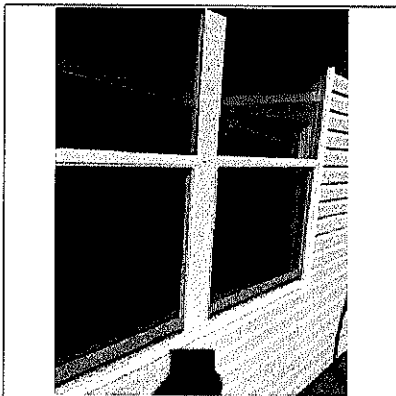
Repair: Lost seals in various areas. Professional window company recommended for further evaluation and repairs.

*rusted frames from moisture  
Broken seals on various  
windows*

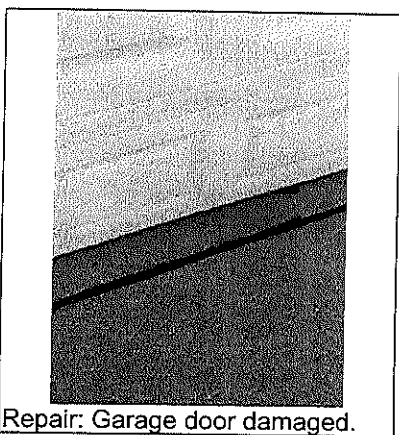
Repair: Garage door damaged.

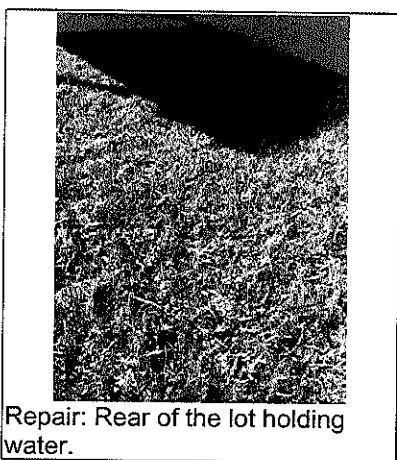
Repair: Rear of the lot holding water.

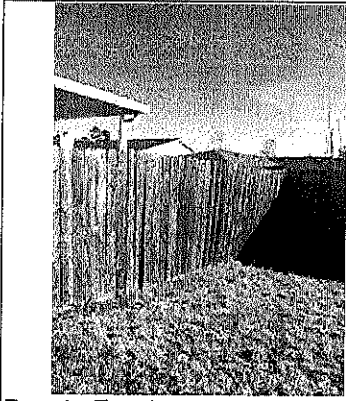
Repair: Fencing damaged in various areas.

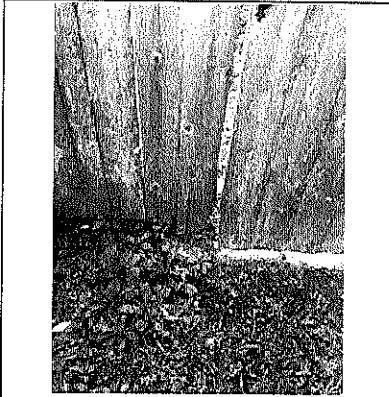
Repair: Right fence board damaged.

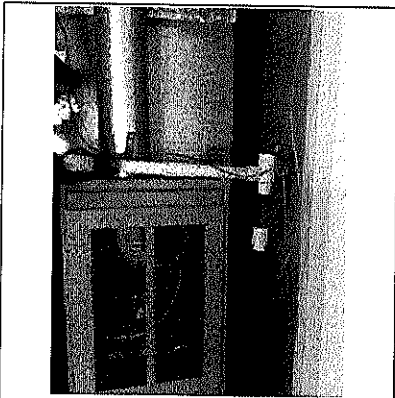
Repair: Coil drain line not insulated, furnace door not sealed and door rubbing the frame.

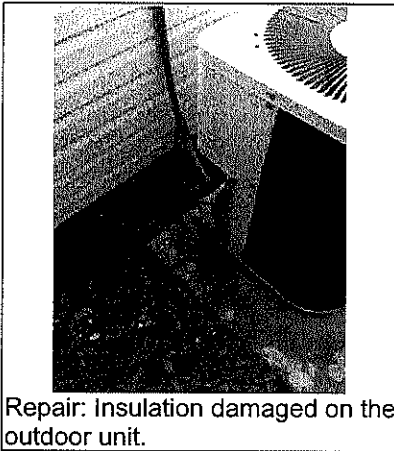
Repair: Insulation damaged on the outdoor unit.

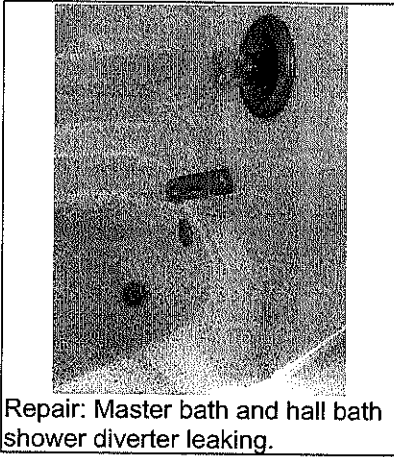
Repair: Master bath and hall bath shower diverter leaking.

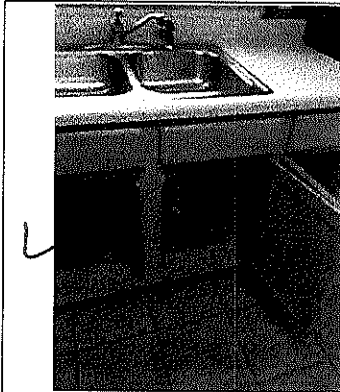
Safety Issue: Possible mold/mildew growth in the kitchen cabinets.

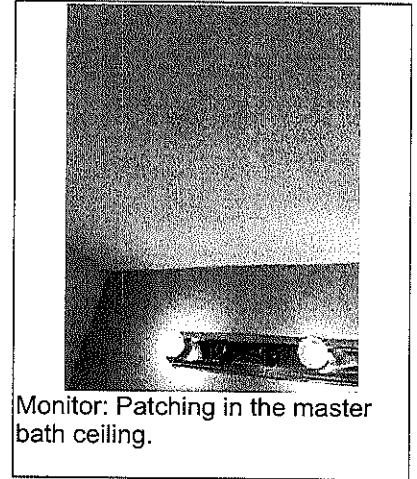
Monitor: Patching in the master bath ceiling.

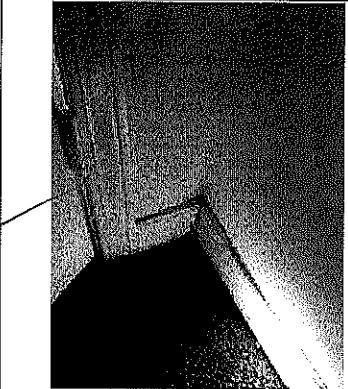
Repair: Master closet wall water damaged.

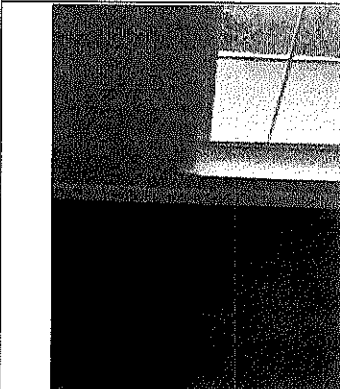
Repair, Monitor: Left front bedroom window sill and base board damaged.

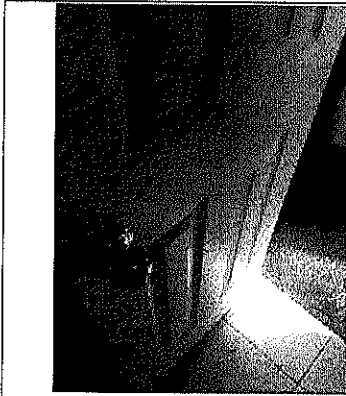
Repair: Master bath door won't latch.

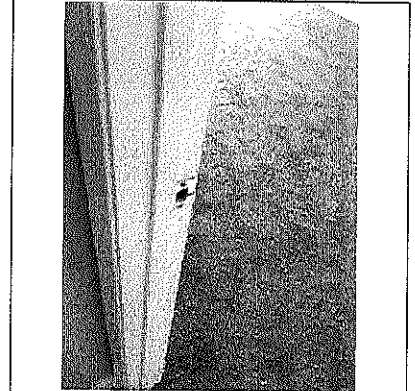
Repair: Master bedroom door hardware loose.

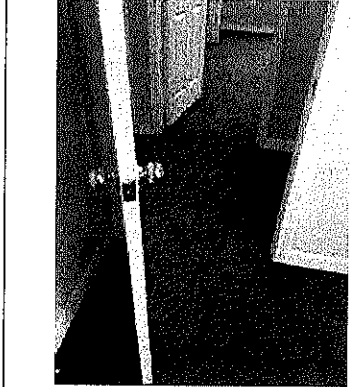
Repair: Right front bedroom door hardware needs adjusted.

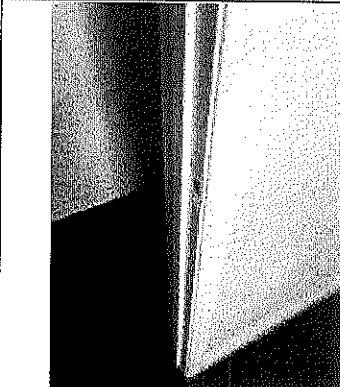
Repair: Left front bedroom door hardware missing.

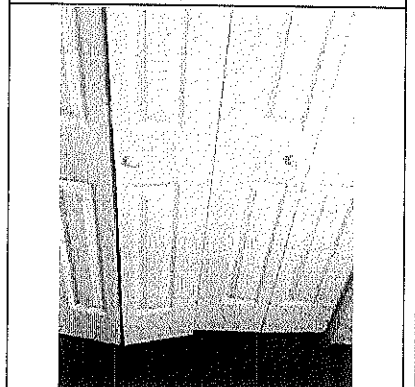
Repair: Right front bedroom closet doors won't close.

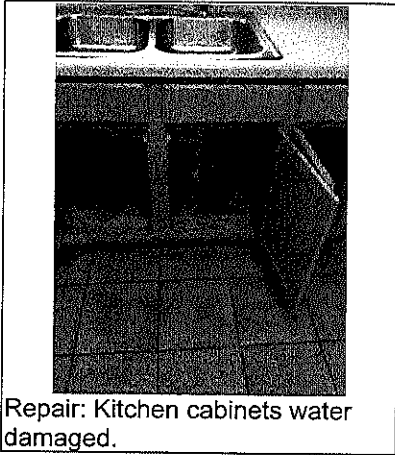
Repair: Kitchen cabinets water damaged.

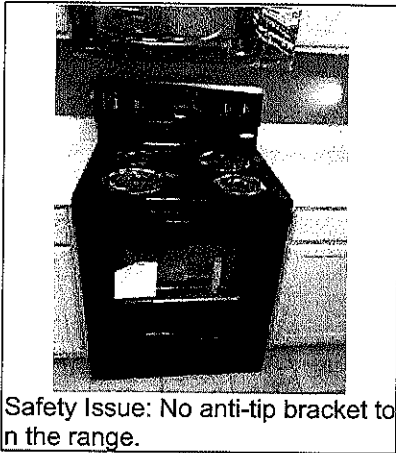
Safety Issue: No anti-tip bracket to n the range.
