58174 Edgewood.

Slidell La 70458

Confidential Inspection Report

March 2, 2017

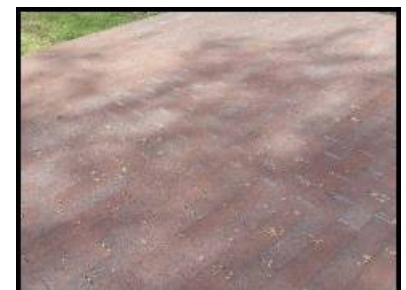
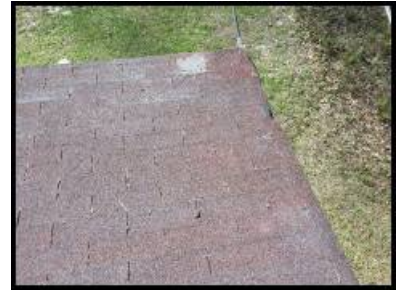
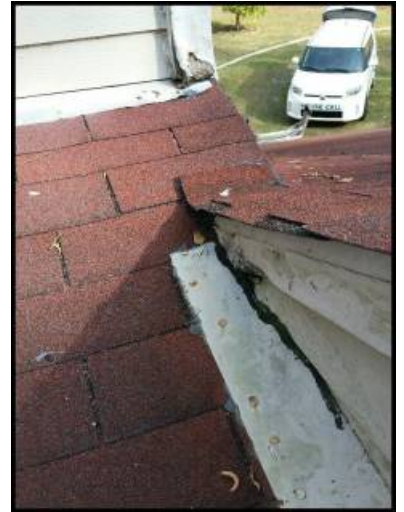
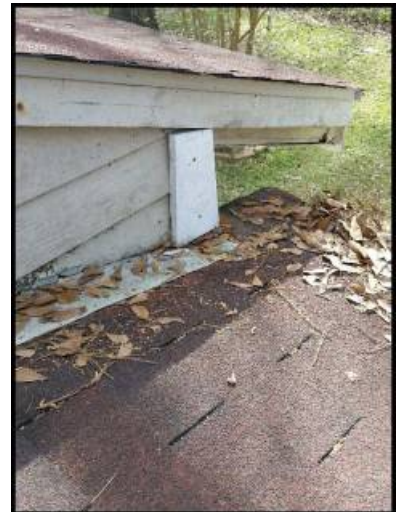
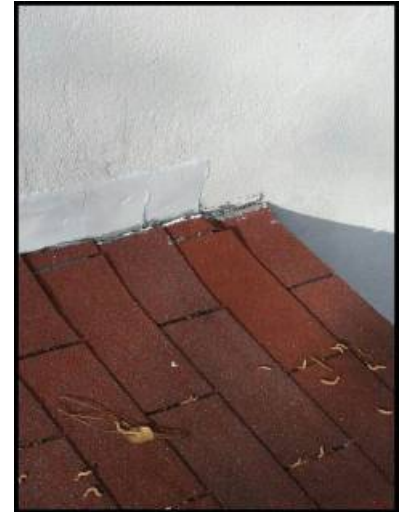
- AGE OF ROOF IN YEARS:** Unknown.
- ROOF STYLE:** Gable.
- ROOF TYPE:** Composition Shingles.
- ROOF ACCESS:** Walked on roof.
- ROOF COVERING CONDITION:** TYPICAL MAINTENANCE RECOMMENDED. This usually consists of repair/replacement of worn & damaged areas. This maintenance should help ensure the weather tightness of the building and should be performed on a regular basis.
- ROOF COVERING CONCERNS:** Loss of granules at the shingles is noted and is usually the result of typical weathering and aging of roof covering. Previous repairs noted. Verify reason with seller and monitor the area for on-going or future problems.

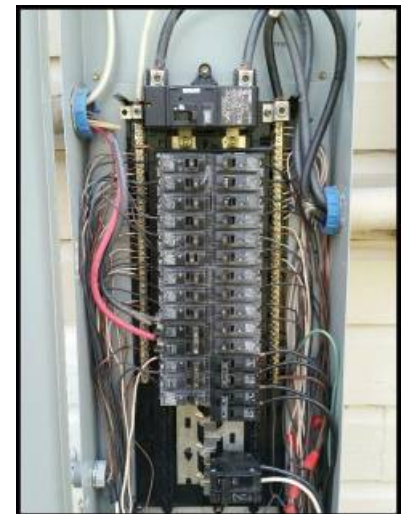
MAIN PANEL CONCERNS: The following concerns were noted at the main electrical panel: Unused openings in the panel are missing covers, White wire used as hot circuit not properly marked (Should be painted/taped black), The following concerns were noted at AFCI/GFCI breakers: No AFCI (arc fault circuit interrupter) breakers were visible. Recommend installing AFCI breakers to comply with current safety standards. Breakers tripped at the panel during the inspection.

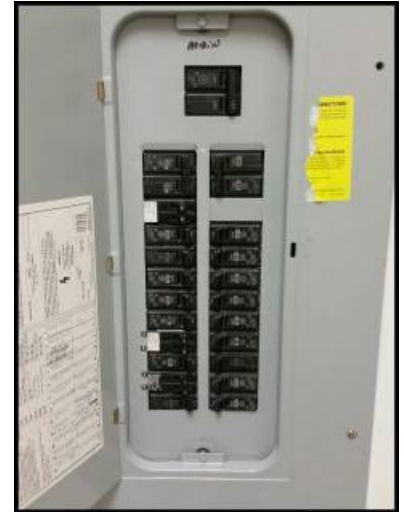
The following concerns were noted at the electrical sub-panel: The following concerns were noted at AFCI/GFCI breakers: No AFCI (arc fault circuit interrupter) breakers were visible. Recommend installing AFCI breakers to comply with current safety standards.

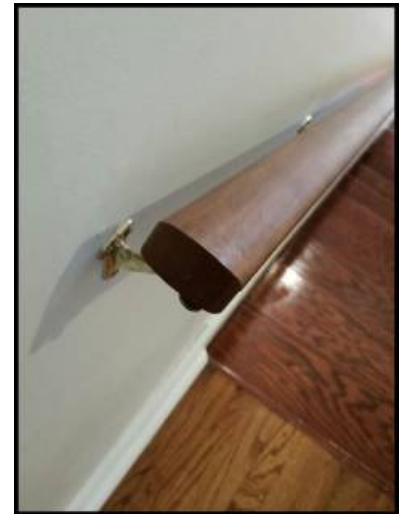
**STAIRS & HANDRAILS
CONCERNS:** The following concerns were noted at the stairs/handrails: The ends of the handrails should return to the wall.
