Structural Inspection

November 23, 2020

Ref: 6627 W Laverne St.
New Orleans, La. 70126

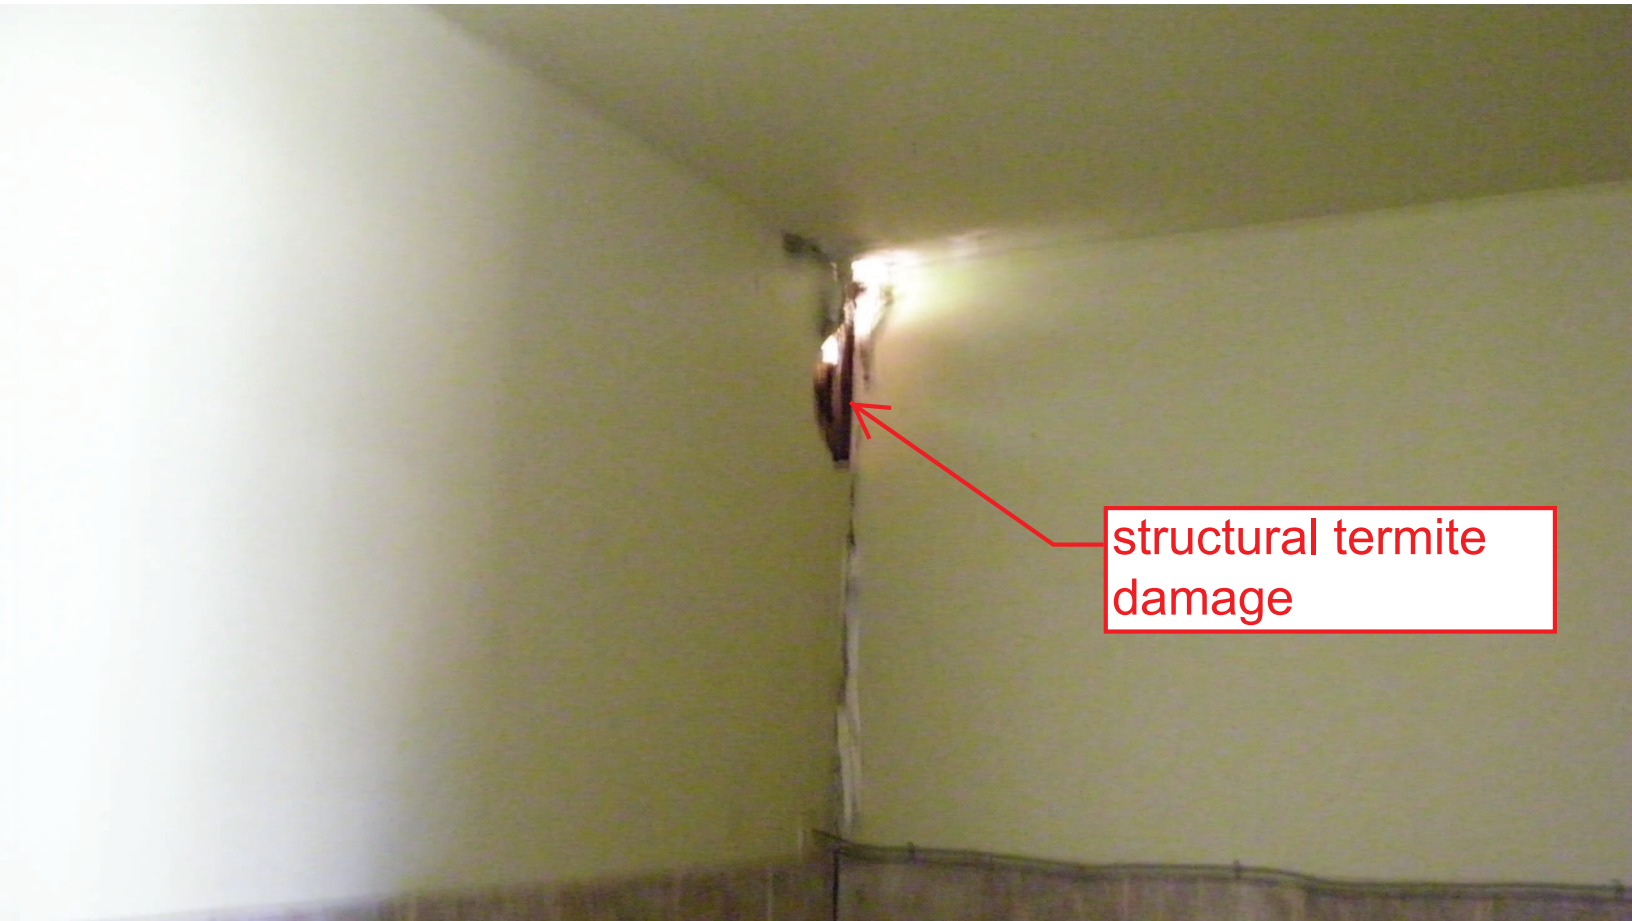
structural termite damage

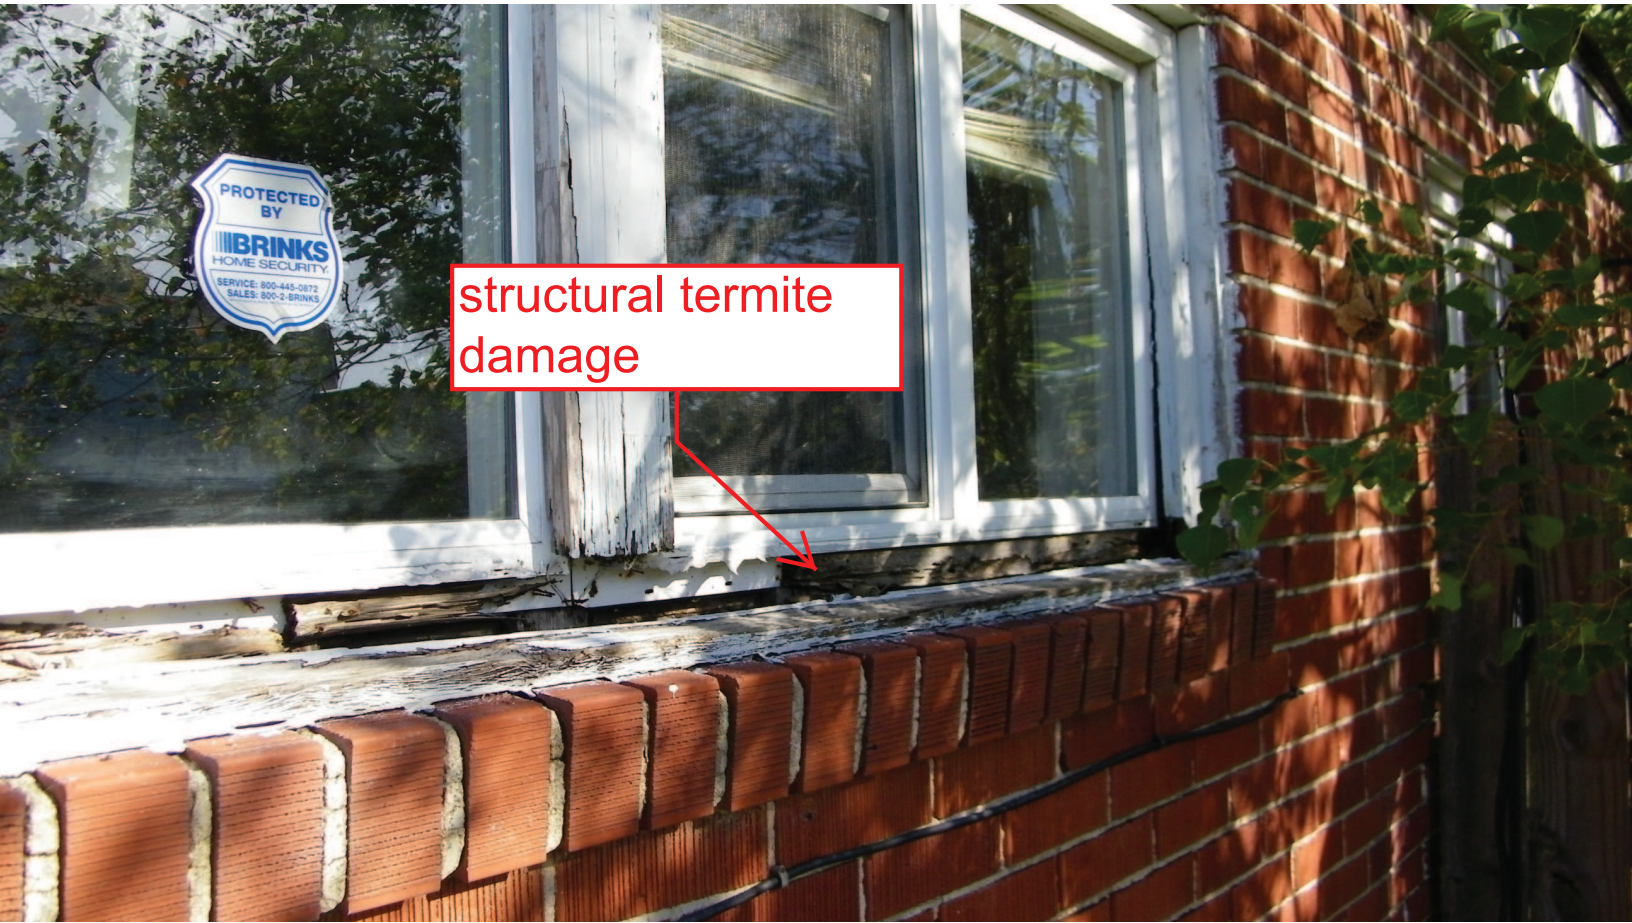
structural termite
damage

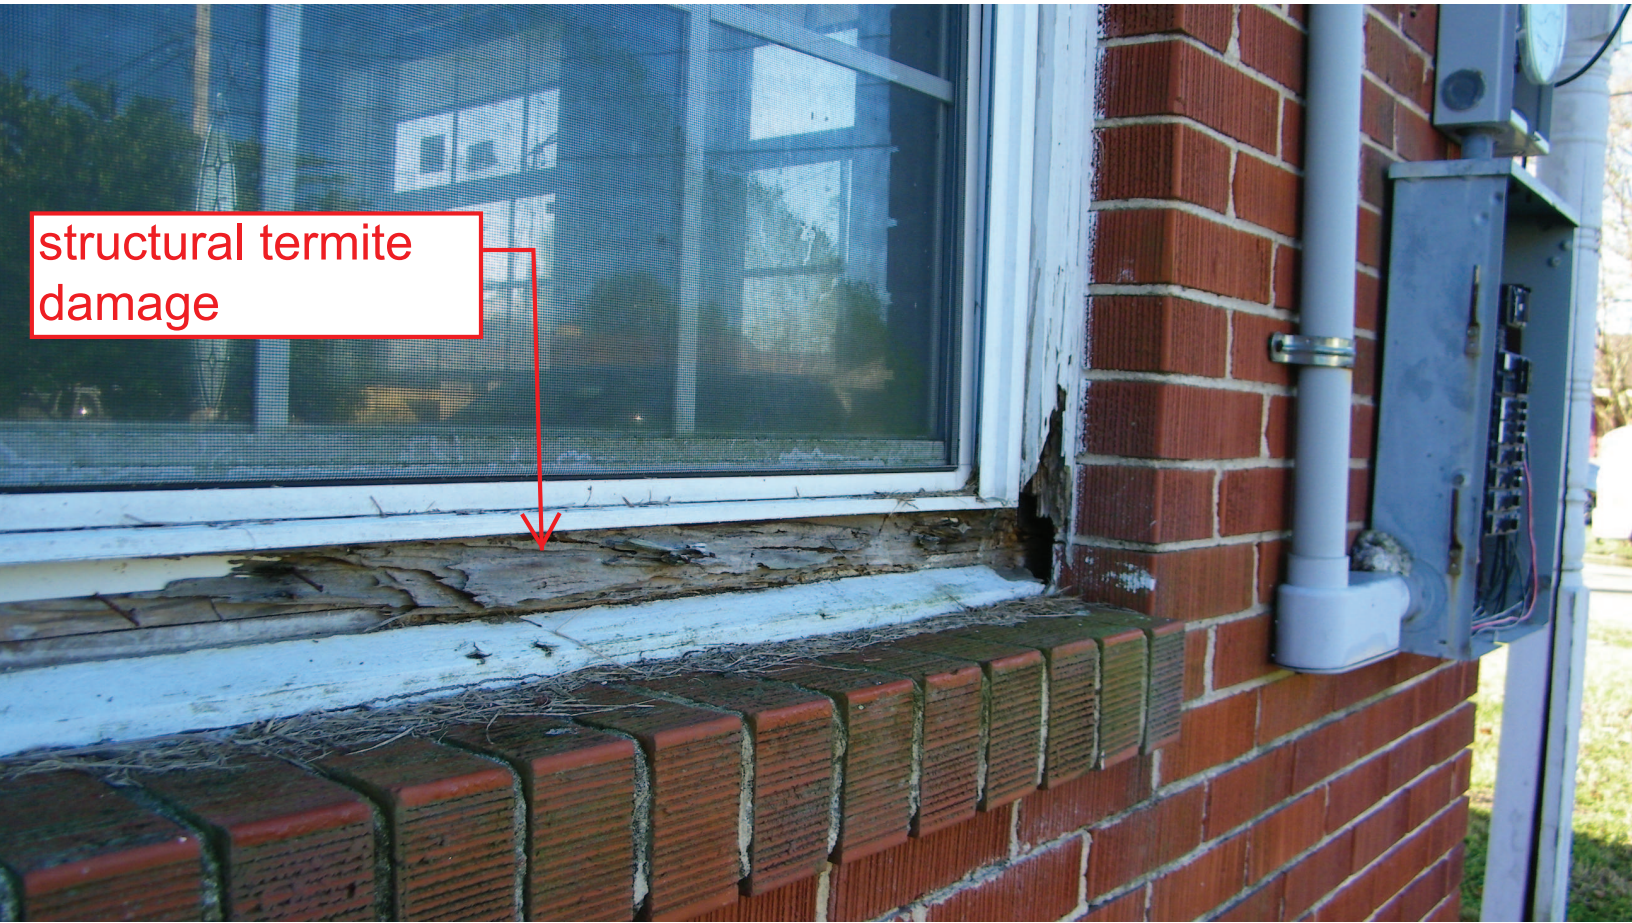
structural termite damage

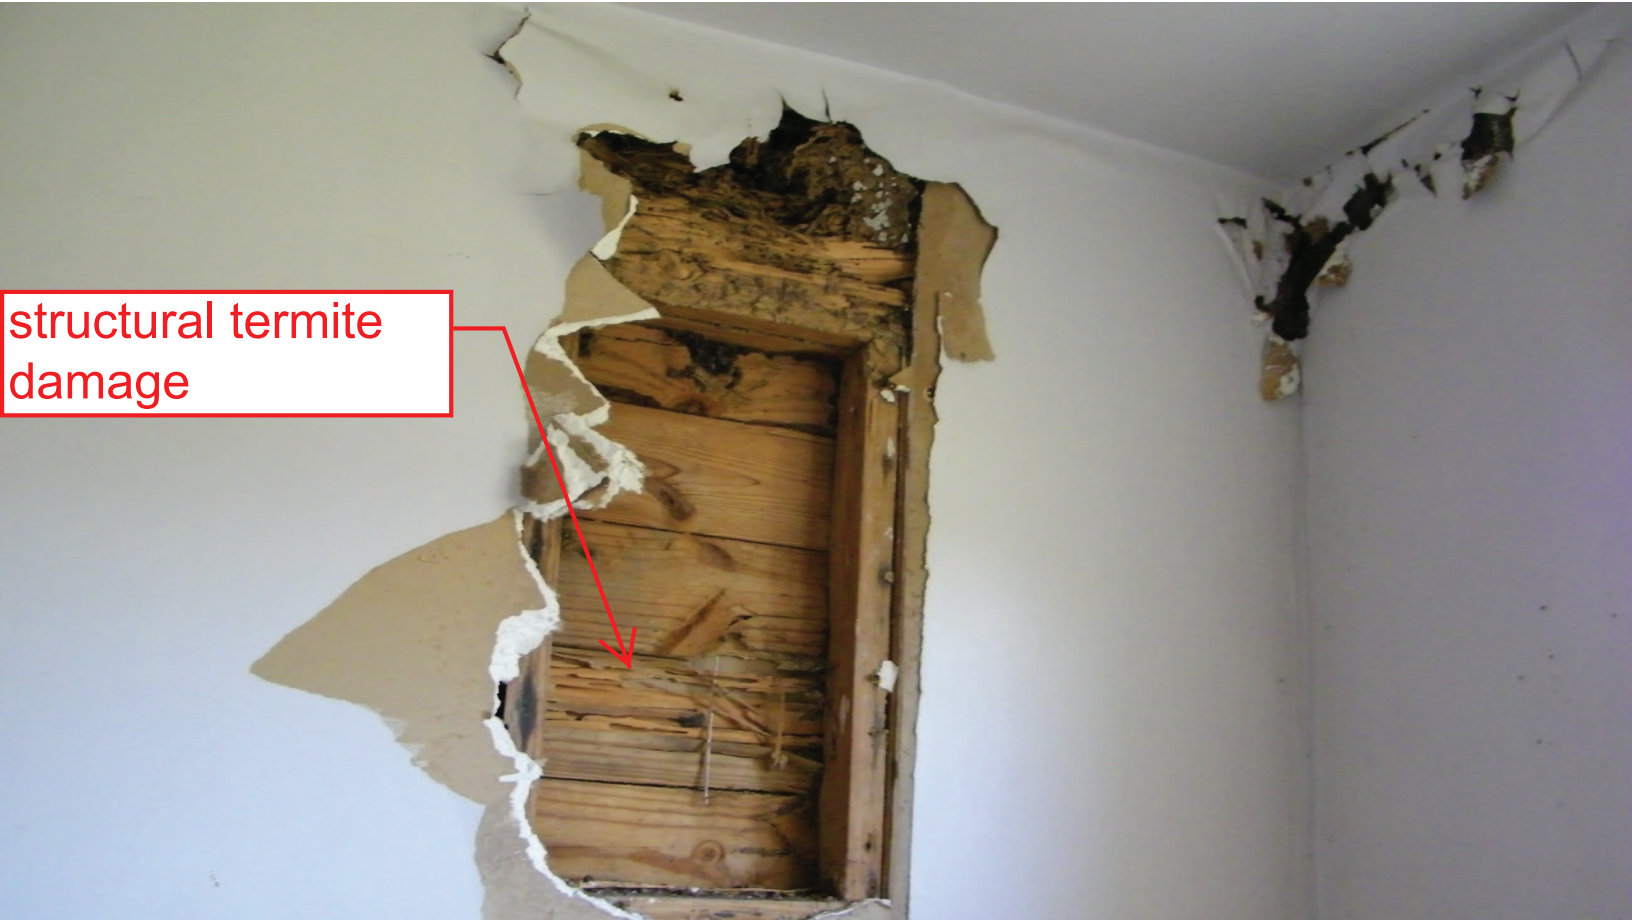
structural termite damage

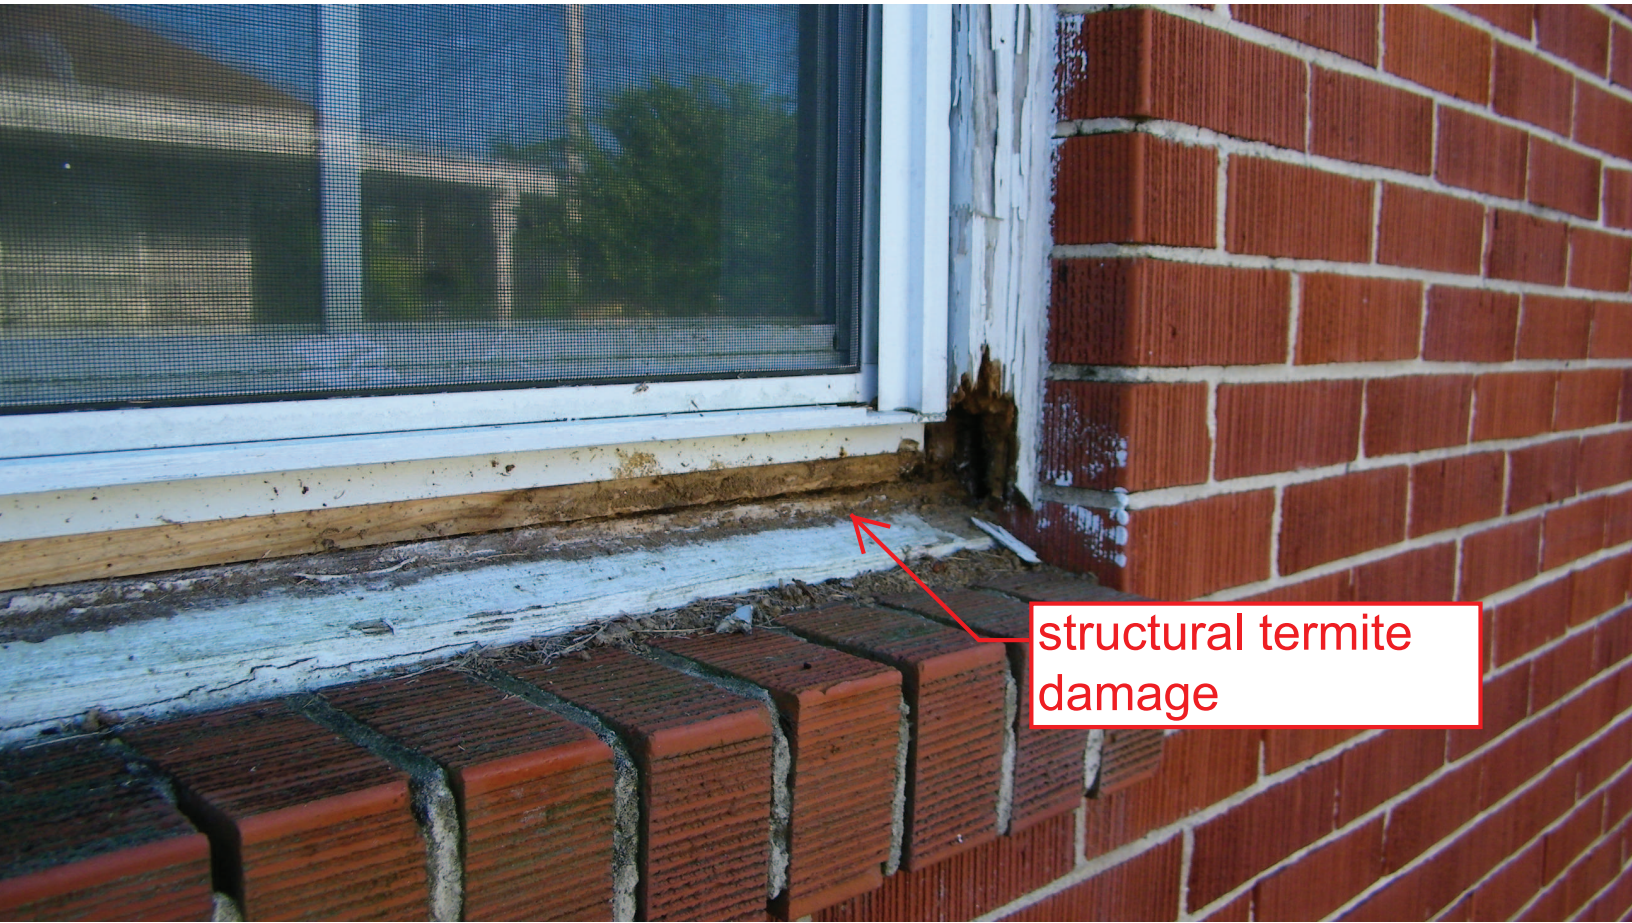
structural termite damage

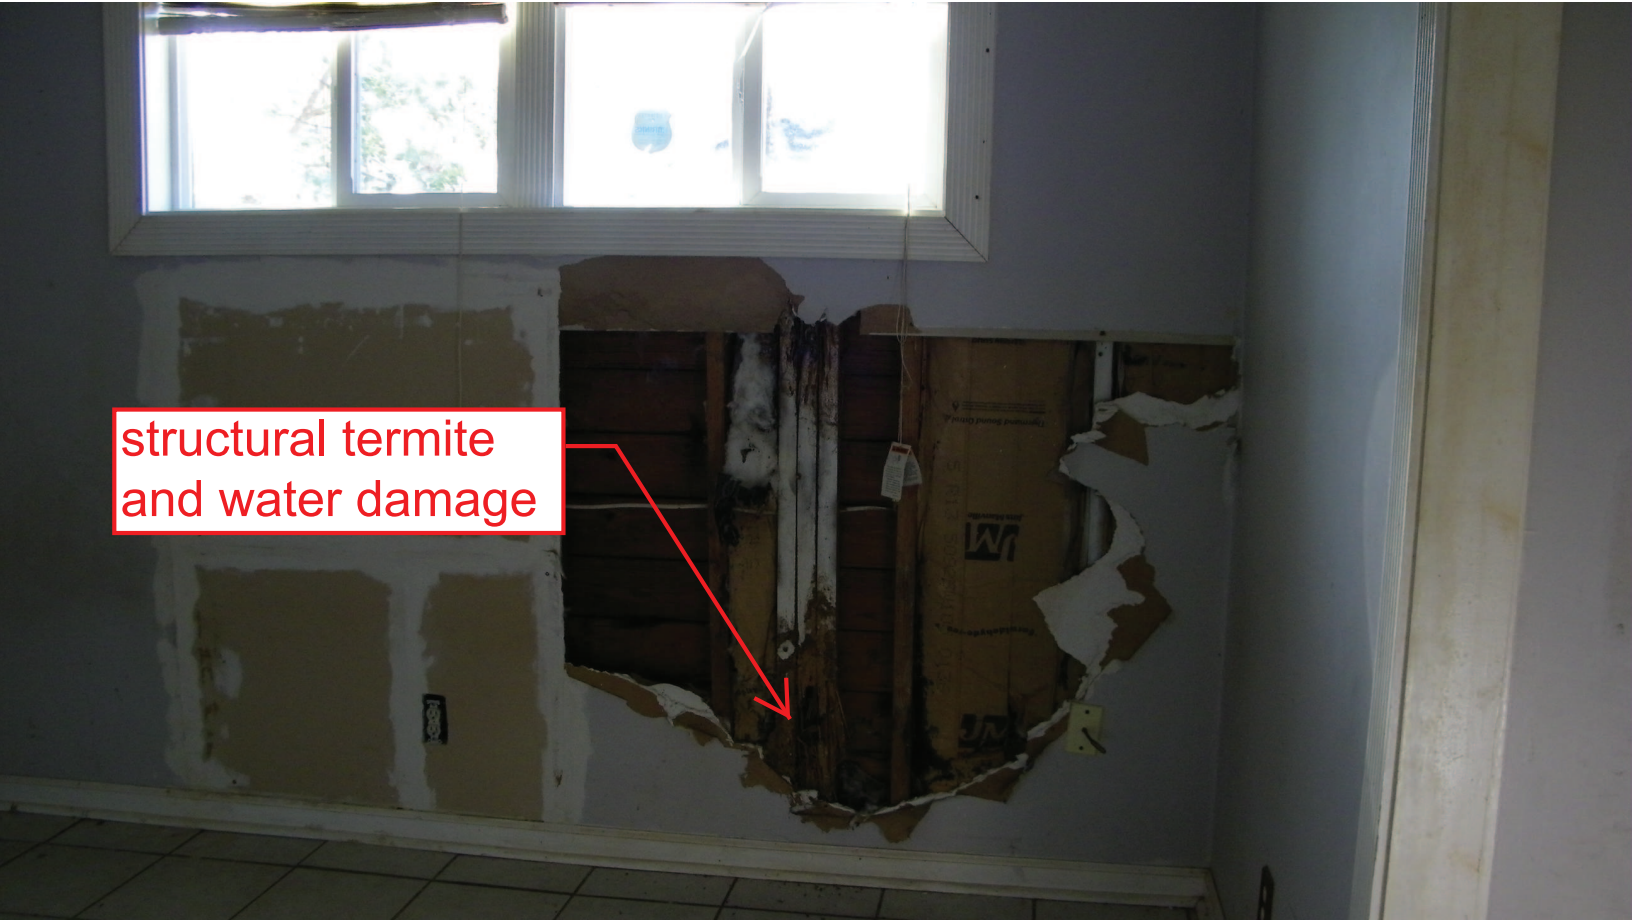
structural termite
damage

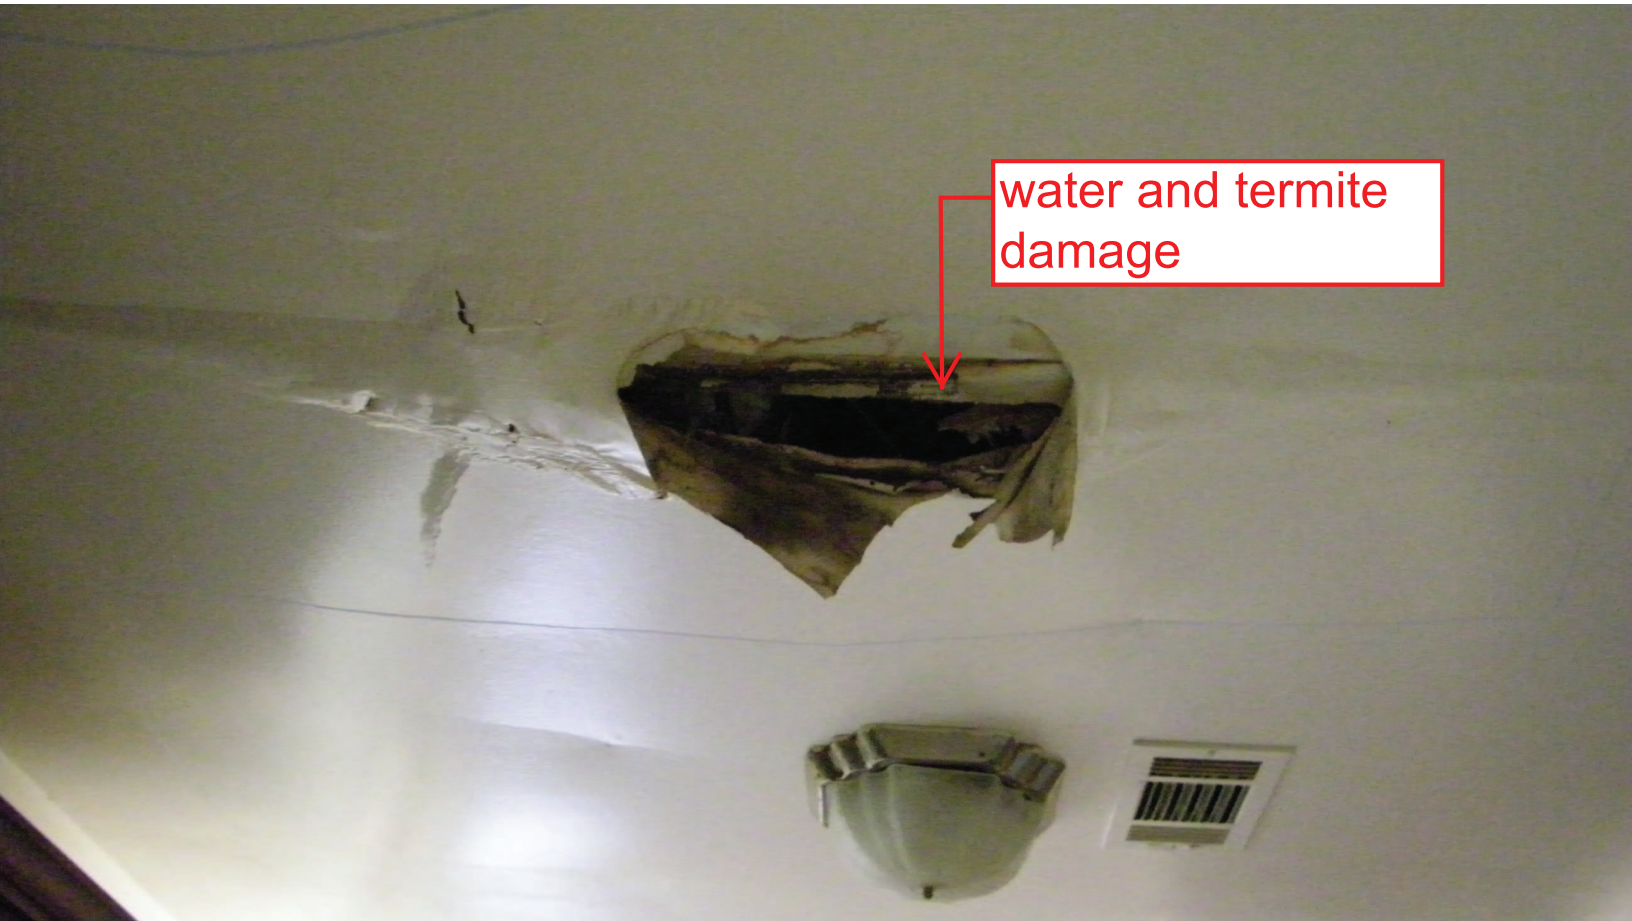
structural termite
and water damage

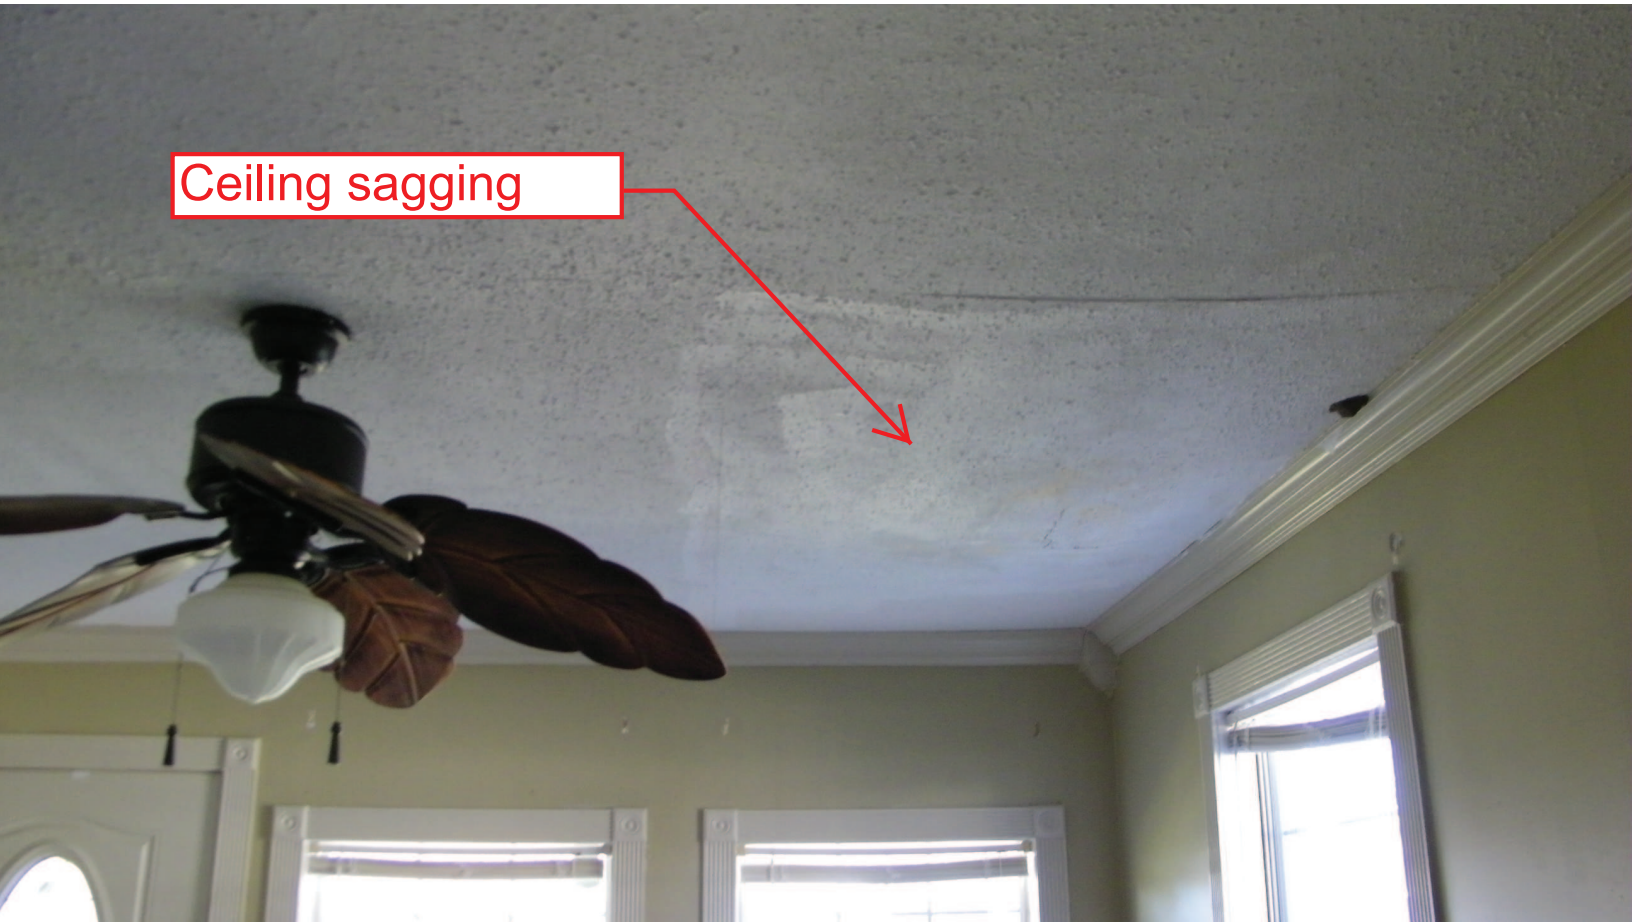
water and termite
damage

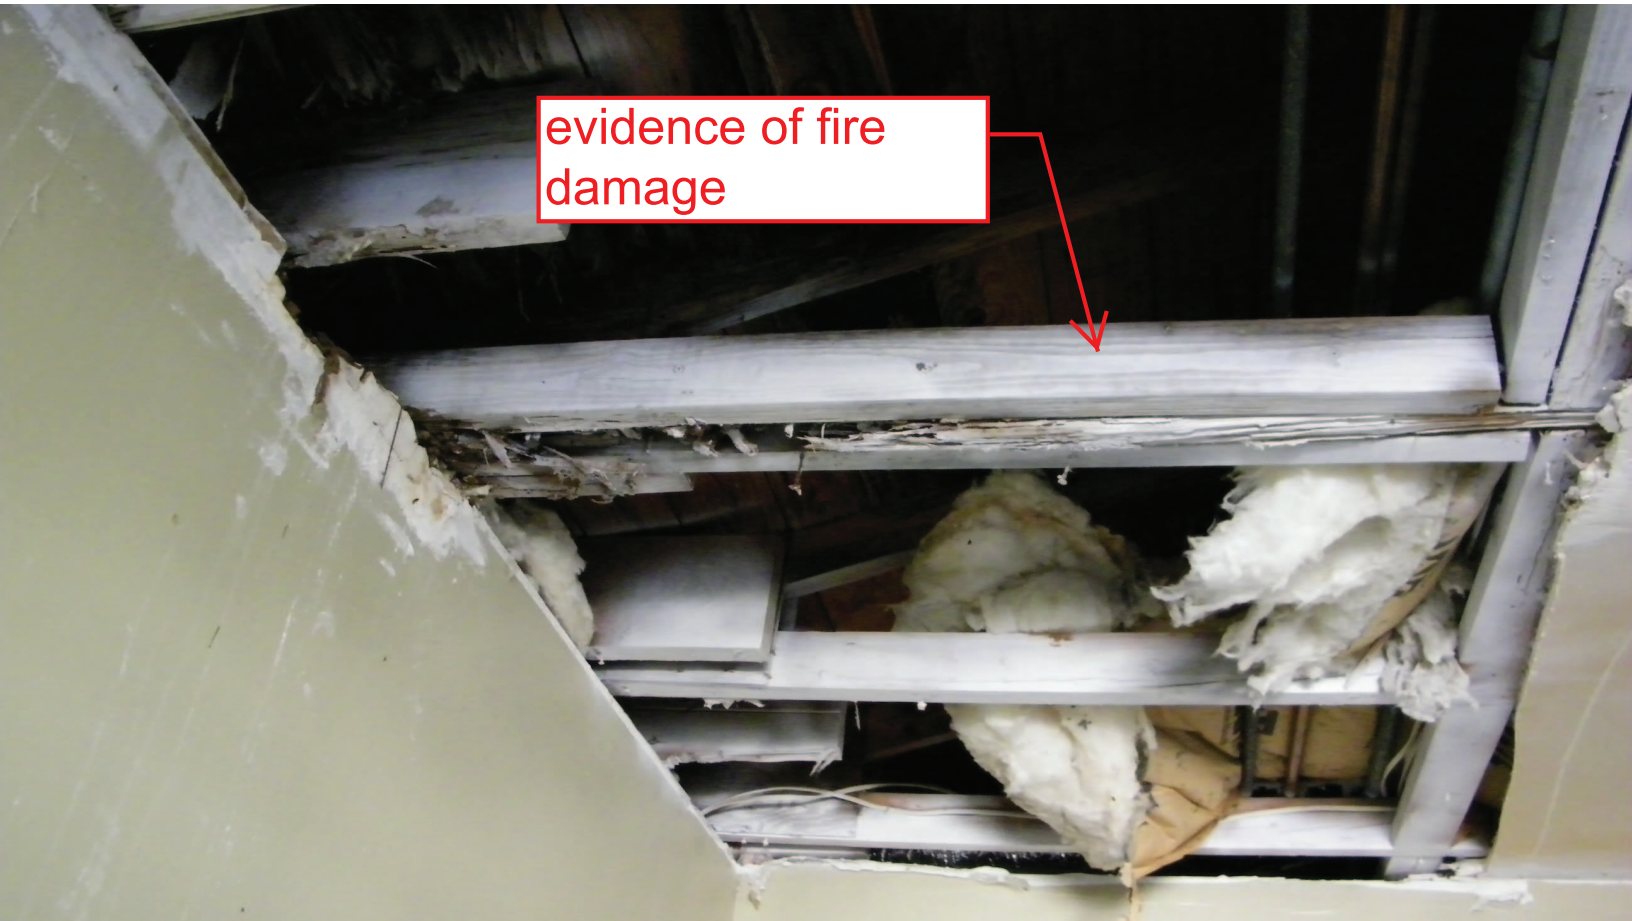
Ceiling sagging

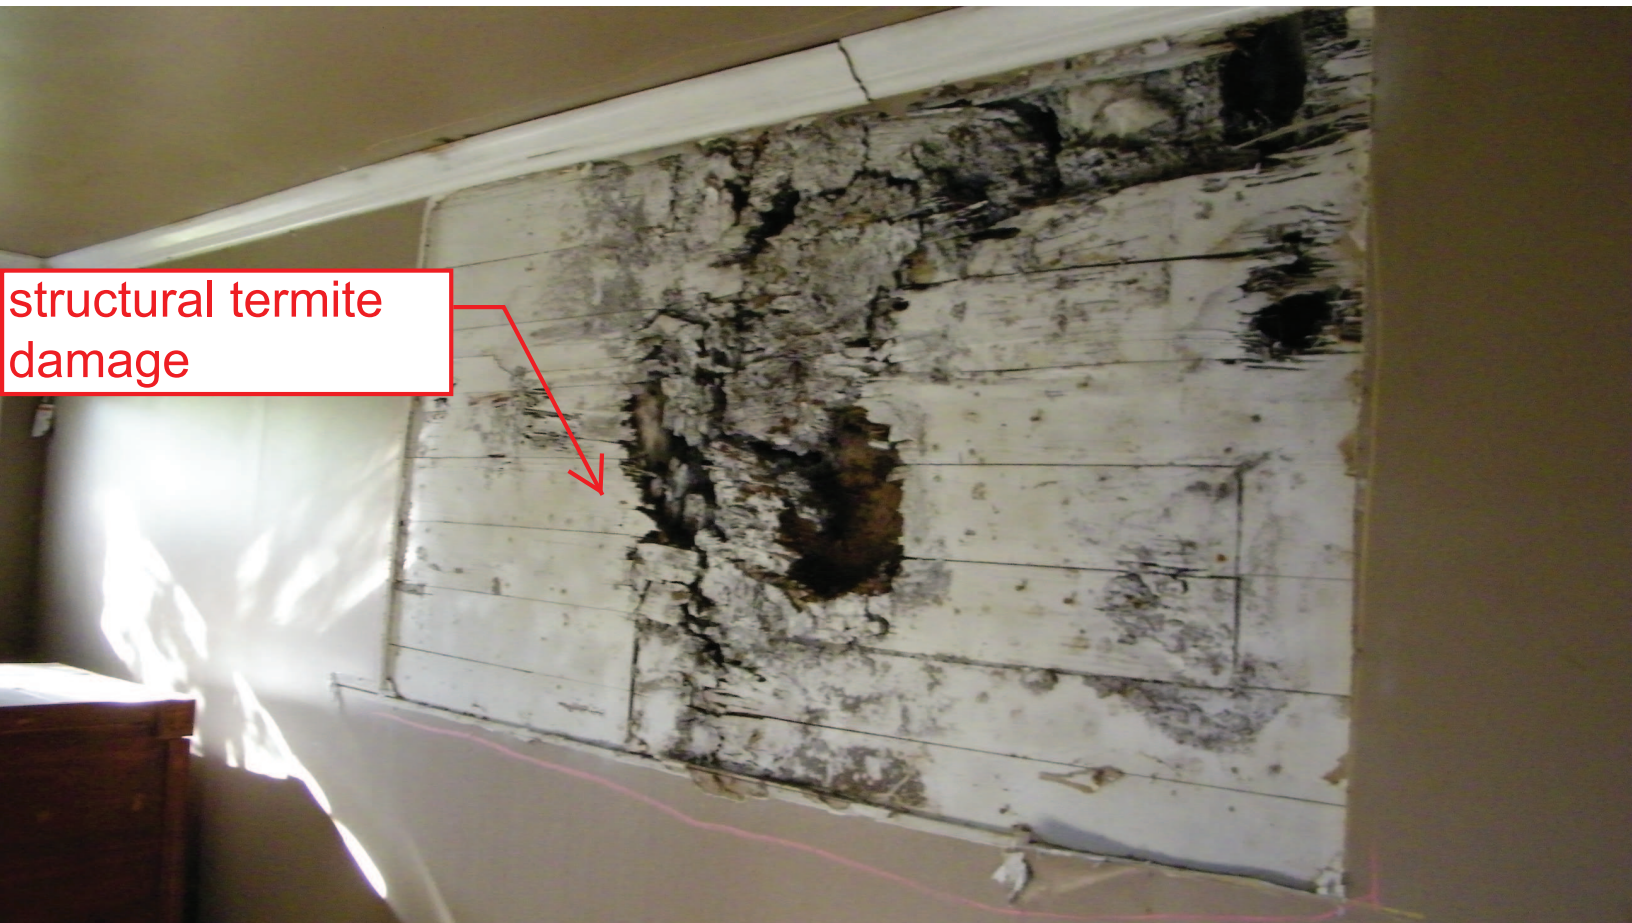
The interior of the home was noted to have severally damaged walls and ceilings in many of the rooms. Where these damages occur it is noted to have major termite infestation. Evidentially this home was in a fire at one time due the roof rafters being painted white. Some of the interior walls that fall on the exterior of the home have termite damage all the way to the exterior sheathing.

evidence of fire
damage

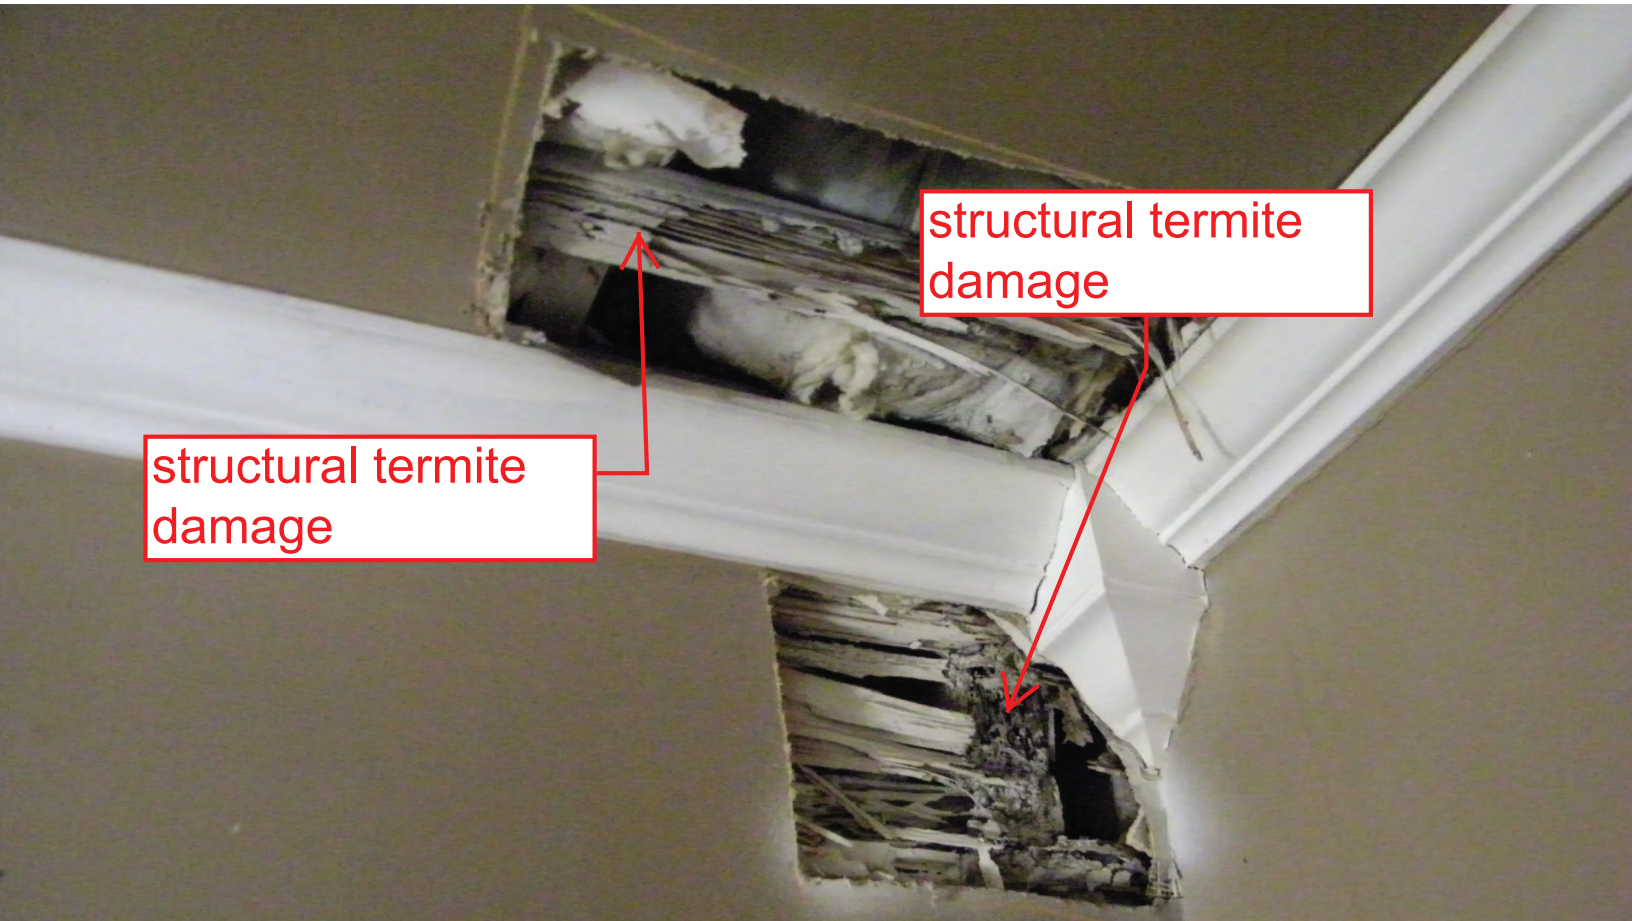
structural termite
damage

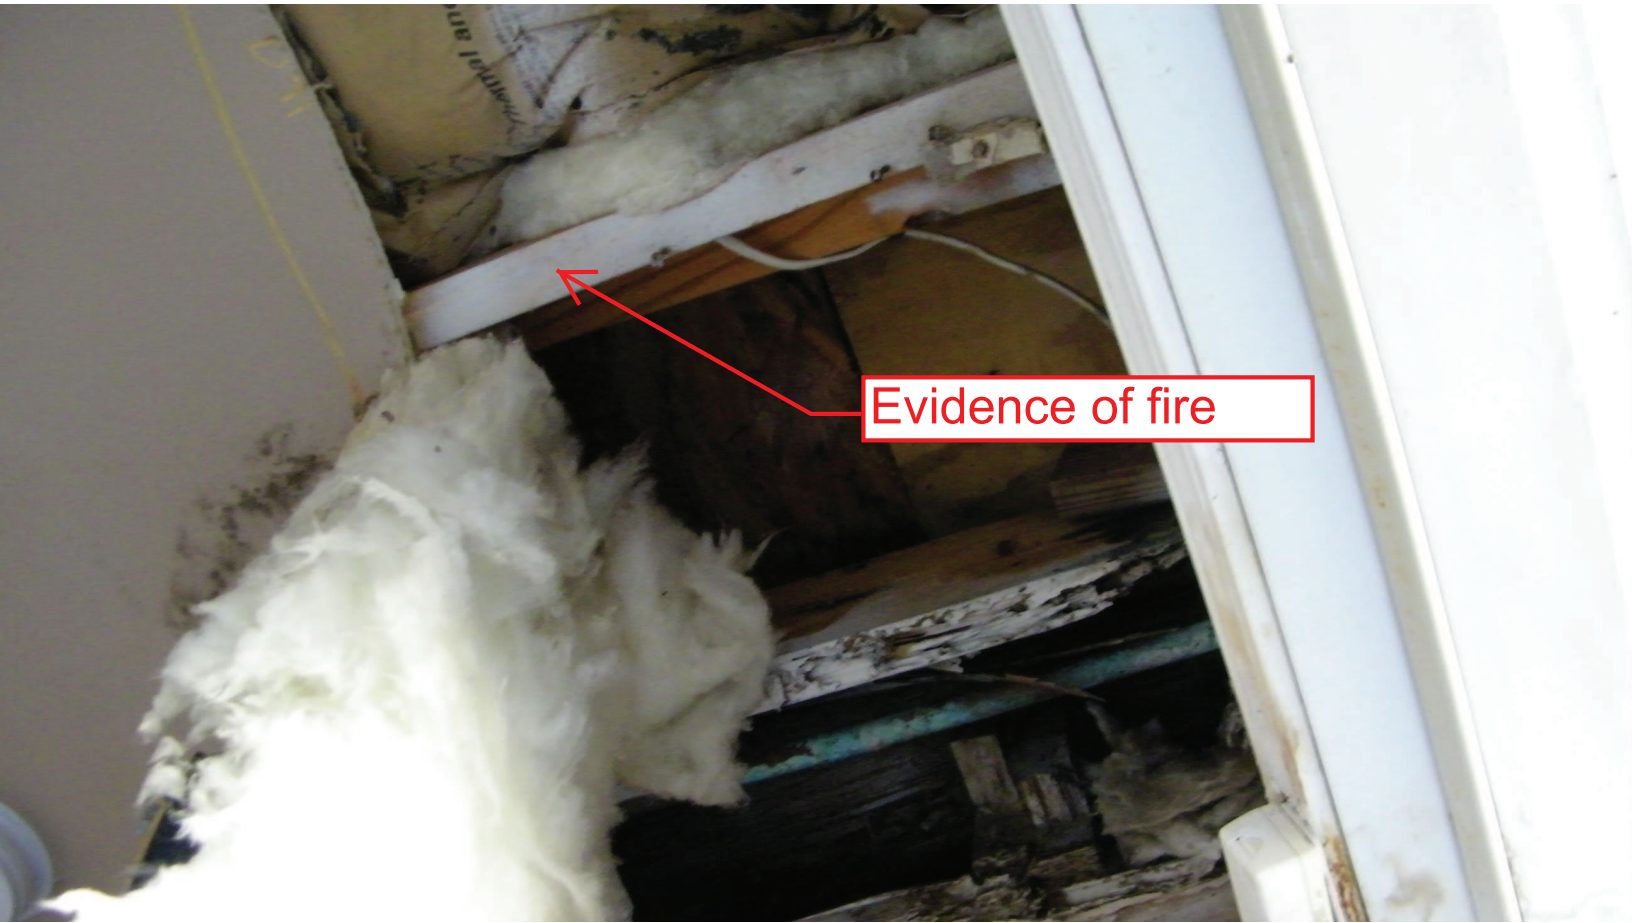
structural termite damage

This home is more than 50% structurally damaged. It is recommended this home be totally demolished as the structural integrity has been compromised.
