Structural Inspection

7-7-2022

Jessica Middleton
7 Hanna Dr.
Carriere, MS 39426

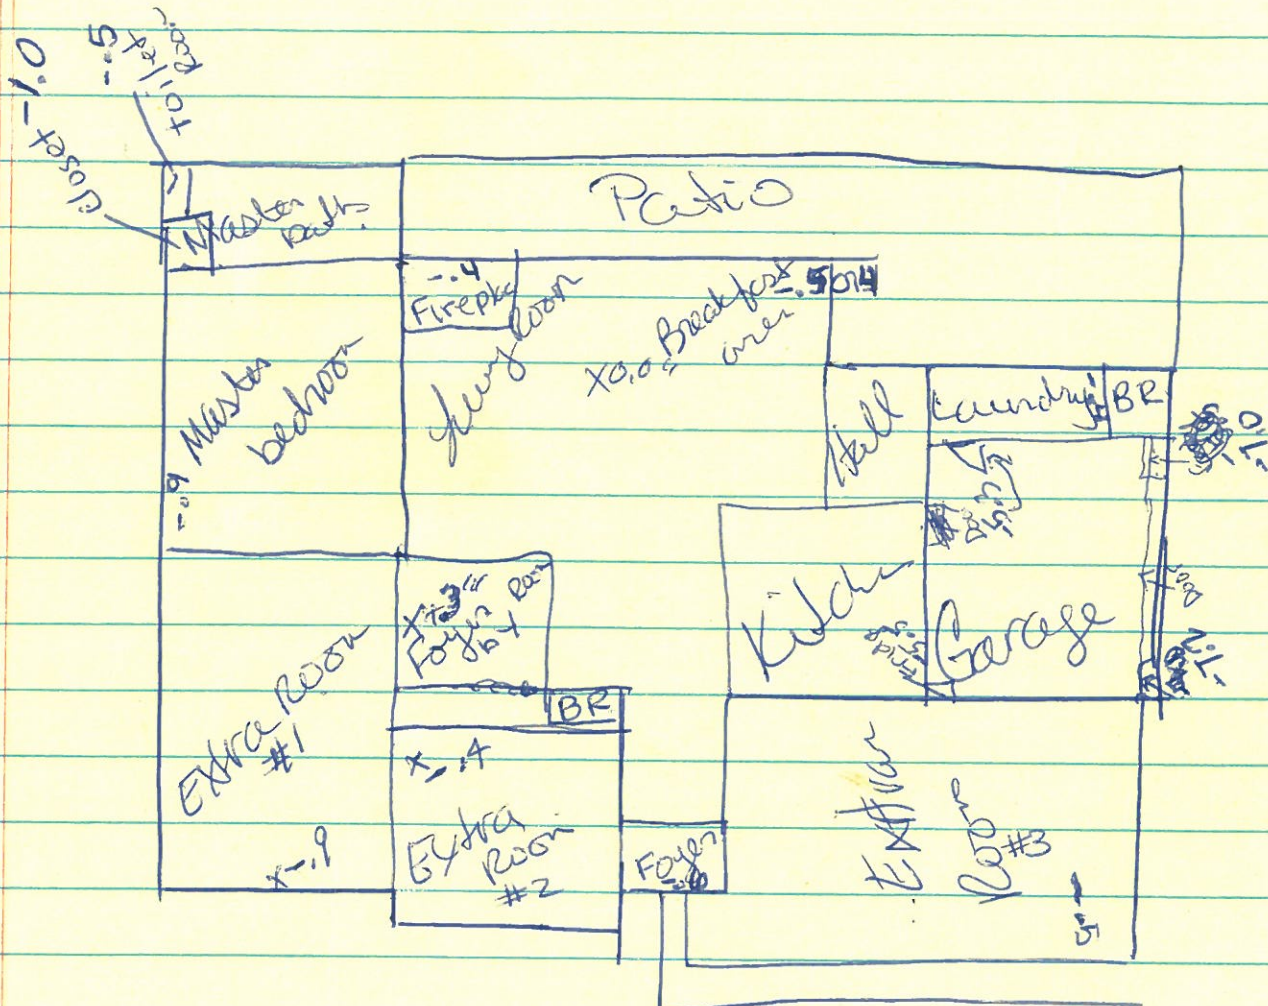
master bedroom, closet, Extra room #1, Extra room #2 = no tile
 Everything else had ceramic tile
 concrete
