Structural Inspection

August 16, 2022

Grand Lagoon Homeowners Association
161 Marina Dr.
Slidell, La 70458

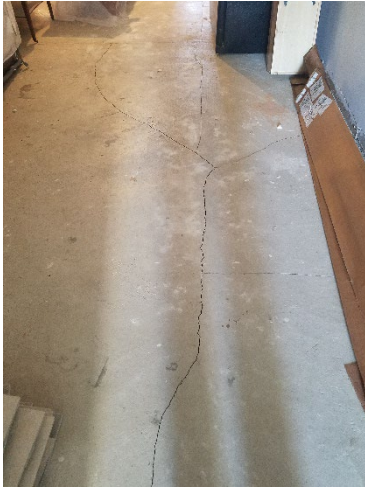
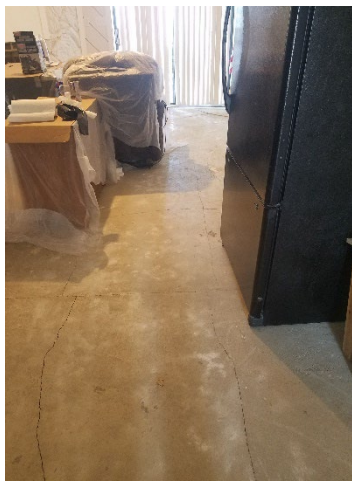
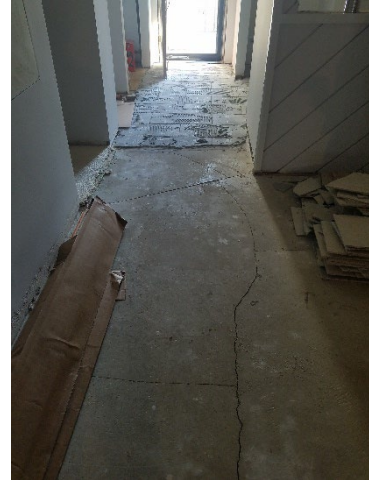
1. The concrete floor in Unit 1155 has multiple cracks across the living room. No apparent damage or deflections were seen in the support of the concrete. See photos below:

the force of the wind. During these events it can cause the concrete to crack. Concrete is excellent in compression but offers very little when subjected to a tension force. This building's concrete was poured without any steel to take the tension force.

- 1) Unit 1155 floor cracks should be floated to obtain a smooth surface to install new flooring.
- 2)
 - a. Unit 1159 ceiling /Unit 1165 porch floor needs to be repaired. Where the supporting plywood has deteriorated it must be cut out and replaced. See detail below for repairing damaged plywood.
 - b. Unit 1165 porch has a column that was improperly repaired. The support for this column was inappropriately distributed to concrete around it, causing the concrete to crack. This column should be replaced with a 6"x6" post to match the type of wood originally installed. The base should receive its support of the perimeter Rim Joist above the exterior wall below. Additional full height blocking should also be installed. See detail and section below. (Note that the Building Cross

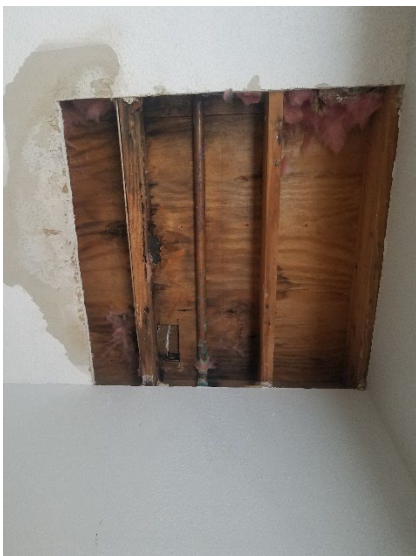
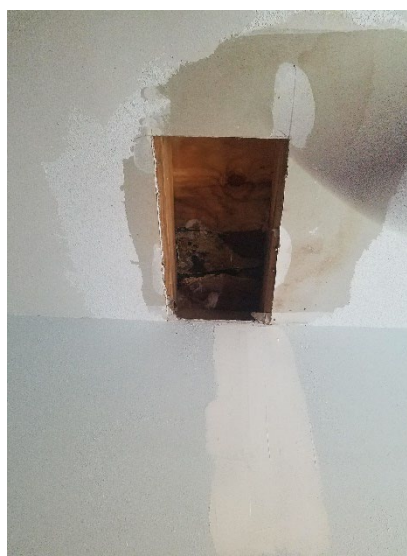
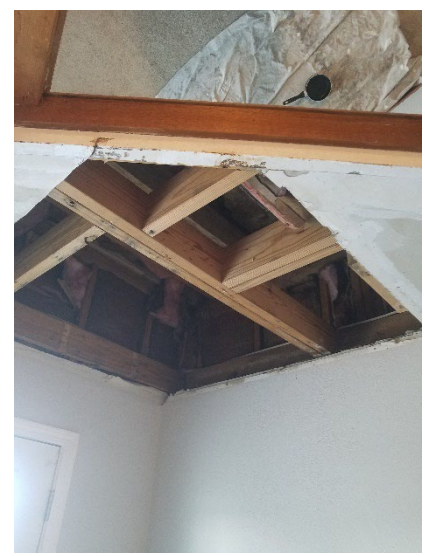
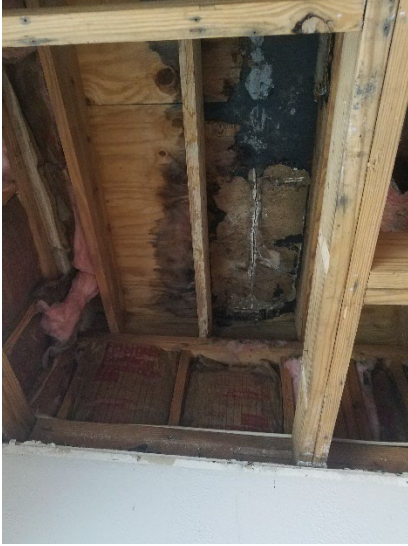
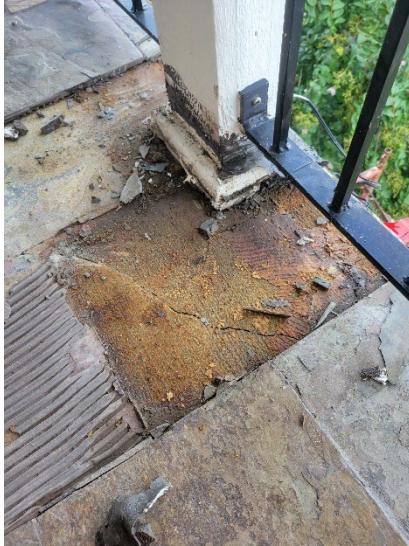
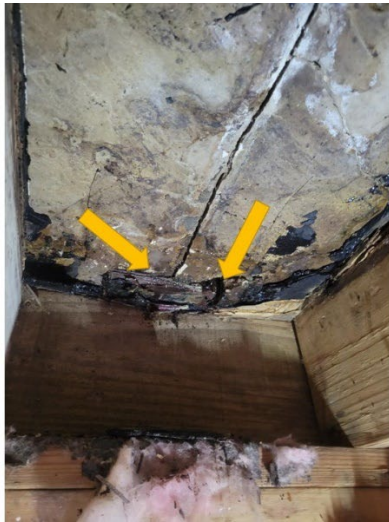
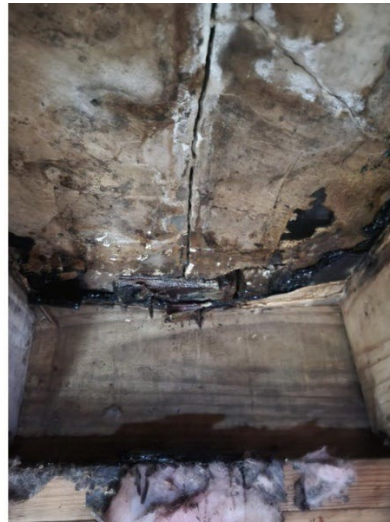
2. The ceiling of Unit 1159 has been experiencing water damage and three of these locations were open for inspection along the exterior wall facing the NorthWest direction. This unit's ceiling-joist(s) also provide support to the porch of Unit 1165 above. Water appears to have infiltrated the cavity between the porch and the ceiling gypsum via cracks in the concrete on the balcony of all three locations that were available for inspection. This infiltration appears to have been over a long period of time which has caused the plywood to deteriorate and left a discoloration in the concrete along the crack. In one location of Unit 1159 it also appears to have deteriorated the ceiling-joist. Another issue is that it appears that one of the structural columns on the porch of Unit 1165 was previously repaired, incorrectly. The column should be attached directly on top of the 2x12 Rim Joist that is supported by the wall below. Yet it appears that the column was cut and a 6" long piece of 2x4 was slipped between the new cut column and the concrete slab. See photos below:

The drawings provided show that the porches were designed to have a slope of 0.7%. The drawings provided also shows a detail that all porches were designed to have a 26-gauge galvanized metal pan between the plywood and concrete. In the areas that were exposed to the underside of a porch, this metal pan was not installed; rather, a tar paper was installed instead. The metal pan and tar paper both provide an excellent vapor (moisture) barrier. Over time the cracks in the concrete have also torn the tar paper which allows the water to get to the plywood decking. Concrete although very impervious, is not totally impervious. Measurements of the 3rd floor side porches were taken and Unit 1161 side porch over Unit 1151 has a slope of 1.5% while the porch of Unit 1165 over Unit 1159 has a slope of 1.1%. These slopes were created when the lightweight concrete was poured. These slopes provide a sufficient slope for rainwater to properly shed from the porches without ponding; however, during a major rain event or a driving rain, the water will find any way to infiltrate through porous material or cracks in the concrete.

When the column on the porch of Unit 1165 was repaired with a 6" length of 2x4 placed between the column and the concrete, it applied pressure to the concrete causing the concrete to crack.

Section provided shows these columns as 6x6 Post; however, the HOA have stated that the original posts were 4x6 cedar and somewhere around 30 +/- years ago some were replaced with 3-1/2 x 5-1/2.)

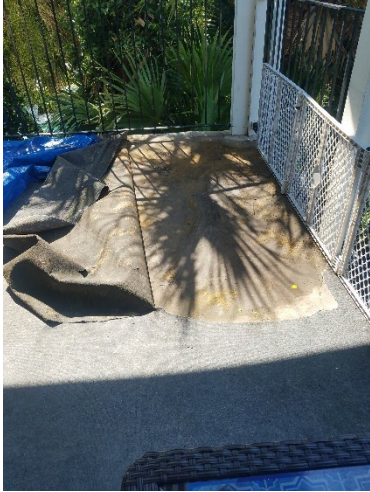
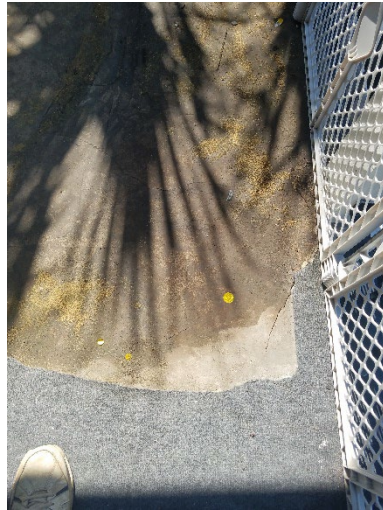
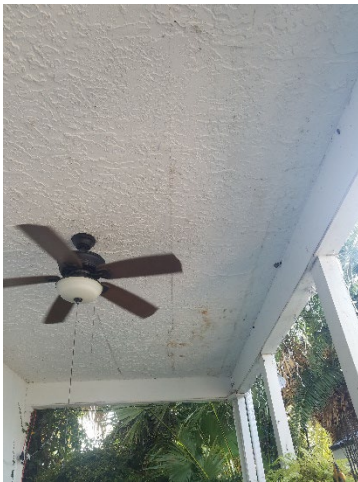
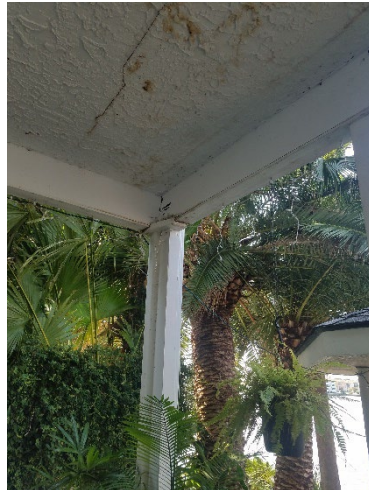
3. The porch floor of Unit 1151 appears to be caving in near the building's Southern corner. This flooring support, plywood and floor-joist, also support the ceiling of the porch below. An inspection of Unit 1141 porch ceiling shows that the ceiling joist appear to be giving way from the pressure above. (This must be corrected)

- 3) Unit 1141 porch ceiling/Unit 1151 porch floor must be exposed to determine the extent of the structural damage. Replace damaged structure with like materials.
- 4) Side porches on the 3rd floor in general are leaking to the unit below. The lightweight concrete, wear surface, appears to have cracked over time. These cracks have torn the tar paper, vapor barrier, allowing water to infiltrate to the plywood and over time as water sits on this plywood it will cause the plywood to deteriorate. Since it is not feasible to easily replace this vapor barrier on these porches, it is recommended that the top surface be treated with something that is UV resistant and exceptionally good at providing a vapor barrier. Also, it is recommended that these porches be maintained with this vapor barrier per the manufacturer's recommendations.
