Structural Inspection

August 16, 2022

Grand Lagoon Homeowners Association
161 Marina Dr.
Slidell, La 70458

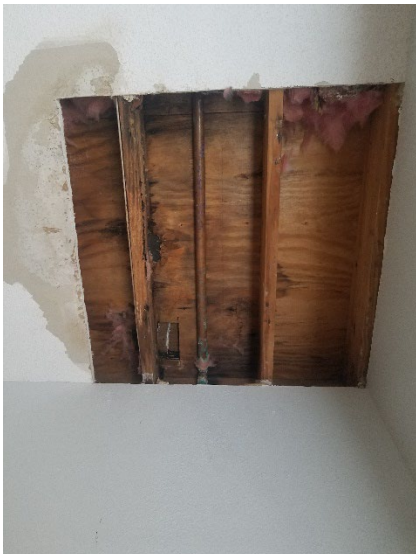
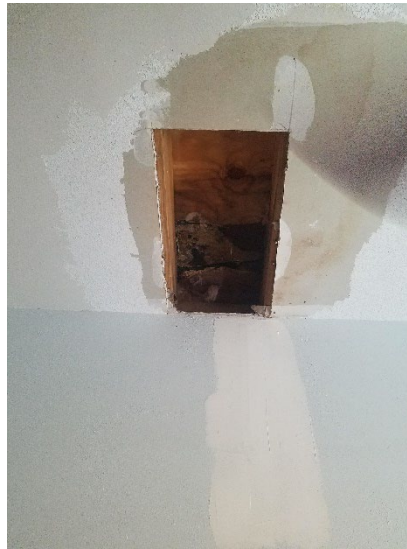
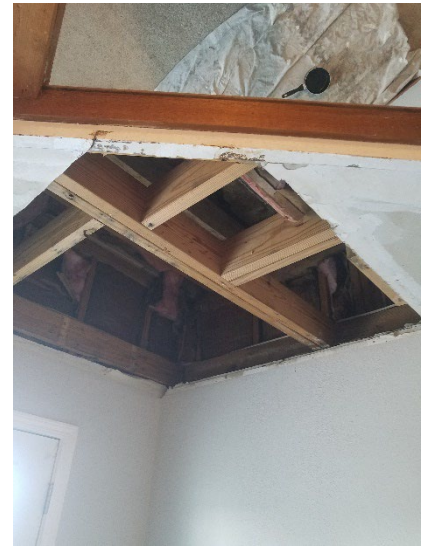
2. The ceiling of Unit 1159 has been experiencing water damage and three of these locations were open for inspection along the exterior wall facing the NorthWest direction. This unit's ceiling-joist(s) also provide support to the porch of Unit 1165 above. Water appears to have infiltrated the cavity between the porch and the ceiling gypsum via cracks in the concrete on the balcony of all three locations that were available for inspection. This infiltration appears to have been over a long period of time which has caused the plywood to deteriorate and left a discoloration in the concrete along the crack. In one location of Unit 1159 it also appears to have deteriorated the ceiling-joist. Another issue is that it appears that one of the structural columns on the porch of Unit 1165 was previously repaired, incorrectly. The column should be attached directly on top of the 2x12 Rim Joist that is supported by the wall below. Yet it appears that the column was cut and a 6" long piece of 2x4 was slipped between the new cut column and the concrete slab. See photos below:

The drawings provided show that the porches were designed to have a slope of 0.7%. The drawings provided also shows a detail that all porches were designed to have a 26-gauge galvanized metal pan between the plywood and concrete. In the areas that were exposed to the underside of a porch, this metal pan was not installed; rather, a tar paper was installed instead. The metal pan and tar paper both provide an excellent vapor (moisture) barrier. Over time the cracks in the concrete have also torn the tar paper which allows the water to get to the plywood decking. Concrete although very impervious, is not totally impervious. Measurements of the 3rd floor side porches were taken and Unit 1161 side porch over Unit 1151 has a slope of 1.5% while the porch of Unit 1165 over Unit 1159 has a slope of 1.1%. These slopes were created when the lightweight concrete was poured. These slopes provide a sufficient slope for rainwater to properly shed from the porches without ponding; however, during a major rain event or a driving rain, the water will find any way to infiltrate through porous material or cracks in the concrete.

When the column on the porch of Unit 1165 was repaired with a 6" length of 2x4 placed between the column and the concrete, it applied pressure to the concrete causing the concrete to crack.

- 1) Unit 1155 floor cracks should be floated to obtain a smooth surface to install new flooring.
- 2)
 - a. Unit 1159 ceiling /Unit 1165 porch floor needs to be repaired. Where the supporting plywood has deteriorated it must be cut out and replaced. See detail below for repairing damaged plywood.
 - b. Unit 1165 porch has a column that was improperly repaired. The support for this column was inappropriately distributed to concrete around it, causing the concrete to crack. This column should be replaced with a 6"x6" post to match the type of wood originally installed. The base should receive its support of the perimeter Rim Joist above the exterior wall below. Additional full height blocking should also be installed. See detail and section below. (Note that the Building Cross

Section provided shows these columns as 6x6 Post; however, the HOA have stated that the original posts were 4x6 cedar and somewhere around 30 +/- years ago some were replaced with 3-1/2 x 5-1/2.)

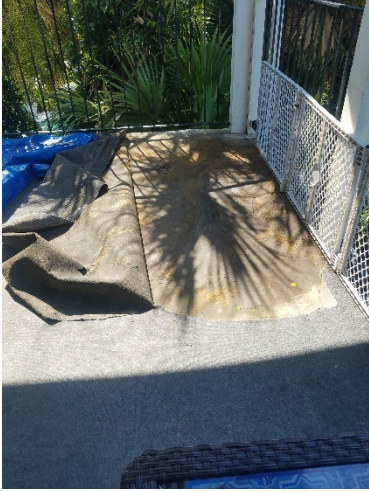
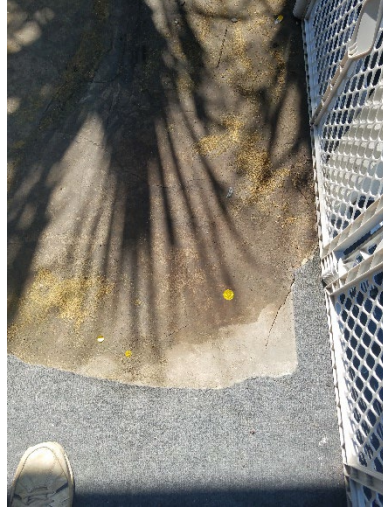
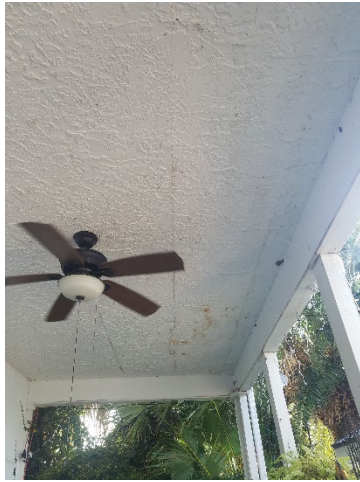
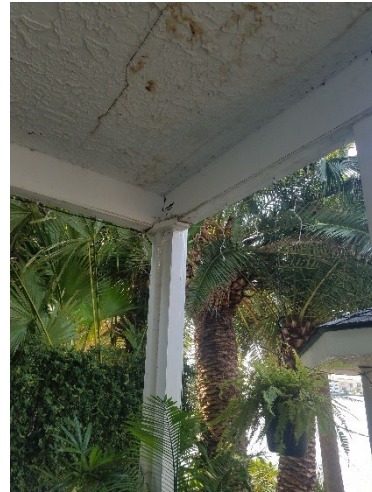
3. The porch floor of Unit 1151 appears to be caving in near the building's Southern corner. This flooring support, plywood and floor-joist, also support the ceiling of the porch below. An inspection of Unit 1141 porch ceiling shows that the ceiling joist appear to be giving way from the pressure above. (This must be corrected)

- 3) Unit 1141 porch ceiling/Unit 1151 porch floor must be exposed to determine the extent of the structural damage. Replace damaged structure with like materials.
- 4) Side porches on the 3rd floor in general are leaking to the unit below. The lightweight concrete, wear surface, appears to have cracked over time. These cracks have torn the tar paper, vapor barrier, allowing water to infiltrate to the plywood and over time as water sits on this plywood it will cause the plywood to deteriorate. Since it is not feasible to easily replace this vapor barrier on these porches, it is recommended that the top surface be treated with something that is UV resistant and exceptionally good at providing a vapor barrier. Also, it is recommended that these porches be maintained with this vapor barrier per the manufacturer's recommendations.
