Structural Inspection

August 16, 2022

Grand Lagoon Homeowners Association
161 Marina Dr.
Slidell, La 70458

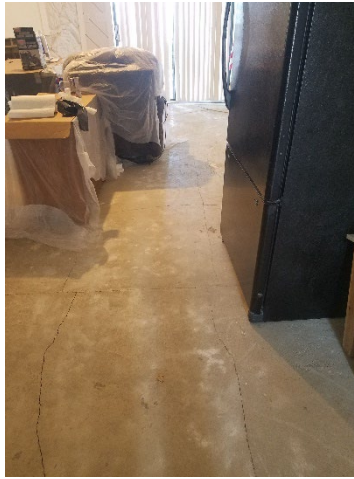
1. The concrete floor in Unit 1155 has multiple cracks across the living room. No apparent damage or deflections were seen in the support of the concrete. See photos below:

- 1) Unit 1155 floor cracks should be floated to obtain a smooth surface to install new flooring.
- 2)
 - a. Unit 1159 ceiling /Unit 1165 porch floor needs to be repaired. Where the supporting plywood has deteriorated it must be cut out and replaced. See detail below for repairing damaged plywood.

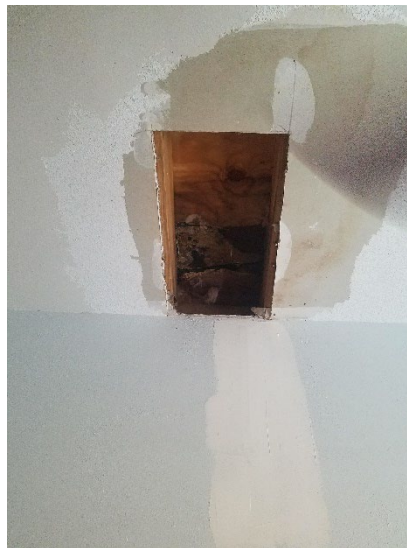
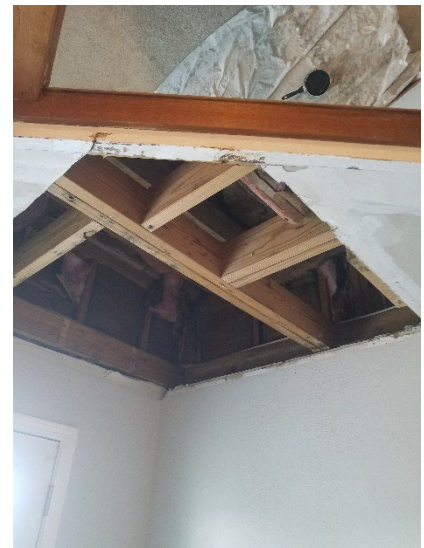
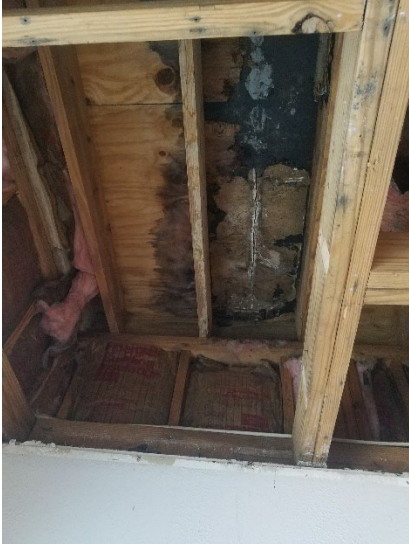
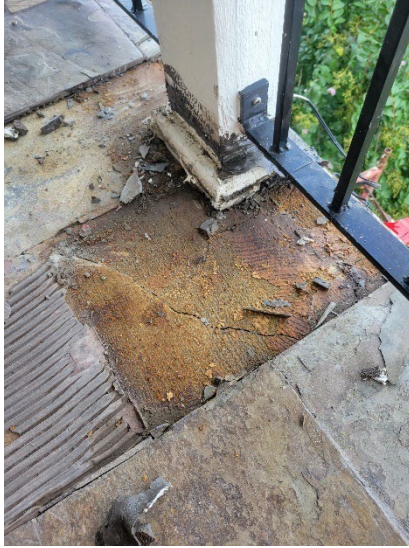
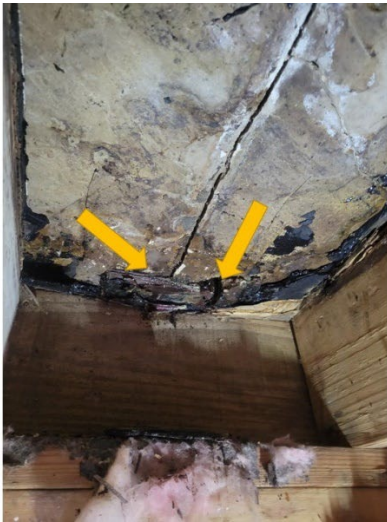
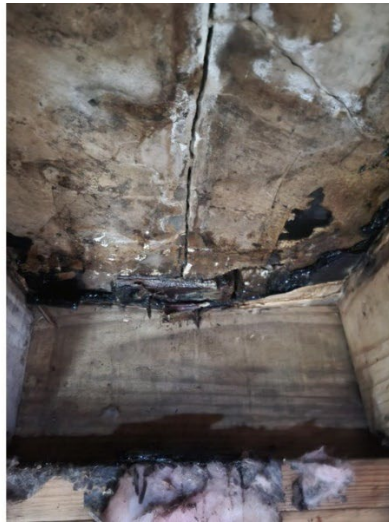
2. The ceiling of Unit 1159 has been experiencing water damage and three of these locations were open for inspection along the exterior wall facing the NorthWest direction. This unit's ceiling-joist(s) also provide support to the porch of Unit 1165 above. Water appears to have infiltrated the cavity between the porch and the ceiling gypsum via cracks in the concrete on the balcony of all three locations that were available for inspection. This infiltration appears to have been over a long period of time which has caused the plywood to deteriorate and left a discoloration in the concrete along the crack. In one location of Unit 1159 it also appears to have deteriorated the ceiling-joist. Another issue is that it appears that one of the structural columns on the porch of Unit 1165 was previously repaired, incorrectly. The column should be attached directly on top of the 2x12 Rim Joist that is supported by the wall below. Yet it appears that the column was cut and a 6" long piece of 2x4 was slipped between the new cut column and the concrete slab. See photos below:

The drawings provided show that the porches were poured with a slope of 0.7%. The drawings provided also shows a detail that all porches were designed to have a 26-gauge galvanized metal pan between the plywood and concrete. In the areas that were exposed to the underside of a porch, this metal pan was not installed; rather, a tar paper was installed instead. The metal pan and tar paper both provide an excellent vapor barrier. Over time the cracks in the concrete have also torn the tar paper which allows the water to get to the plywood decking. Concrete although very impervious, is not totally impervious. The slope of the concrete provides a minimum amount of slope for rainwater to properly shed from the porches without ponding; however, during a major rain event or a driving rain, the water will find any way to infiltrate through porous material or cracks in the concrete.

When the column on the porch of Unit 1165 was repaired with a 6" length of 2x4 placed between the column and the concrete, it applied pressure to the concrete causing the concrete to crack.

- b. Unit 1165 porch has a column that was improperly repaired. The support for this column was inappropriately distributed to concrete around it, causing the concrete to crack. This column should be replaced with a 6"x6" post to match the type of wood originally installed. The base should receive its support of the perimeter Rim Joist above the exterior wall below. Additional full height blocking should also be installed. See detail and section below. (Note that the Building Cross Section provided shows these columns as 6x6 Post; however, the HOA have stated that the original posts were 4x6 cedar and somewhere around 30 +/- years ago some were replaced with 3-1/2 x 5-1/2.)

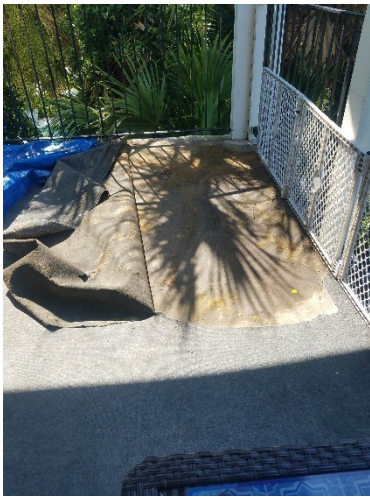
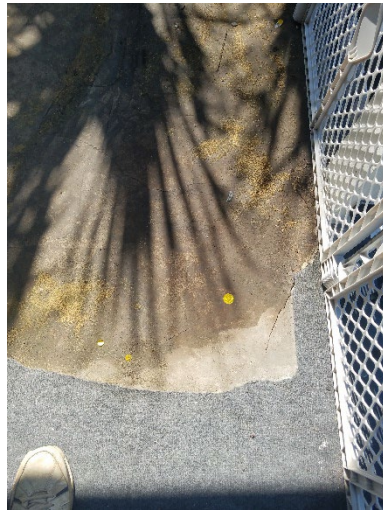
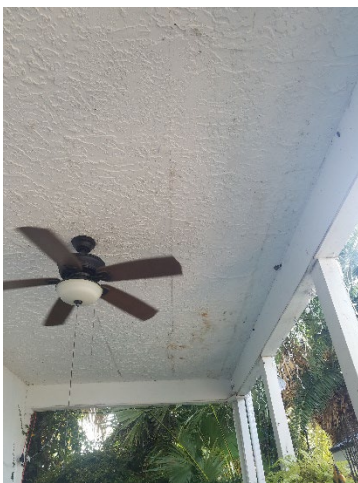
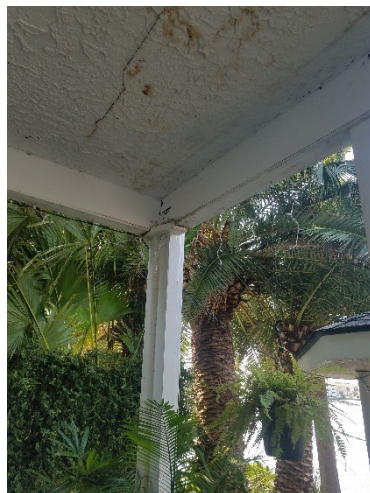
3. The porch floor of Unit 1161 at the Eastern corner of the complex, changes the direction of flow for rainwater in this corner. This corner should have water flowing towards the corner; however, it is actually inches higher than it should be. Looking at the support for this corner and the supports below this corner, shows nothing that appears to be compromised.

4. The porch floor of Unit 1151 appears to be caving in near the building's Southern corner. This flooring support, plywood and floor-joist, also support the ceiling of the porch below. An inspection of Unit 1141 porch ceiling shows that the ceiling joist appear to be giving way from the pressure above. (This must be corrected)

- 3) Unit 1151 balcony ceiling/Unit 1161 porch floor should be exposed to determine the cause of the change in direction of the porch slope.
- 4) Unit 1141 porch ceiling/Unit 1151 porch floor must be exposed to determine the extent of the structural damage. Replace damaged structure with like materials.
