Structural Inspection

05-04-2022

Mimi Mckee
207 S Holly St.
Hammond, La 70403

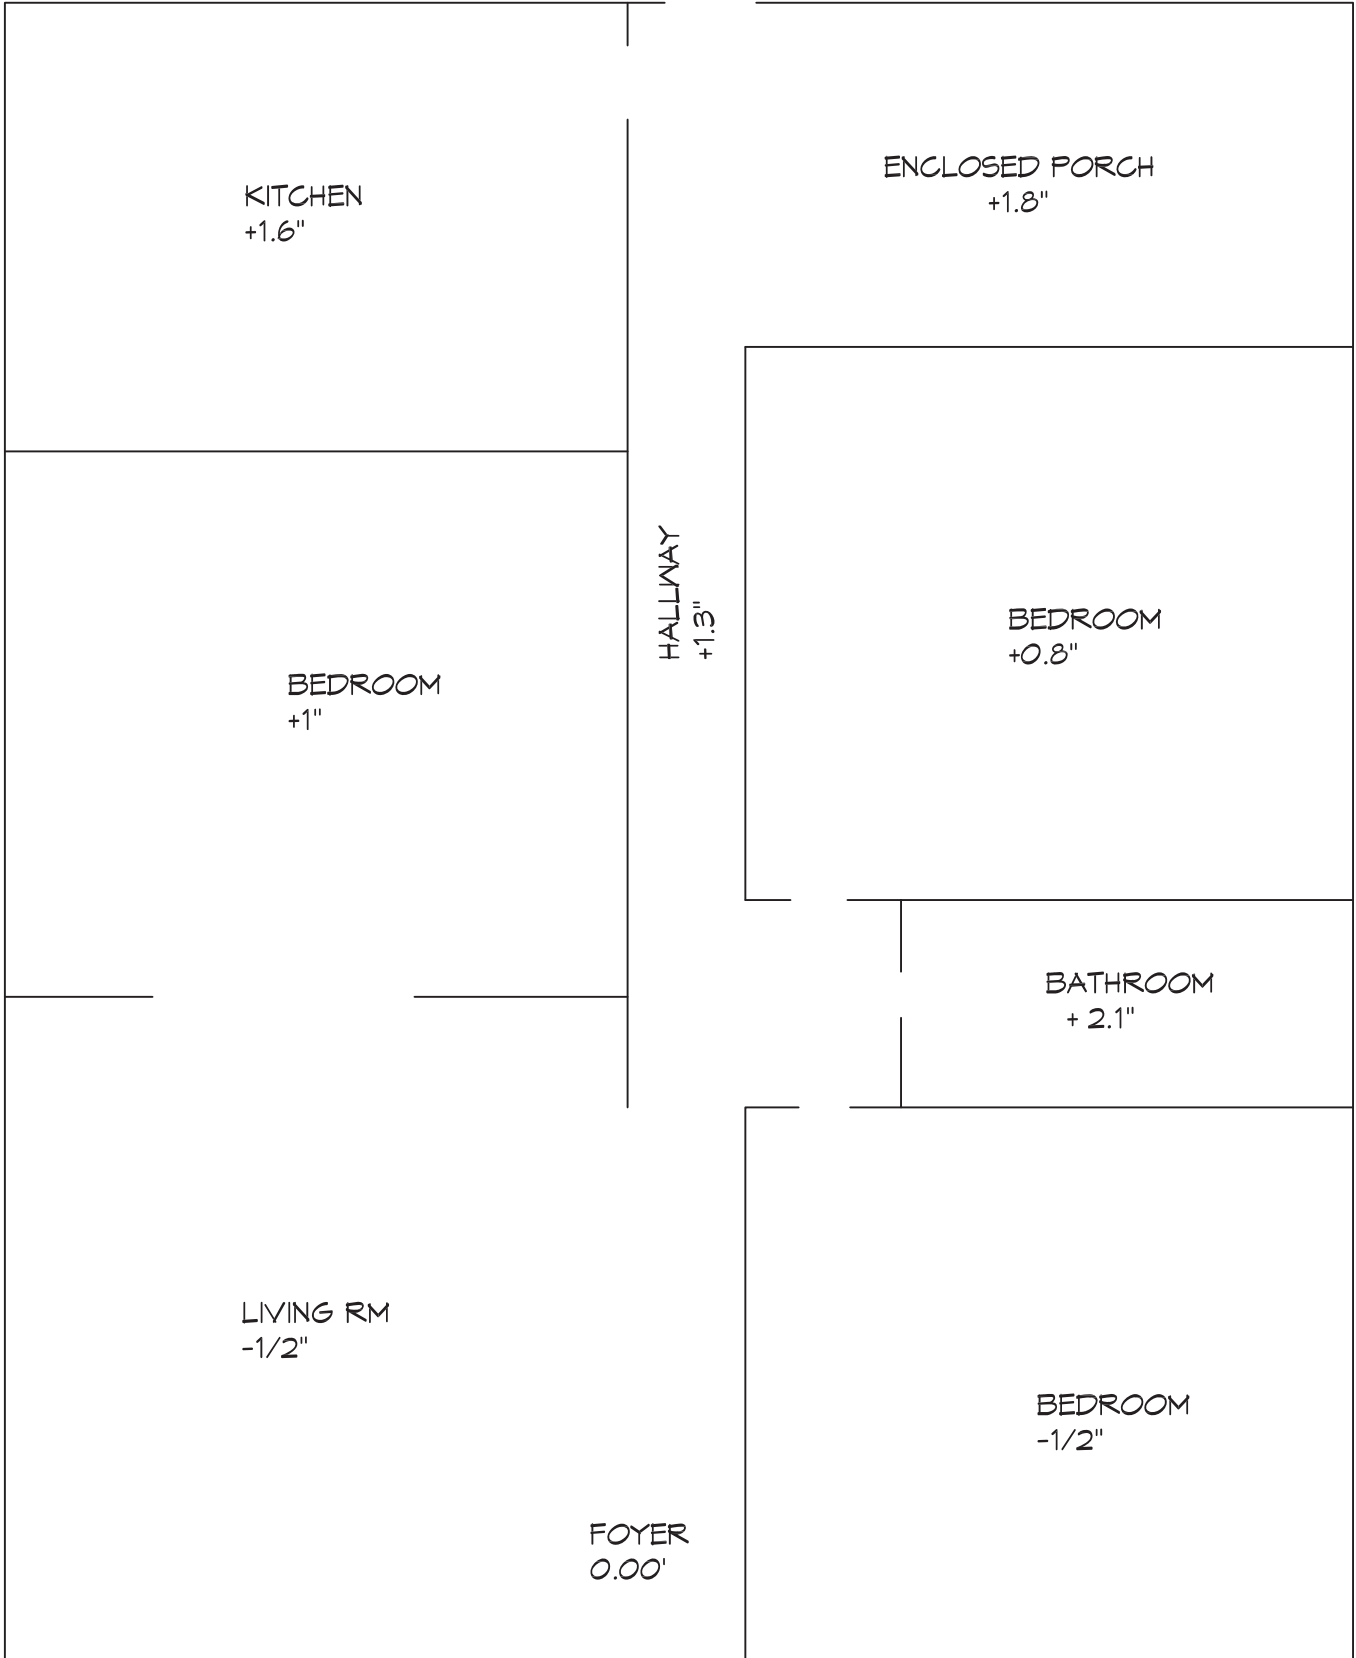
See the attached

A zip level was used inside the home to verify the floor height conditions throughout. The level was set up at the front of home in the foyer. As per the attached sketch it shows that the home slopes from the rear of the home +1.8" to the front of the home of 0.0".

It is recommended to have the home leveled prior to any repairs.

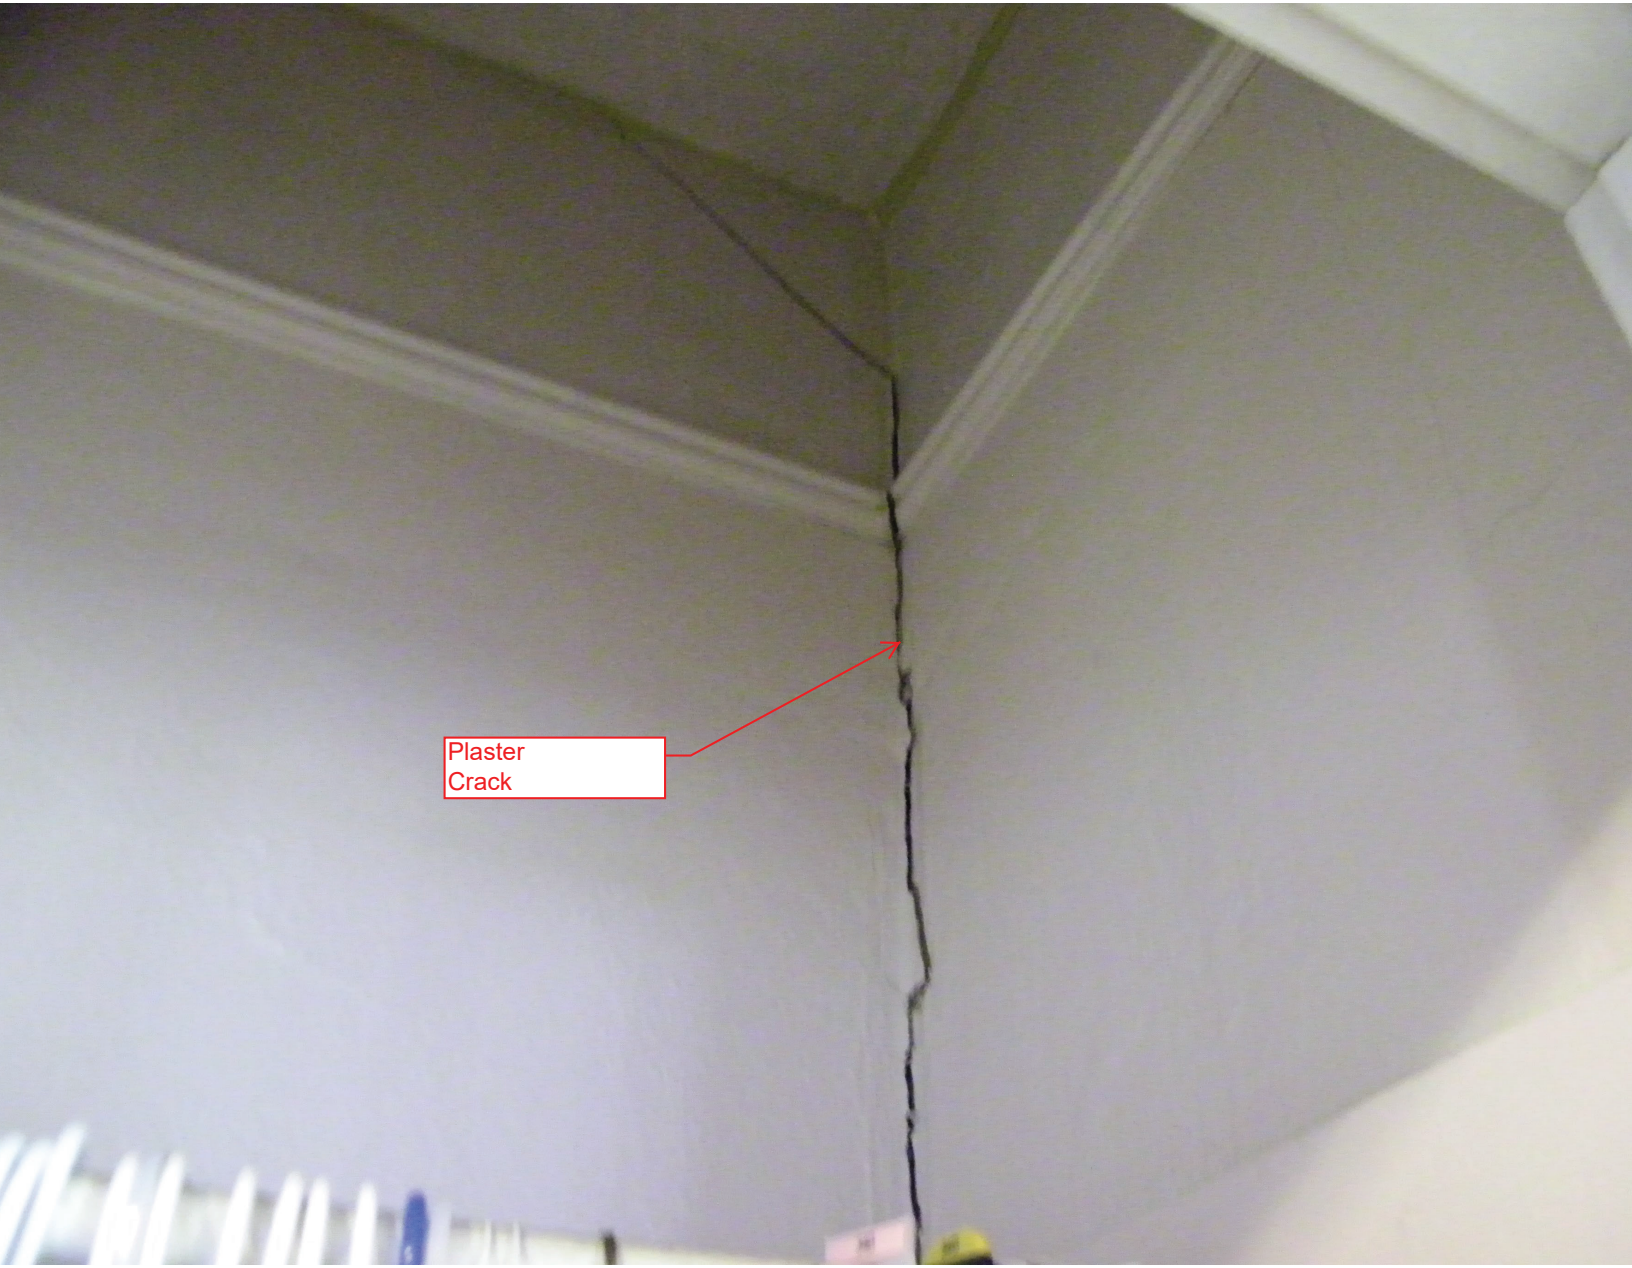
A visual inspection in the interior of the home noted plaster cracks in the front bedroom closets, living area, bathroom and kitchen walls and ceilings. It was also noted to have water stains in the ceilings in these areas as well.

It appears that the front of the home settled from saturation of the earth. It also explains how the cypress trees are lying on their side from the earth being saturated in front of the home. With the wind and rain hitting the house it has caused it to wrack back and forth therefore causing plaster damage.

Plaster
Crack

- 1) Stabilize and level the CMU piers.
- 2) Replace broken windows.
- 3) Install all gutters and down spouts to direct rain water away from the home.
- 4) Repair plaster.
- 5) Paint all affected areas.

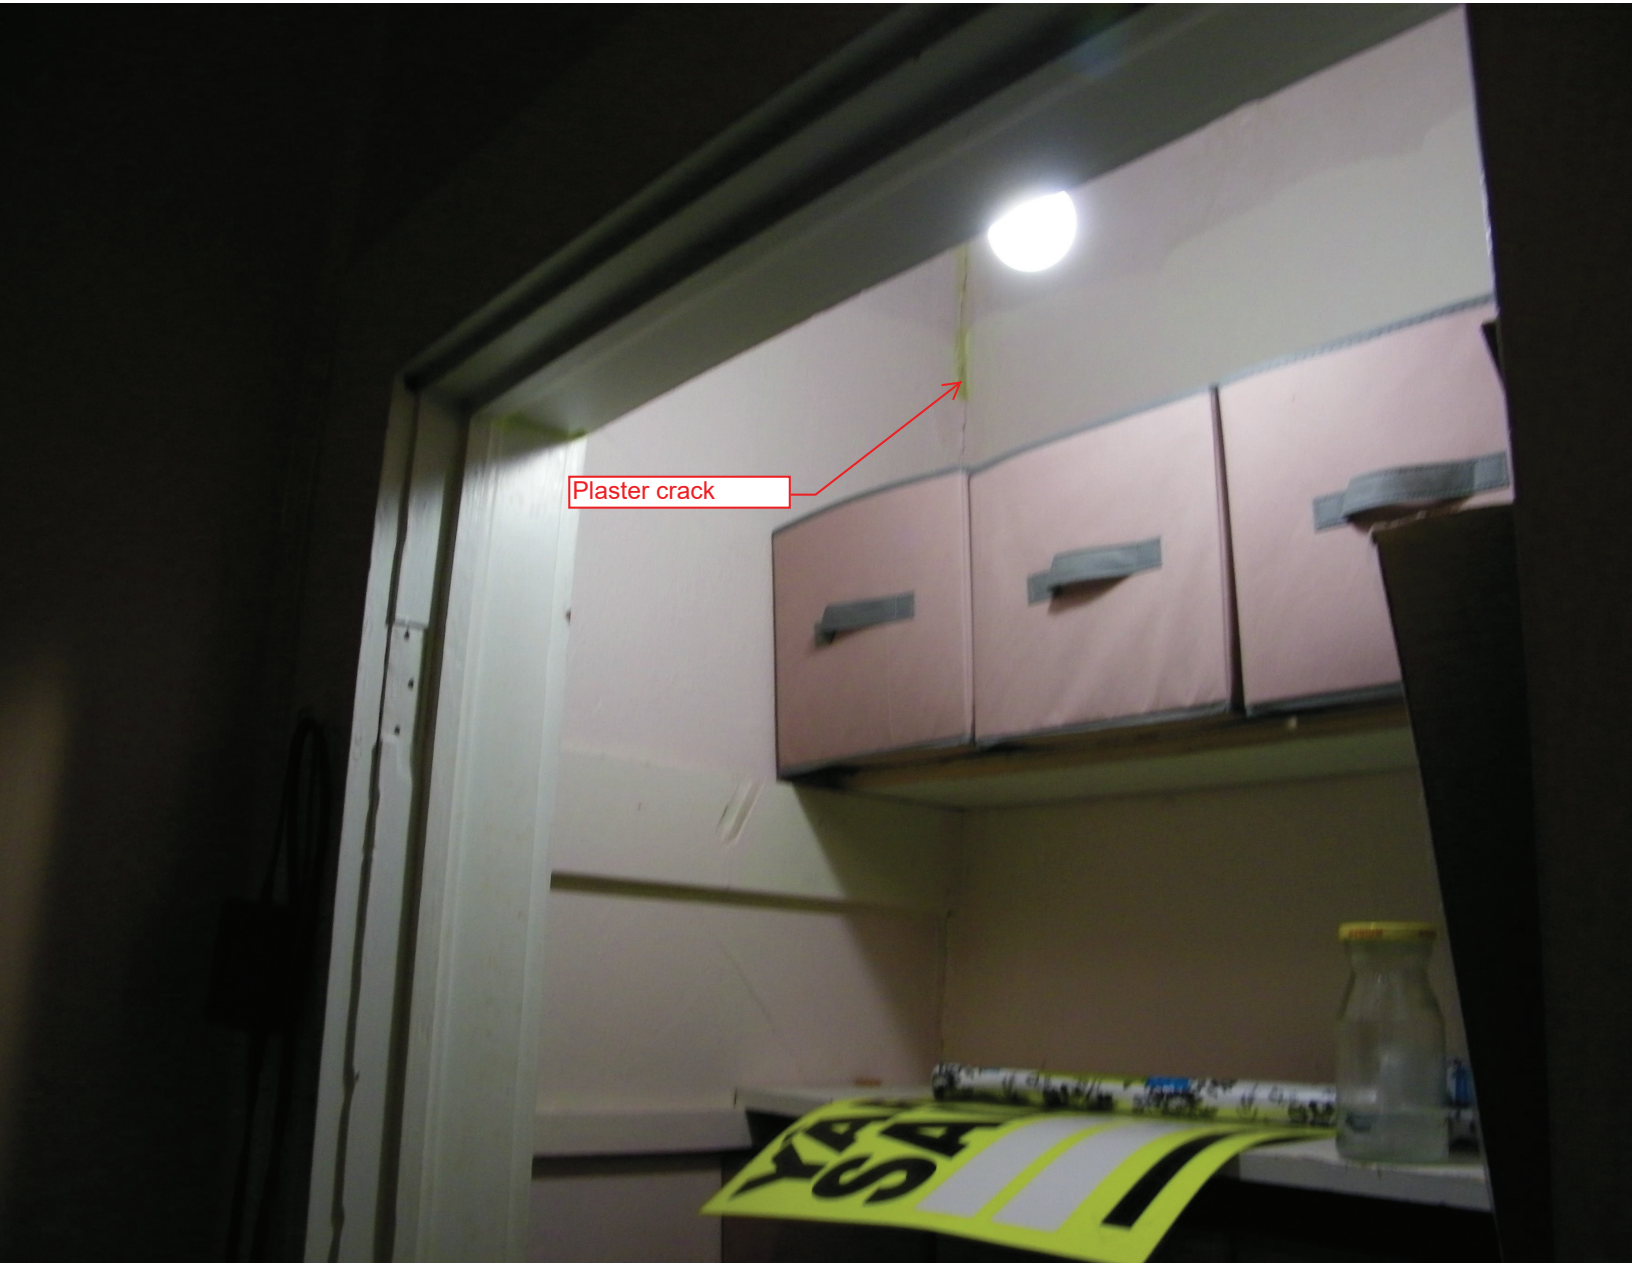
Plaster crack

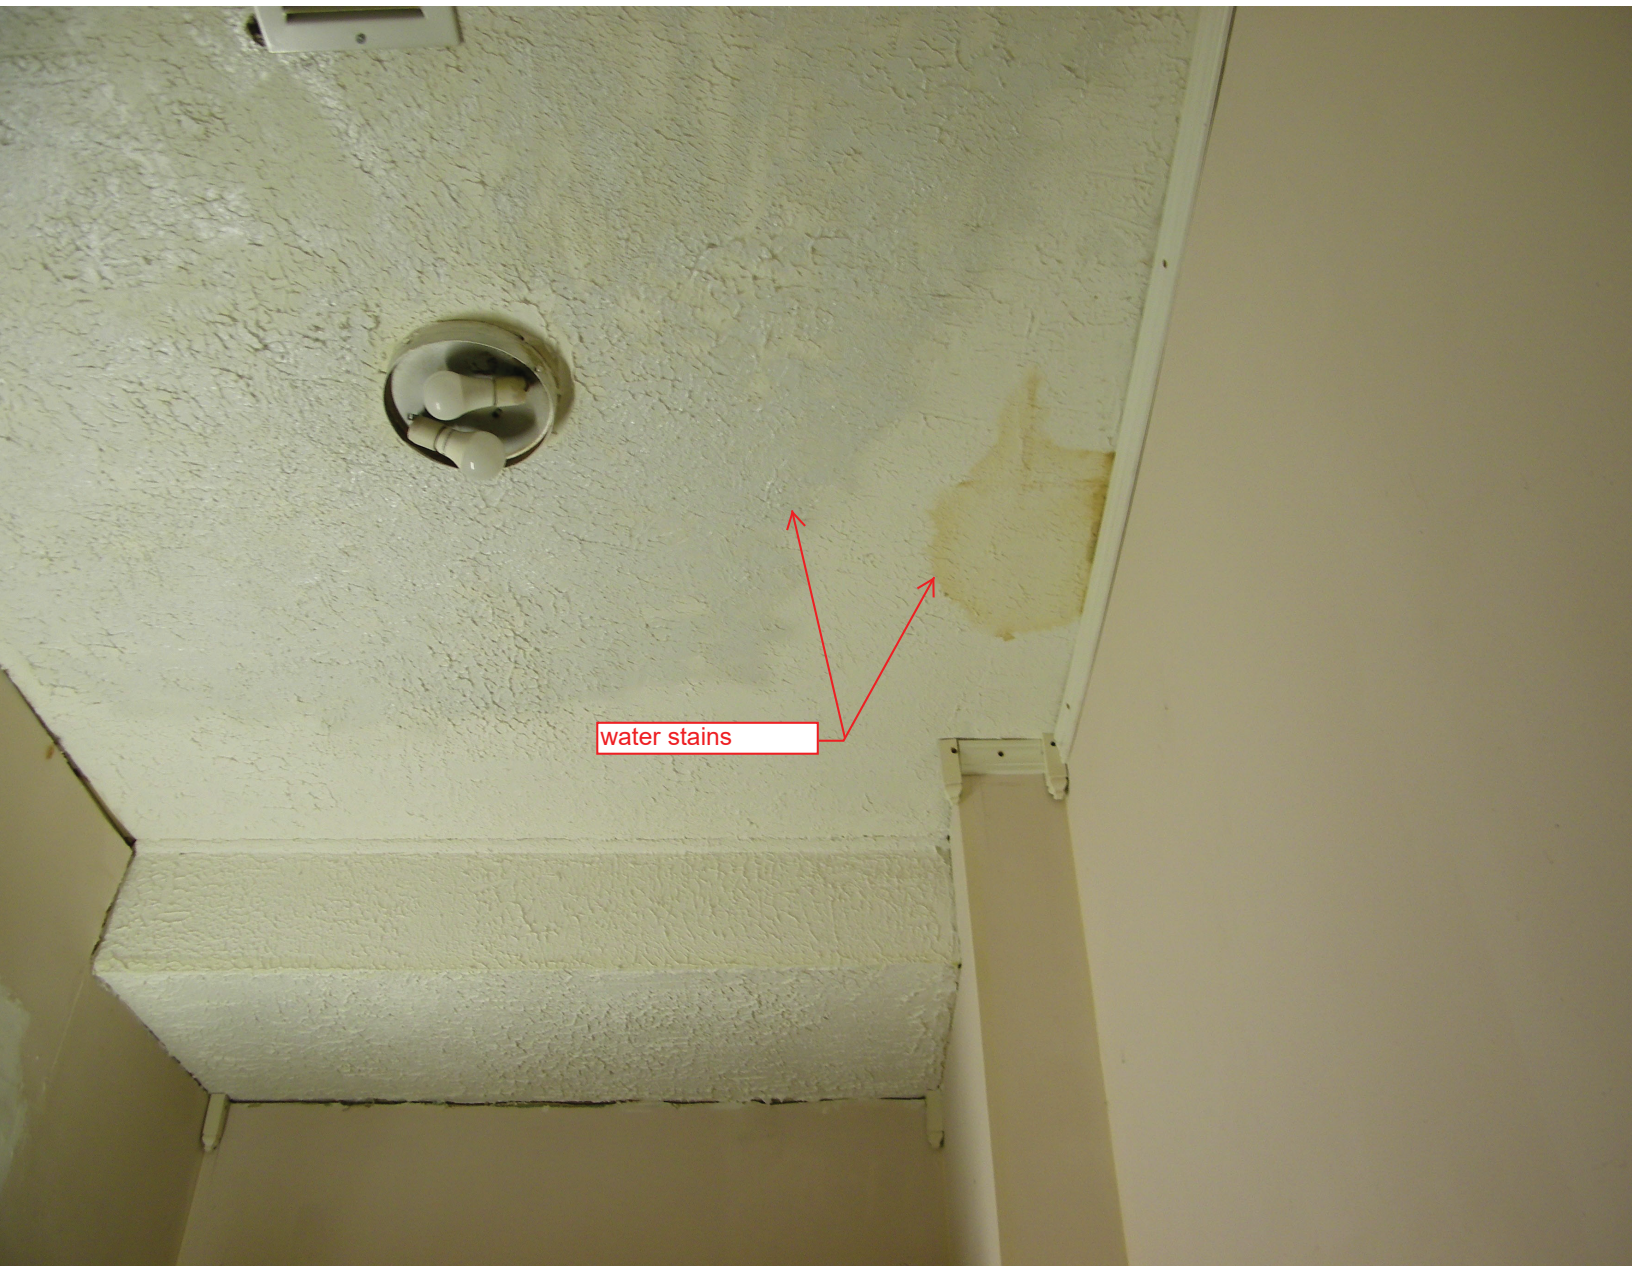
water stains

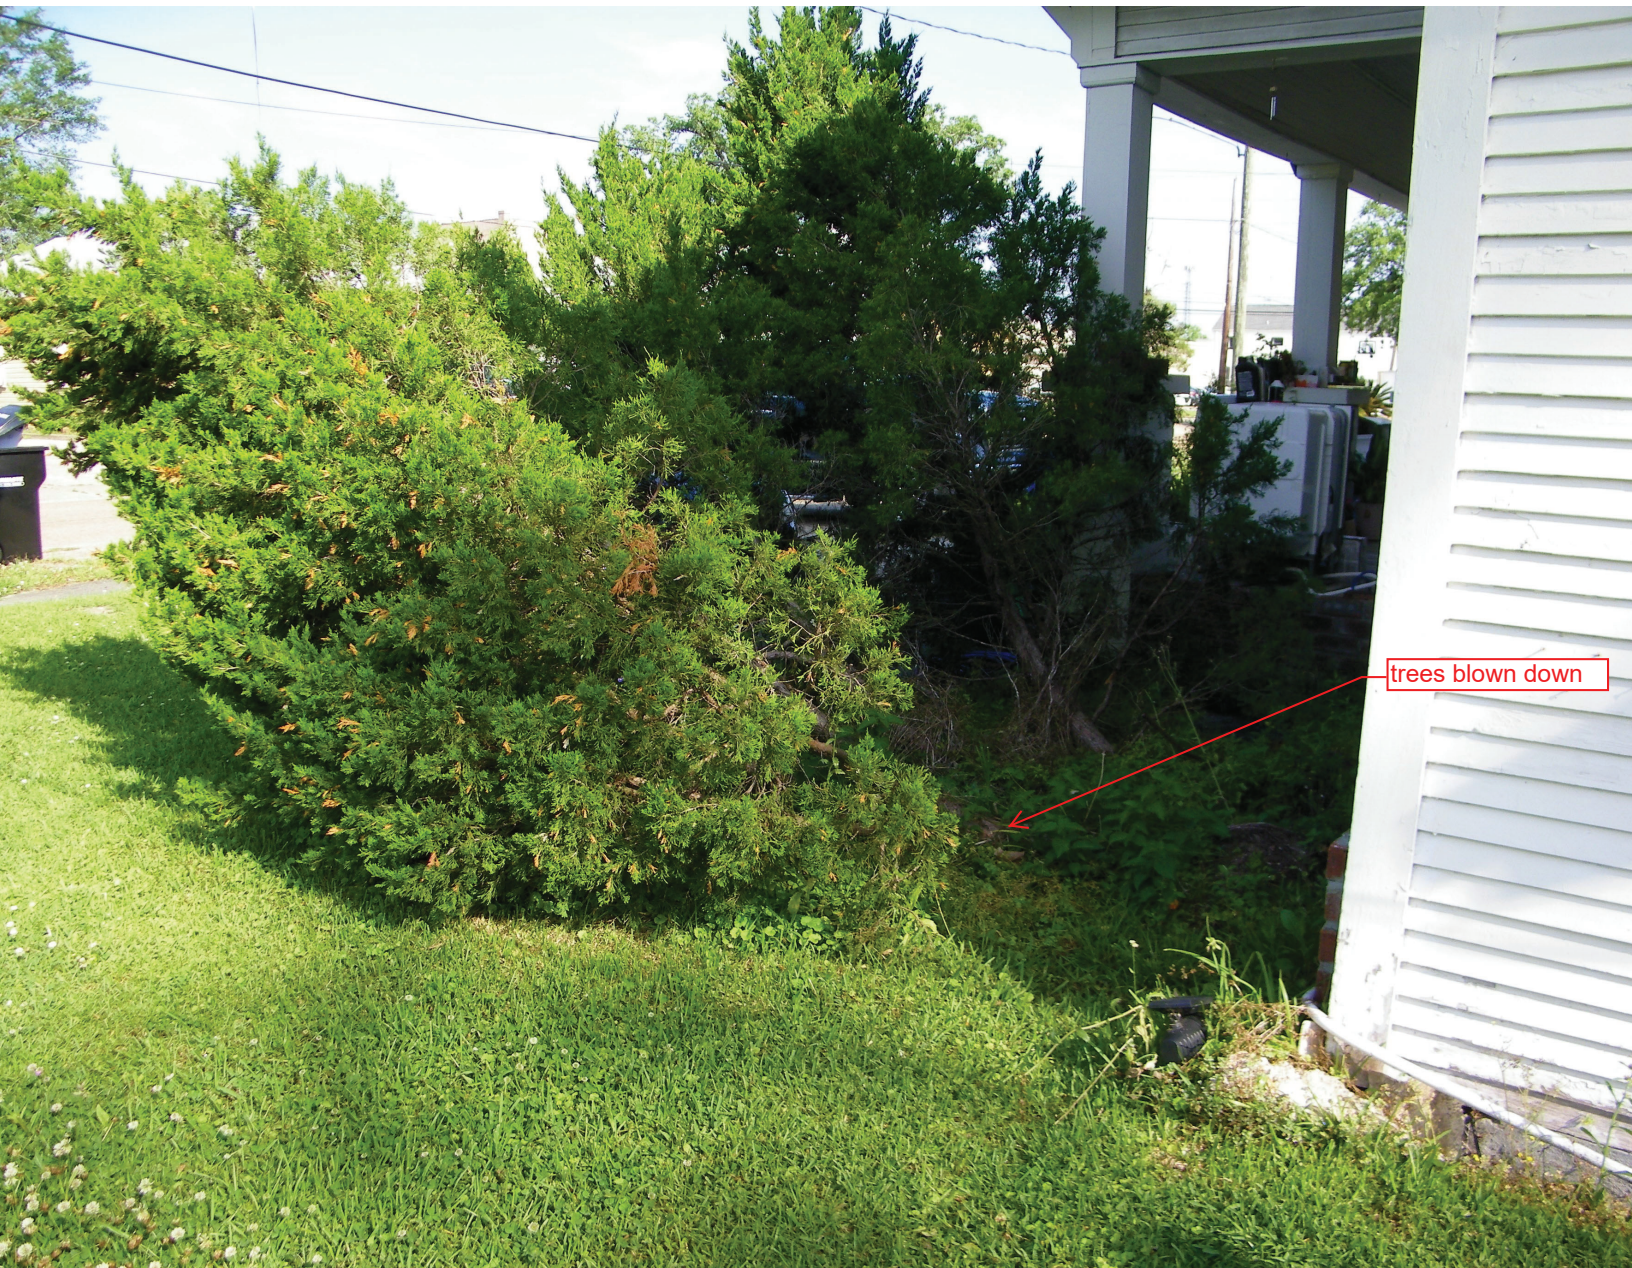
Upon a visual inspection of the exterior of the home, it was noted that a new roof was required. Three cypress trees in front of the home are lying down to the northwest. The rear of the home has busted out windows in the enclosed porch from a tree branch that fell onto it. Many gutters and down spouts are missing. Some of the wood roof supports in the rear of the home are loose from the fascia board.

trees blown down

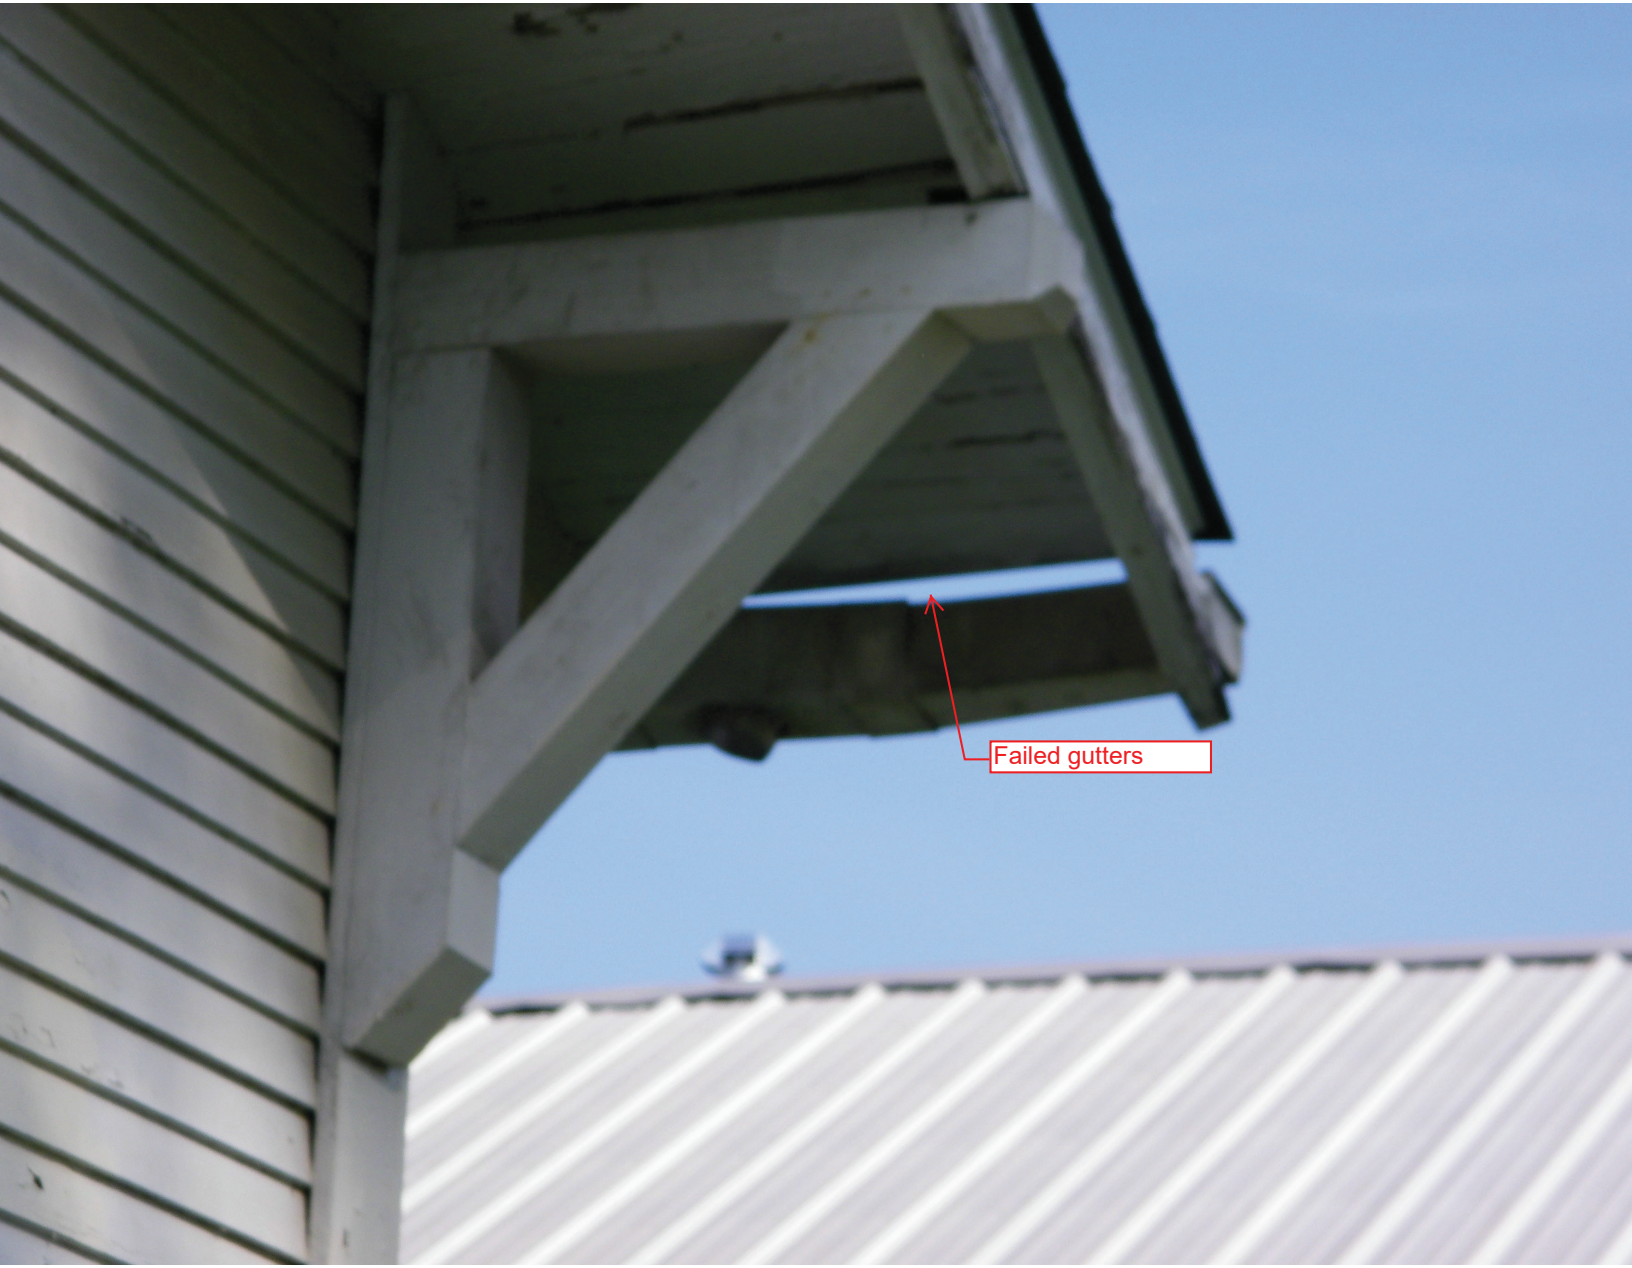
Failed gutters

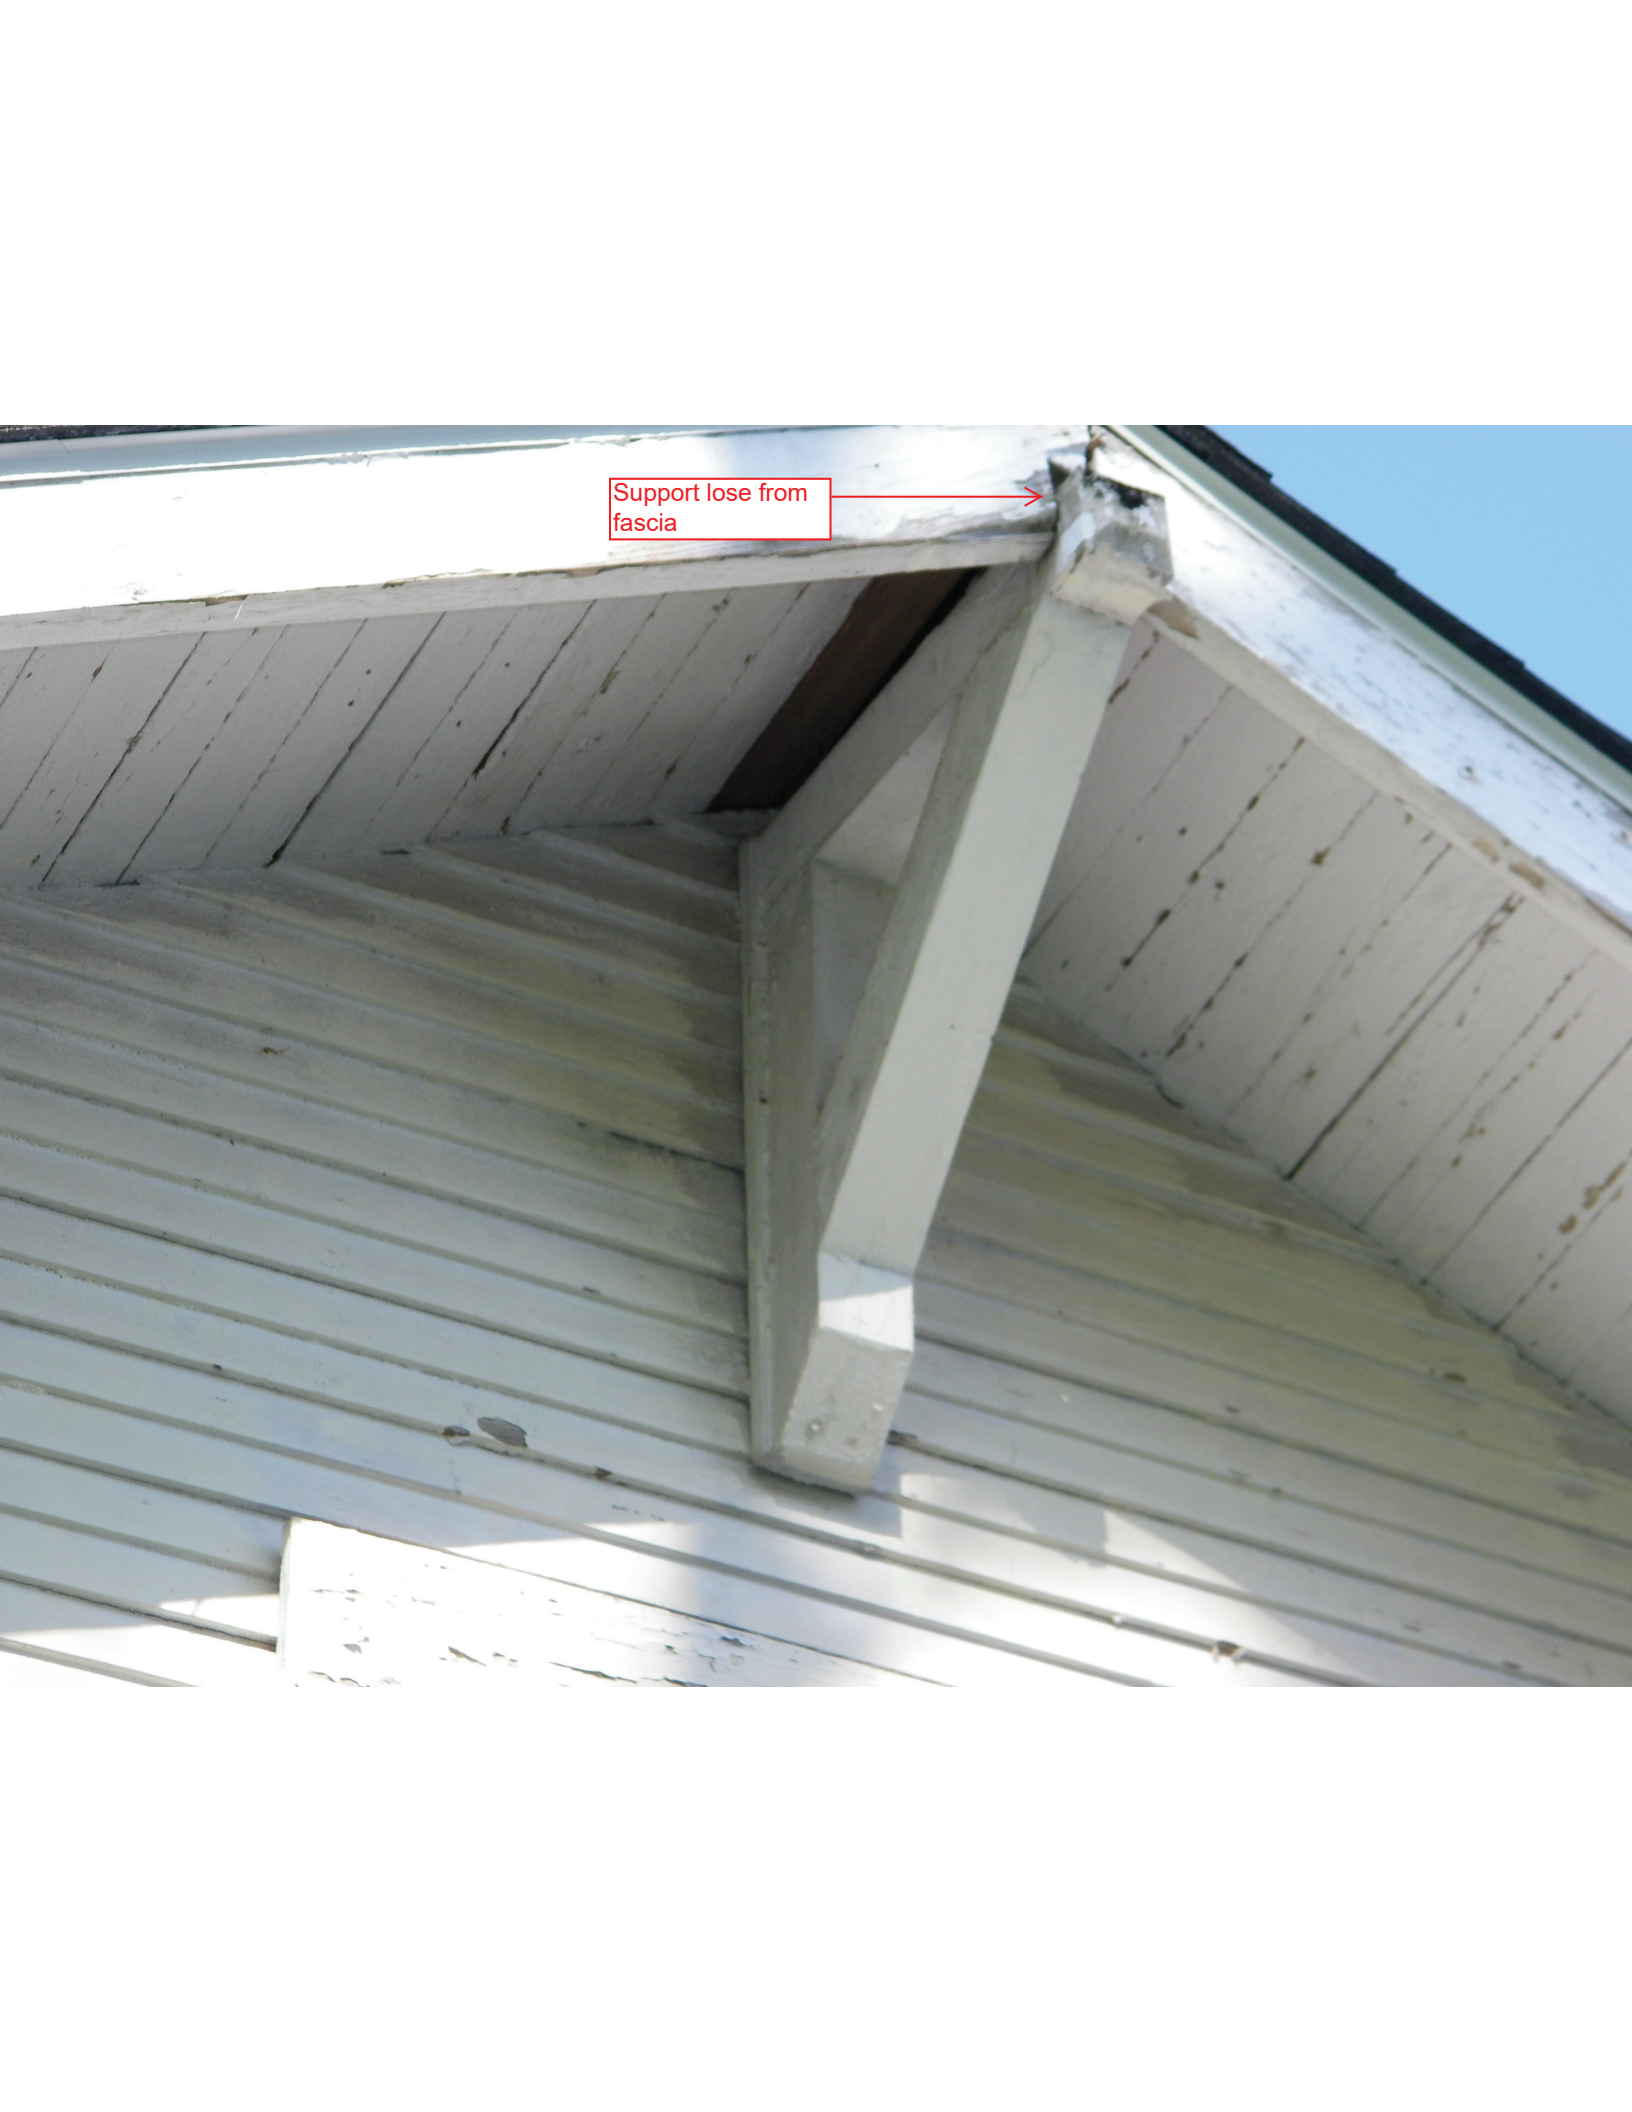
Support lose from
fascia
