Structural Inspection

06-20-2022

Jason & Rebecca Massa
61173 N. 15th St.
Lacombe, La. 70445

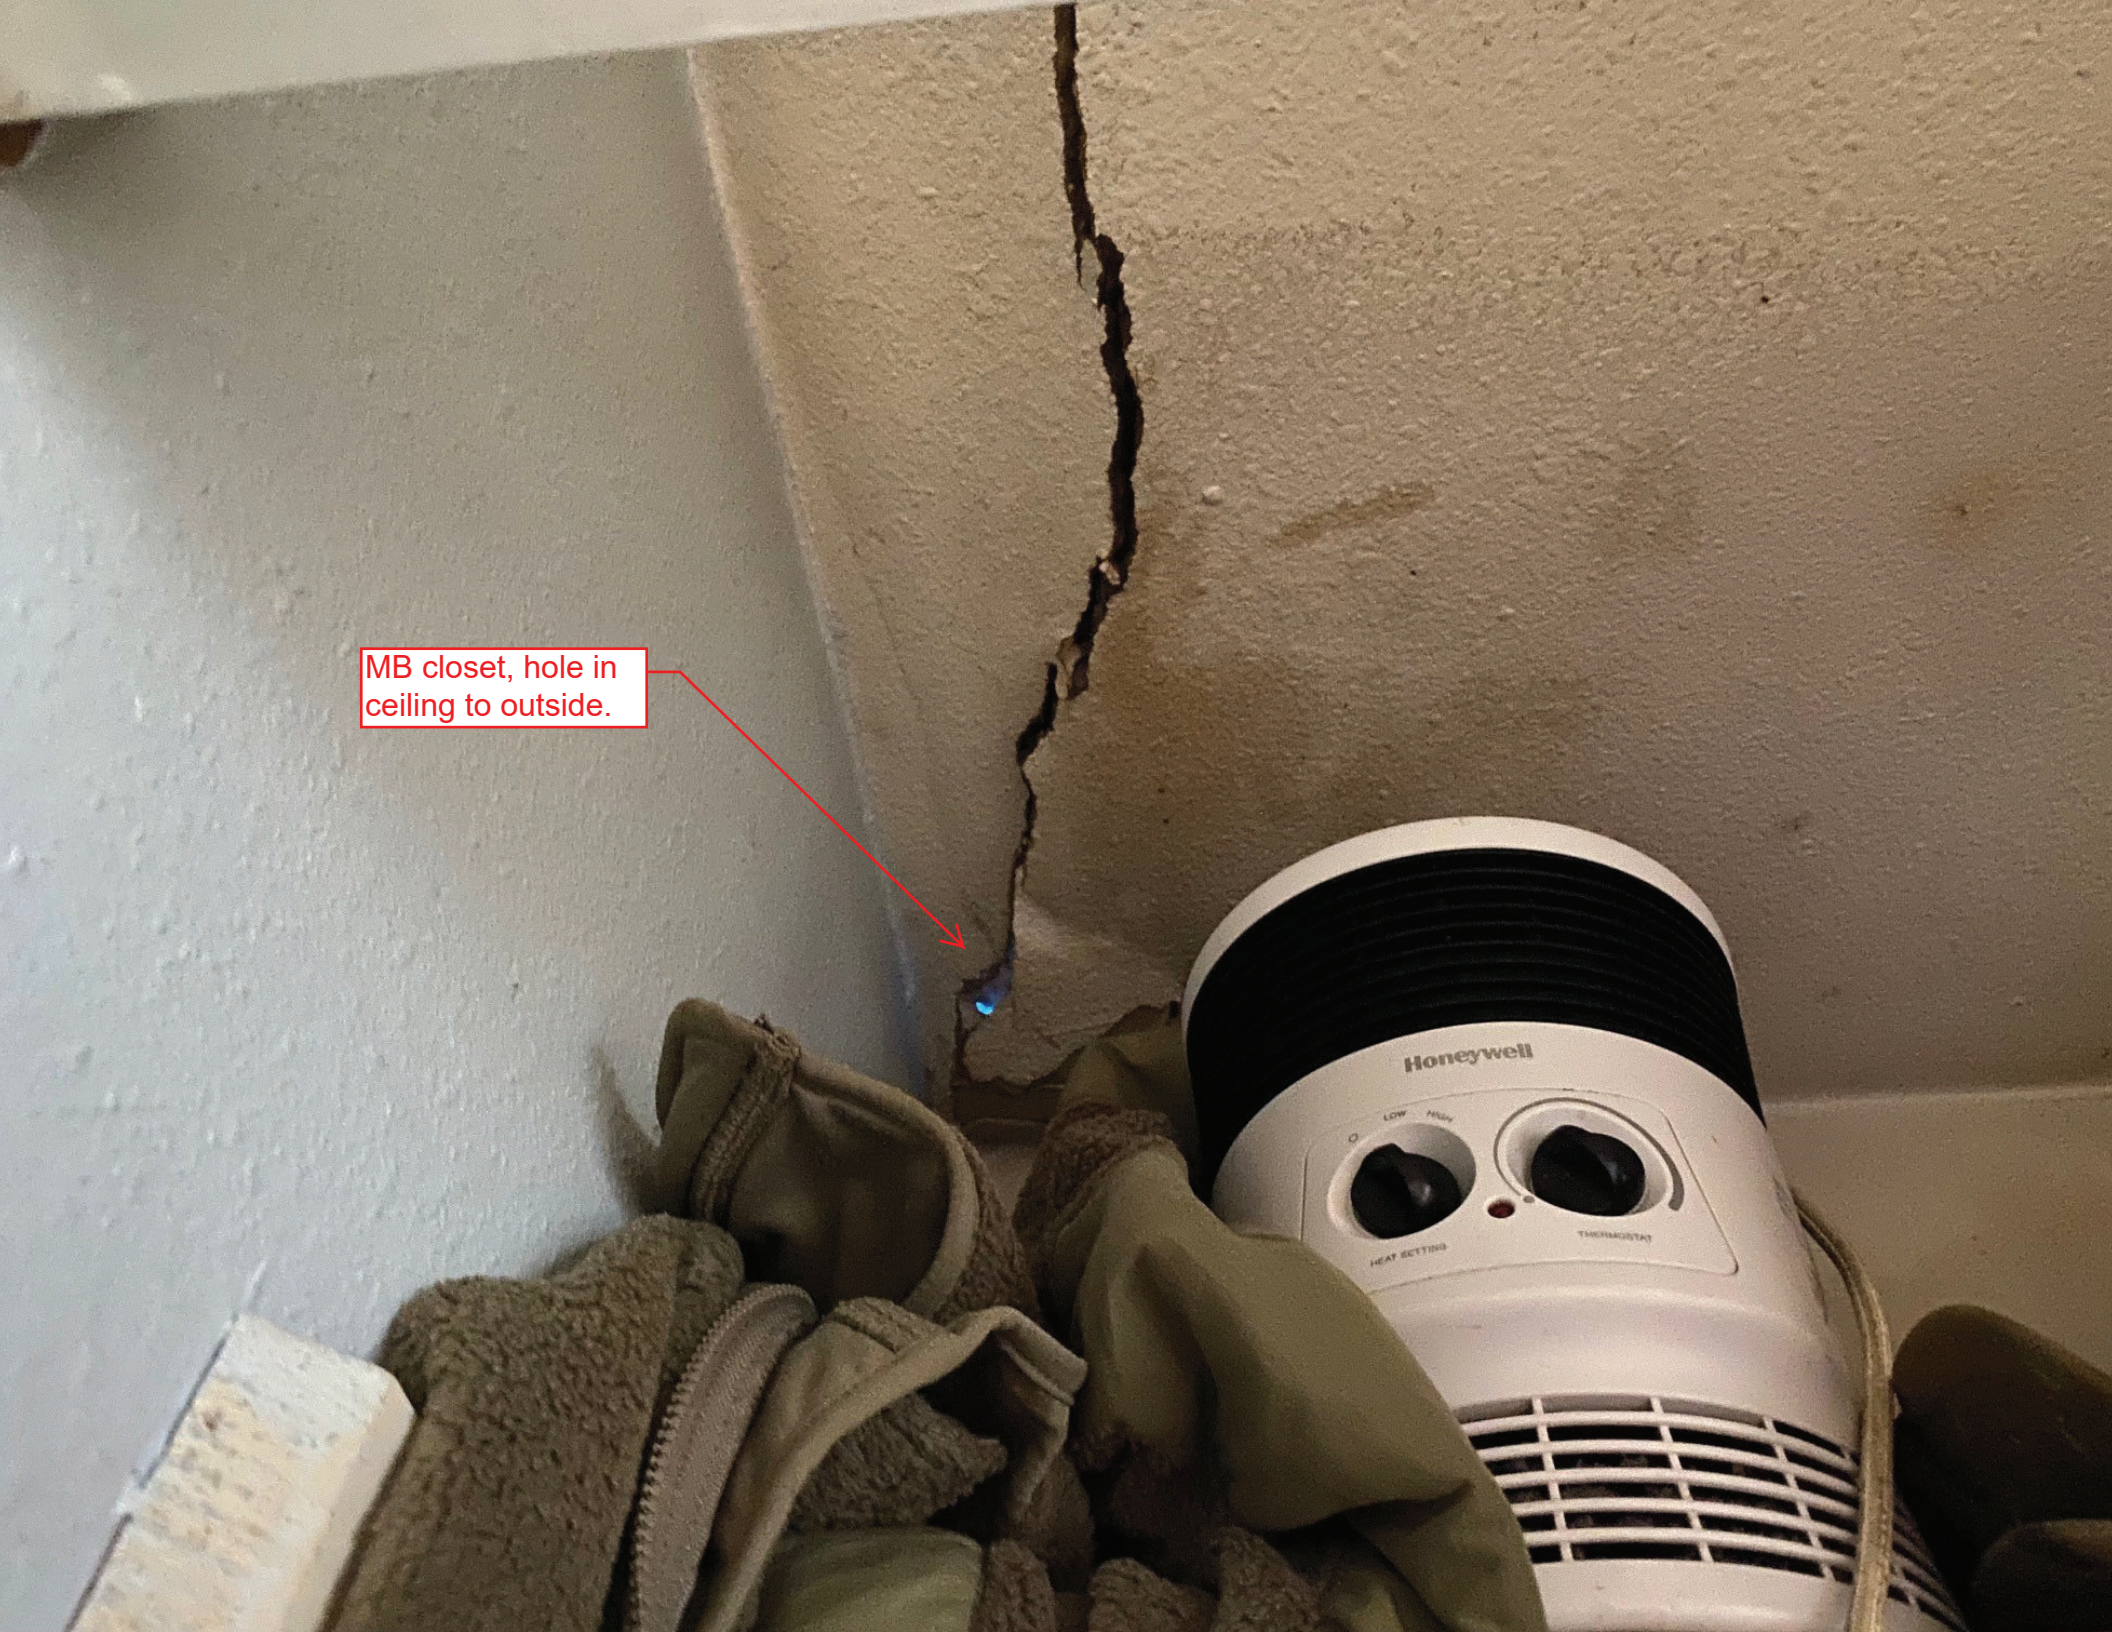
Door busted off of hinge

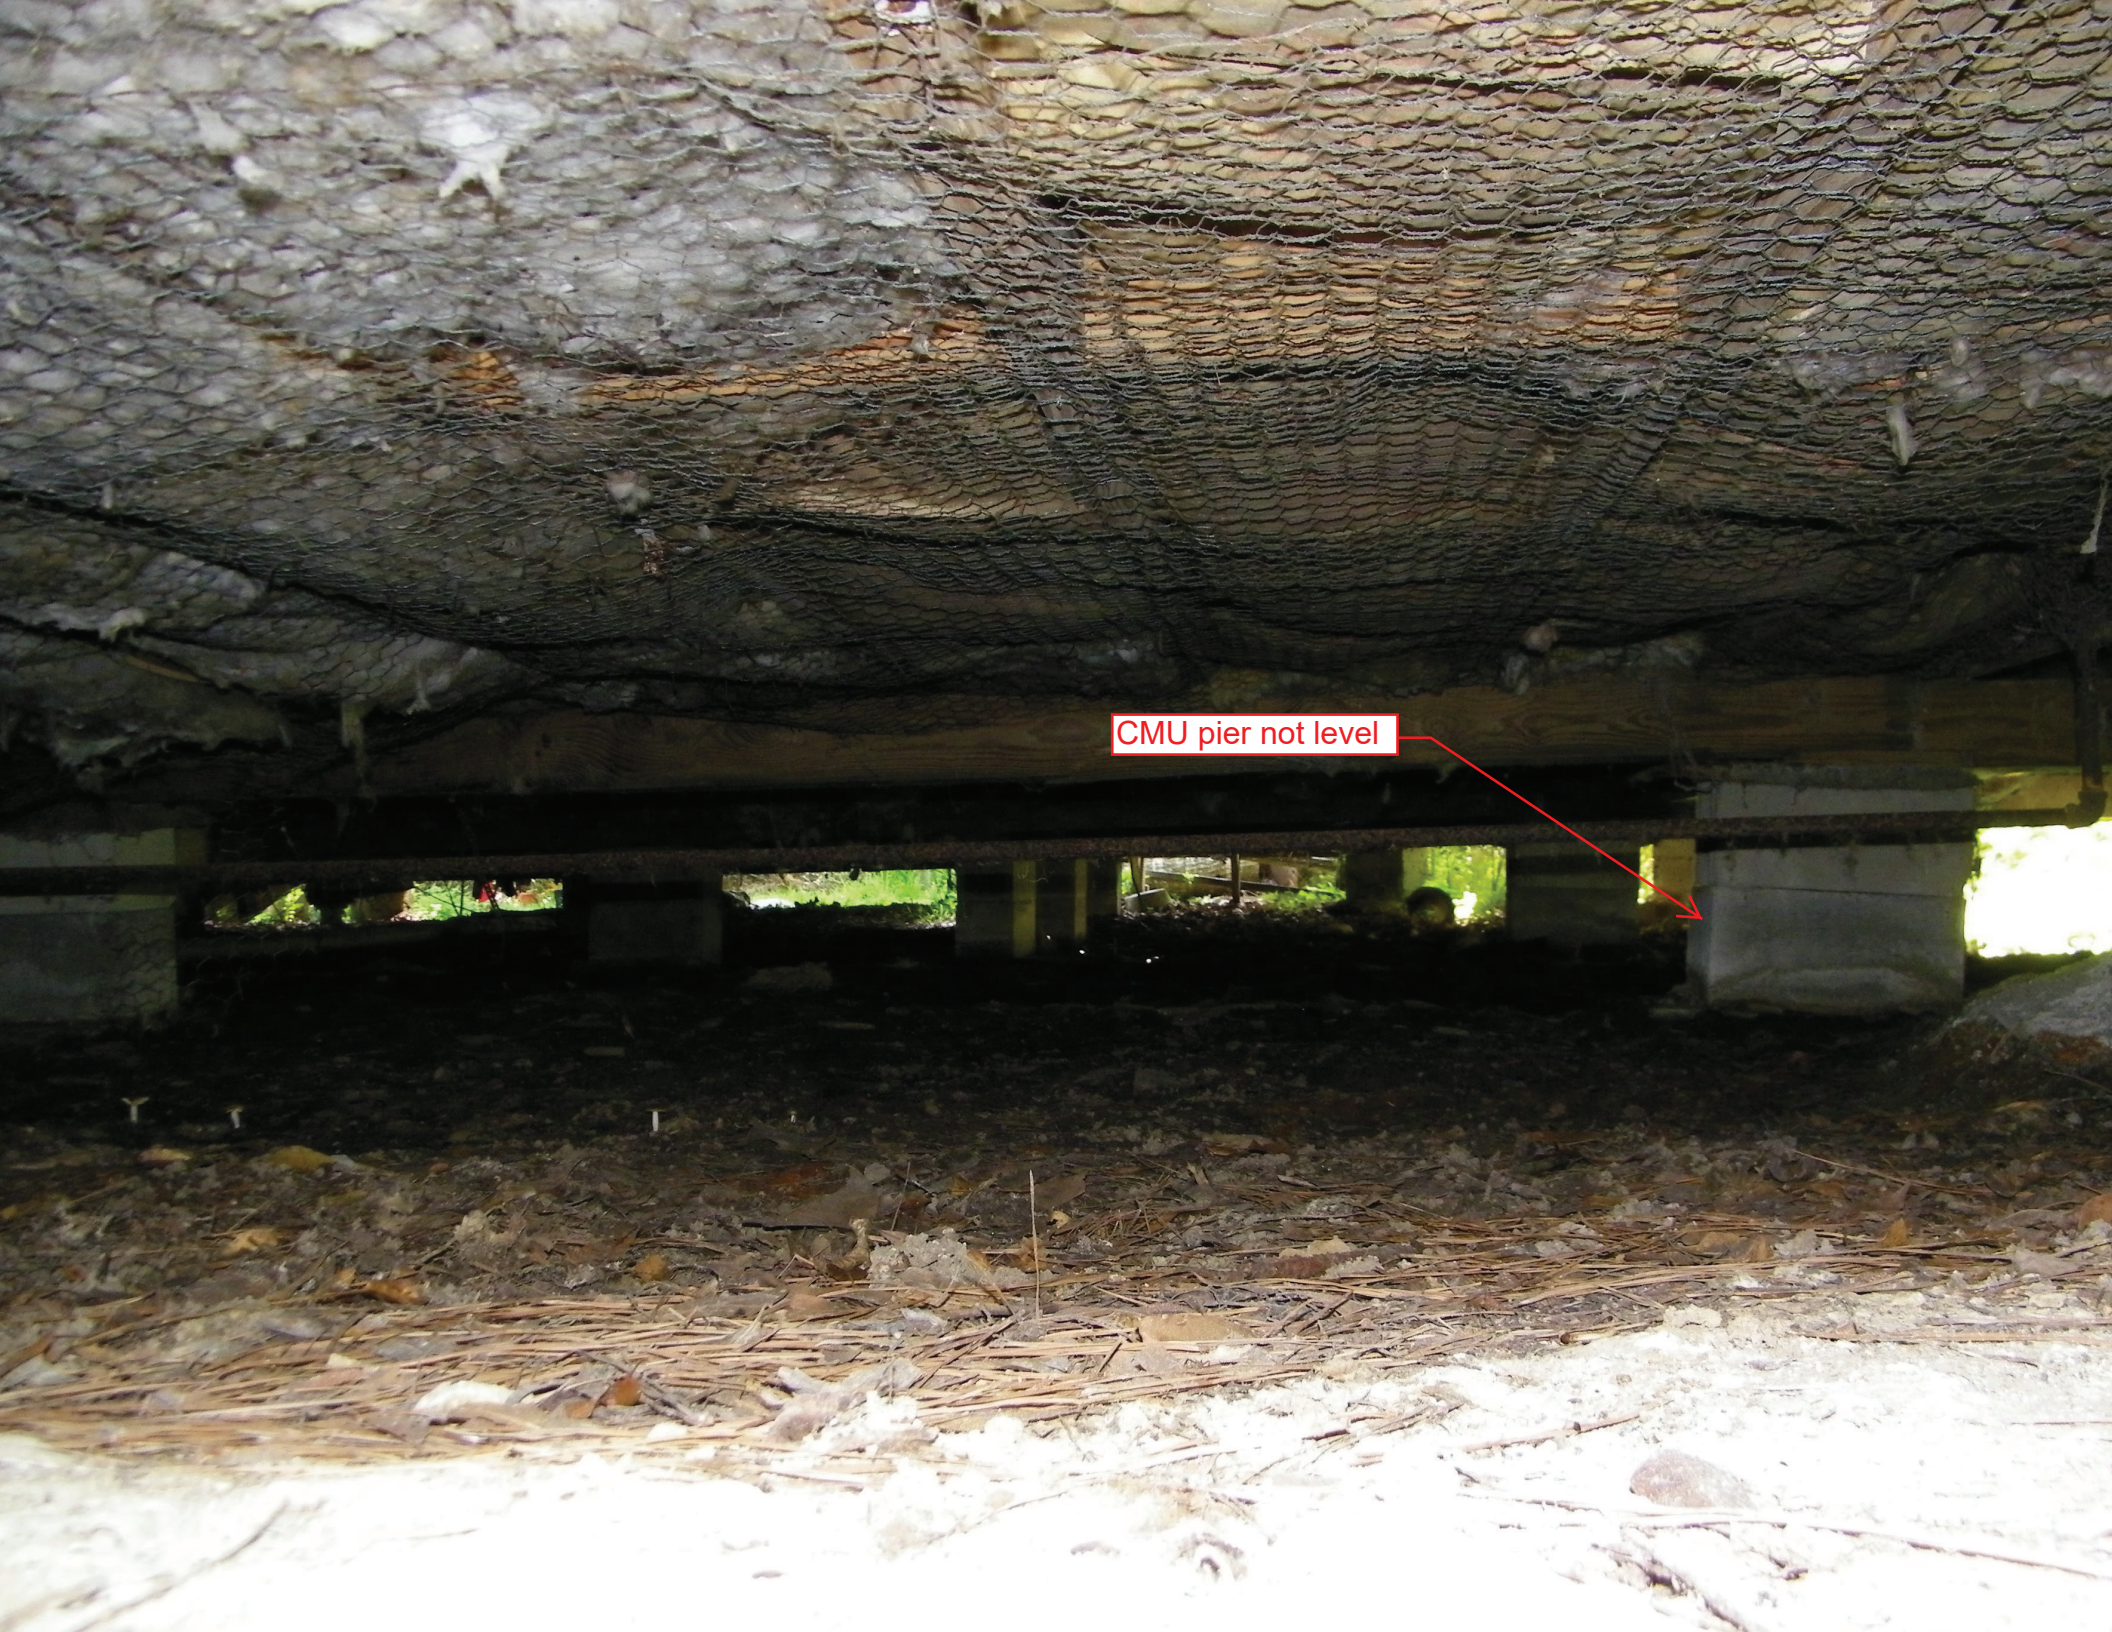
CMU pier not level

- 1) Stabilize and level CMU piers throughout home
- 2) Replace top plates in the damaged area
- 3) Replace cracked ceiling joist in the damaged area
- 4) Replace roof rafters in the damaged area
- 5) Replace roof decking in the damaged area
- 6) Replace asphalt shingles throughout entire roof
- 7) Replace air-conditioned ductwork in the damaged area
- 8) Replace insulation in the damaged area
- 9) Replace sheetrock in the master bathroom closet ceiling
- 10) Repair sheetrock cracks throughout home
- 11) Replace damaged flooring
- 12) Paint all affected areas

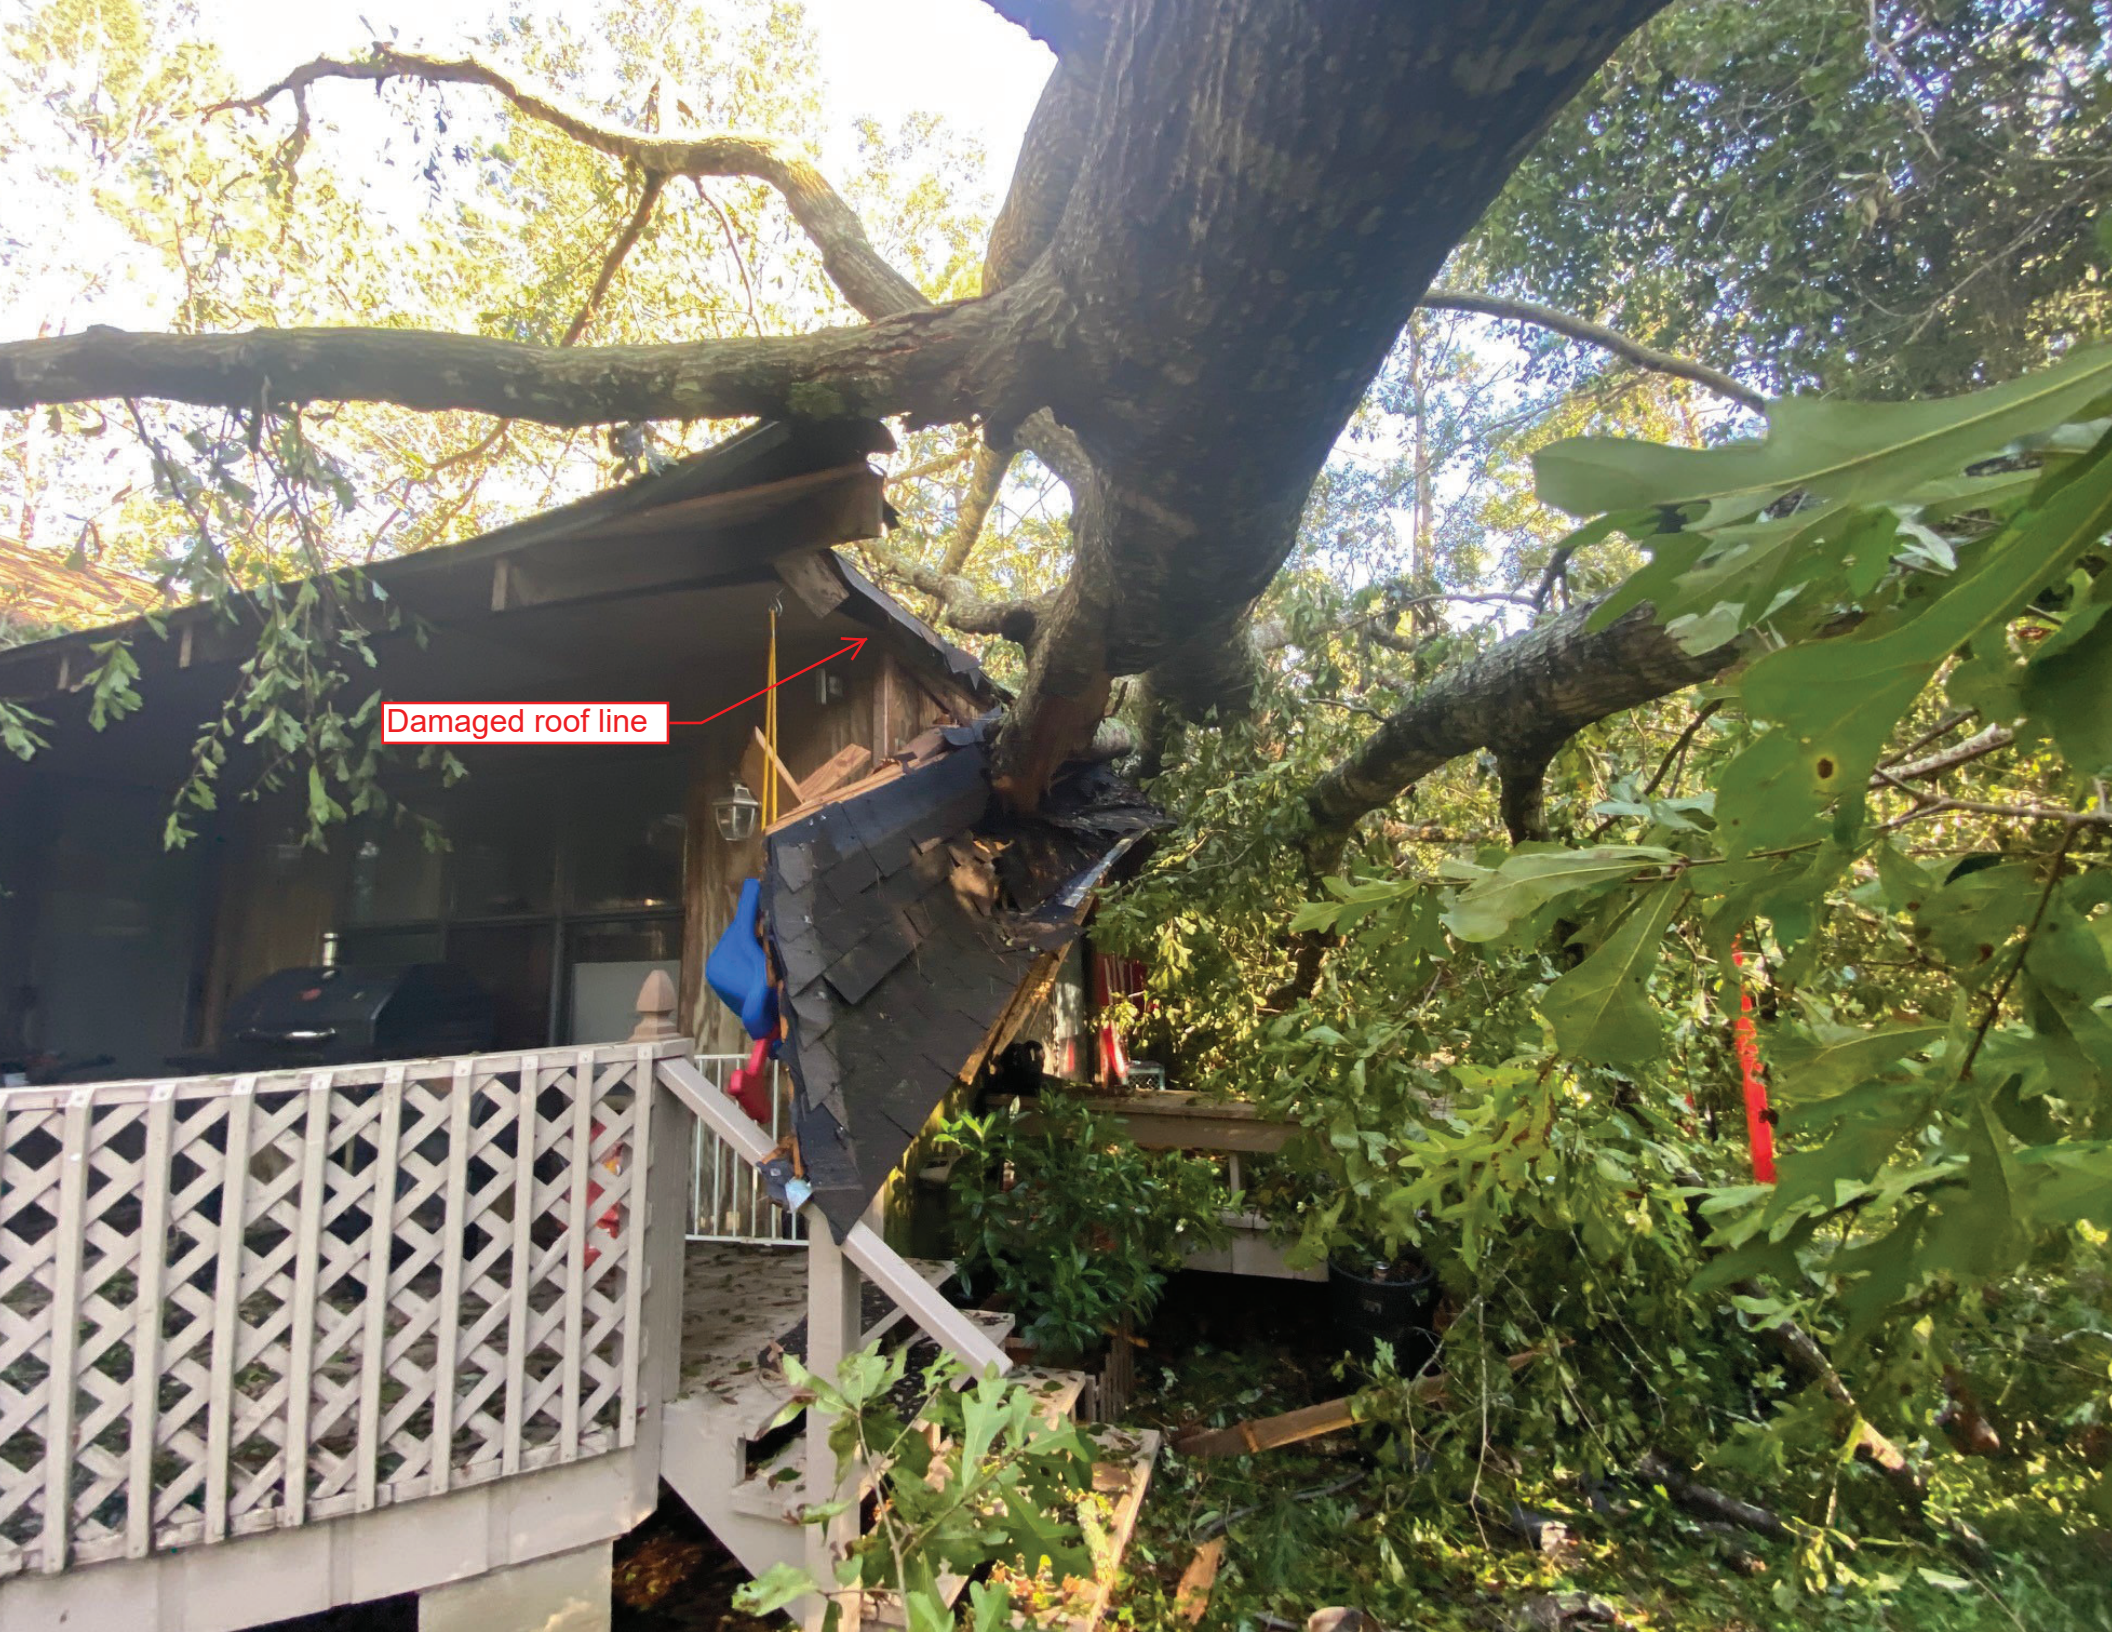
Damaged roof line

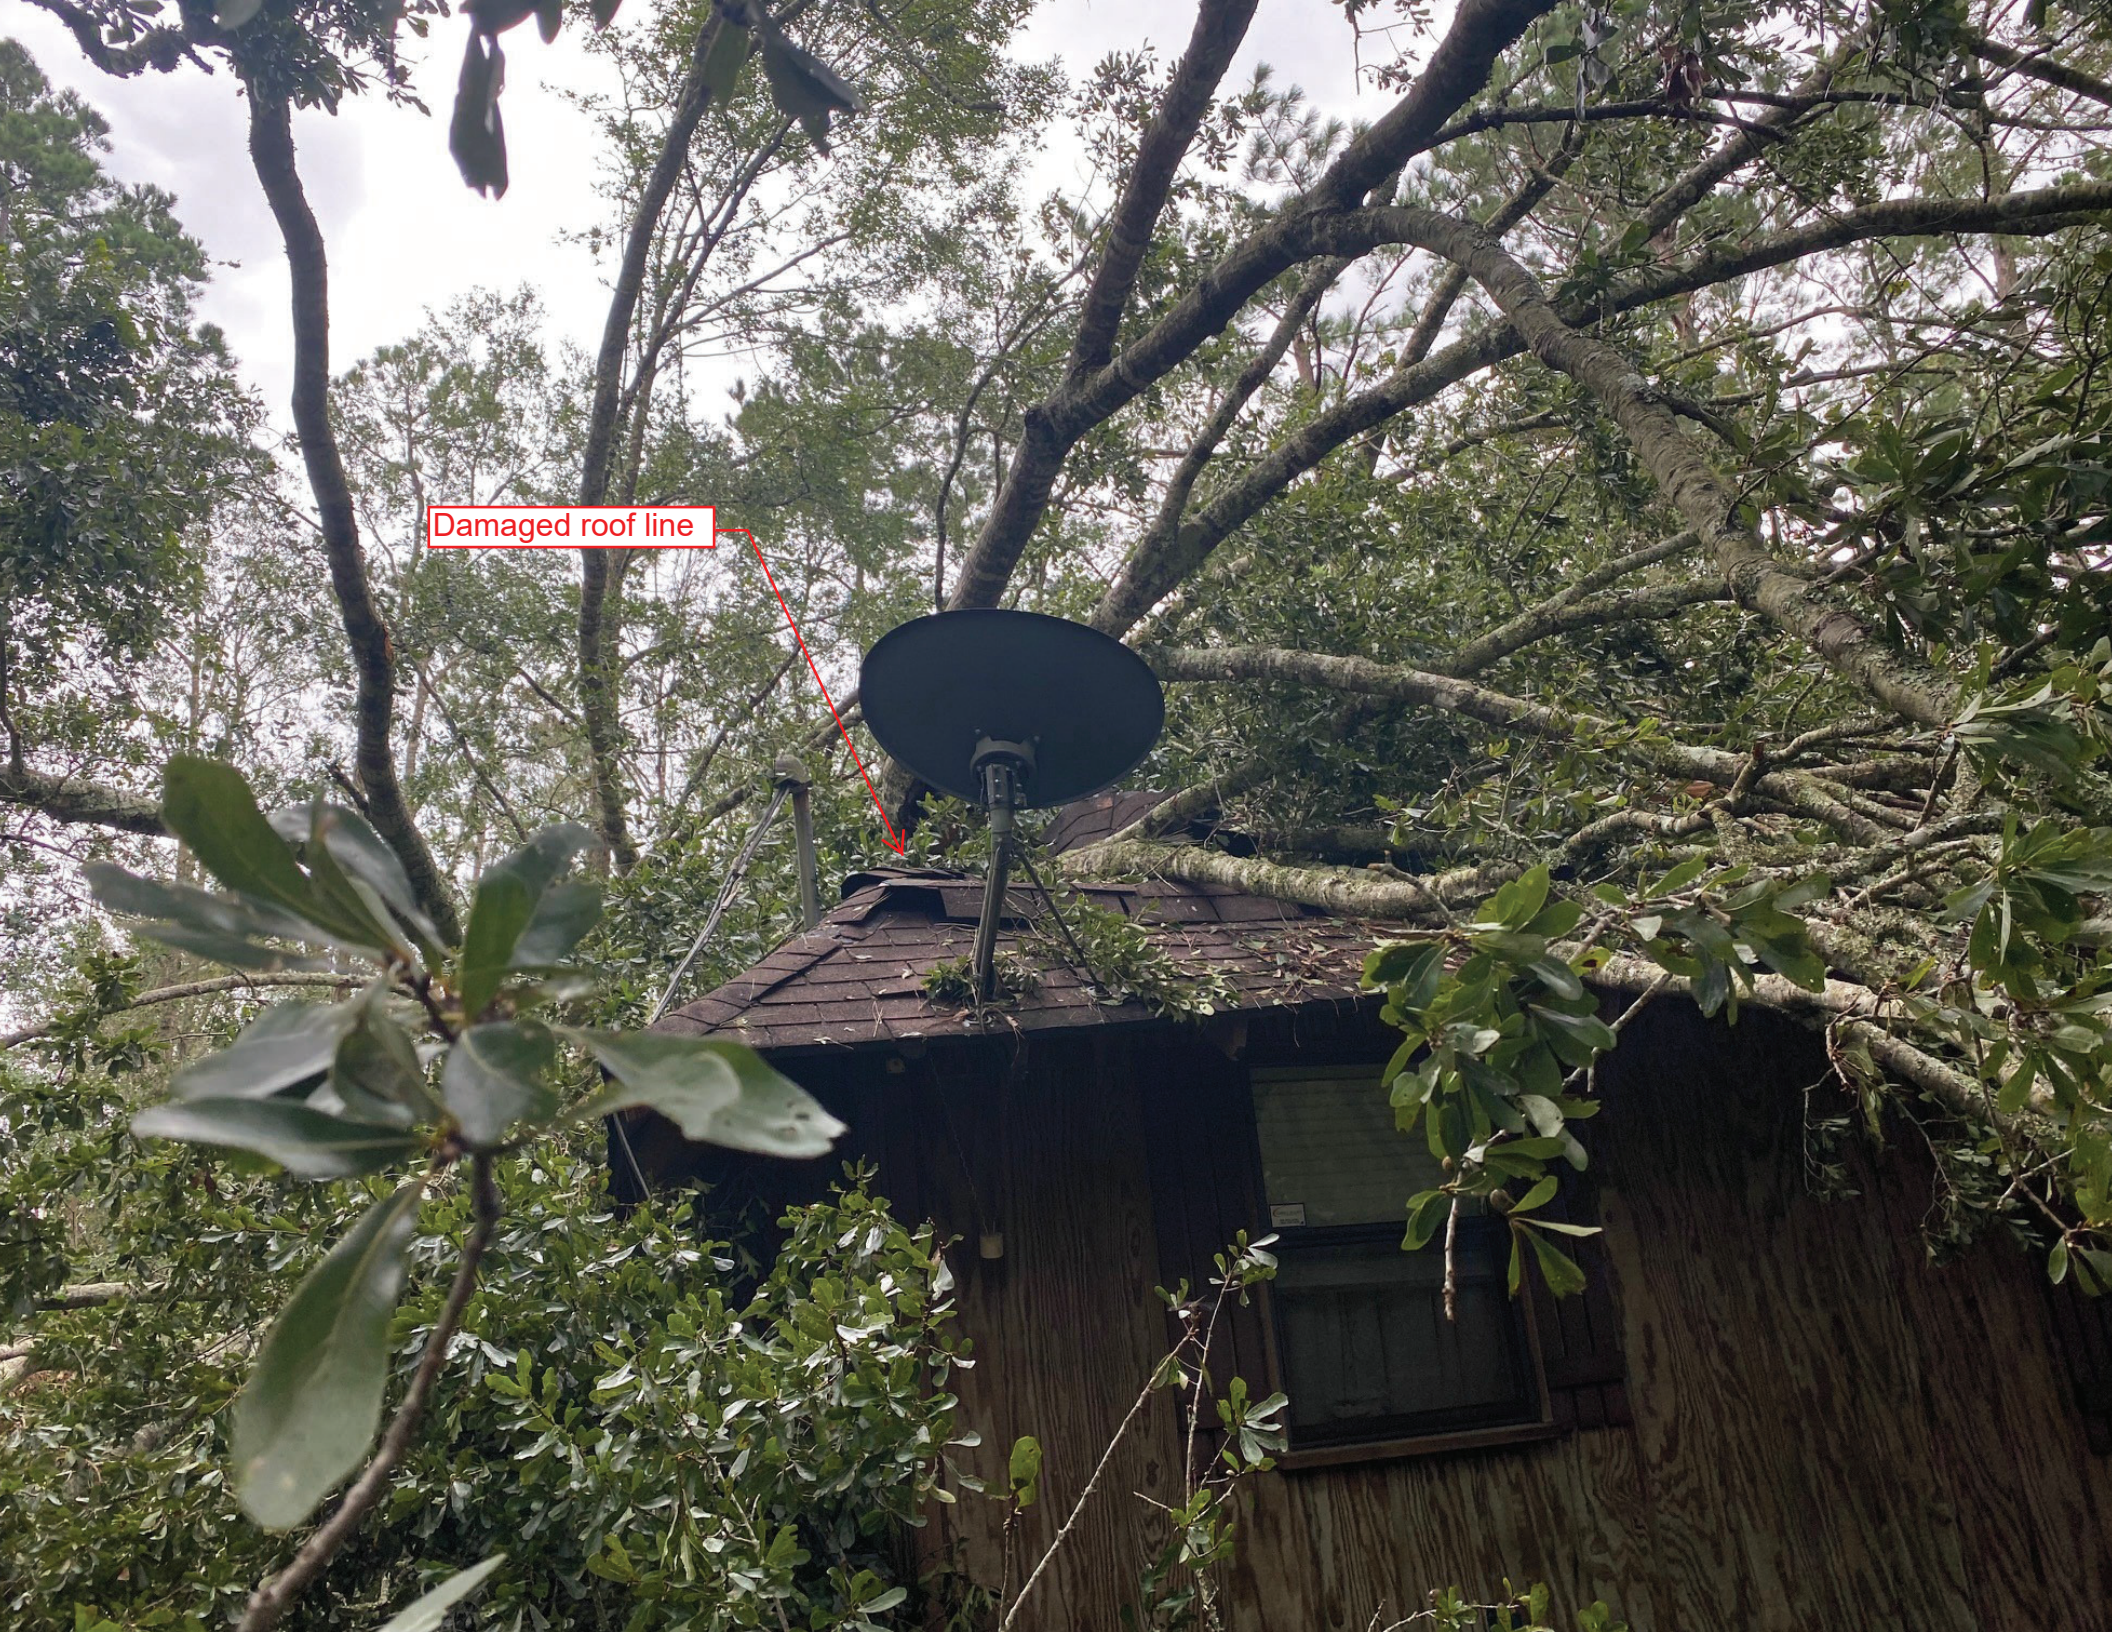
Damaged roof line

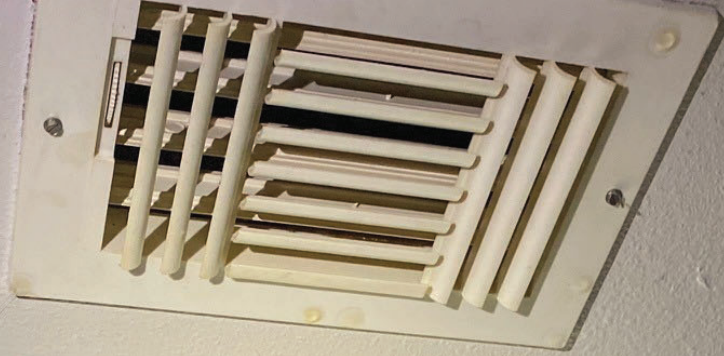
Water stains and mold growth

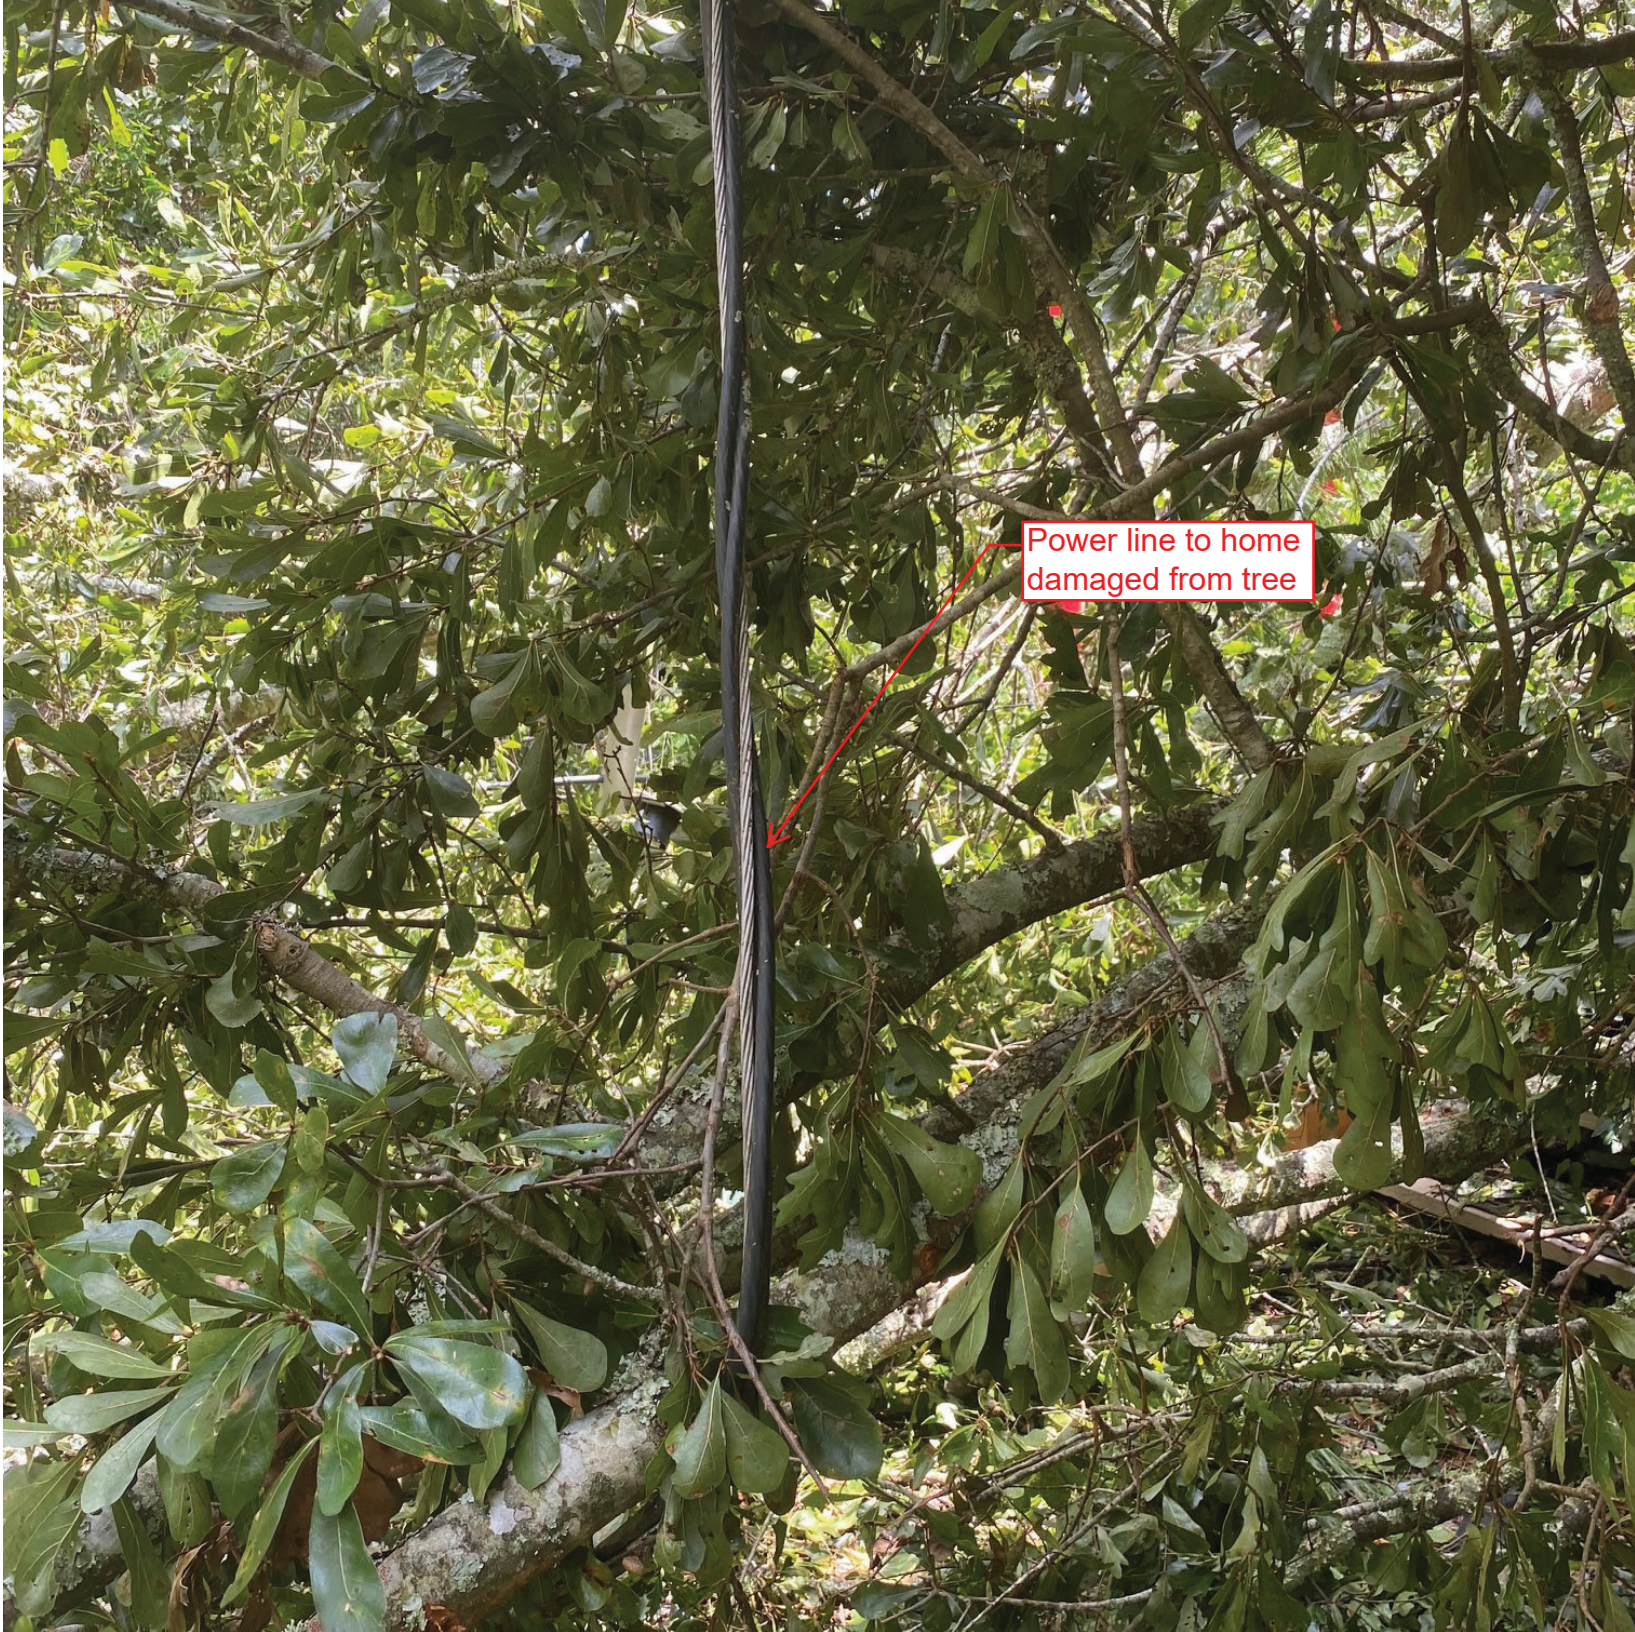
Power line to home
damaged from tree
