Inspection

March 15, 2016

Re: 2274 PetSmart
Fremaux Town Center
Slidell, LA

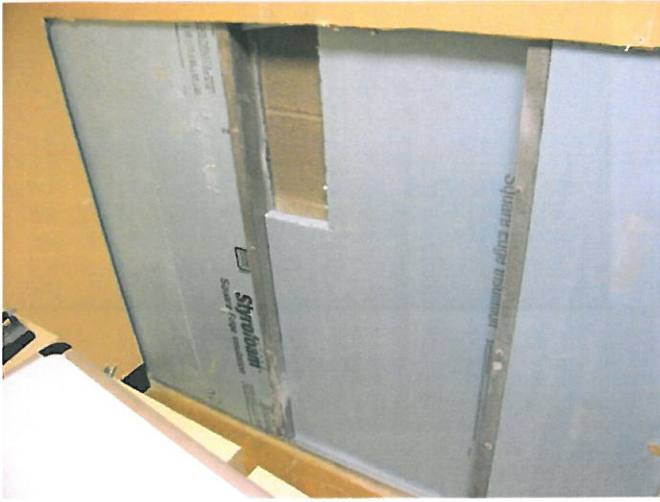
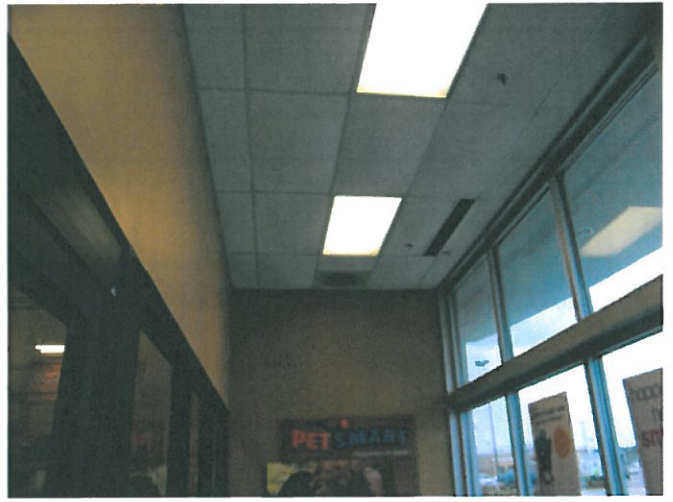
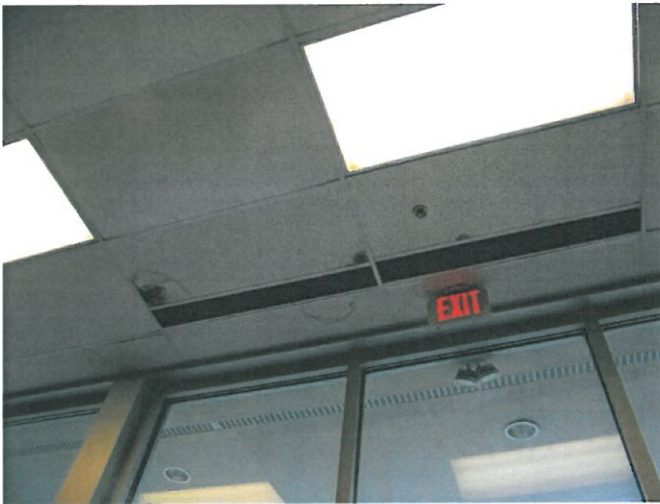
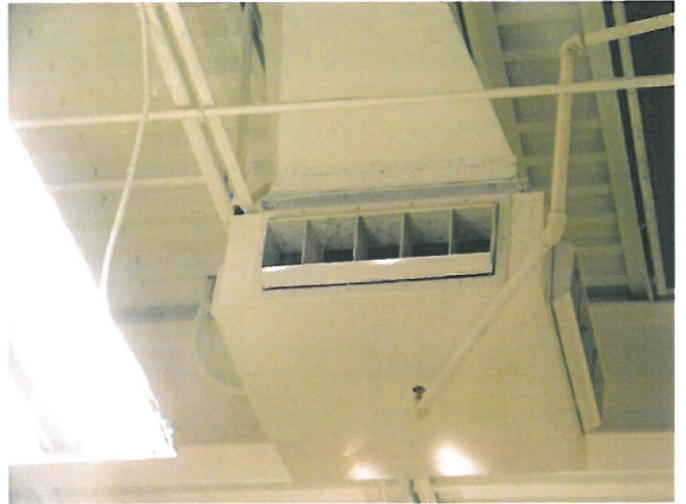
It was noted that a section of sheet rock in the front office wall had been removed due to excessive mold growth. The removal of sheetrock exposed the front block wall and insulation. This area was secured with a plastic wrap screen.

This office has a supply air and return grille in the drop ceiling. The main entrance of the building also has a drop ceiling with supply and return air. The ceiling tiles in this area were noted to have mold growth as well. These areas of concern are noted to have a single 6 ton roof top unit and no Humiditrol sensor, as per the RTU schedule on sheet M1.0.

The Vet/Banfield in the rear of the building was also noted to have mold on the ceiling tiles. No Humiditrol control was called for on the RTU schedule.

After talking with the manager, she stated that all the floors are "sweating." The "sweating" is reportedly present only during the morning time and dries up as the day goes on.

There is no positive air forced into the main entrance area which would help keep the humidity in check. The addition of positive forced air into this area would help to control the humidity levels at the entrance of the store. Furthermore, in this entrance area the ductwork appears to be possibly sweating due to improper insulation coverage on the supply ducts.

In reference to the wall with mold, it appears that cold air from the vent blows directly on the wall in this area; this cooling of the wall can cause sweating much as the floors do when the air units are turned off during the night hours. The combination of direct cold air from the vent and humidity build up in the evening hours is the possible culprit resulting in mould growth. Running the air handlers at night and deflecting the air from the vent away from the wall should alleviate the mold growth.

It would also be wise to install the Humiditrol on all the units since this store is experiencing high levels of humidity.

Once these improvements are complete, all the units should be air-balanced to make sure they are performing at maximum capacity.

It is also recommended that the AHU's be left on over night to help with humidity control.
