Ref: Our File # ANC 11 PON  
3013 Pontchartrain Drive  
Slidell, Louisiana 70458

## **EXECUTIVE SUMMARY**

The property, building, and space are aged but appear in reasonably good condition except for normal wear and tear. The subject unit is unfinished and in need of some minor repairs. Air conditioning, plumbing and electrical systems have been altered or de-activated and are in need of repair.

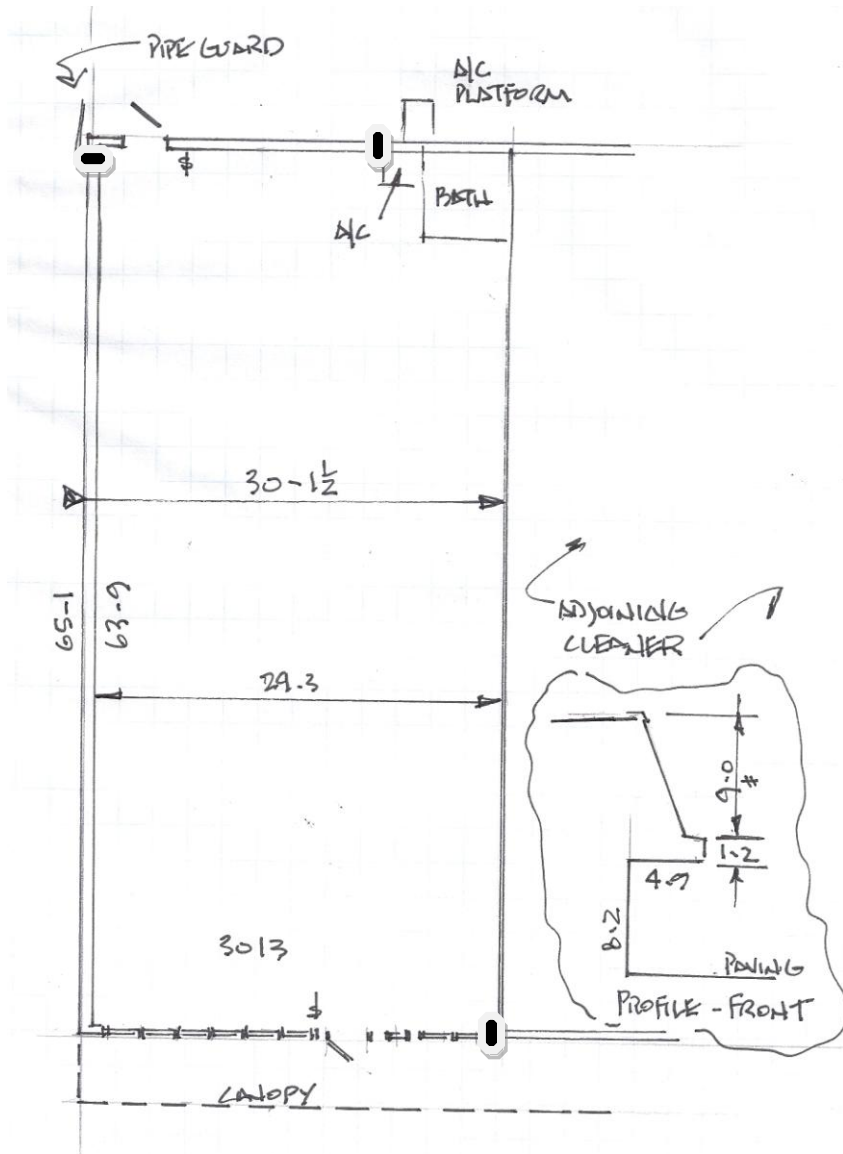
# DIAGRAM

1. There are some areas where coatings are weak and moisture is likely penetrating.
2. There are a few un-sealed openings or pipe/wire penetrations.
3. There are several places at the bottom of masonry, particularly in the front at the paving joints and in the rear at low damage, where the slab elevation is very close to floor level, and in the rear in several locations, where there is moisture and/ insect entry evident. See on diagram (3 locations observed).

1. There is evidence of insect infestations at three locations inside the space (see diagram
