**Re: Property Condition Assessment Report  
Ruby Tuesday  
798 E I-10 Service Road  
Slidell, Louisiana 74061  
Nova Project No.: V18-3955**

# **PROPERTY CONDITION ASSESSMENT REPORT**

**RUBY TUESDAY  
798 E I-10 SERVICE ROAD  
SLIDELL, LOUISIANA 74061**

**REPORT DATE: AUGUST 9, 2018  
NOVA PROJECT NO. V18-3955**

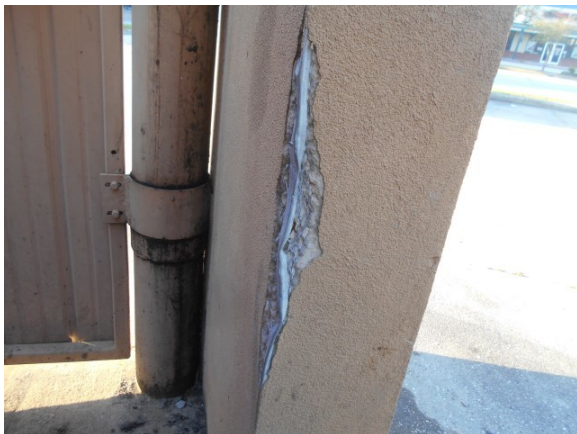
23. Damaged to compactor enclosure

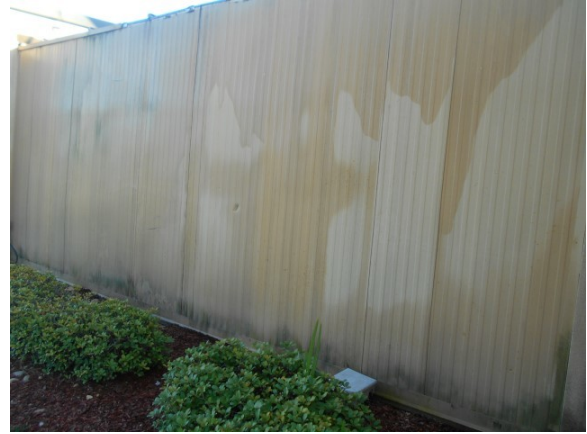
The exterior facades are in good condition. Repainting and re-caulking will be required during the reserve reserve term.

26. Faded paint

COST RECOMMENDATION	EUL	EFF AGE	RUL	YEAR	COST
Exterior Building Painting	10	8	2	2 12	\$3,640 \$3,640
Total					\$7,280

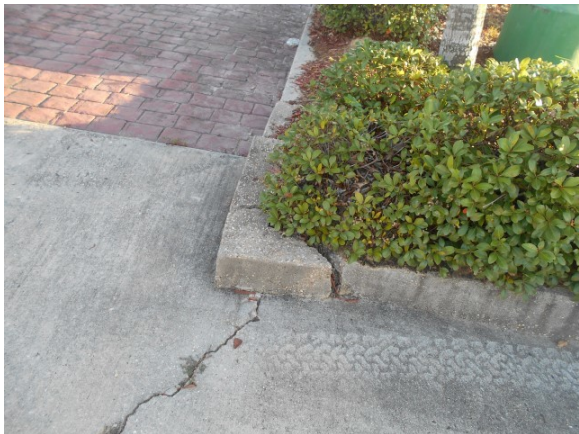
The concrete pavement is in generally good condition, but has localized areas of potholing and linear cracks. In order to prevent further deterioration, and to mitigate tripping hazards, these areas should be repaired as an immediate need.

27. Cracked curbing and concrete

COST RECOMMENDATION	EUL	EFF AGE	RUL	YEAR	COST
Concrete Pavement patching (6)	40	11	29	2	\$4,000
				7	\$4,000
				12	\$4,000
Parking Striping and Markings	5	3	2	2	\$696
				7	\$696
				12	\$696
Total					\$14,088

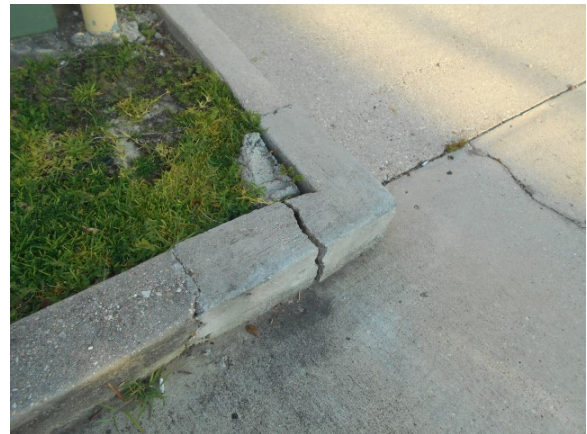
28. Cracked curbing

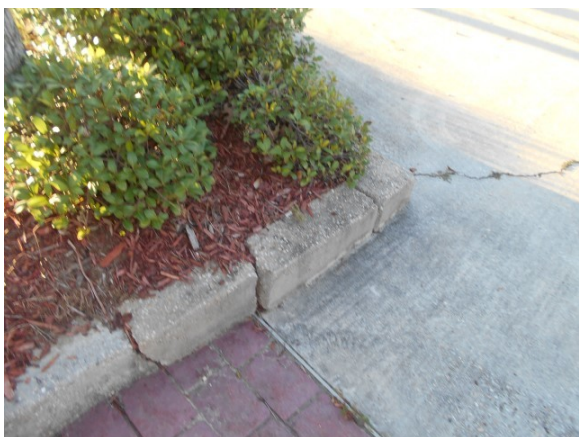
29. Cracked curbing and concrete

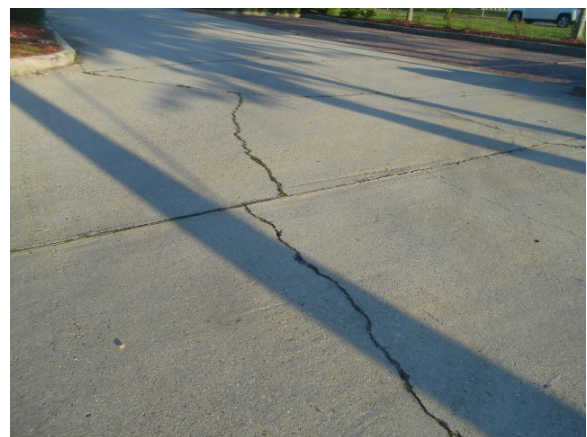
30. Cracked concrete paving

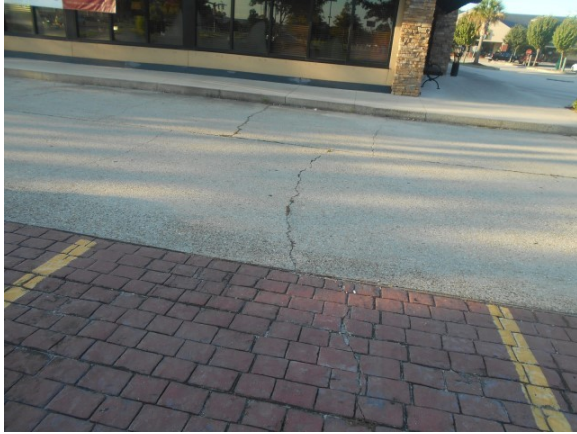
31. Cracked concrete

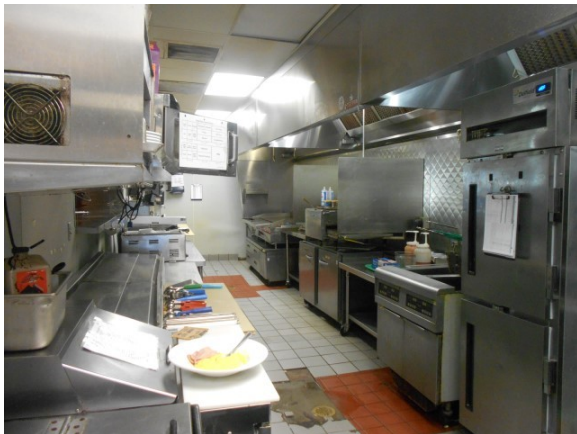
33. Missing floor tiles in kitchen

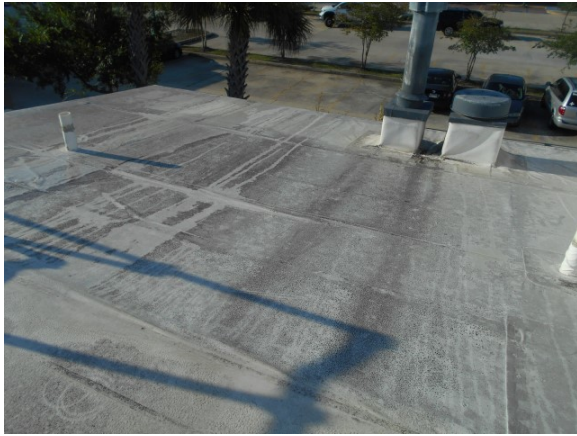
No deficiencies were observed or reported. The components can be maintained under routine maintenance as part of the normal operating program during the reserve term; however, it is expected that the main roof covering will need to be replaced during the reserve term due to its age and observed condition.

49. BUR modified bitumen roof with flood coat

COST RECOMMENDATION	EUL	EFF AGE	RUL	YEAR	COST
Roofing Modified Bitumen with seal coat	20	11	9	9	\$23,850
Total					\$23,850

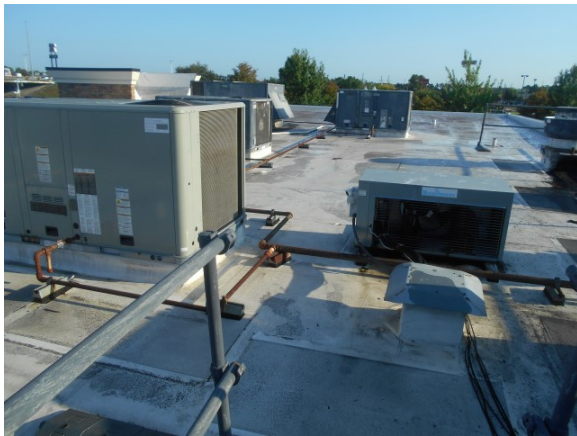
The package units are in overall good to fair condition, relative to their individual age. Cycle replacement are anticipated during the reserve term.

51. Rooftop gas-fired packaged HVAC units

COST RECOMMENDATION	EUL	EFF AGE	RUL	YEAR	COST
RTU Single-Zone Elect. Cool Only (7.5 Ton)	15	11	4	4	\$10,000
				5	\$10,000
				6	\$10,000
Total					\$30,000
