This report is prepared exclusively for **Richard Moody**  
Inspected On: **05-06-2025**

107 Technologies

Older raised home that is well maintained on the inside but very poorly kept on the exterior. Lot of items will need attention for general repairs and safety.

Jason Koonce, Louisiana State License  
#LHI #11404

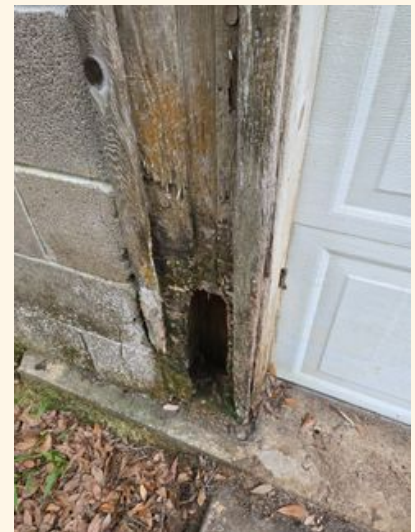
**(G-4) Repair:** Conditions conducive to wood destroying organisms were noted around the site. The organic way to reduce risks from wood destroying organisms is to eliminate conducive conditions around the property.

- Remove old rotted wood retaining wall material
- Eliminate siding to soils contact
- Eliminate wood to soils contact

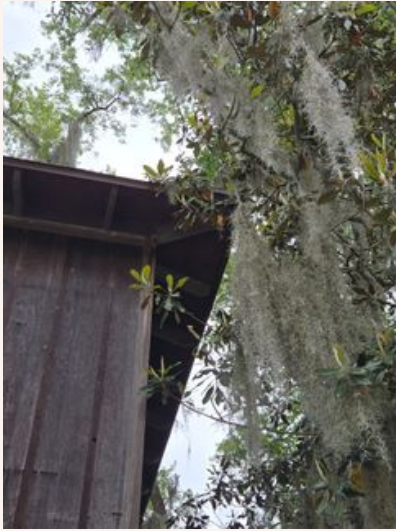
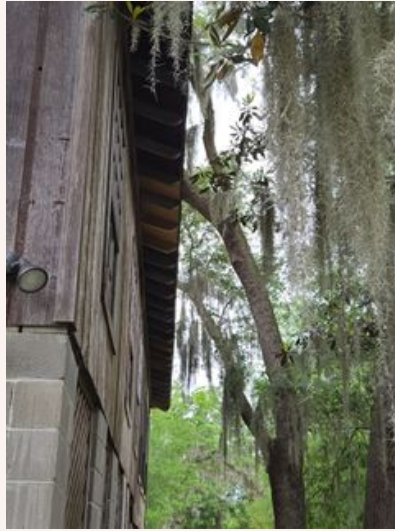
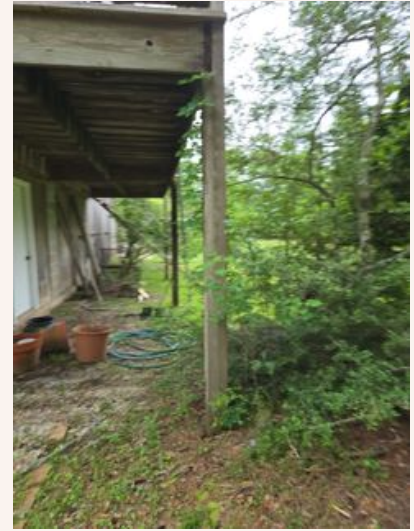
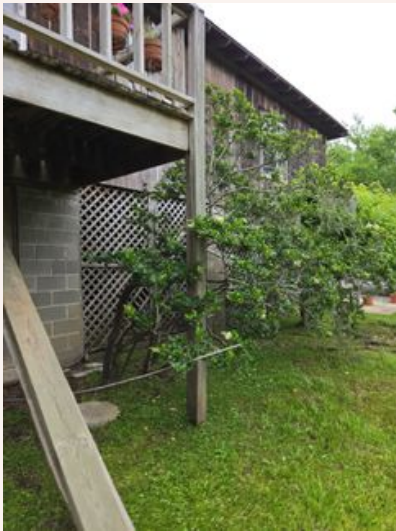
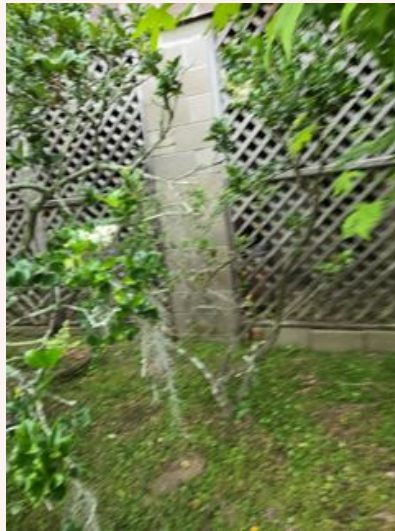
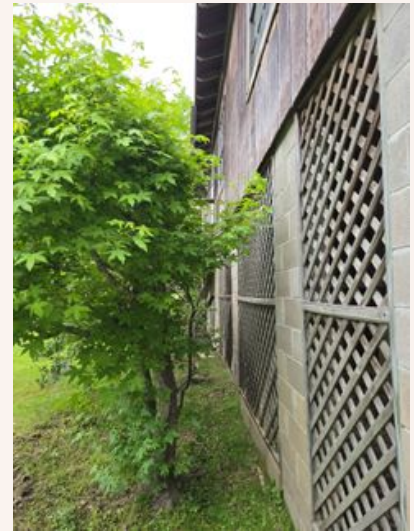
**(G-2) Recommended Maintenance:** Prune tree limbs and vegetation away from the building. This will help to protect the building from wood destroying organisms and other pests and rodents.

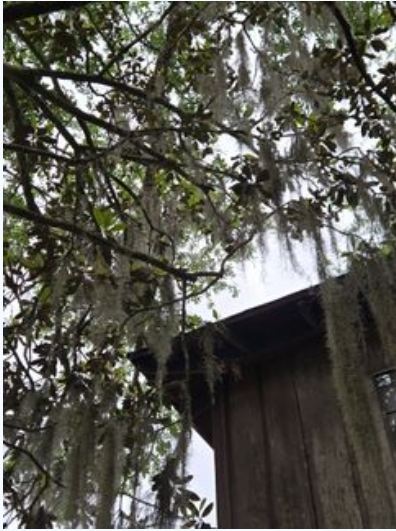
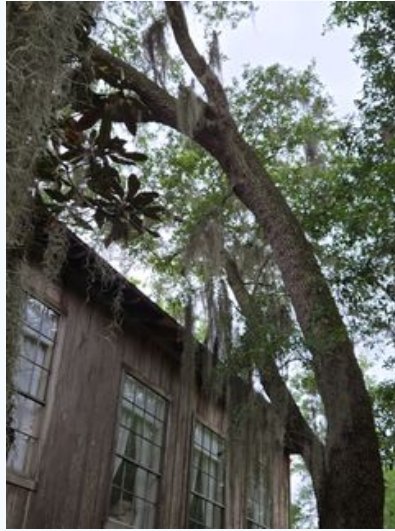
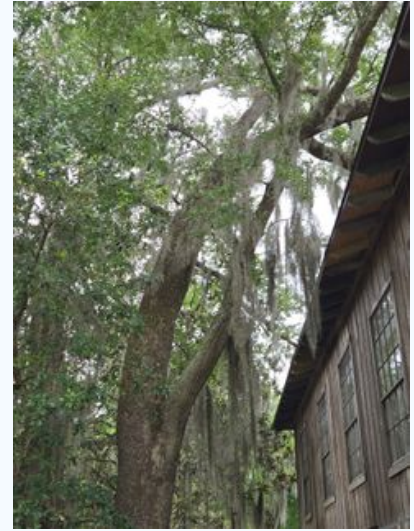
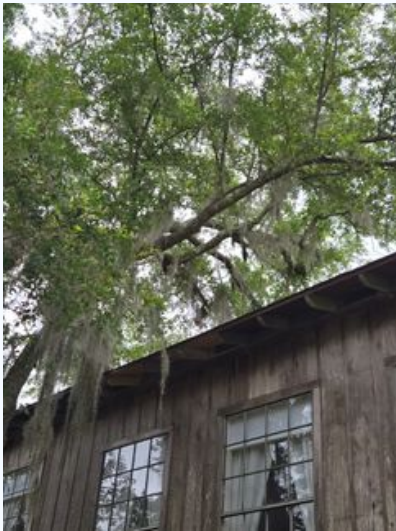
🔍 **(G-3) Due Diligence:** Large trees were noted near the building and on this site. To reduce risks from tree and limb-falls an arborist is recommended to evaluate the trees and prune or remove as needed.

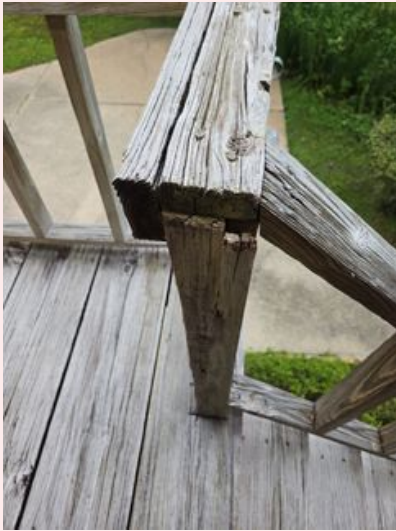
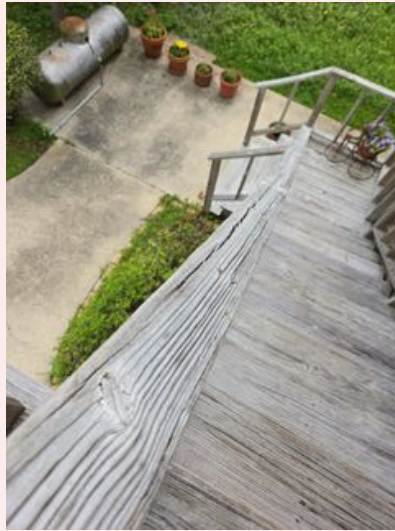
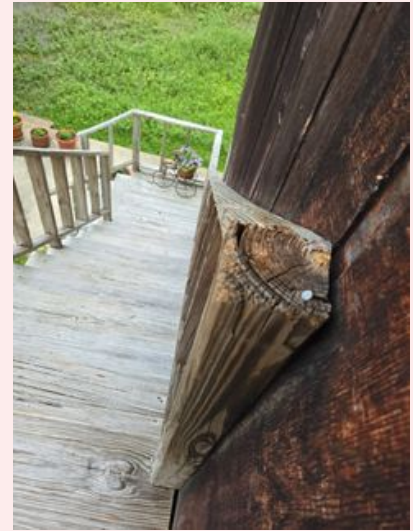
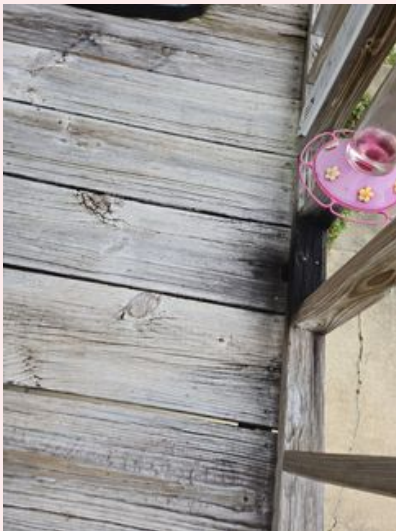
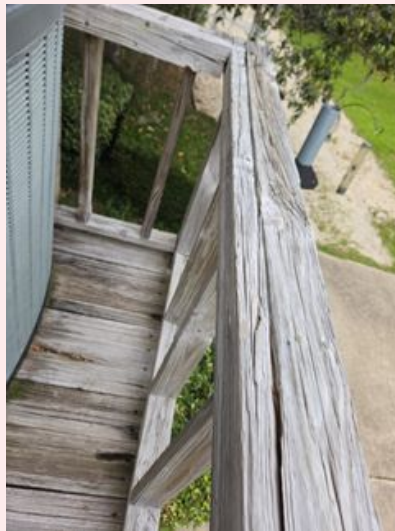
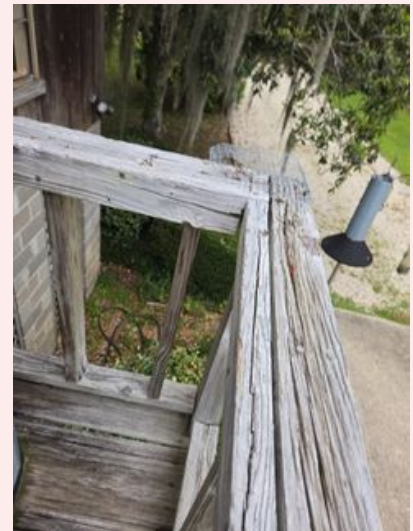
- Nailed, no lag bolts used
- Rotting/Splitting wood
- Wood to concrete/ground contact
- Wood to siding contact noted
- Separation from home
- Loose railing

Recommend a qualified contractor repair or replace as necessary.

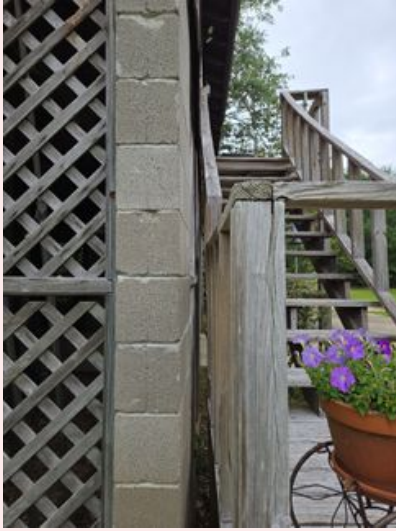
*(This video is only viewable online.)  
Railing is very loose and poses a safety risk.*

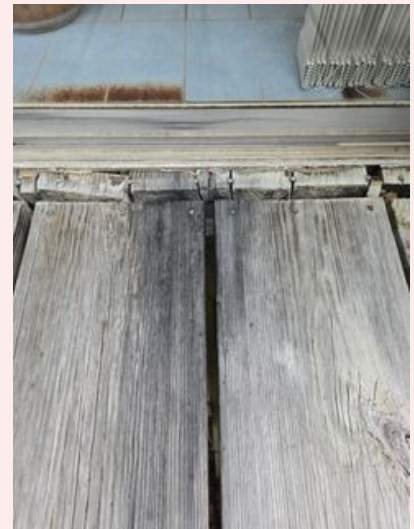
*Some boards are loose particularly in the middle where they have already pulled the nails free from the joist underneath*

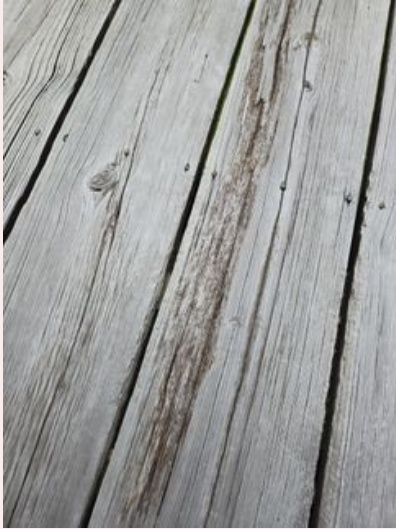
*Additional decay noted under the flower pots and hummingbird Peter were additional moisture is added to the horizontal surfaces*

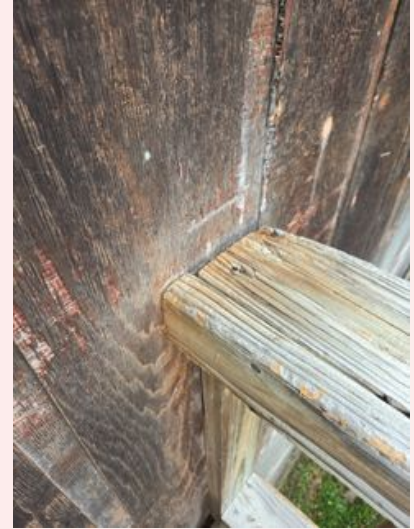
*Wood rot and excessive material loss at end of board near joist*

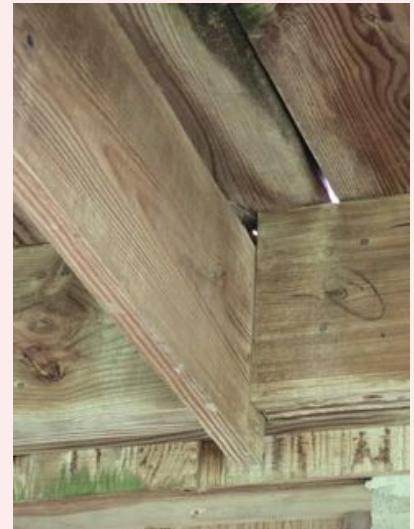
**⚠ (G-9) Major Concern:** Back patio structural support is minimal and failing. The one center joist is separated from the remainder of the framing, which is part of the loose board from the top of the deck. Additionally, the deck was attached via nails, not lag bolts. No clips/ties noted. A common, but not recommended practice.

Recommend replacing the deck by a qualified contractor for safety.

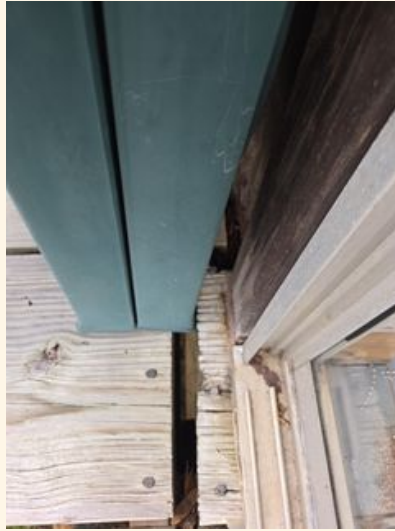
🔧 **(G-8) Repair:** The patio has been installed in contact with the siding. This can lead to wood decay and moisture control problems. Repair as needed to eliminate contact and repair any water damage if necessary.

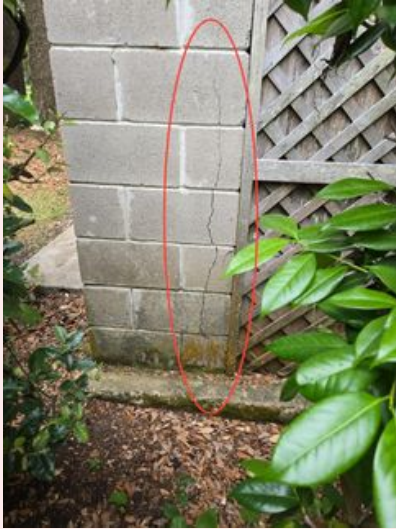
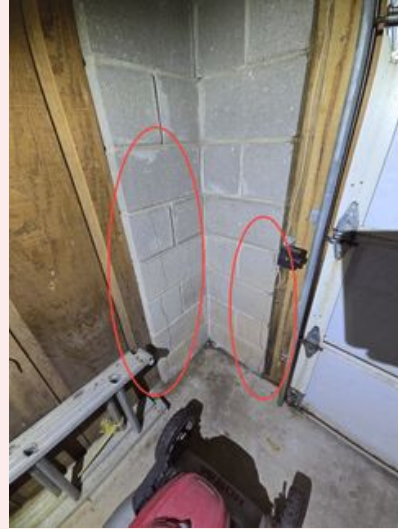
⚠️ **(E-1) Major Concern:** Visible cracks were noted in the foundation as viewed from the exterior and interior. Recommend a structural engineer further evaluate and repair or replace as necessary.

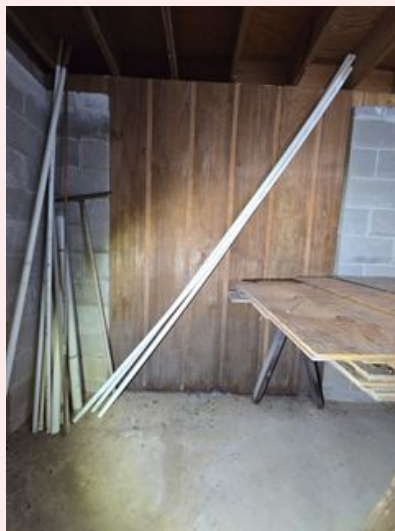
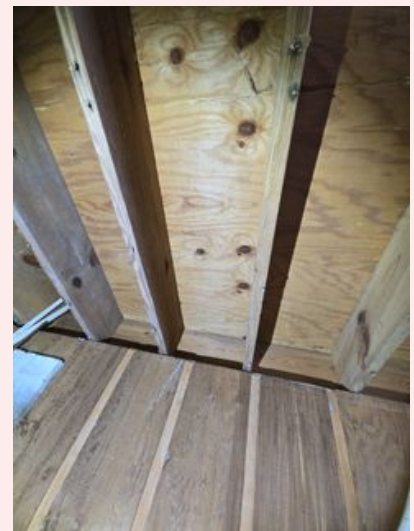
**⚠️ (G1-1) Major Concern:** Wood to concrete/ground contact. This is conducive to both wood rot and wood destroying insects. Recommend a qualified contractor repair or replace as necessary.

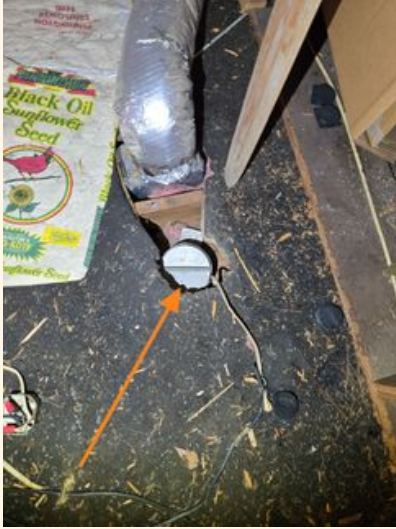
✂️ **(A-6) Repair:** Kitchen/bath fan exhaust vents in the attic are not correctly vented to the exterior. Repair is needed for moisture control.

*Unknown vent purpose.  
The floor in this area appears to  
be old roof structure. This is  
likely an old vent that is no  
longer in use. Unable to  
determine at time of inspection.*

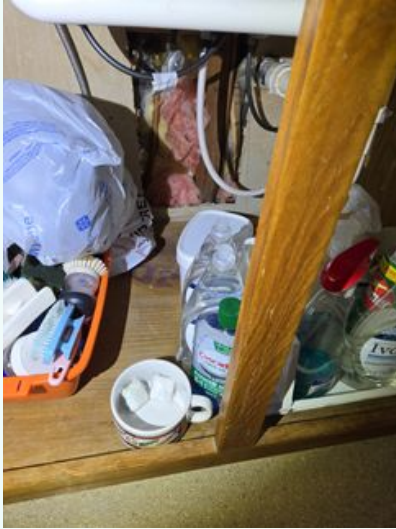
*Previous moisture damage noted. This can lead to microbial growth underneath however does not appear to be an active leak. Recommend monitor and repair or replace as necessary by qualified contractor.*

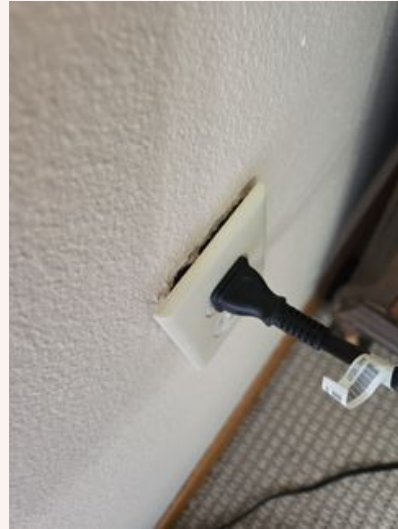
**(CR-7) Recommended Maintenance:** Repairs are needed to the electric receptacles.

- Loose receptacle(s)

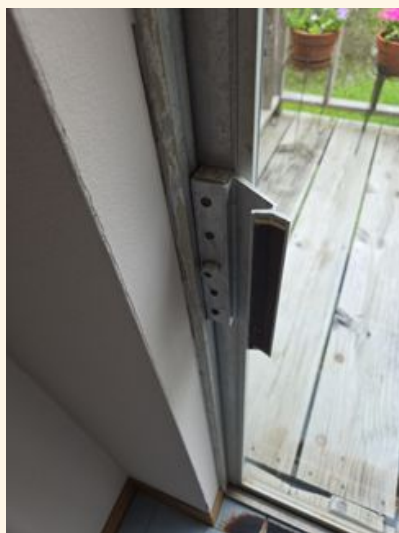
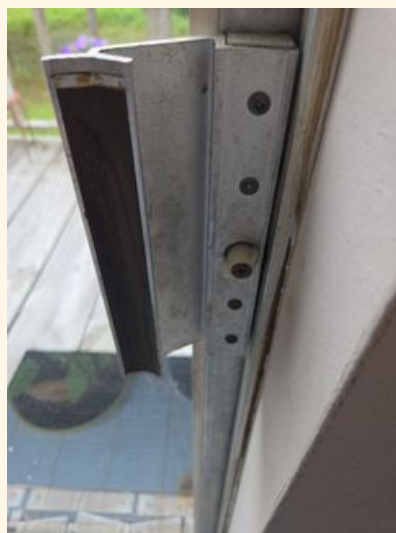
**(CR-8) Repair:** Repairs are needed to the door(s).

- Broken/missing hardware was noted

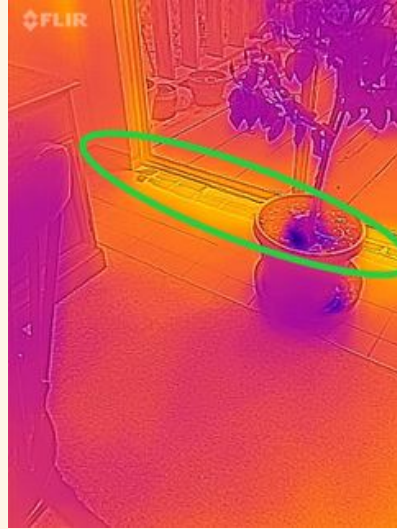
**(CR-9) Repair:** Repairs are needed to the floor transition to the sliding glass doors this part is linoleum that has appeared to be burnt and crumbling in spots.

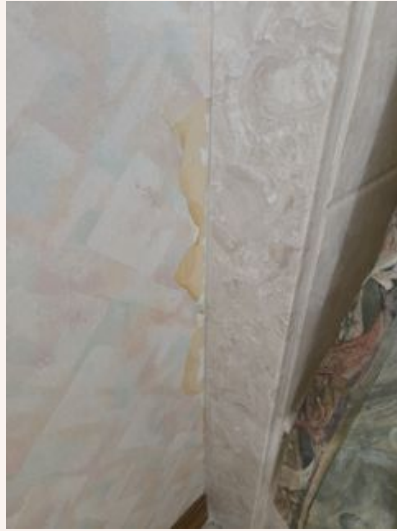
**(B-2) Recommended Maintenance:** High humidity area has the wallpaper beginning to peel at the seams. Recommend repair or replace as necessary by qualified professional.

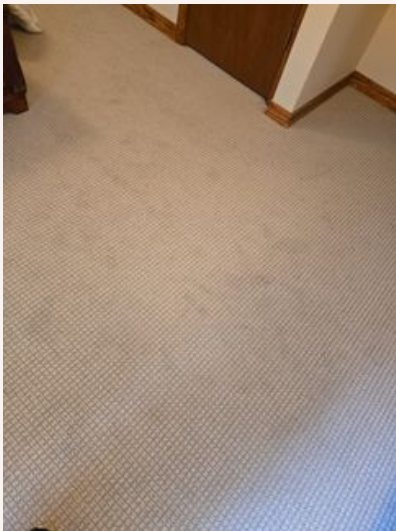
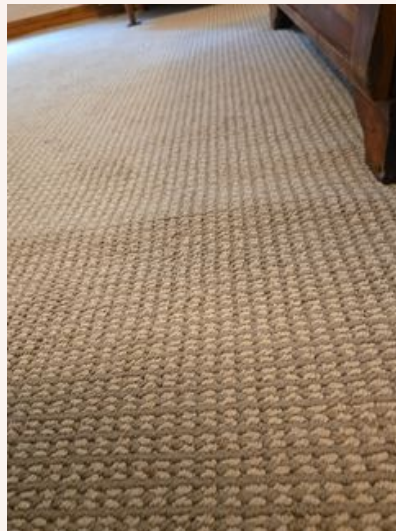
**(B1-2) Recommended Maintenance:** Carpet has minor staining and is starting to loosen in some areas.

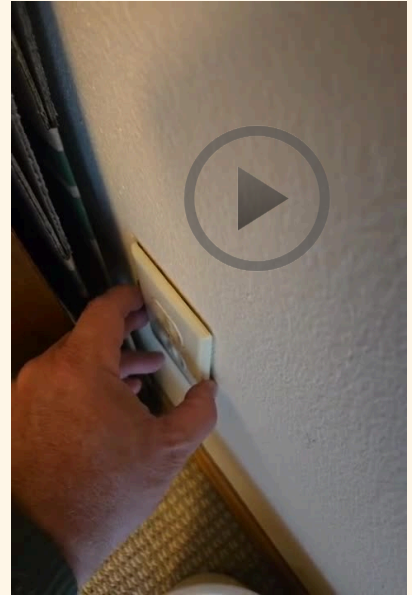
Repairs are needed to the electric receptacles.

- Loose receptacle(s)

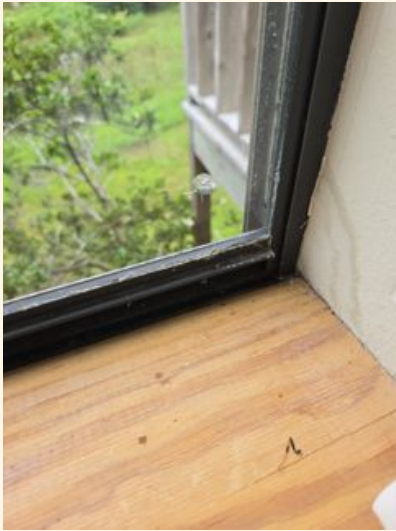
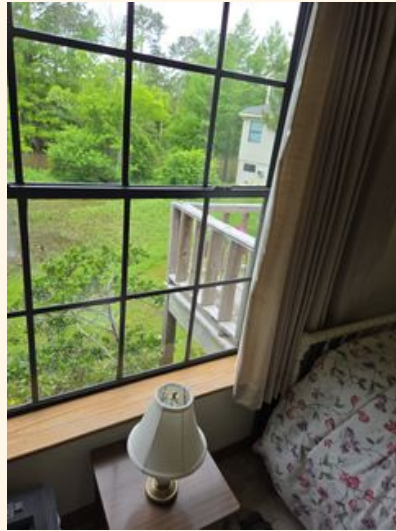
**(B2-3) Repair:** Repairs are needed to the window(s).
- Cracked glass

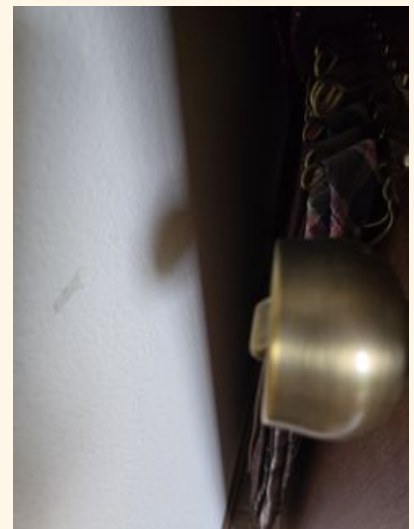
Repairs are needed to walls and/or ceilings.

- Damaged areas

*Cool and drywall from door knob lock*

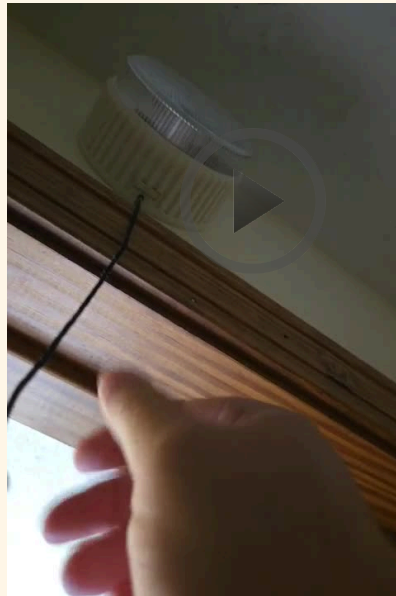
**(B3-3) Repair:** Closet light receptacle is missing and temporary is also non-operational  
recommend repair replace it as necessary by qualified contractor

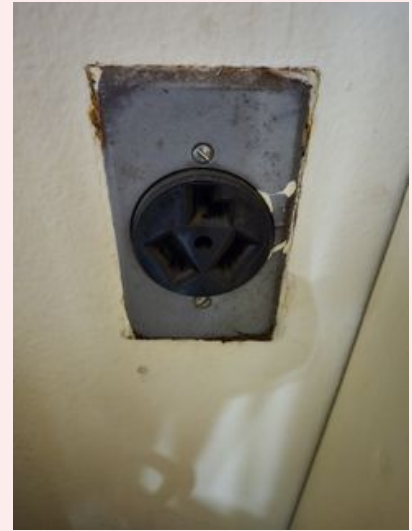
Repairs are needed to the electric receptacles.

3 prong receptacle noted for the dryer. For safety purposes recommend a 4 prong receptacle. A four-prong receptacles considered modern standards for grounding and fire hazard safety. Recommend replace on a qualified contractor as soon as practical.

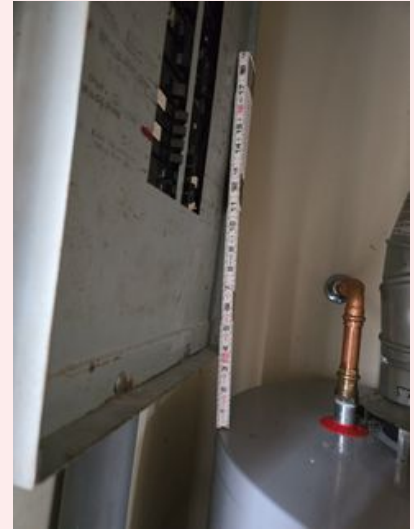
**⚠ (ESE-1) Major Concern:** The electric panel was located in The same closet as the water heater not providing adequate clearance. Recommend further evaluation by qualify the electrician and repair, replace or relocate as necessary.

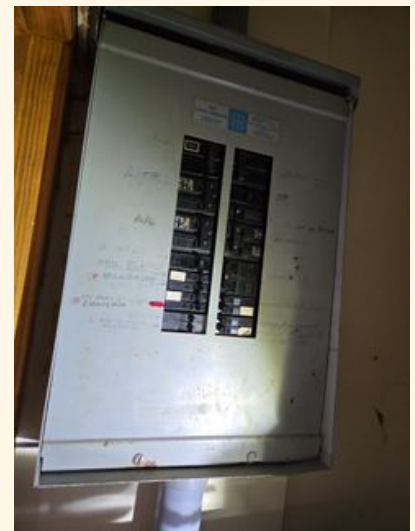
**🔧 (ESE-3) Repair:**

There is no main breaker on this panel. Recommend a qualified electrician further evaluate and repair or replace as necessary.
