## Structural Inspection

March 3, 2026

Kirk Hartsell  
1224 Maris Stella St.  
Slidell, La. 70460

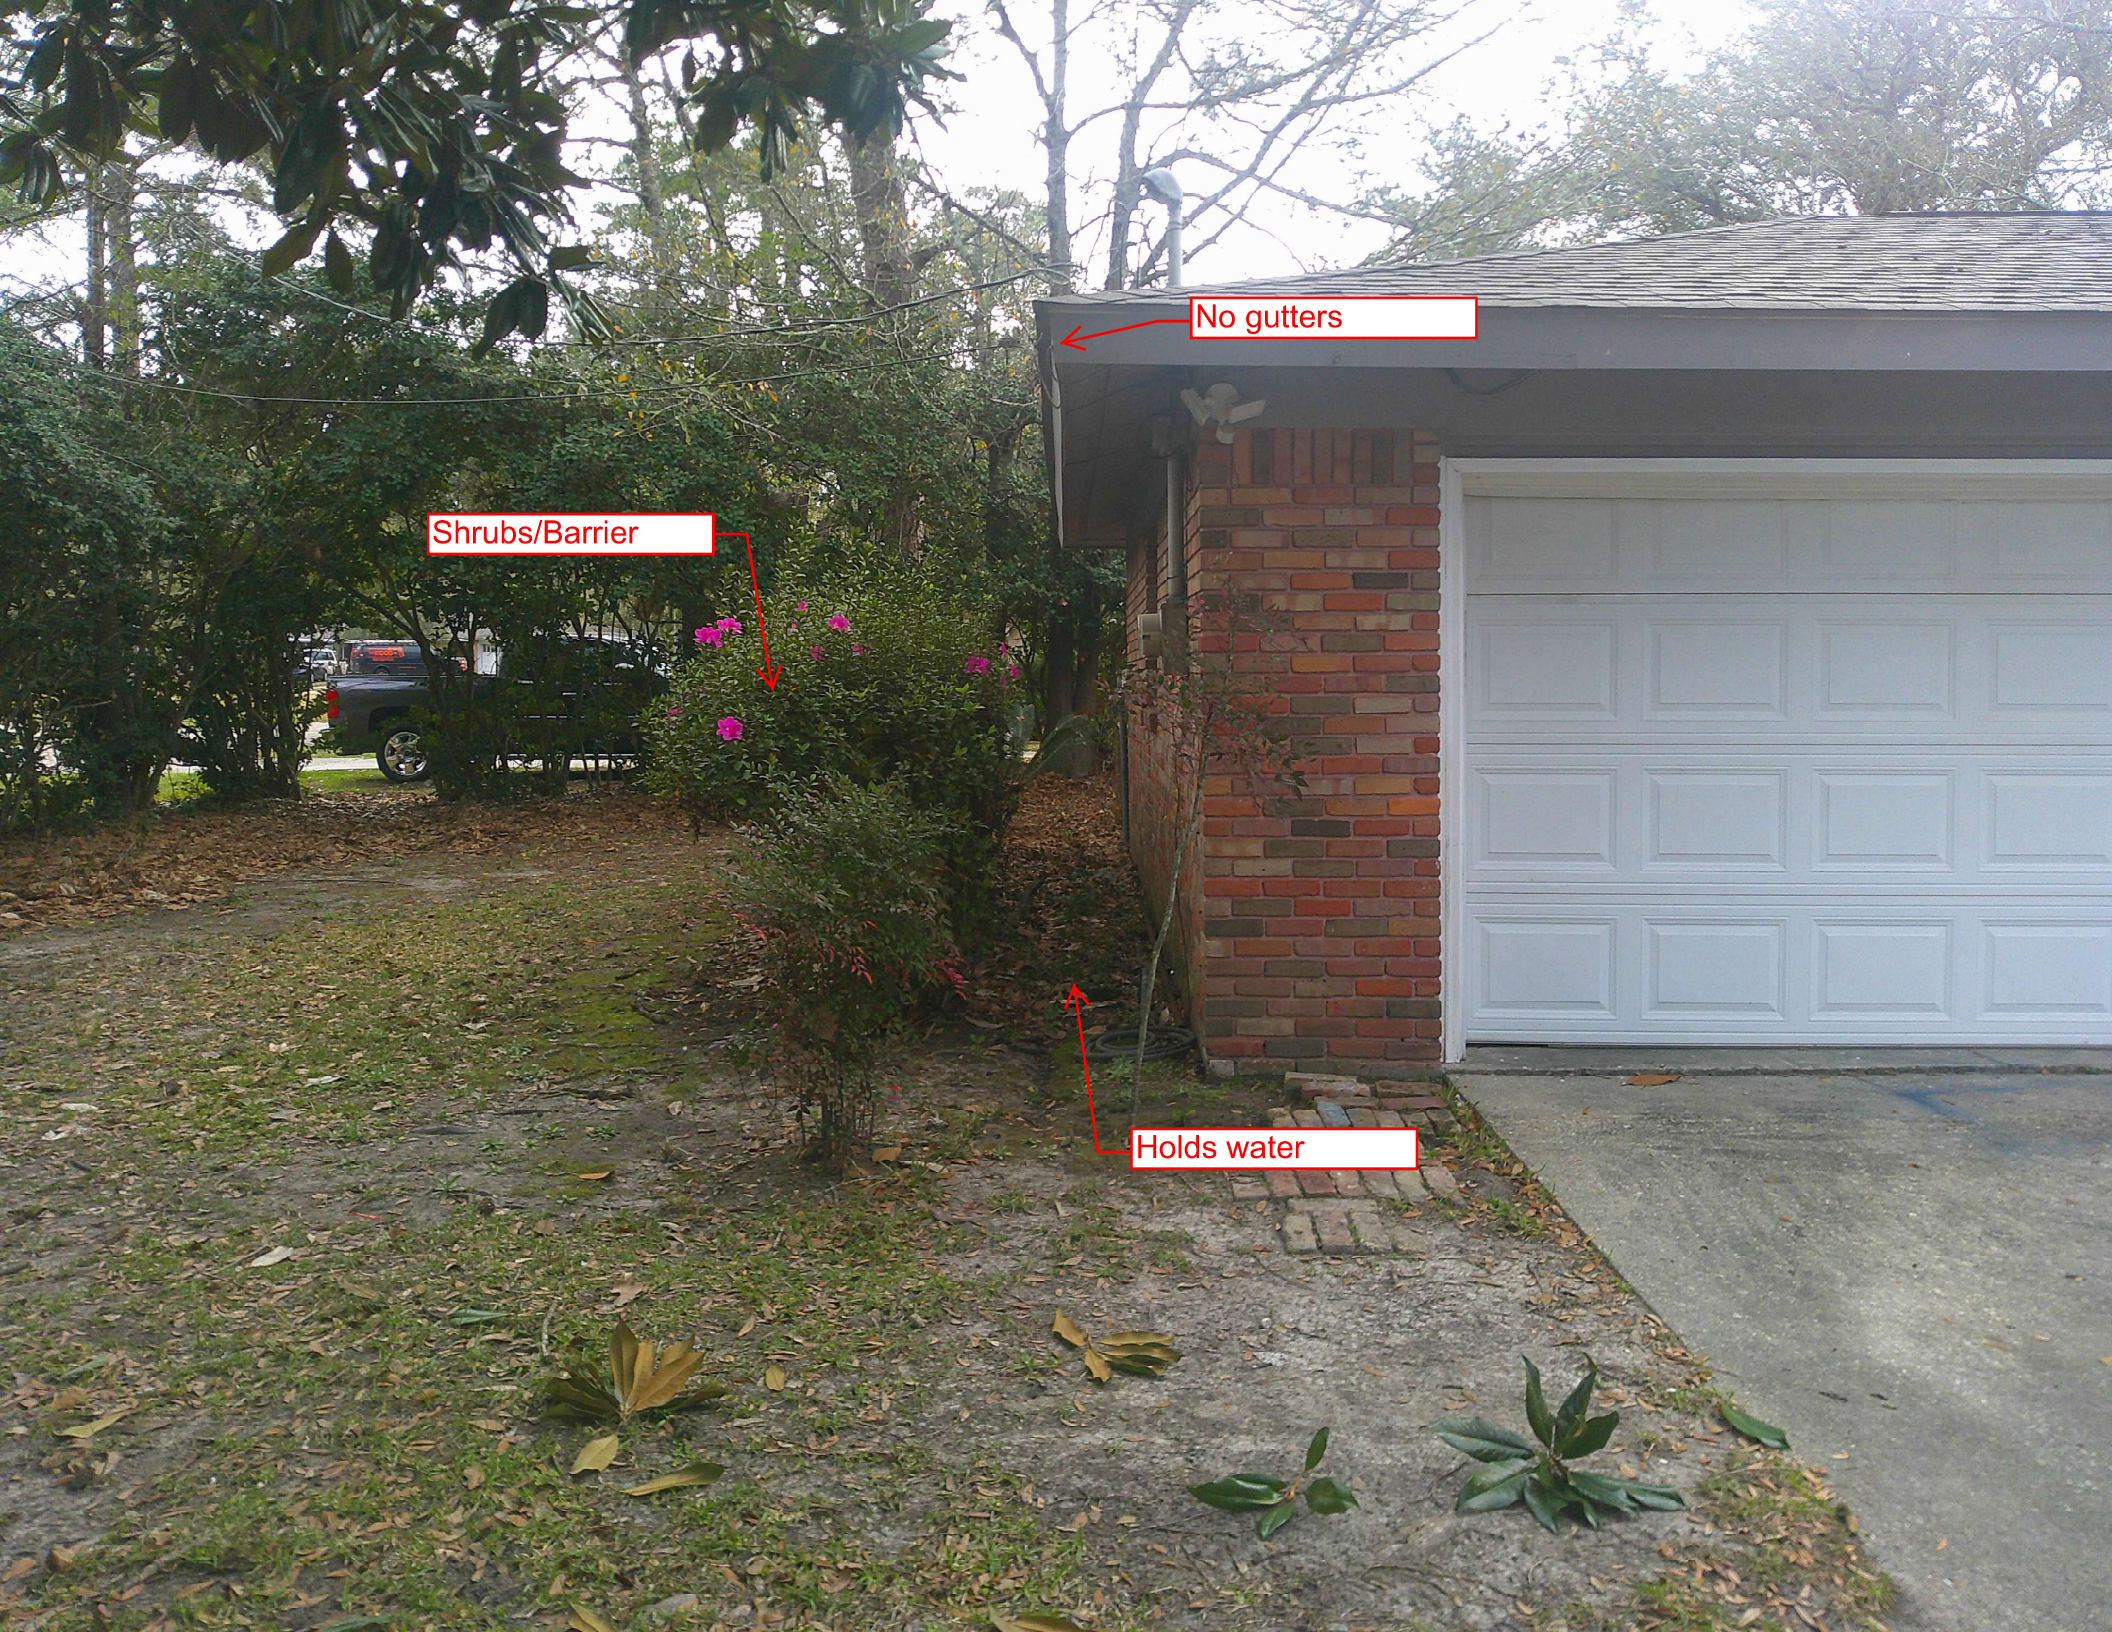
No gutters

Shrubs/Barrier

Holds water

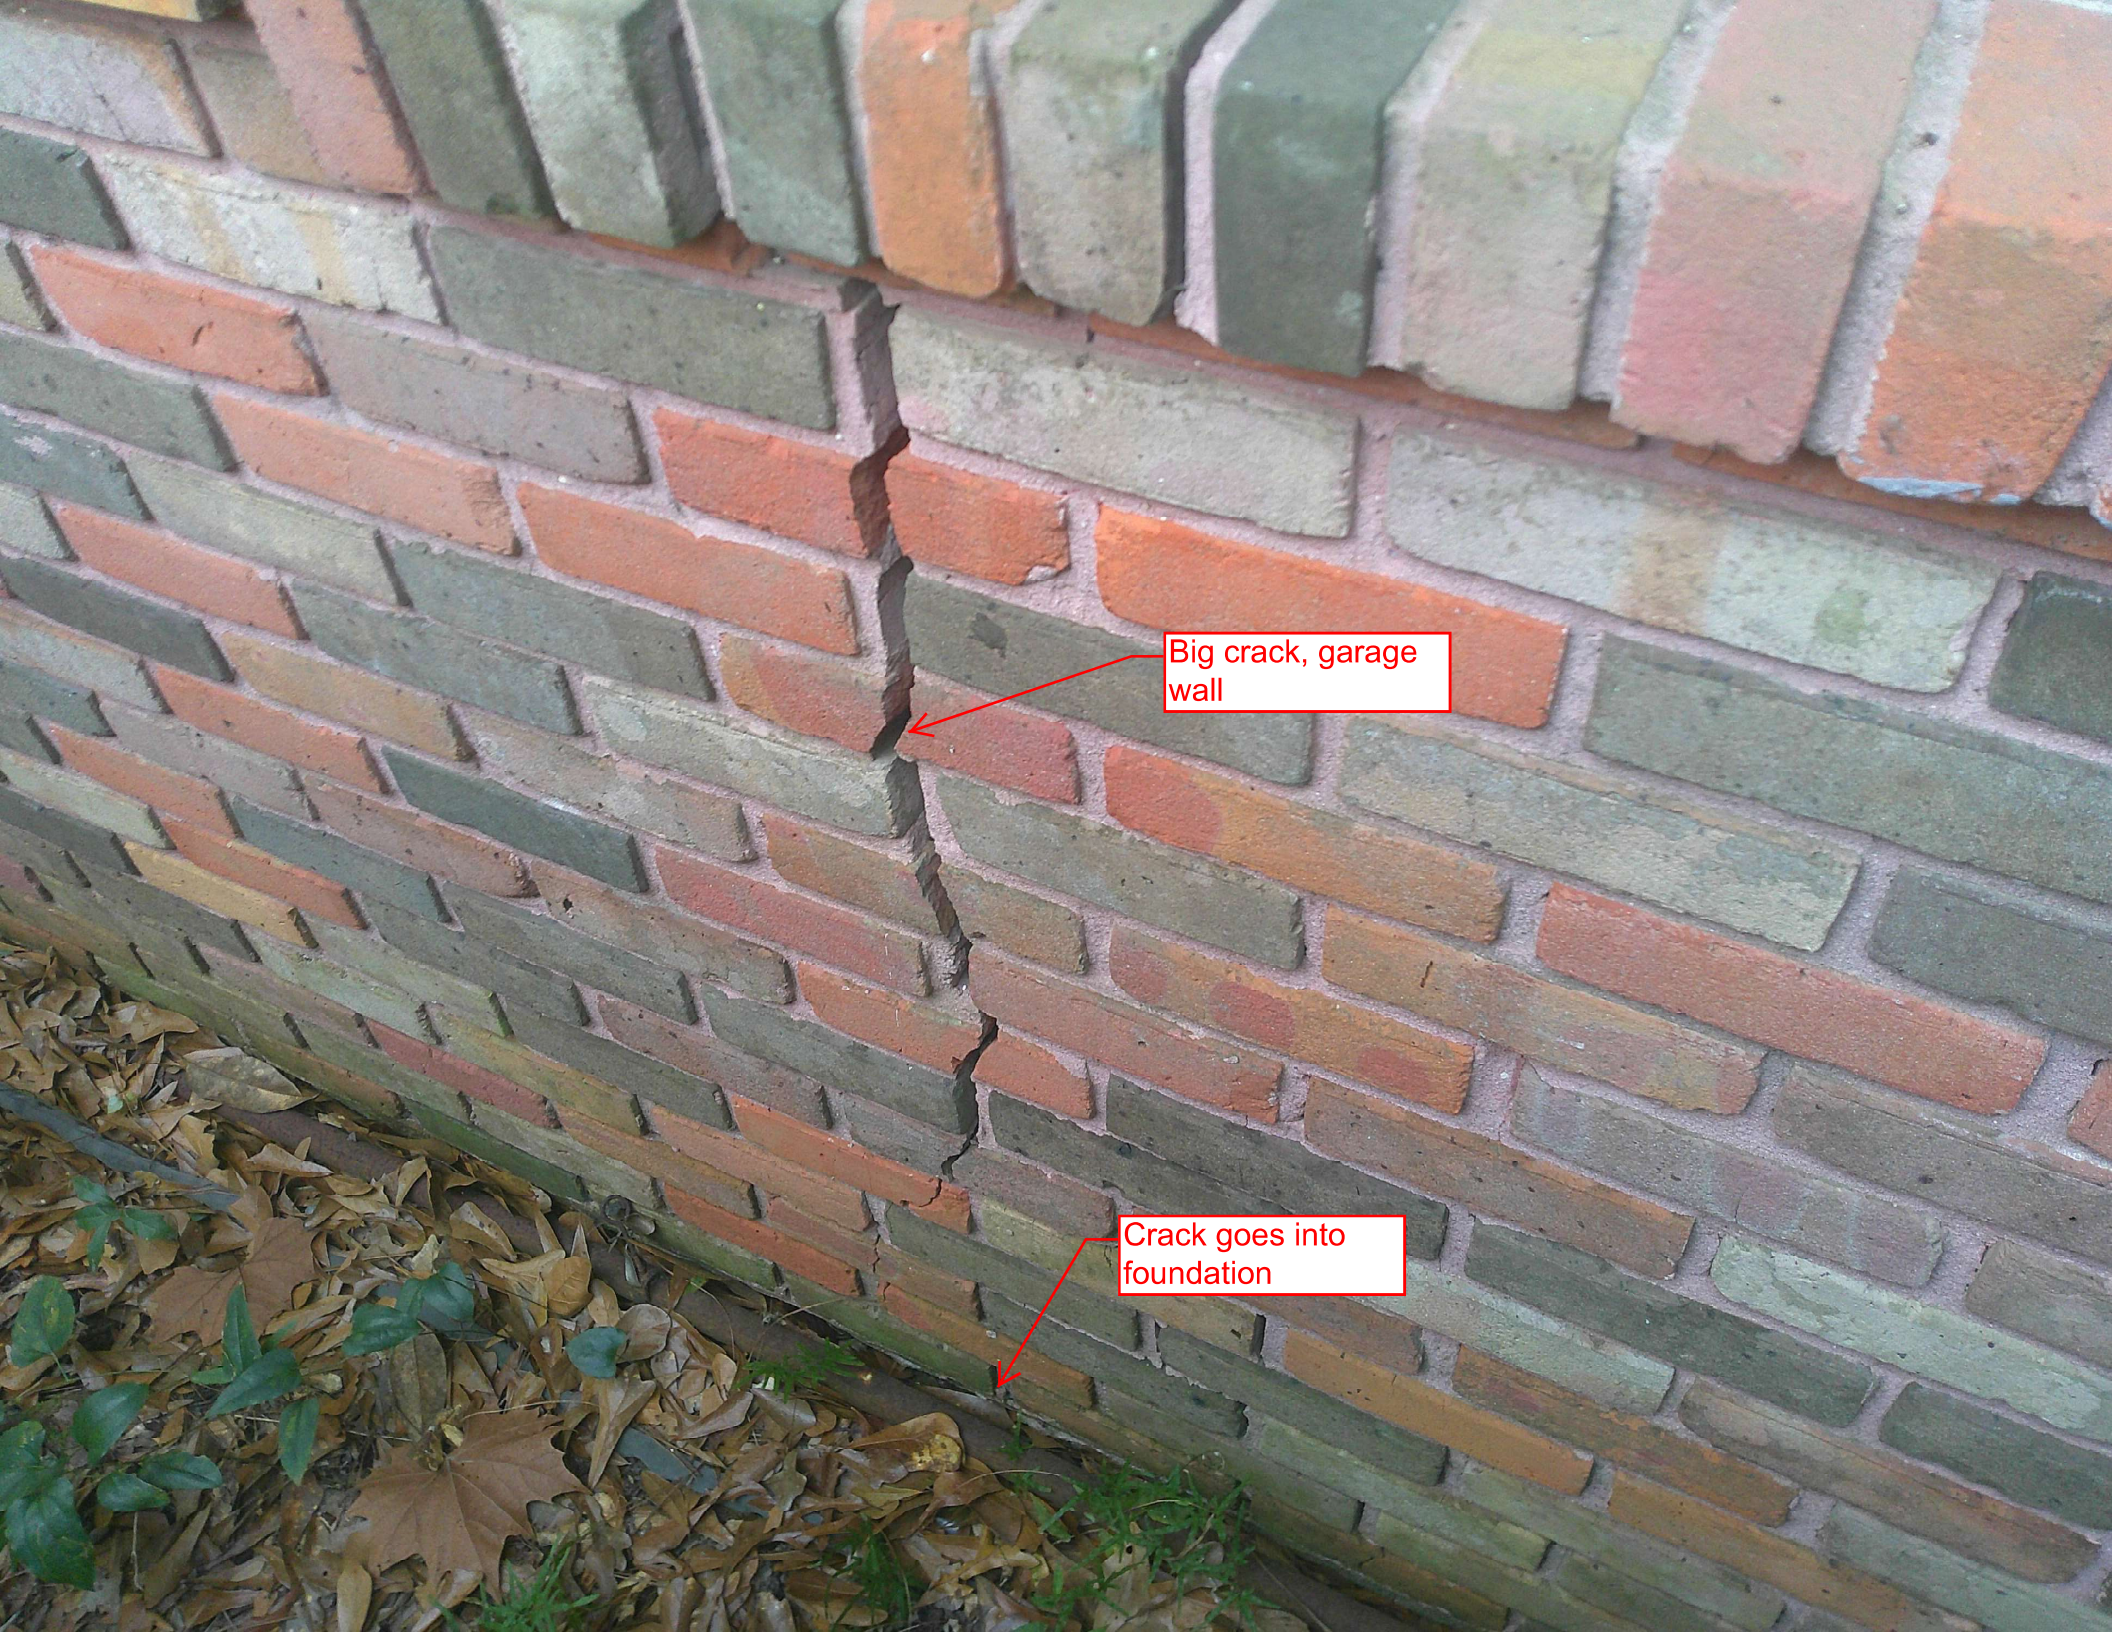
Big crack, garage wall

Crack goes into foundation

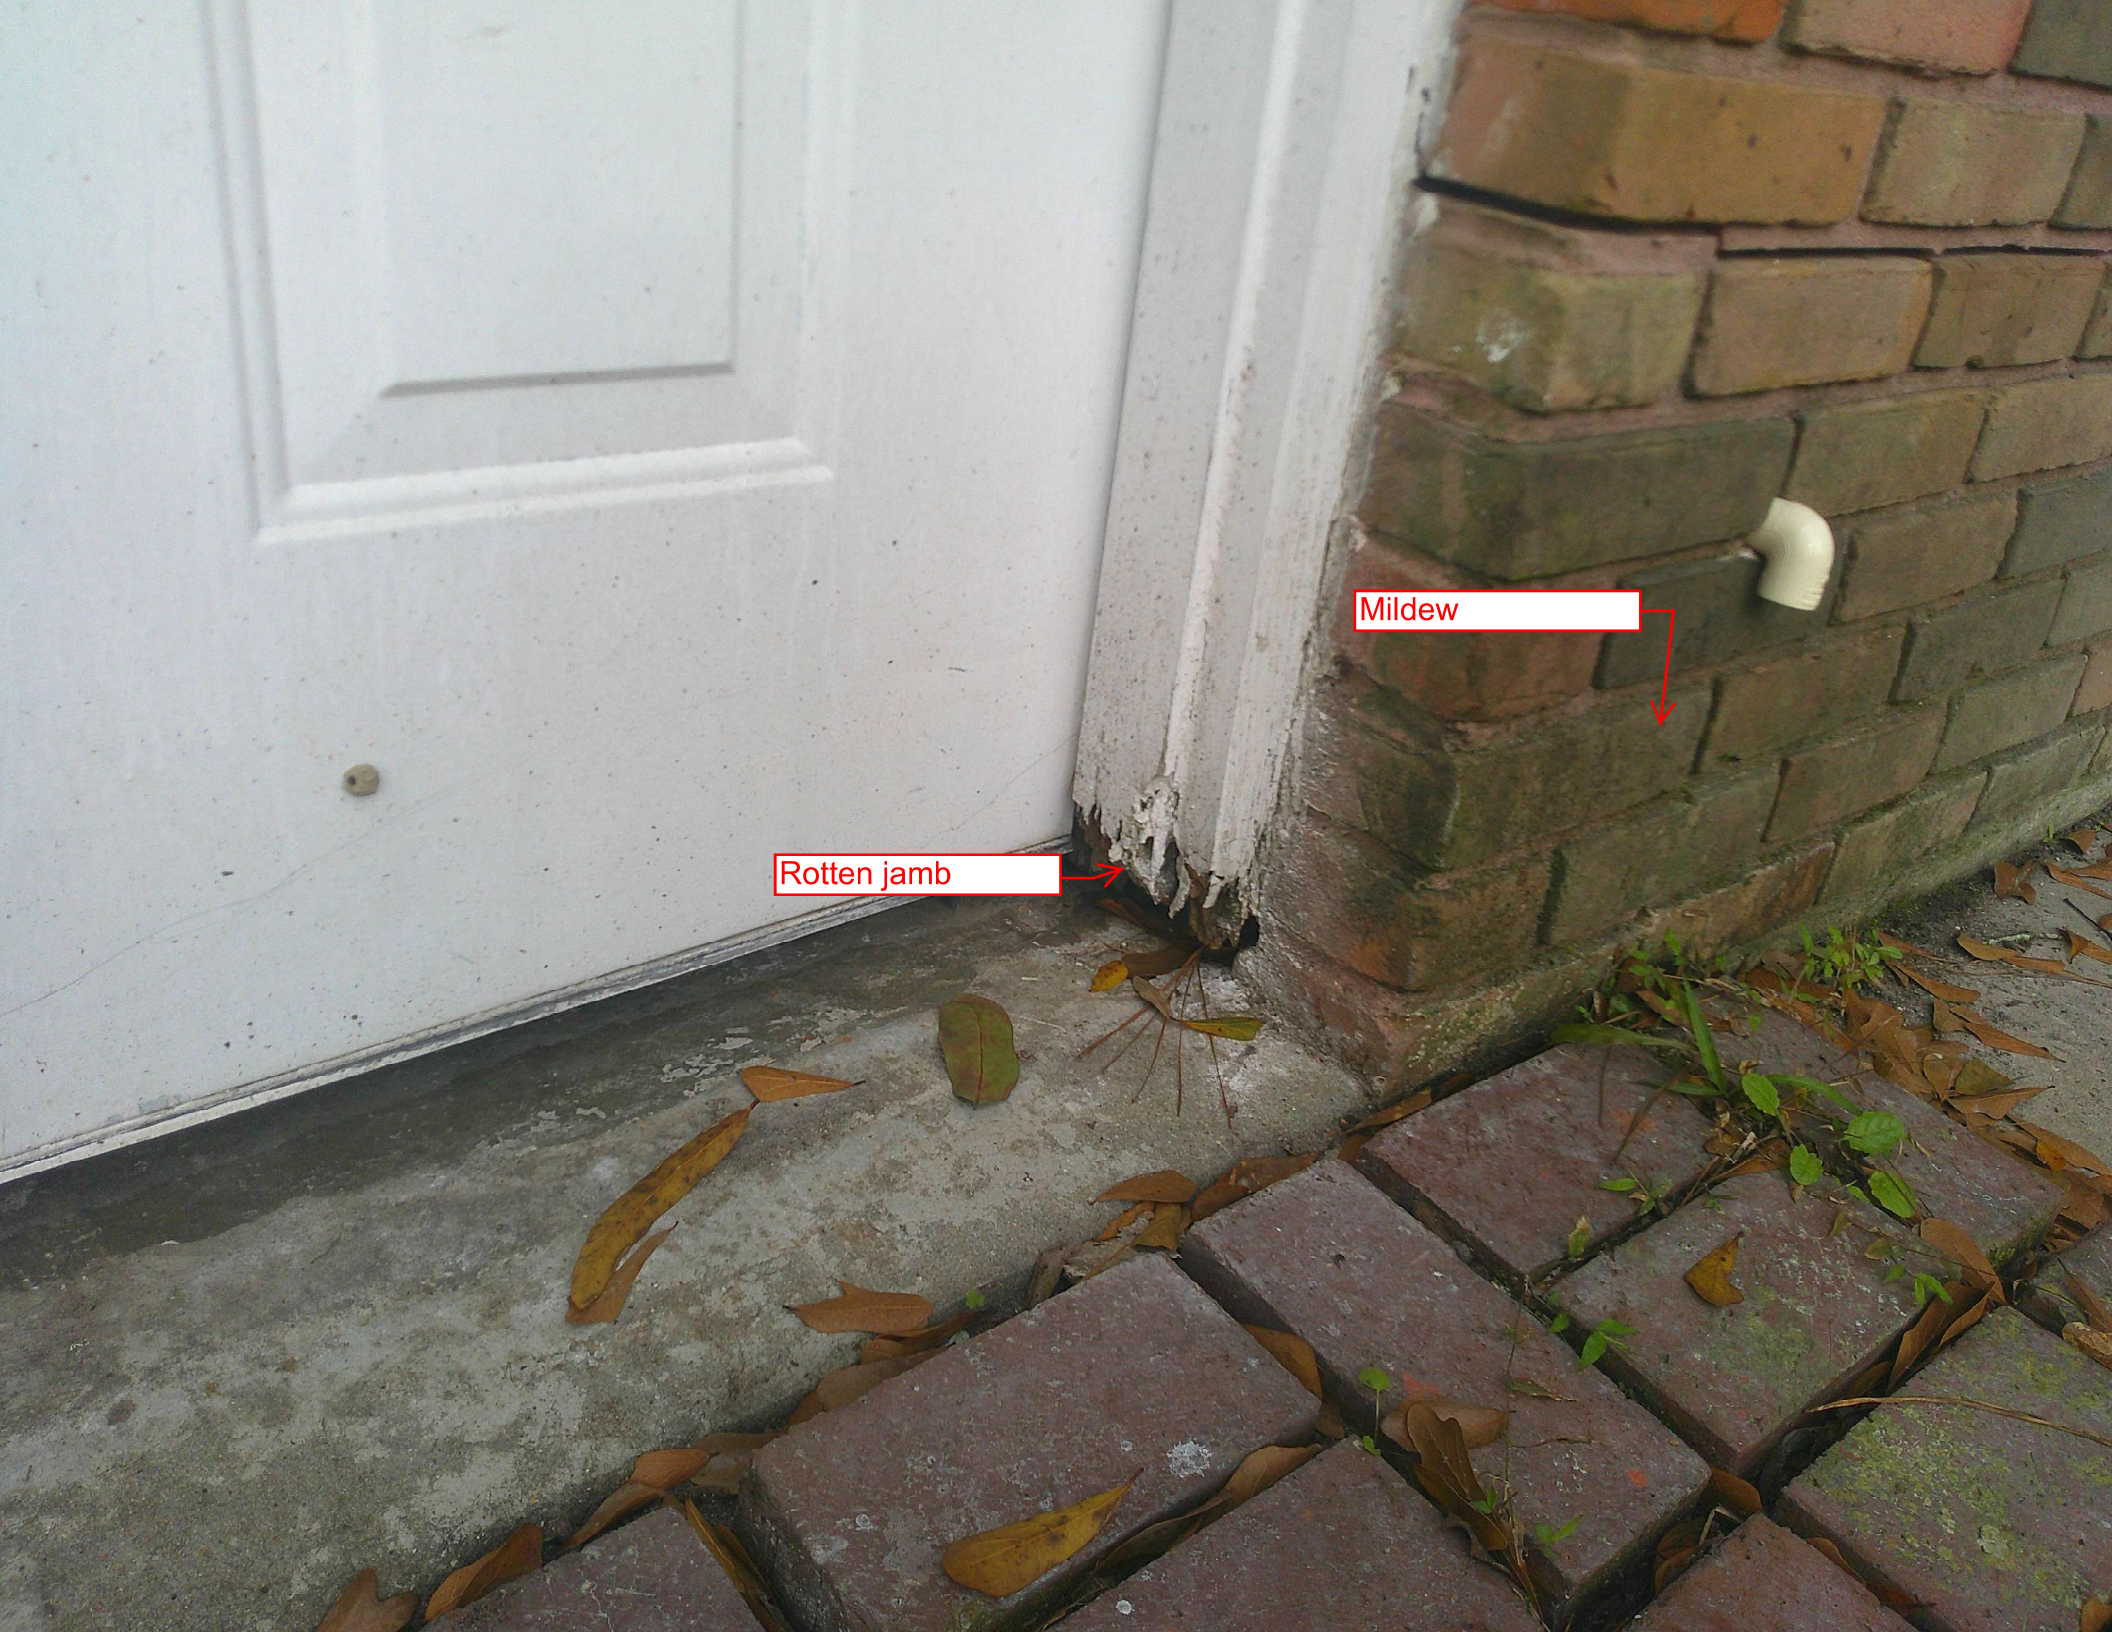
Rotten jamb

Mildew

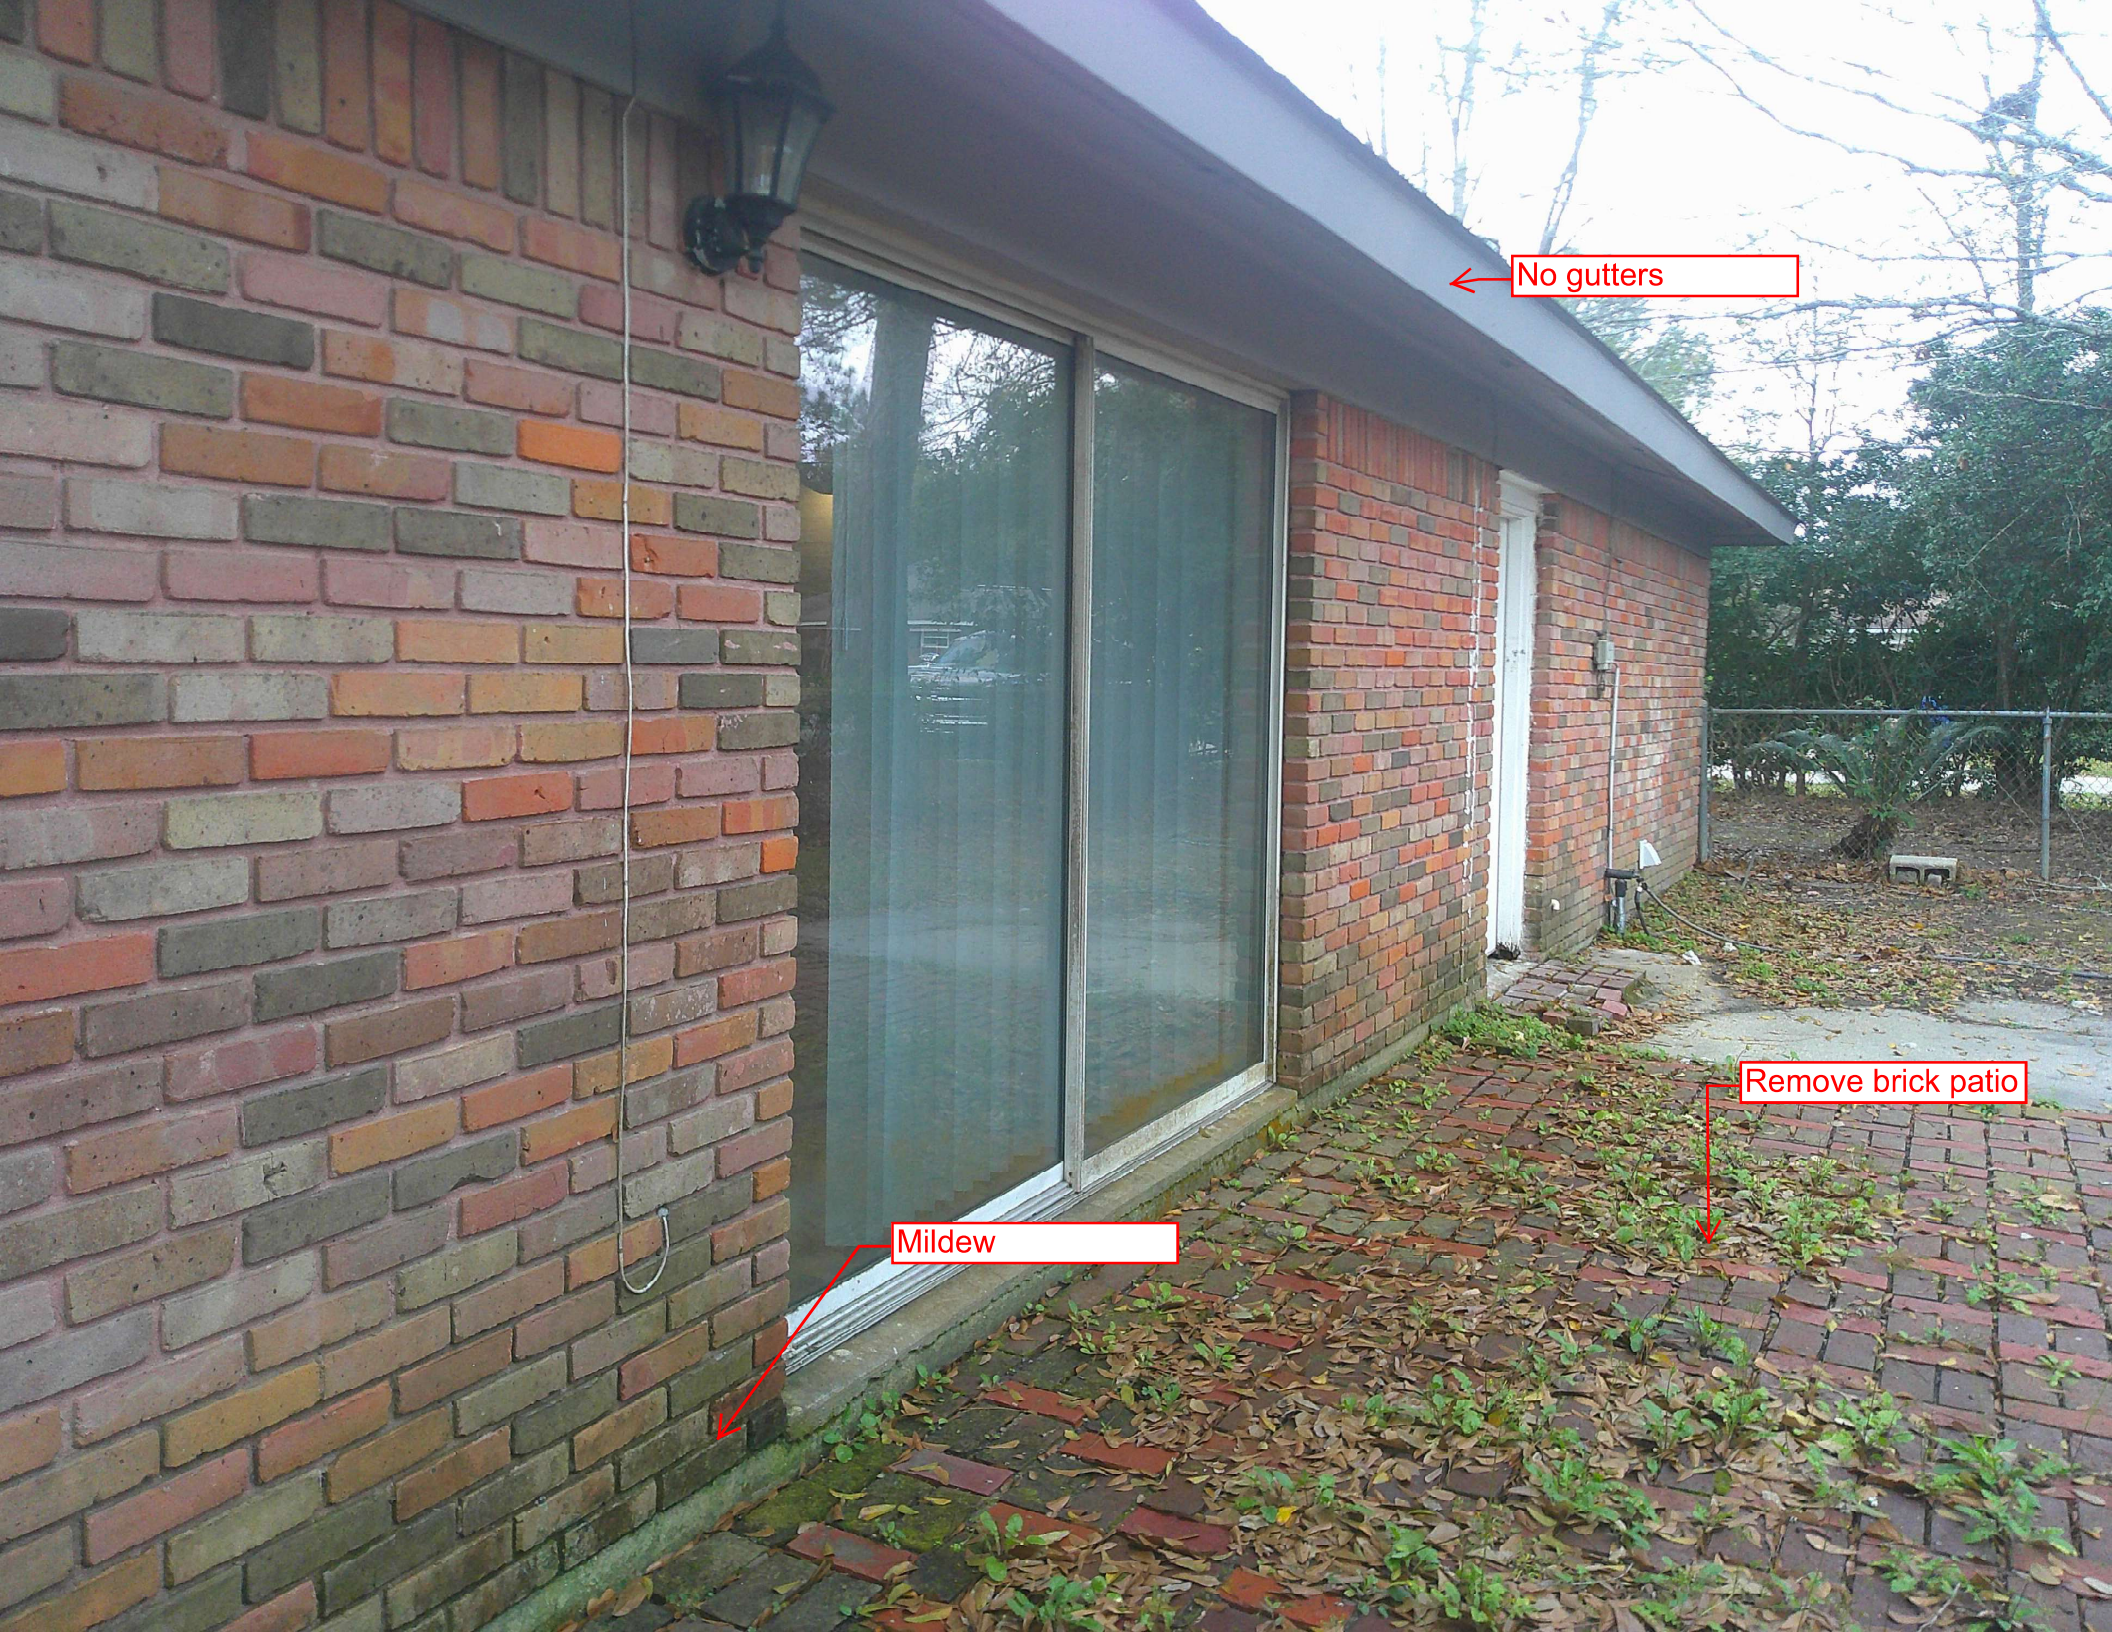
No gutters

Mildew

Remove brick patio

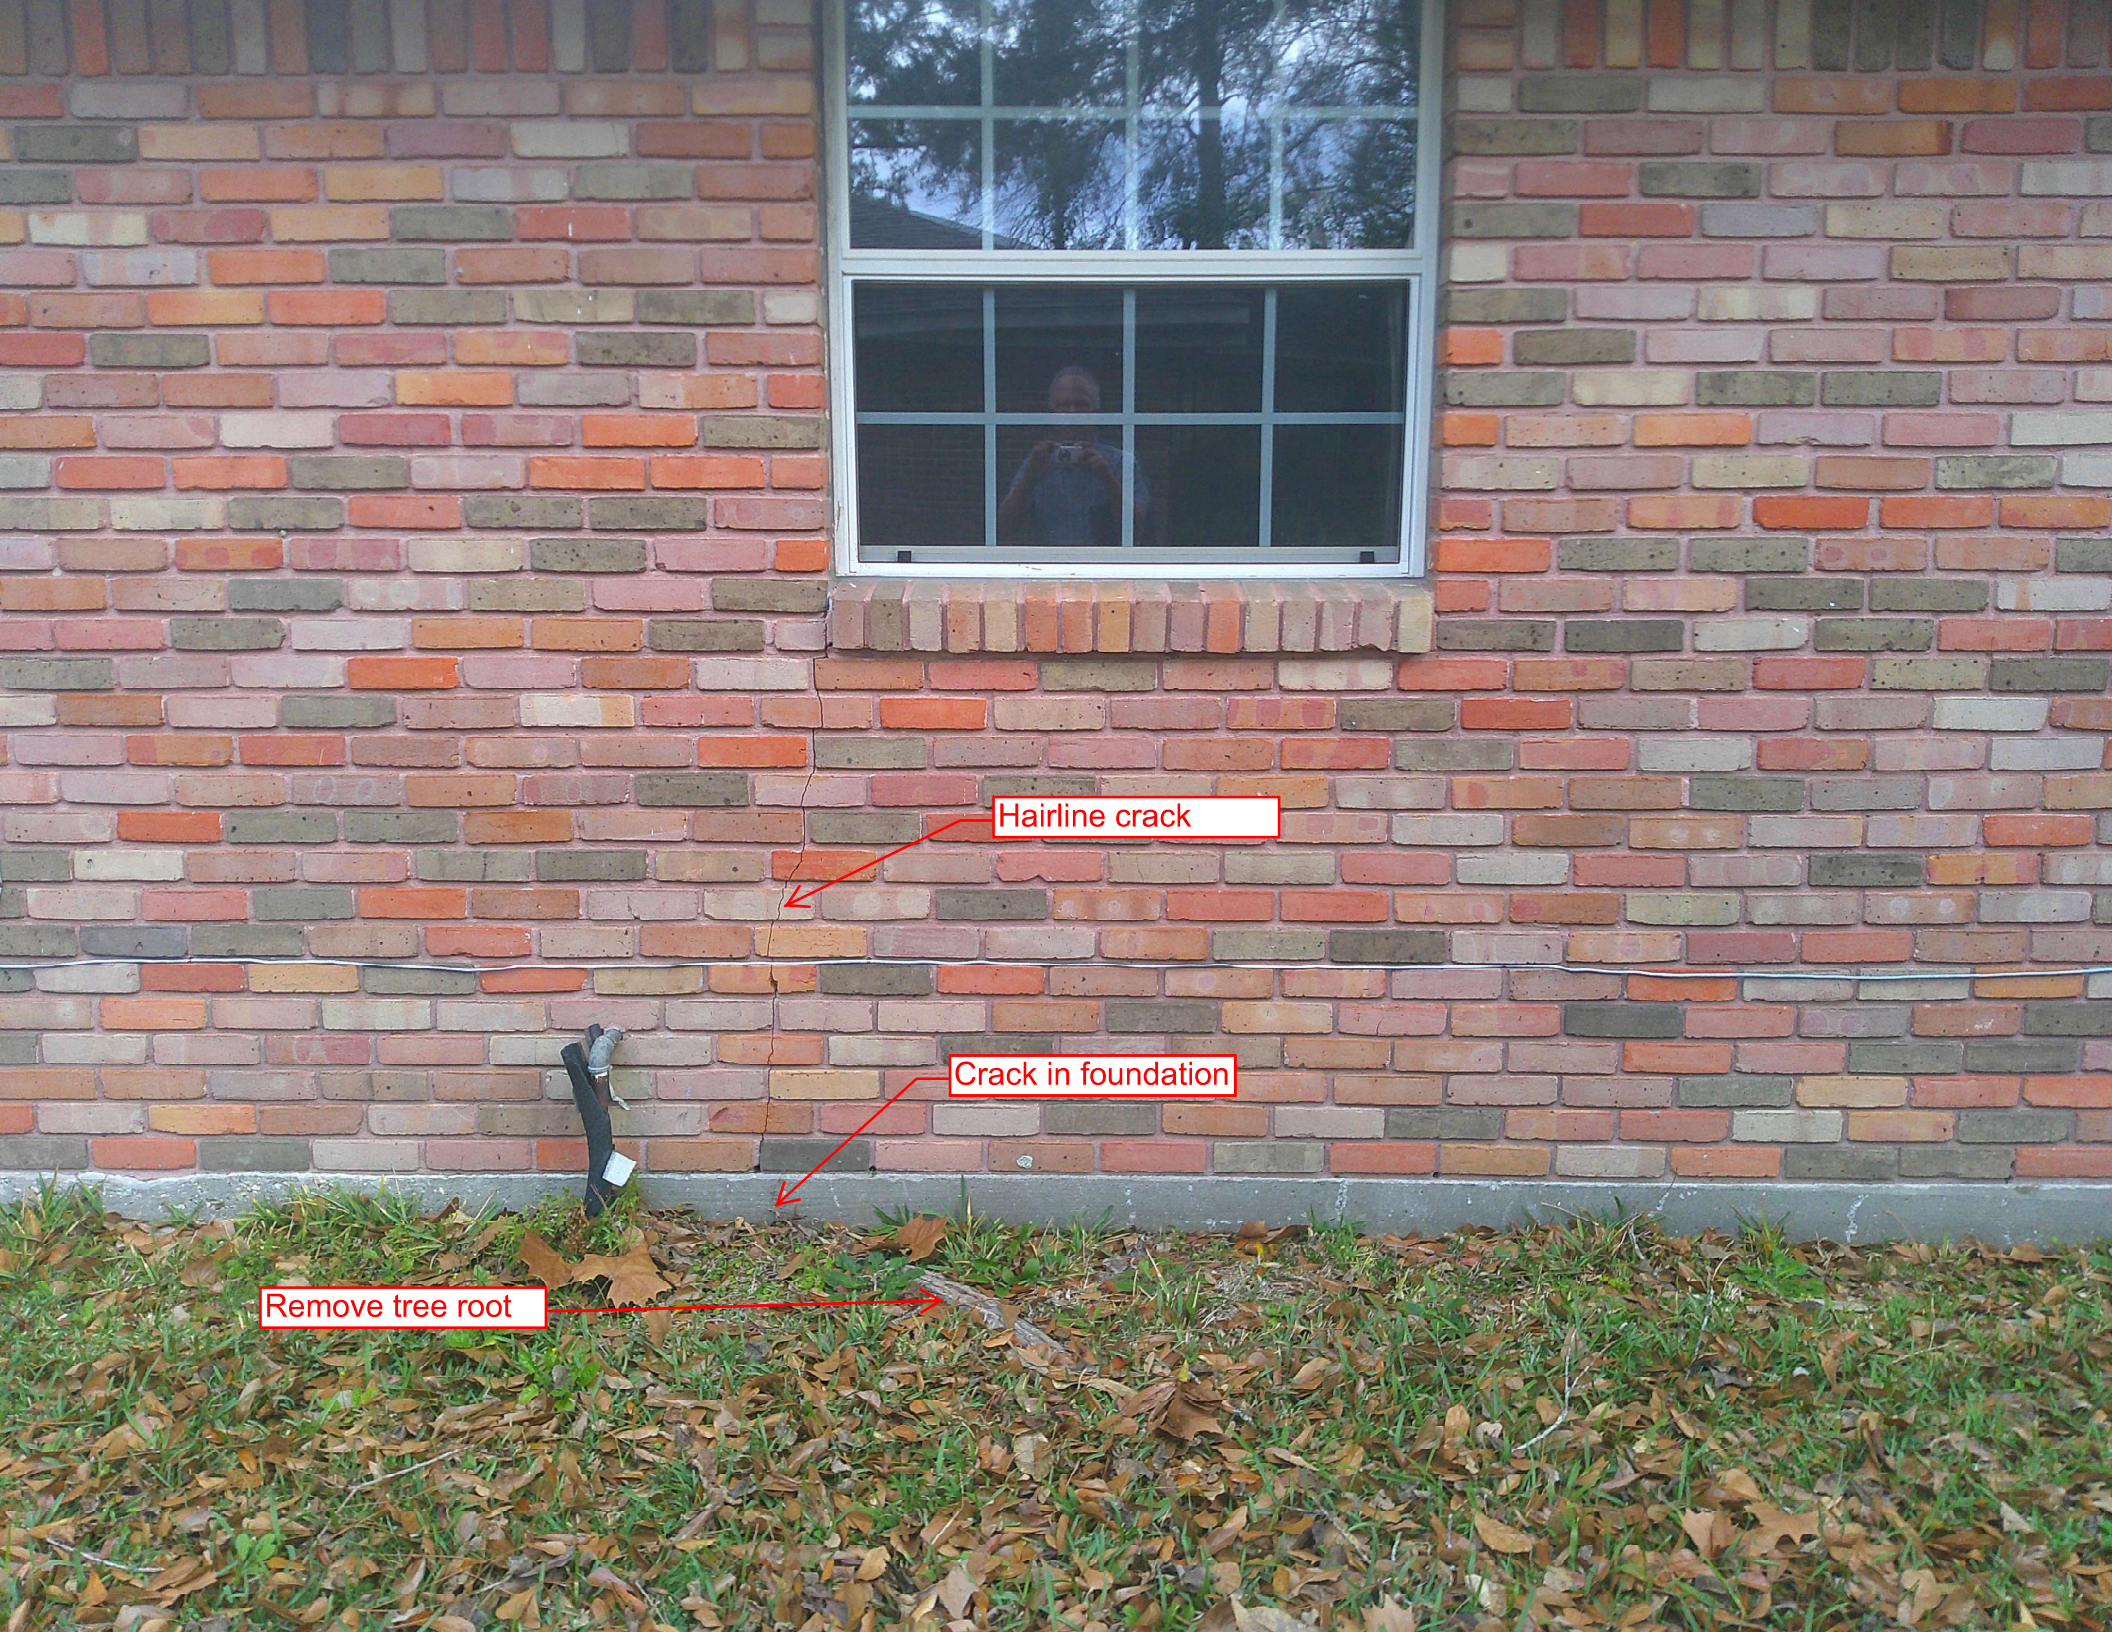
Hairline crack

Crack in foundation

Remove tree root
