## Structural Inspection

July 1, 2024

Michael Koster  
3616 Peachtree Street  
Slidell, La. 70458

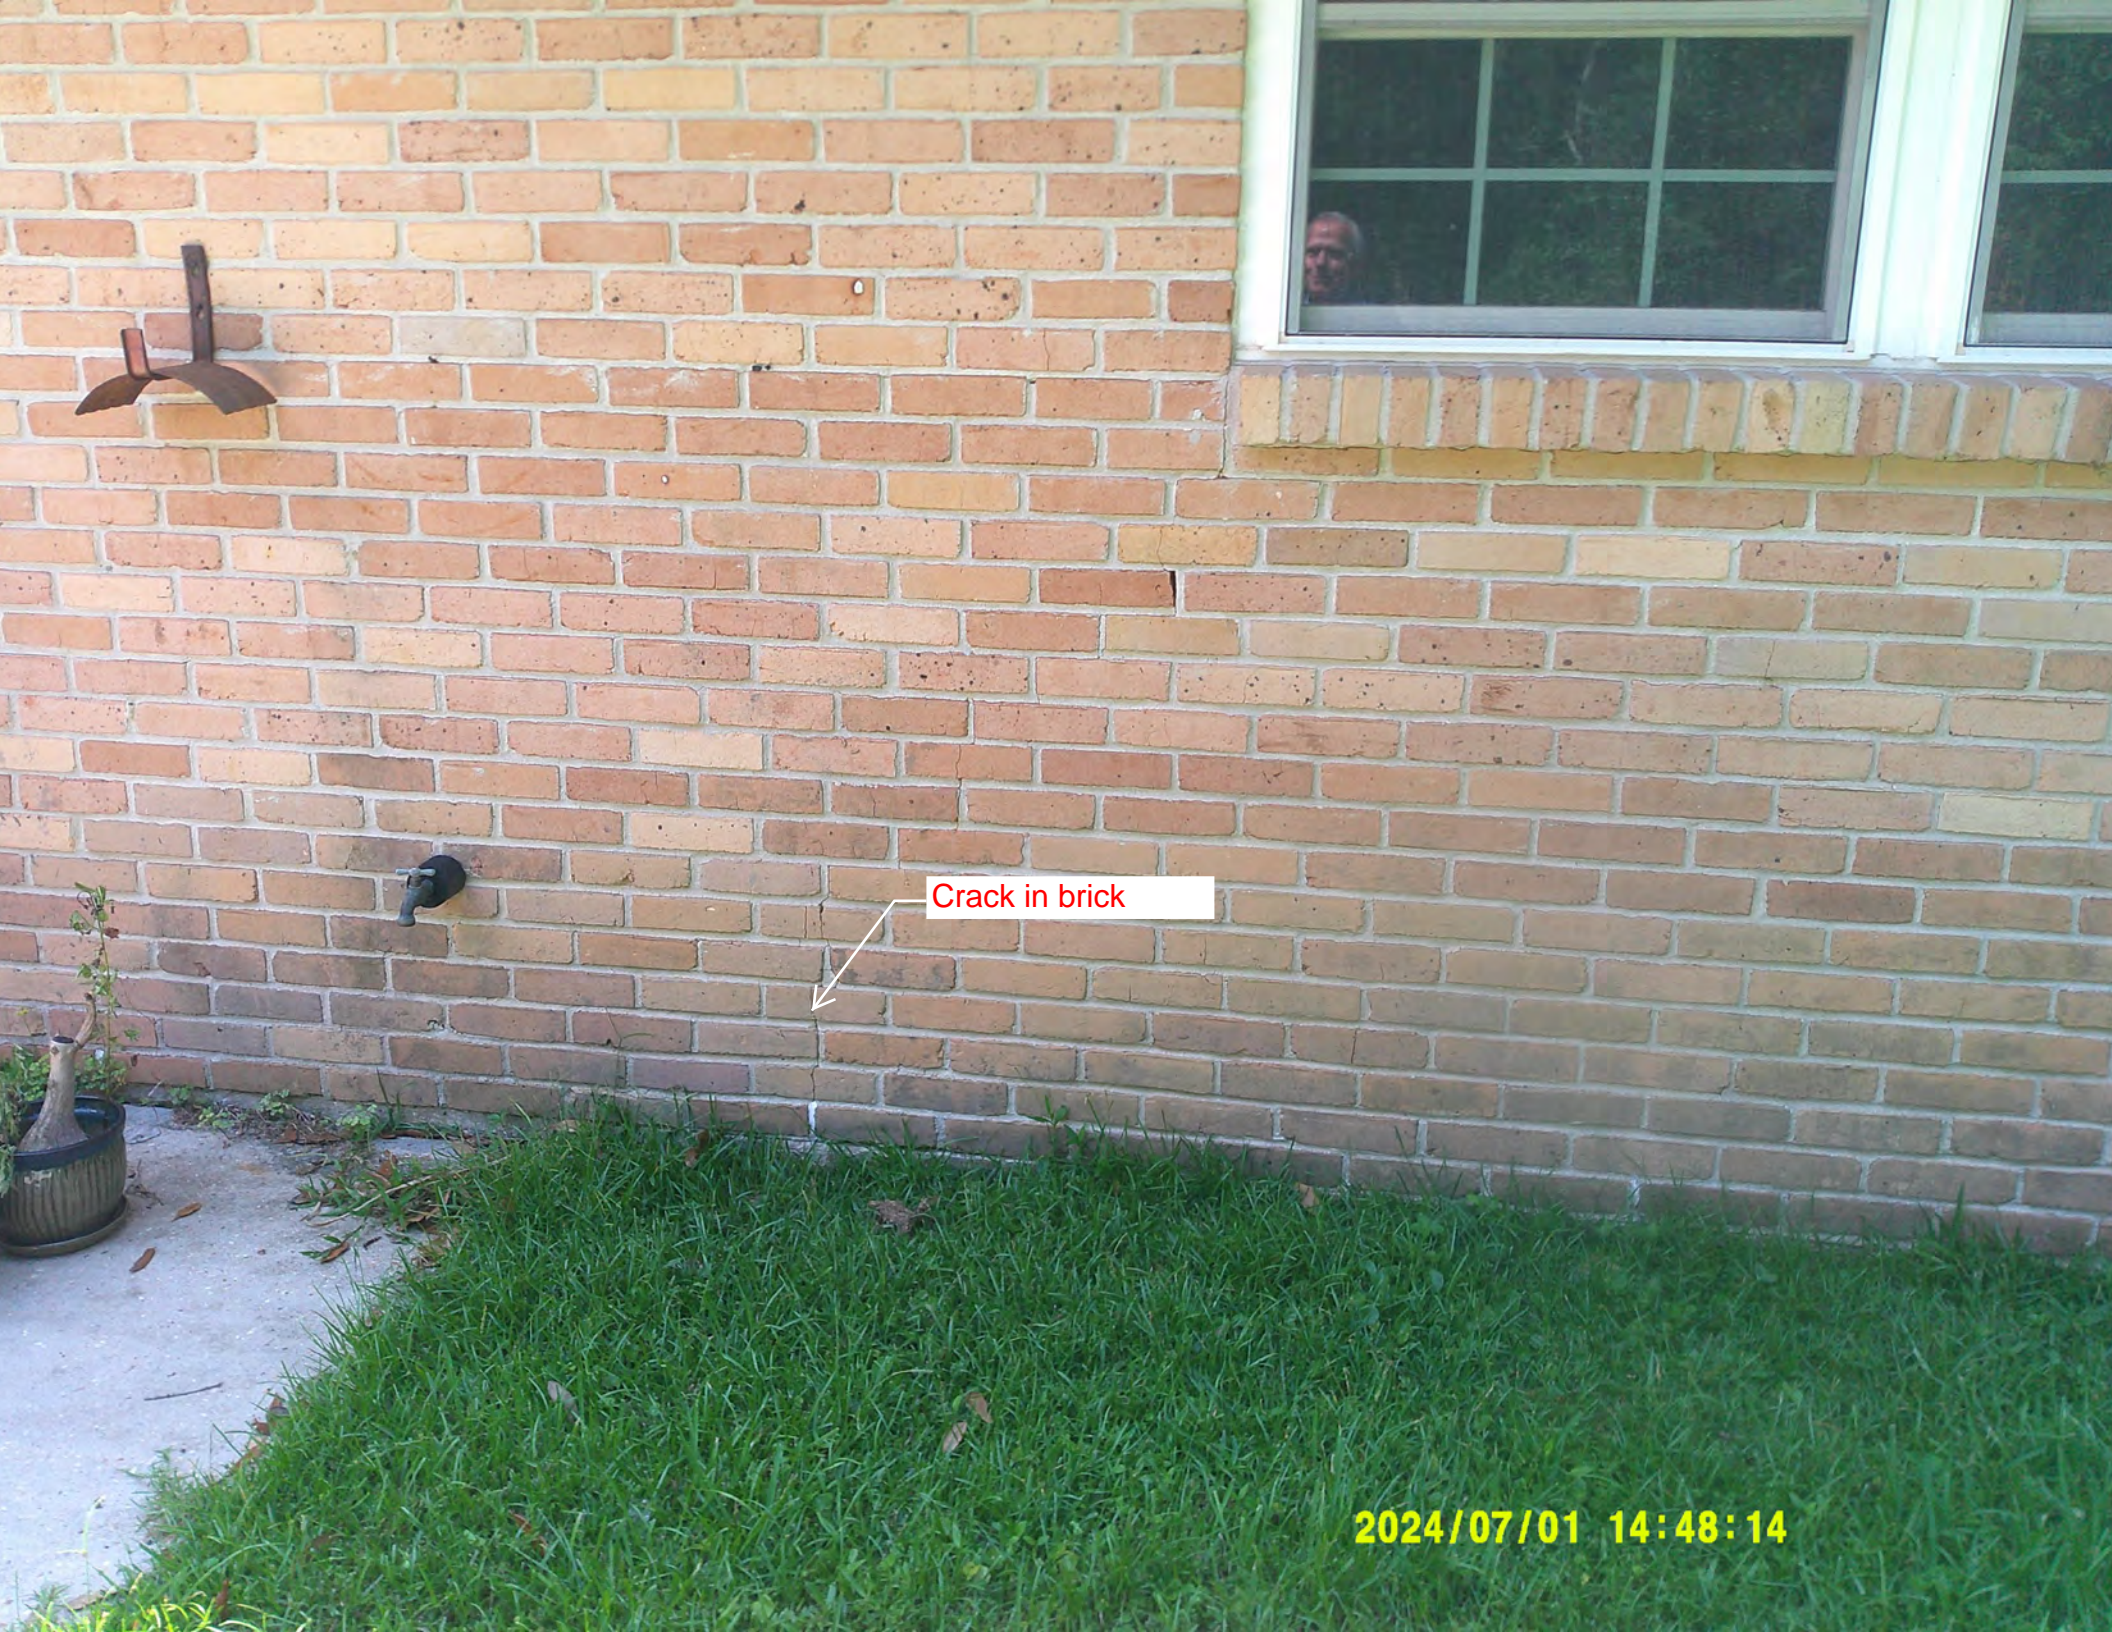
The exterior wall of the right side of the garage was noted to have a crack in the brick veneer in the upper half of the wall. It was also noted that this wall has mold growing on it indicating rainwater splashing off the concrete drive onto the wall and running under the foundation.

Garage wall crack

Mold from rainwater

- 1) Add gutters and downspouts and tie into subsurface drainage on all downspouts that are needed to allow for proper drainage of rainwater away from the foundation.
- 2) Seal the cracks in the brick veneer and foundation with a non-shrinking grout, to prevent insects from entering the home.

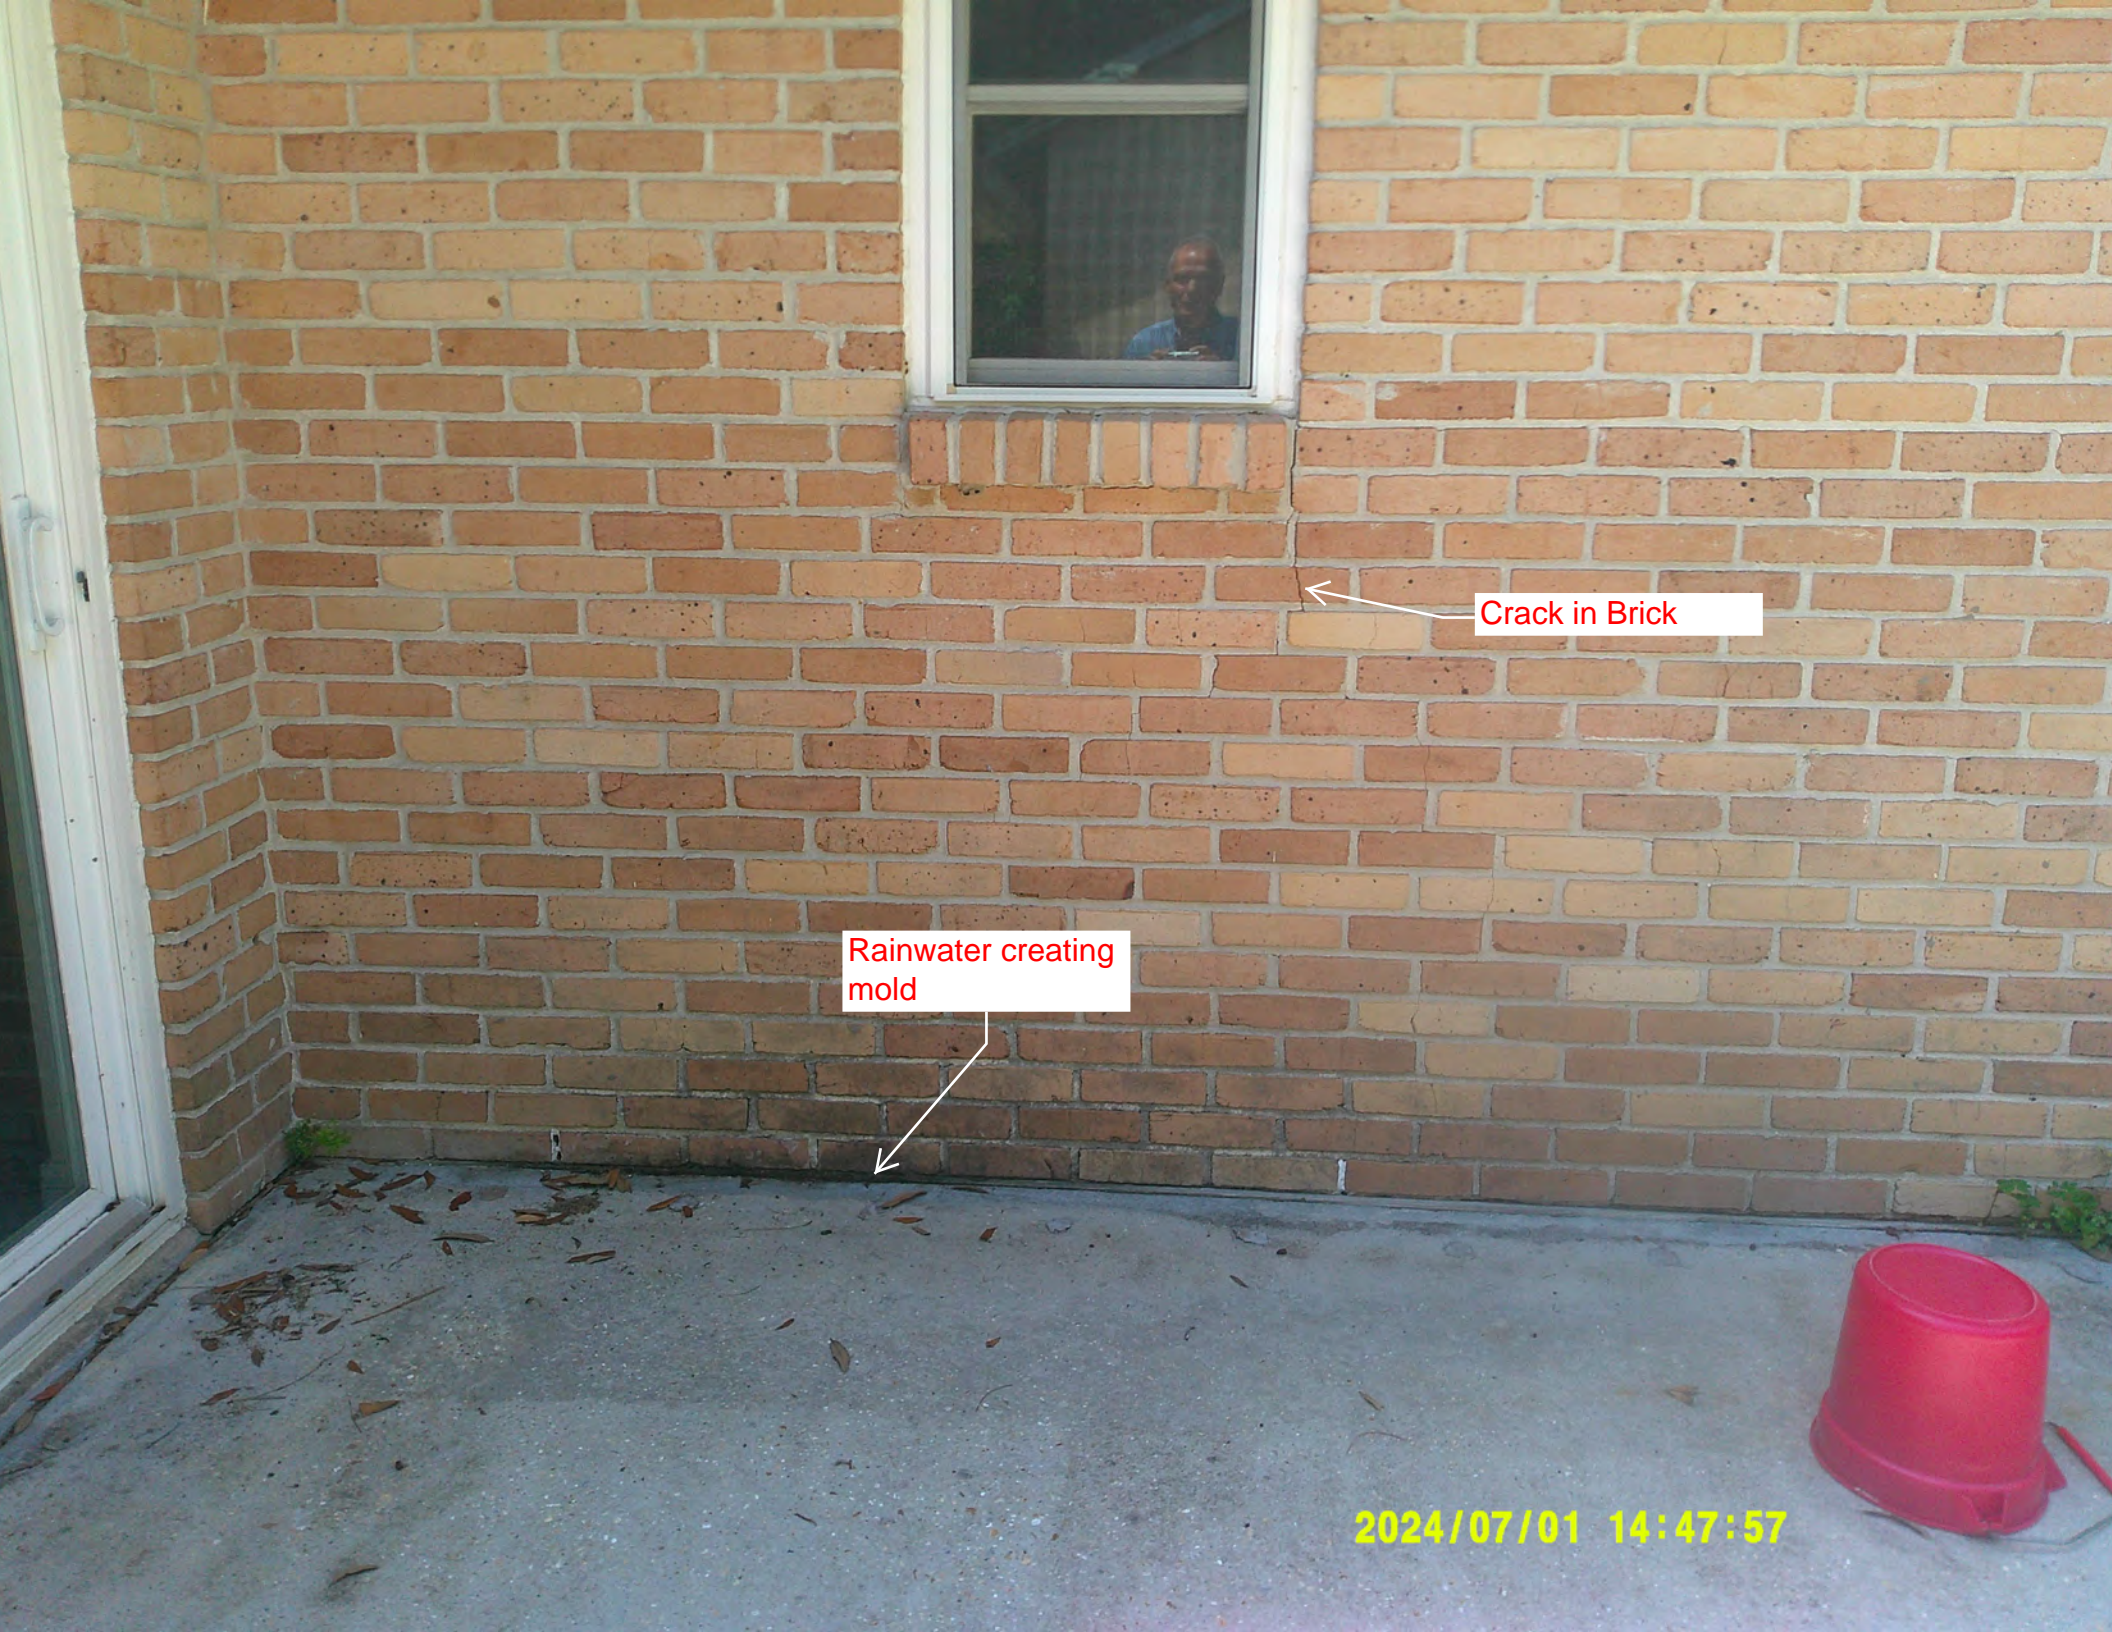
It was also noted on the rear of the home near the bathroom and out past the concrete patio that the bricks have a hairline crack. This is the same, rainwater running off the roof and splashing onto the wall and under the foundation.

Downspout  
allowing rainwater  
to get under the  
foundation.

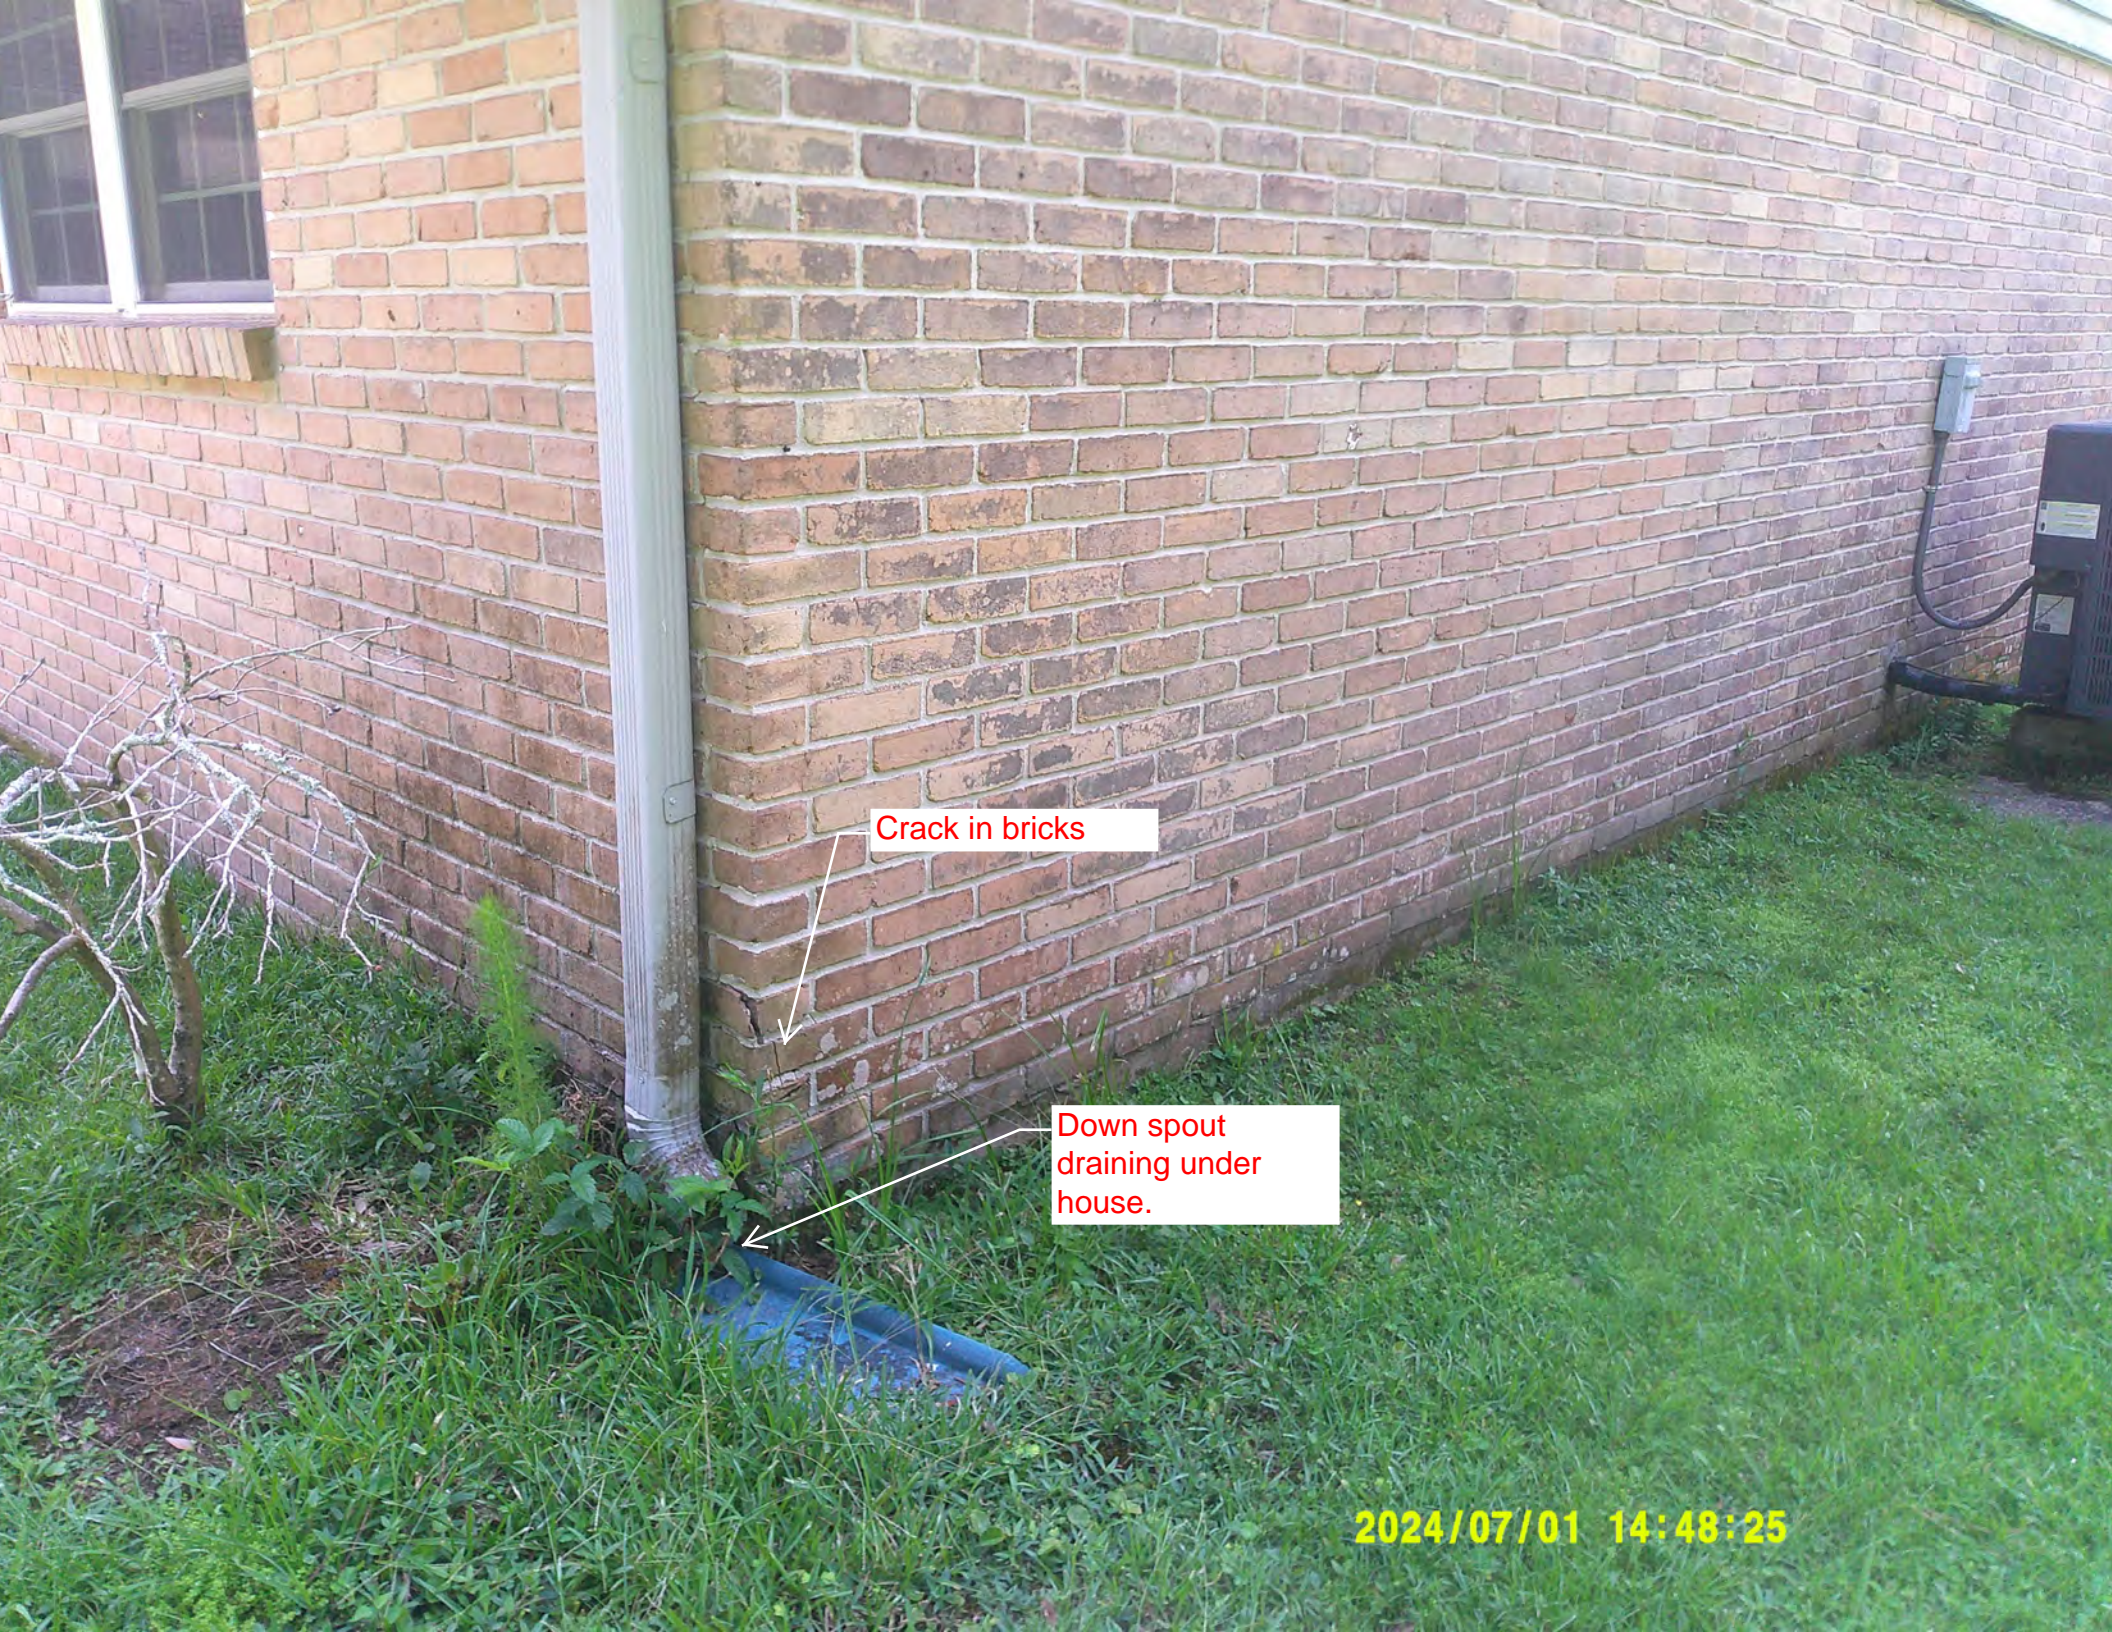
Crack in Brick

Rainwater creating mold
