Structural Inspection

July 15, 2025

Ansley Tullis
416 Juliette Lane
Mandeville, La. 70448

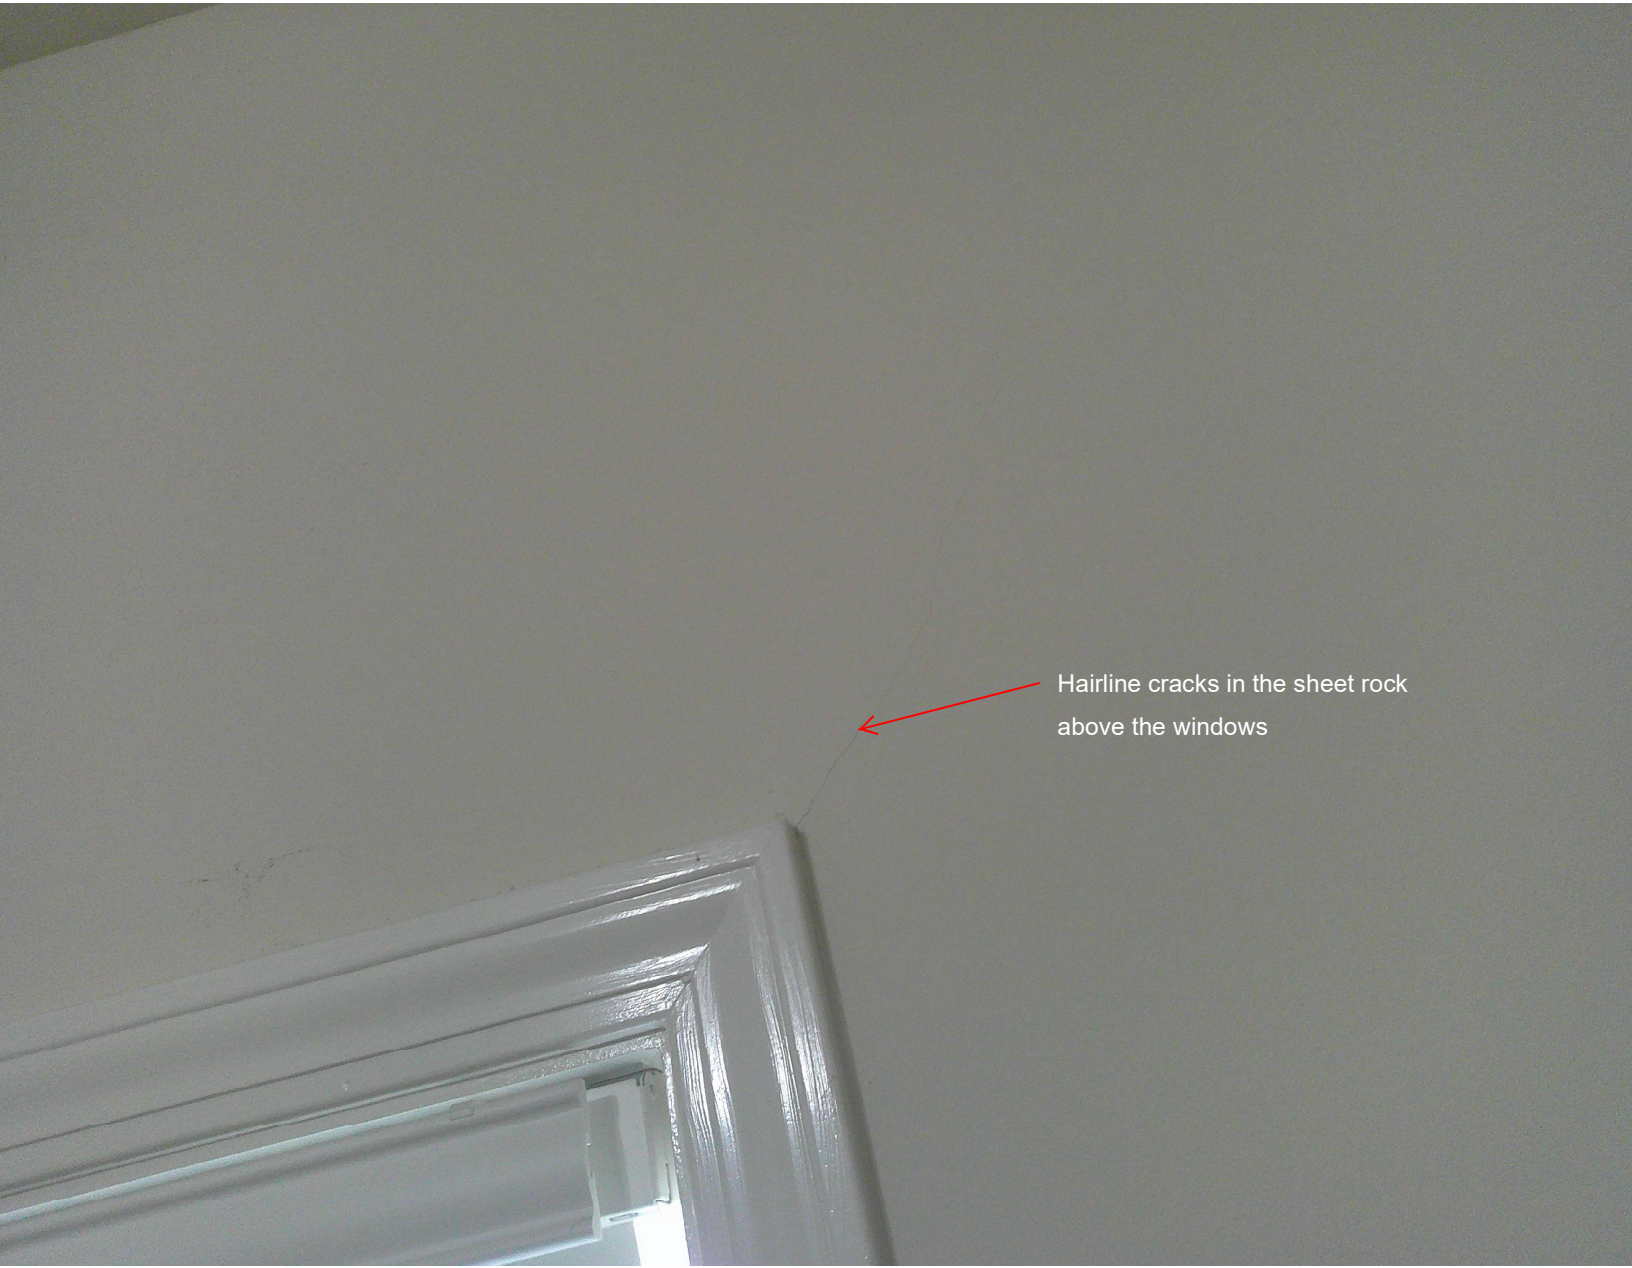
Upon an interior inspection, the bedroom windows show signs of sheetrock cracking at the corners of the windows.

Hairline cracks in the sheet rock
above the windows

- 1) Remove the large pine tree and surrounding roots to level the rear patio foundation.
- 2) Add fill under the home and slope outwards to keep the pier and beam foundation dry.
- 3) Add gutters and down spouts around the home with subsurface drainage and tie into the central ditch.
- 4) Repair the cracked sheetrock around the windows and paint to match.

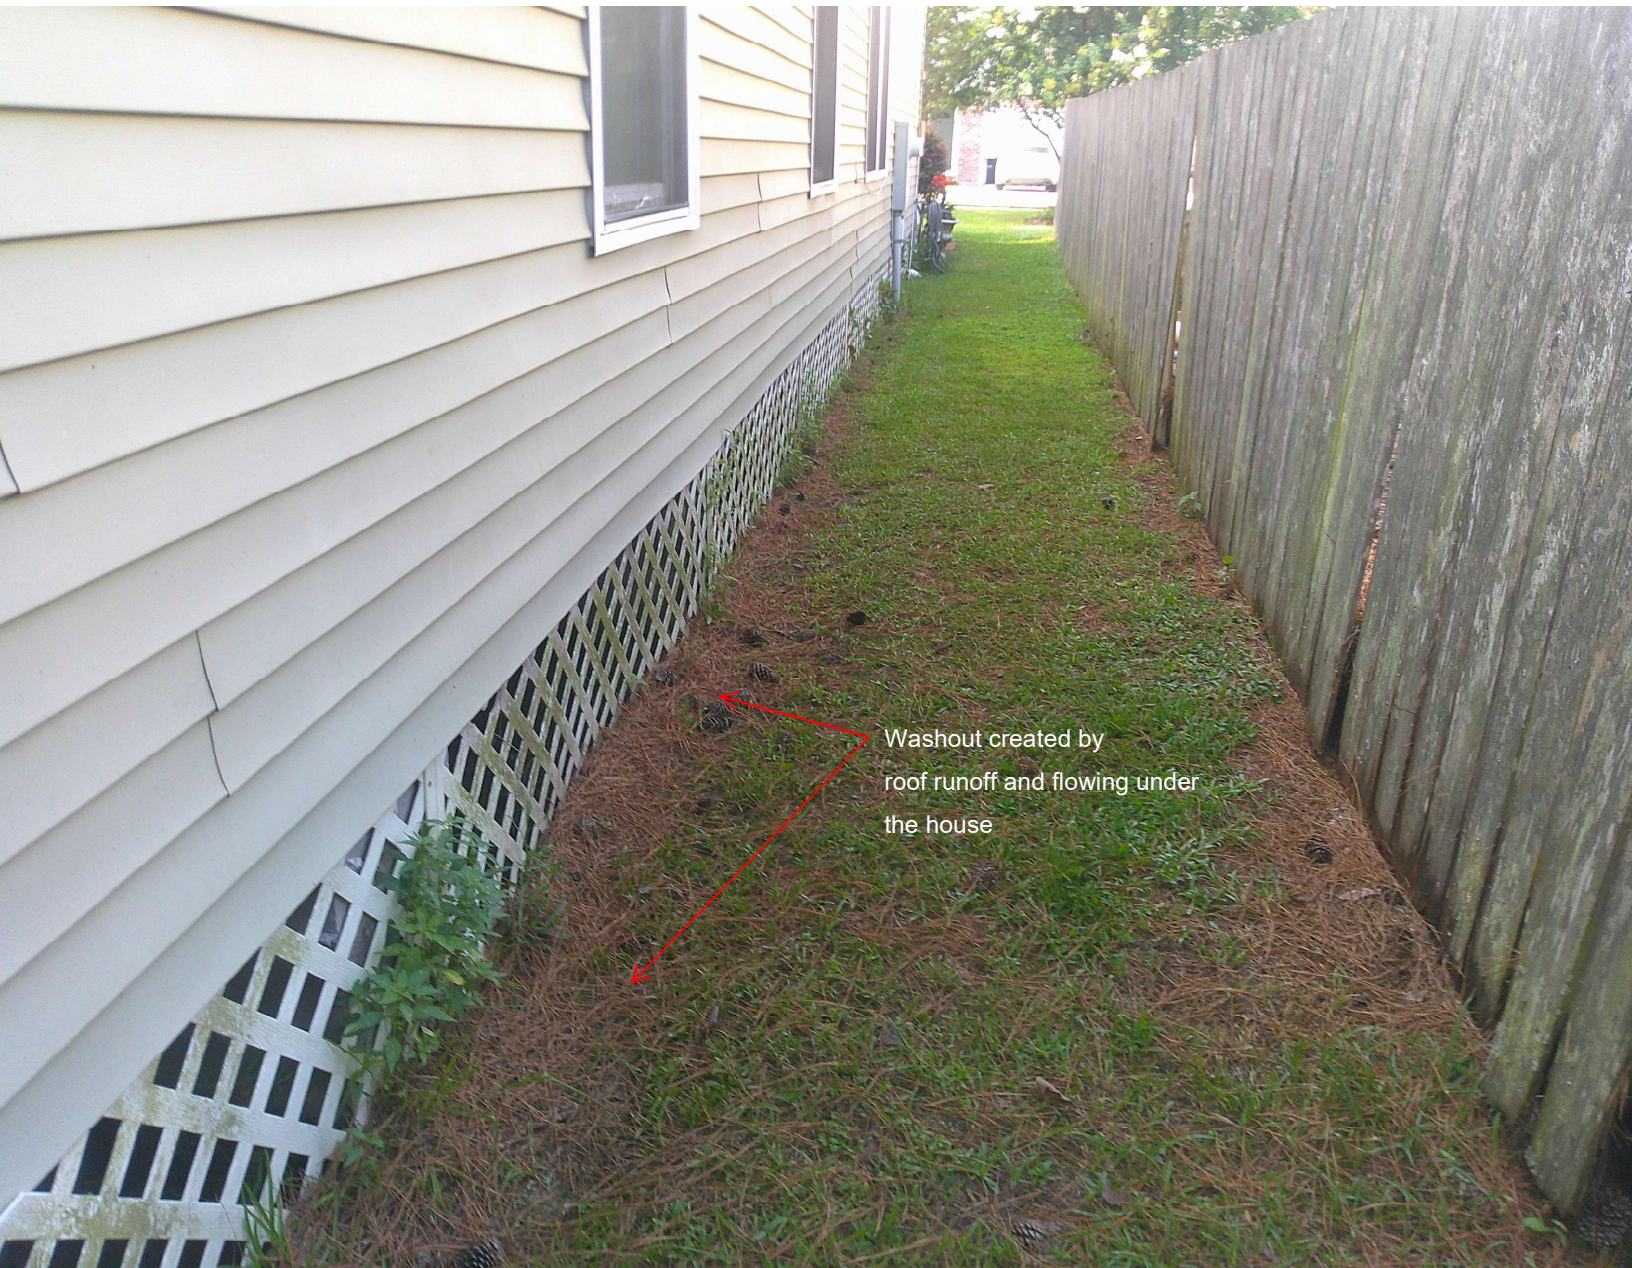
It was noted that the ground around the home slopes back toward the house and water sheet flows under the home and out toward the central drainage. This will cause foundation settlement and crack the sheetrock.

Washout created by
roof runoff and flowing under
the house

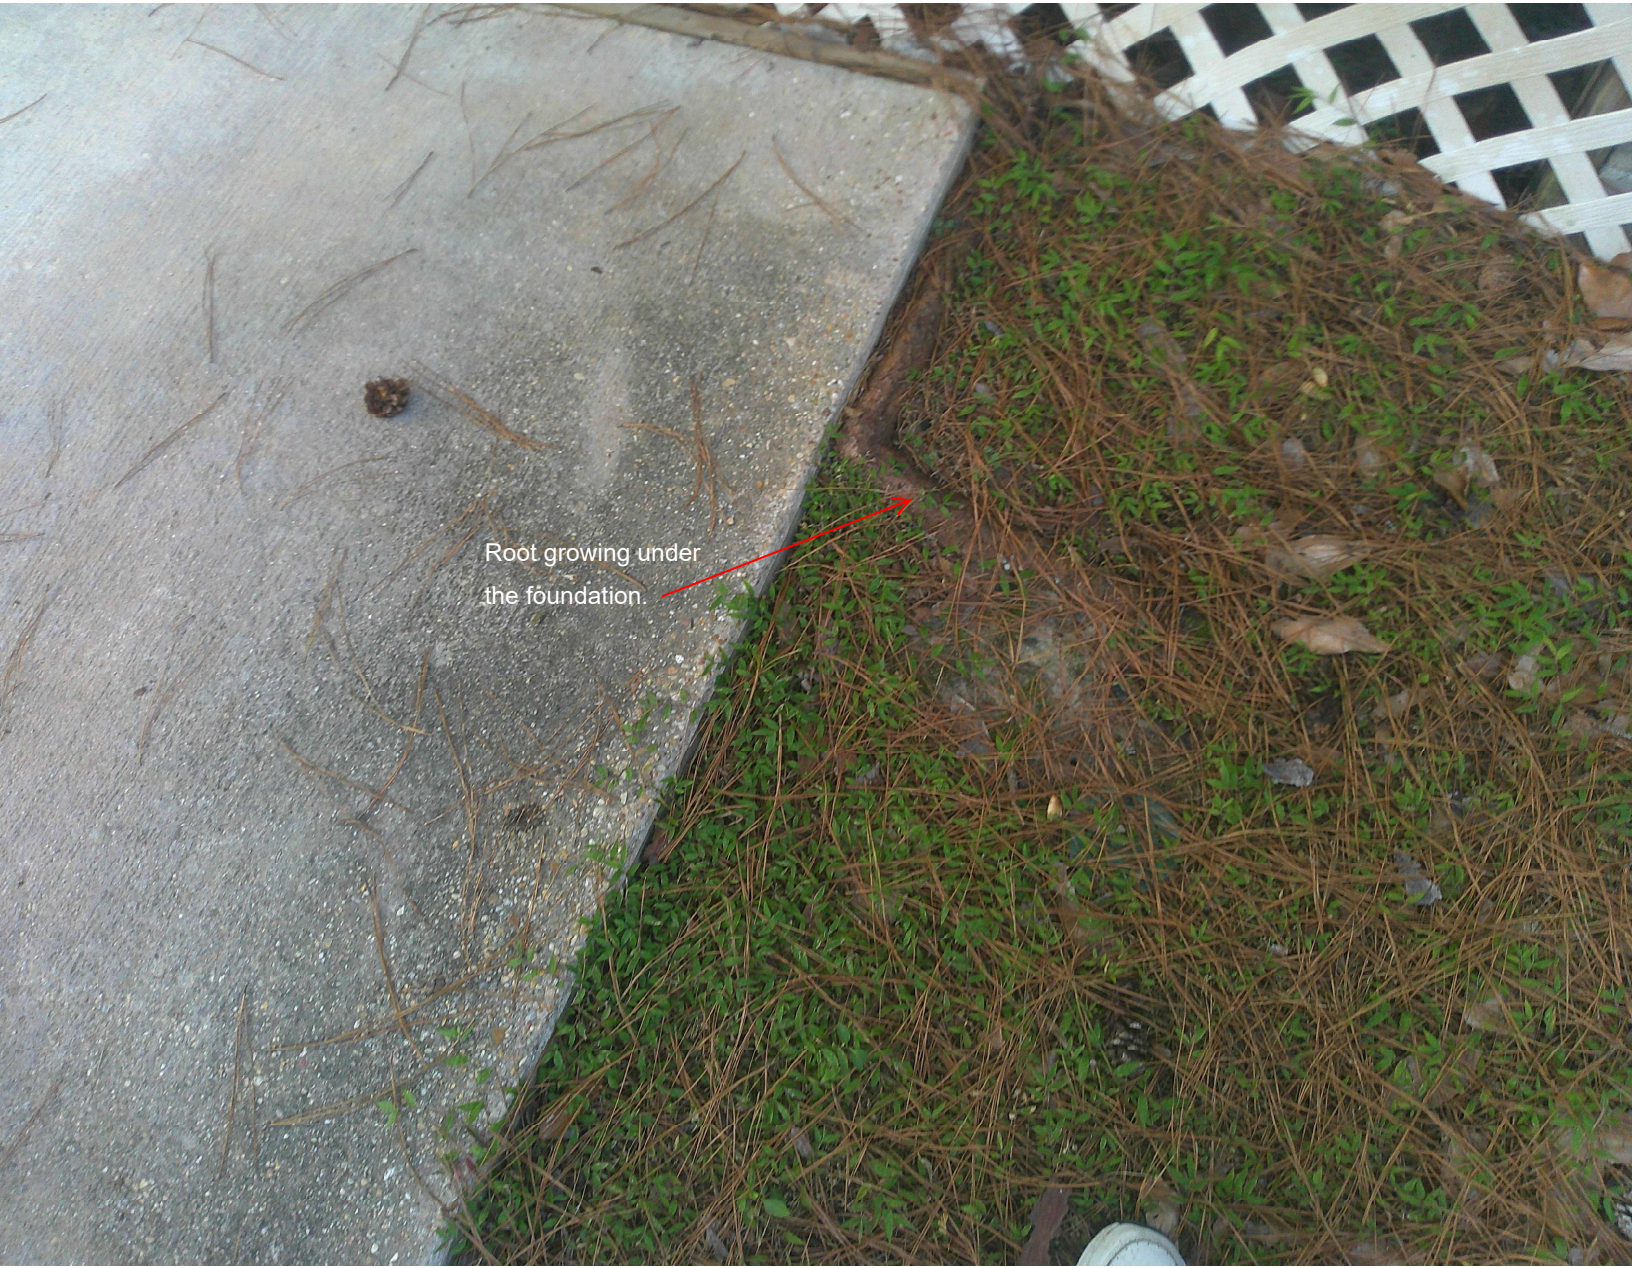
The back patio concrete foundation is being lifted up on one corner where a large pine tree is growing and its roots are lifting the foundation up.

Root growing under
the foundation.

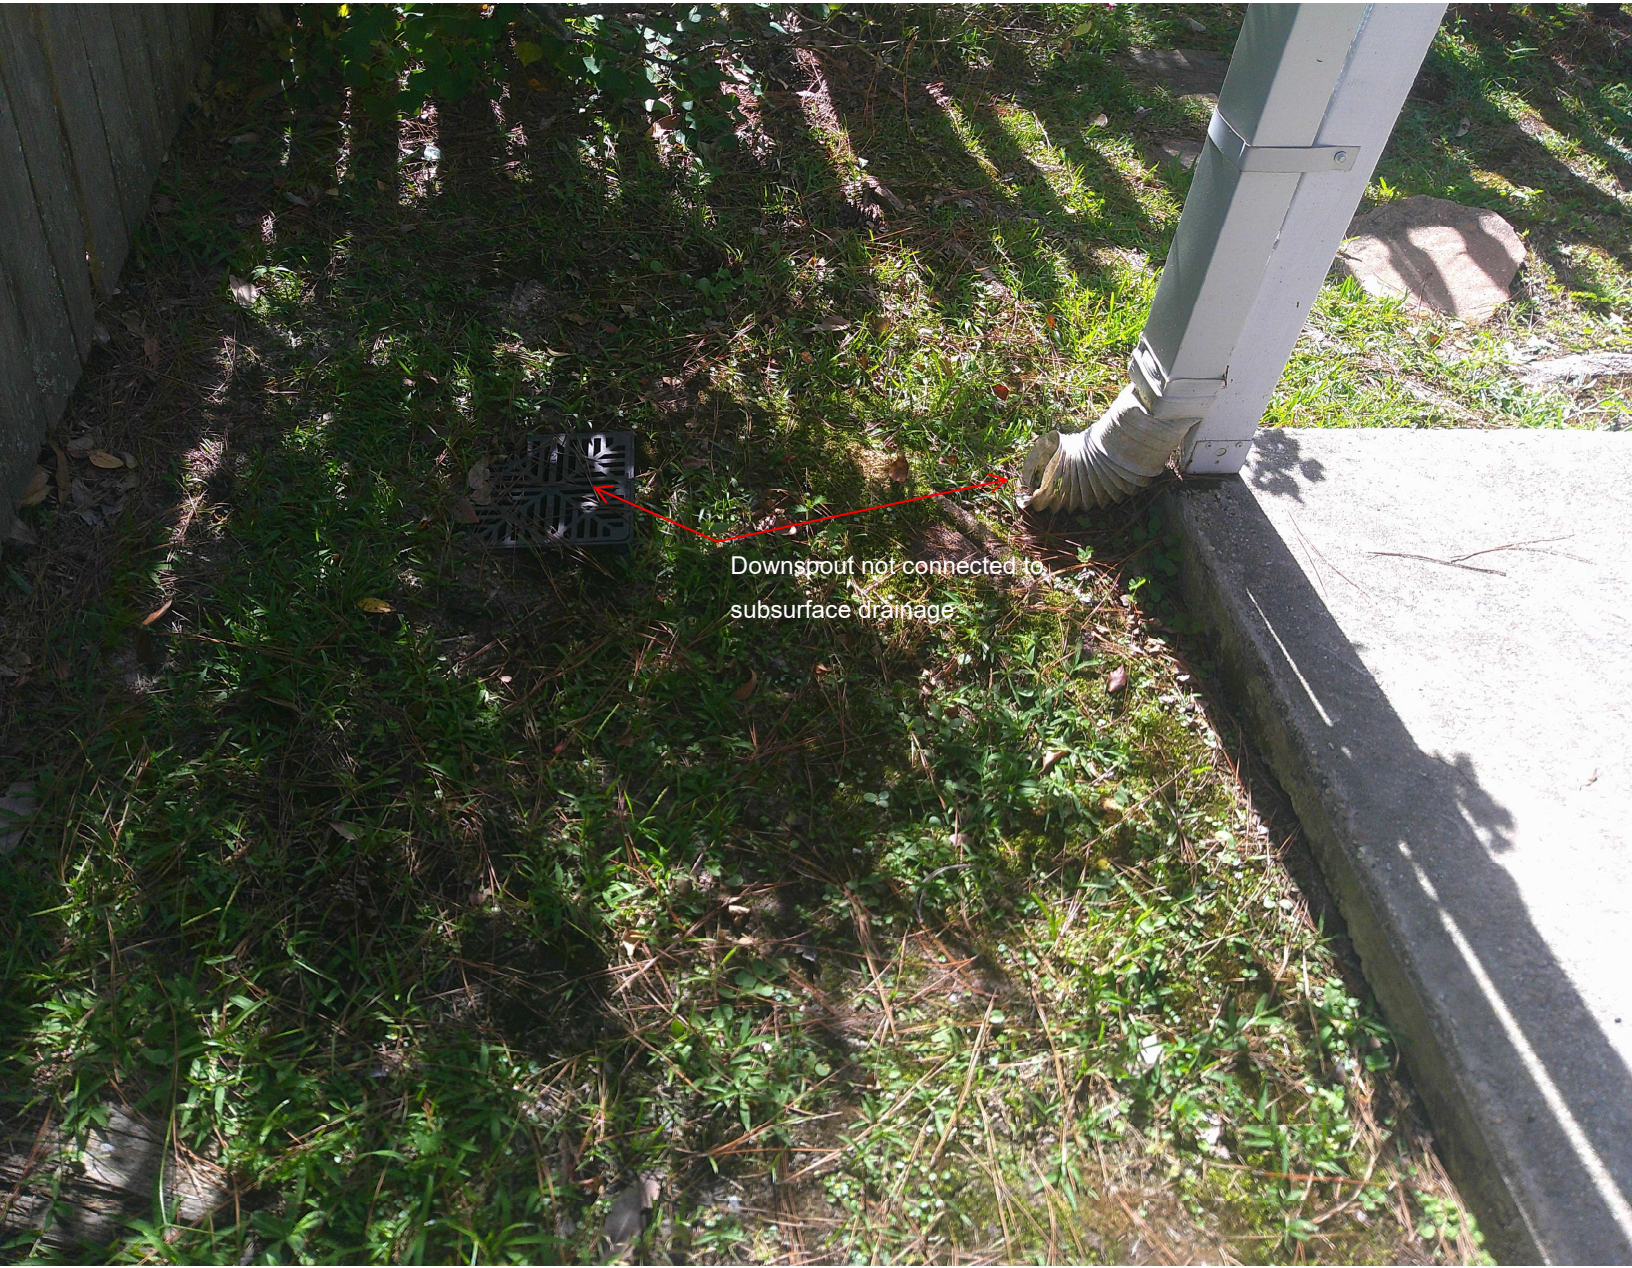
The exterior of the home was noted not to have gutters and down spouts on the home itself. The rear of the home has a covered patio and does have a gutter and down spouts that sheet flow onto the ground to subsurface drainage. Some of the subsurface pipe is cracked and above ground.

Downspout not connected to
subsurface drainage
