Structural Inspection

February 13, 2025

Anthony Herbert
6160 2nd Street
Bay St. Louis, Ms. 39520

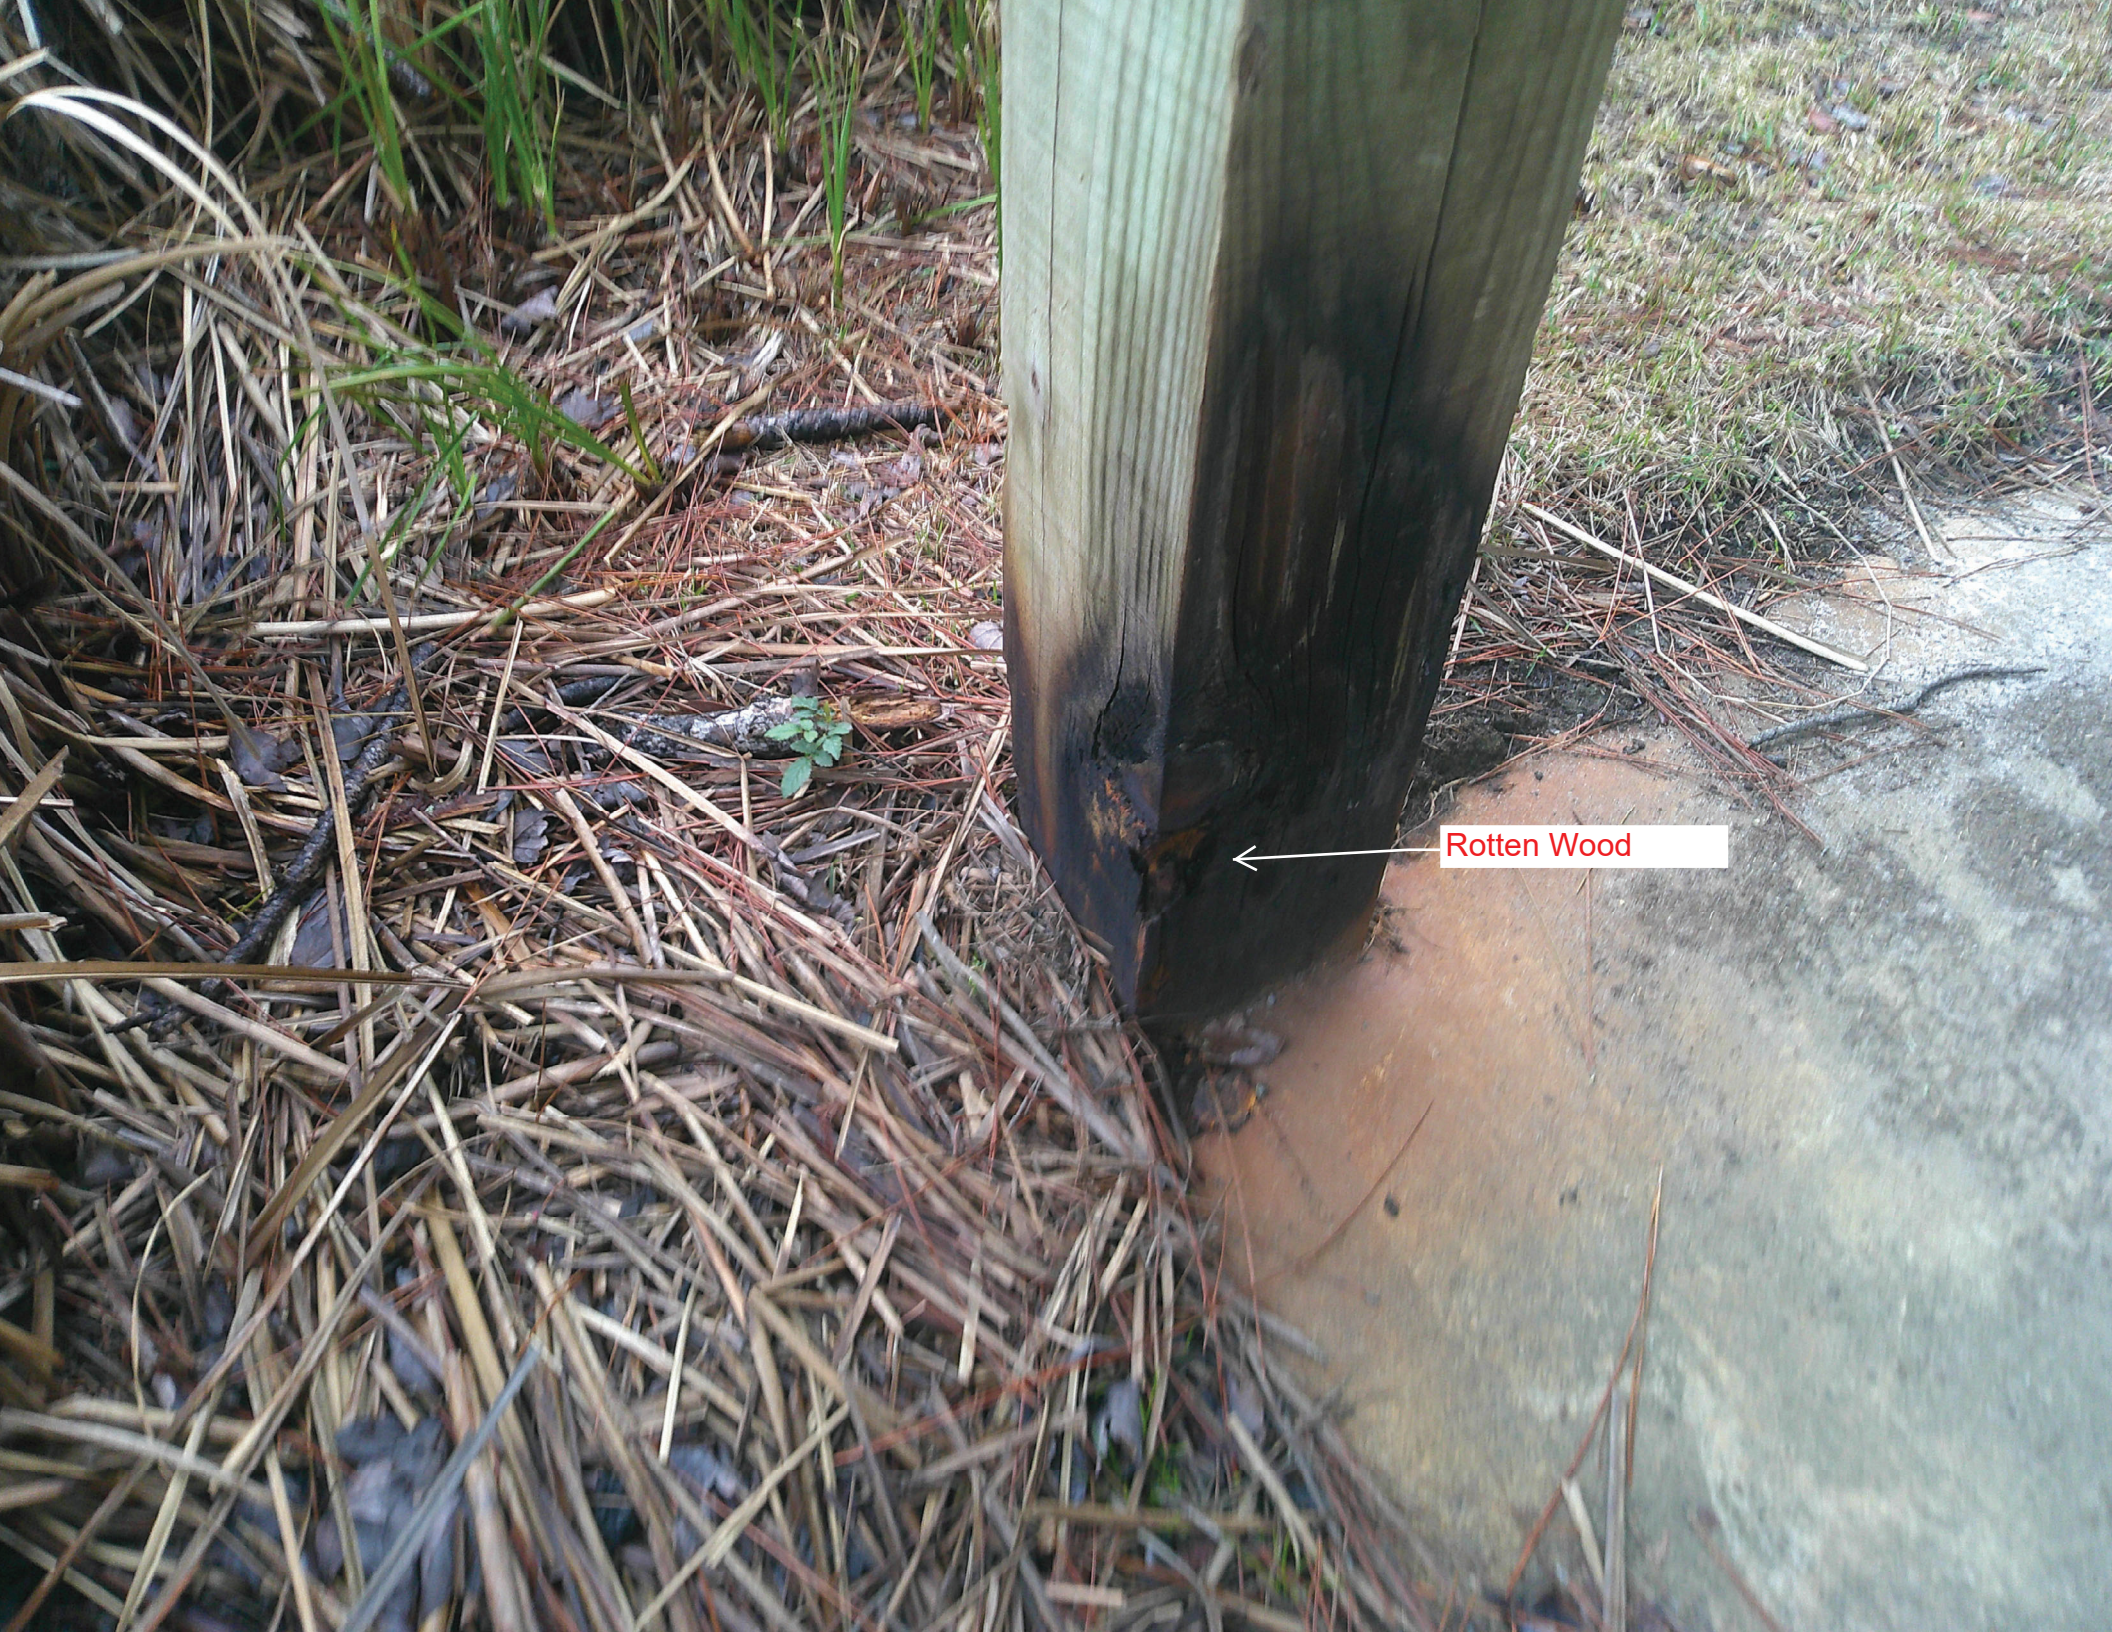
An overall visual inspection was conducted of the 21 8"x 8" wood columns. All of the wood columns have rotten basses at the bottom near the concrete foundation. Some have more damage than others. The signs of damage are noted by the color of the wood. A hammer was used to tap on the columns and listen for the sound of solidness and hollowness. All of these columns have a hollowness sound near the bottom of the column.

Rotten Wood

It is our opinion that all of the wood columns should be replaced or repaired with the same size wood column.

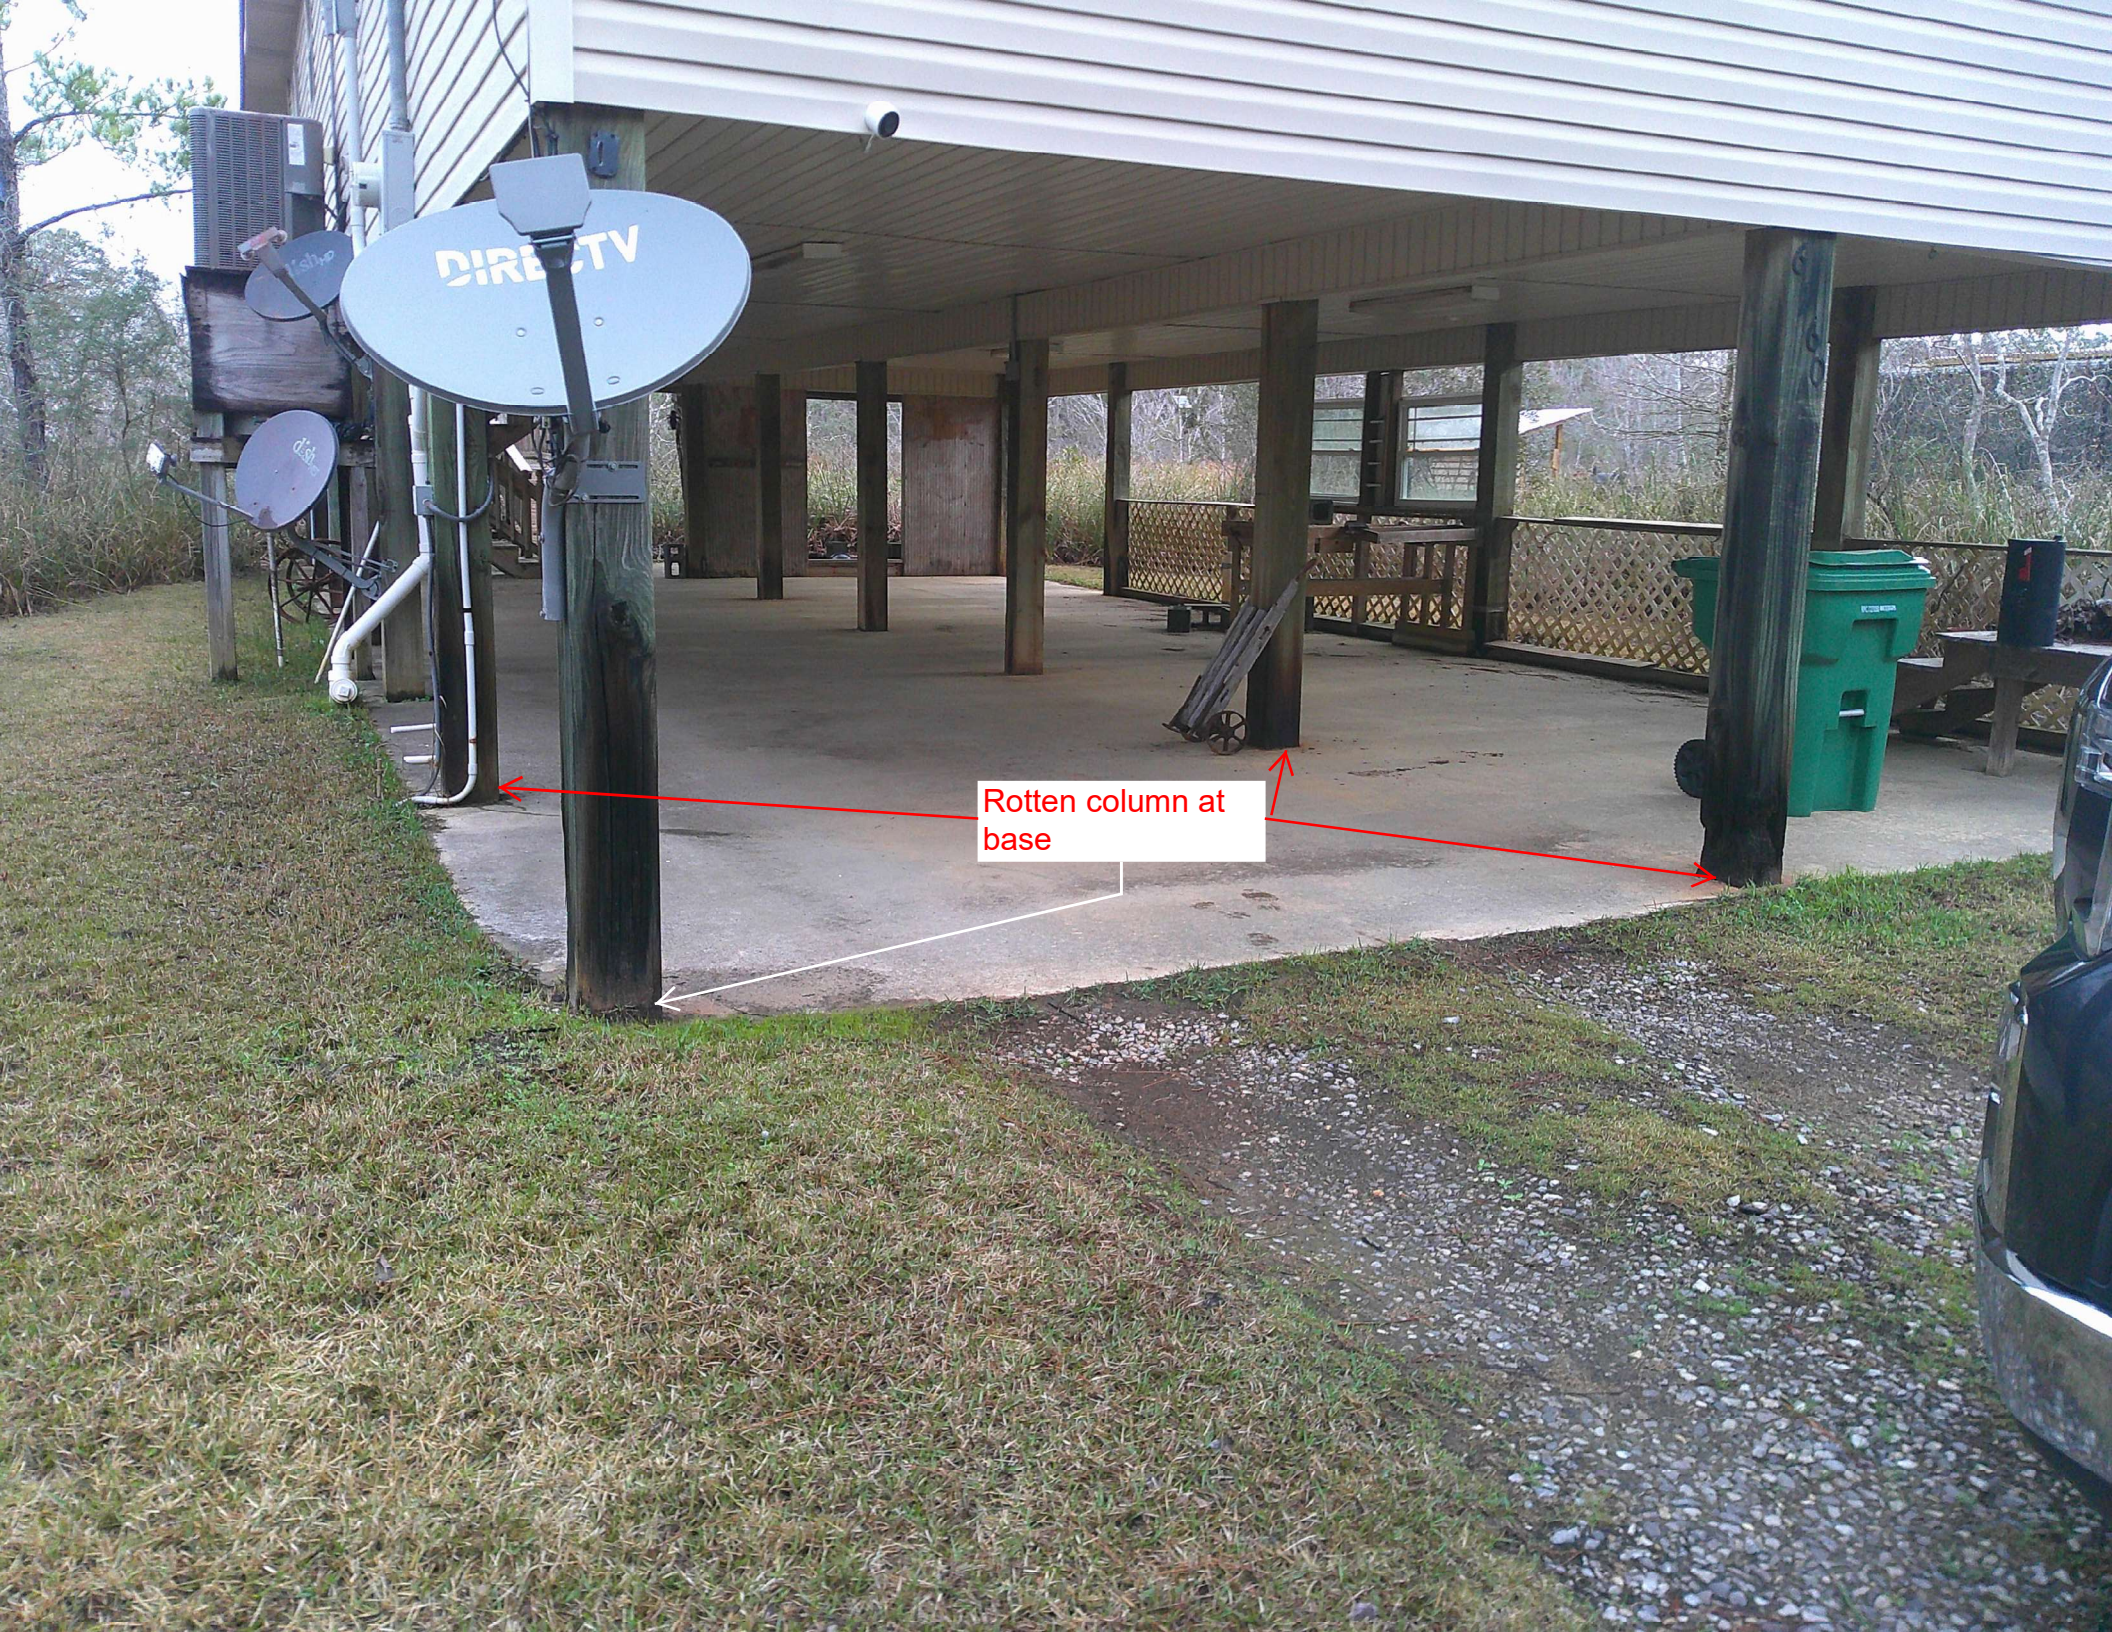
Rotten column at base

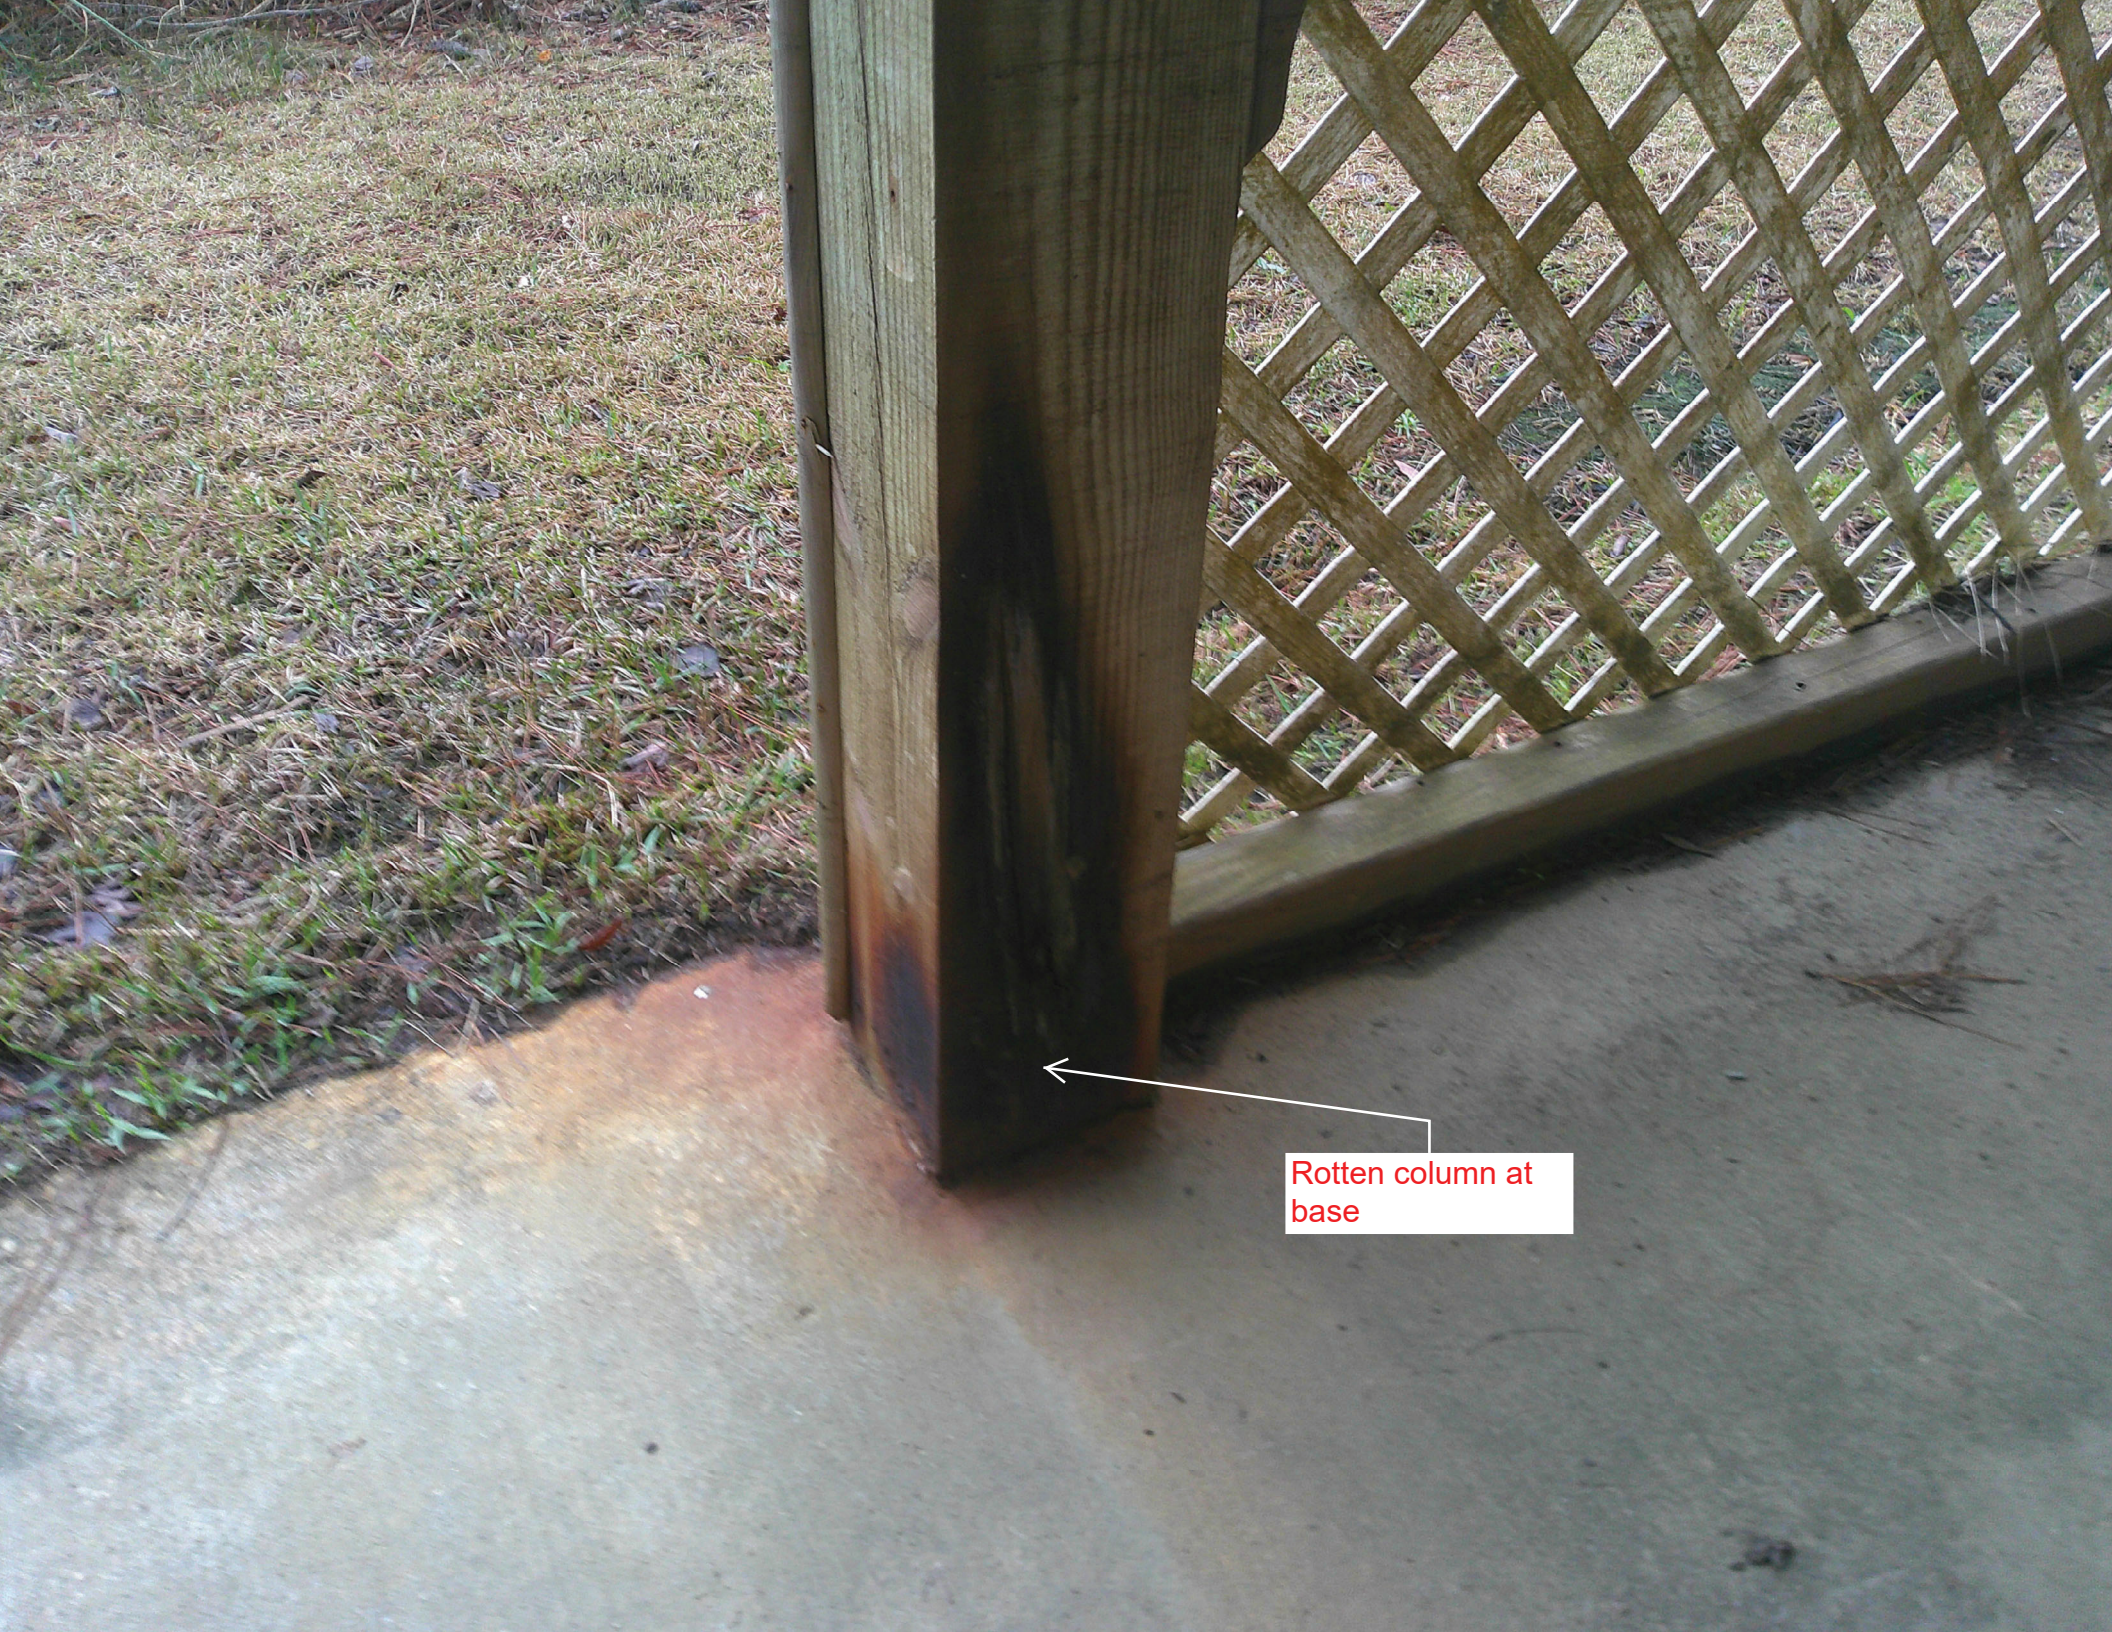
Rotten column at
base

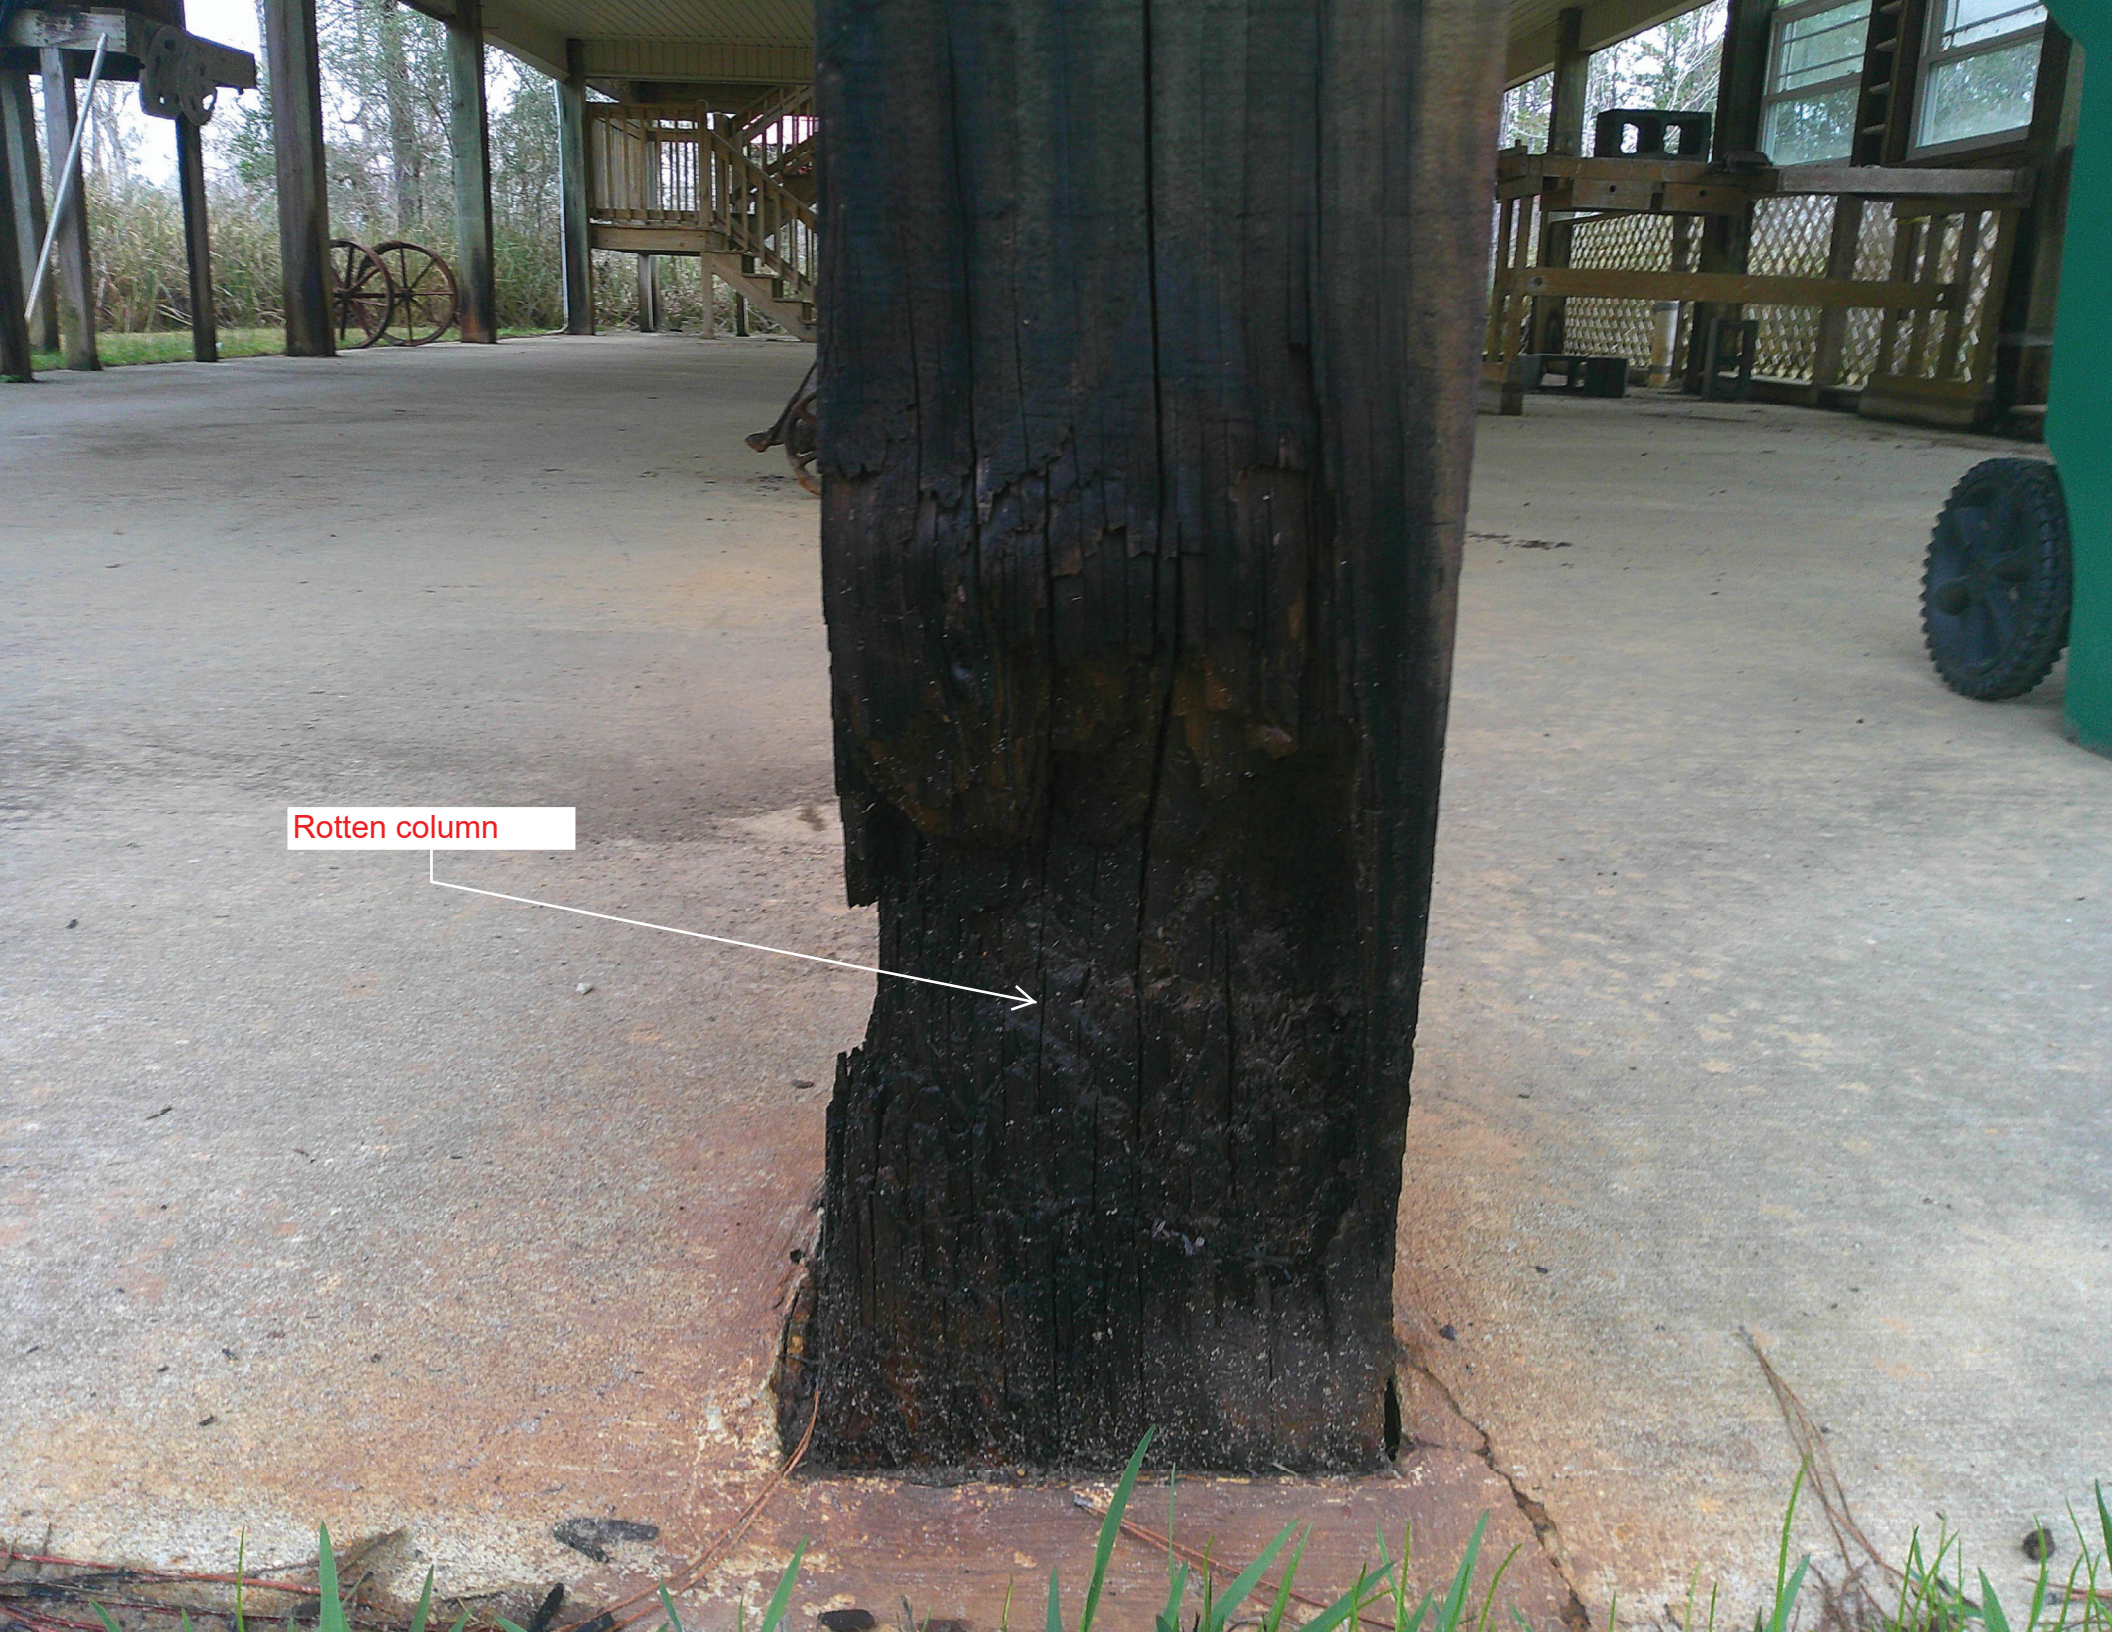
Rotten column
