Structural Inspection

12-03-2025

Amrize
Honey Island Sand and Gravel
70164 Atlas Rd.
Pearl River, Louisiana 70452
November 6, 2025

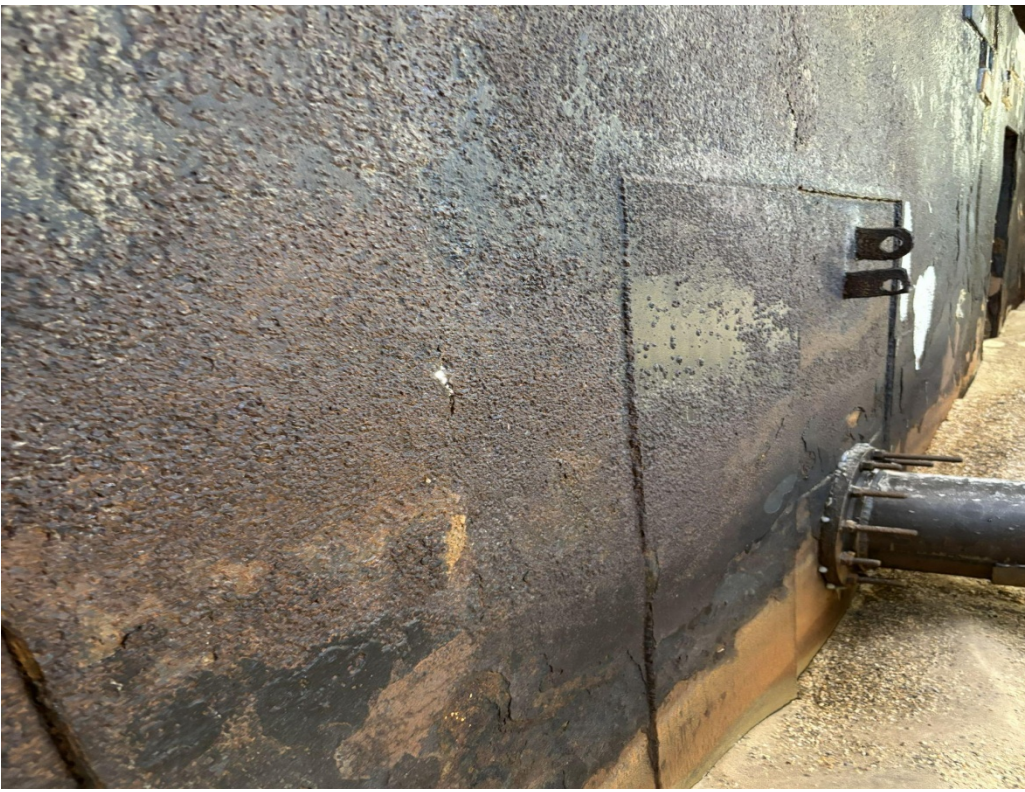
Level one: This level exhibits moderate to severe corrosion on interior structural support. Additional framing has been added in the past to shore up original framing. Exterior plates (photo A) show moderate to heavy surface scaling and several areas have been replated at previous dates. Interior plates (photo B) show moderate to heavy surface scaling. Process Water inlet feed line flanges appear in good shape. Access hatches appear to be in good shape. Structural framing supporting the vibratory shaker exhibits moderate scaling and additional framing has been added in the past to shore up original framing.

(Photo A) Exterior view level one looking northeast

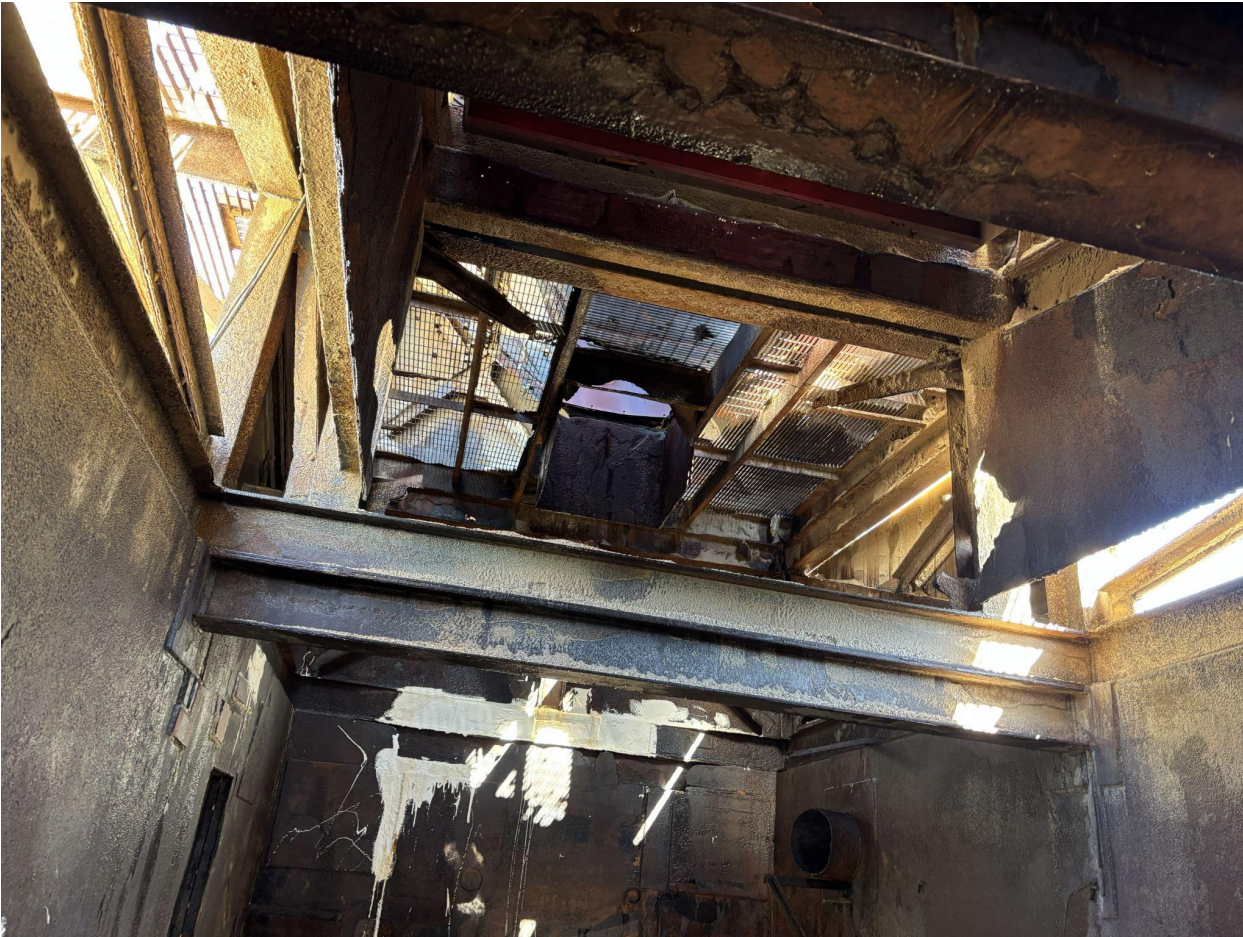
(photo B) Interior view level 1 under vibrator screen looking west

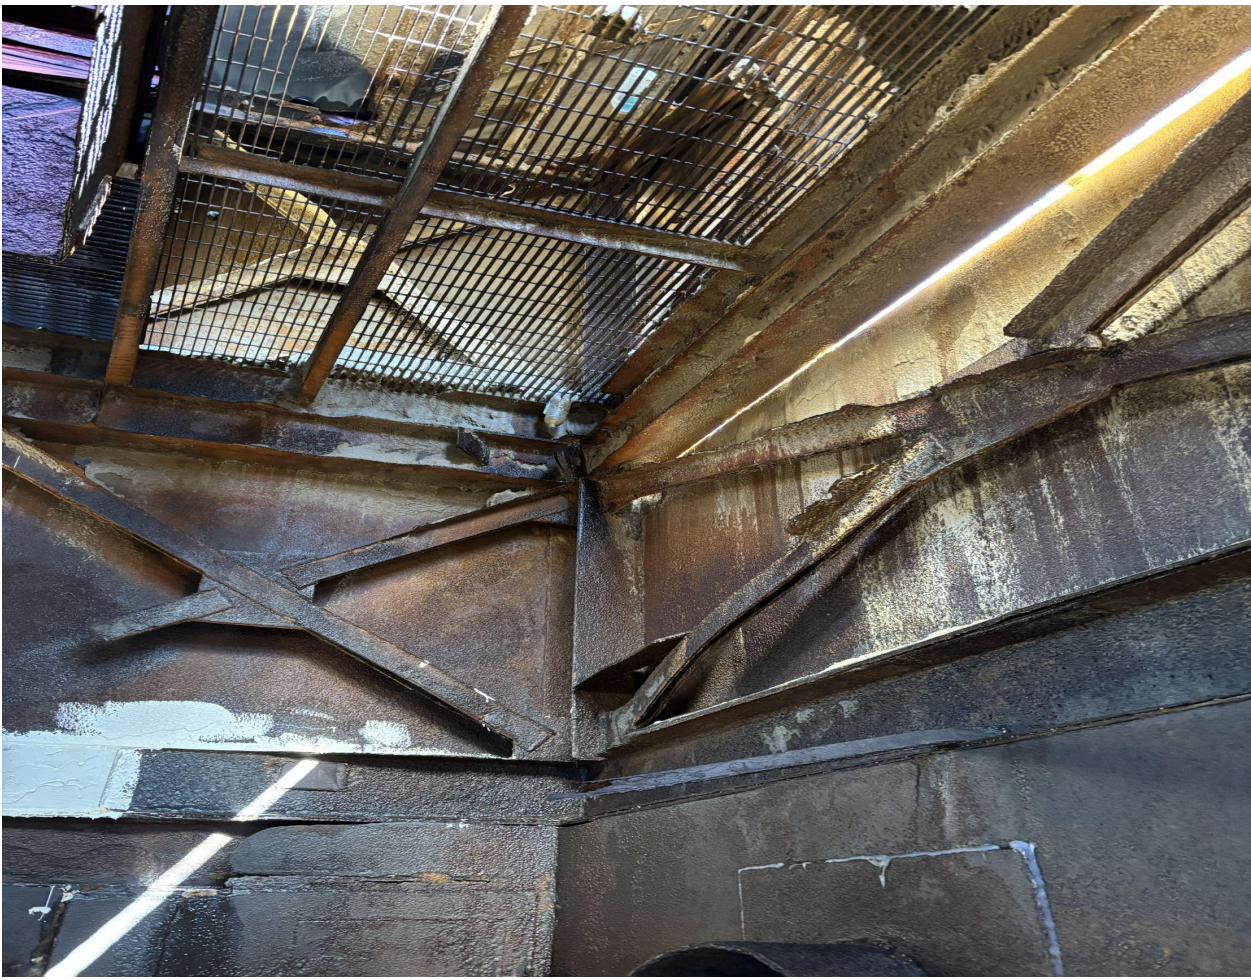
(Photo C)

Level two: This section exhibits severe corrosion and deteriorated structural support members. Several of the lateral X bracing is completely deteriorated and missing. (Photo C and D) The bottom and top wide flange framing around the perimeter between level one and two and level 2 and three is severely deteriorated and in some areas non-existent. The south exterior plating has completely separated for the structural framing. The western vertical support shows buckling at the base. (Photo E)

interior view level two looking northwest

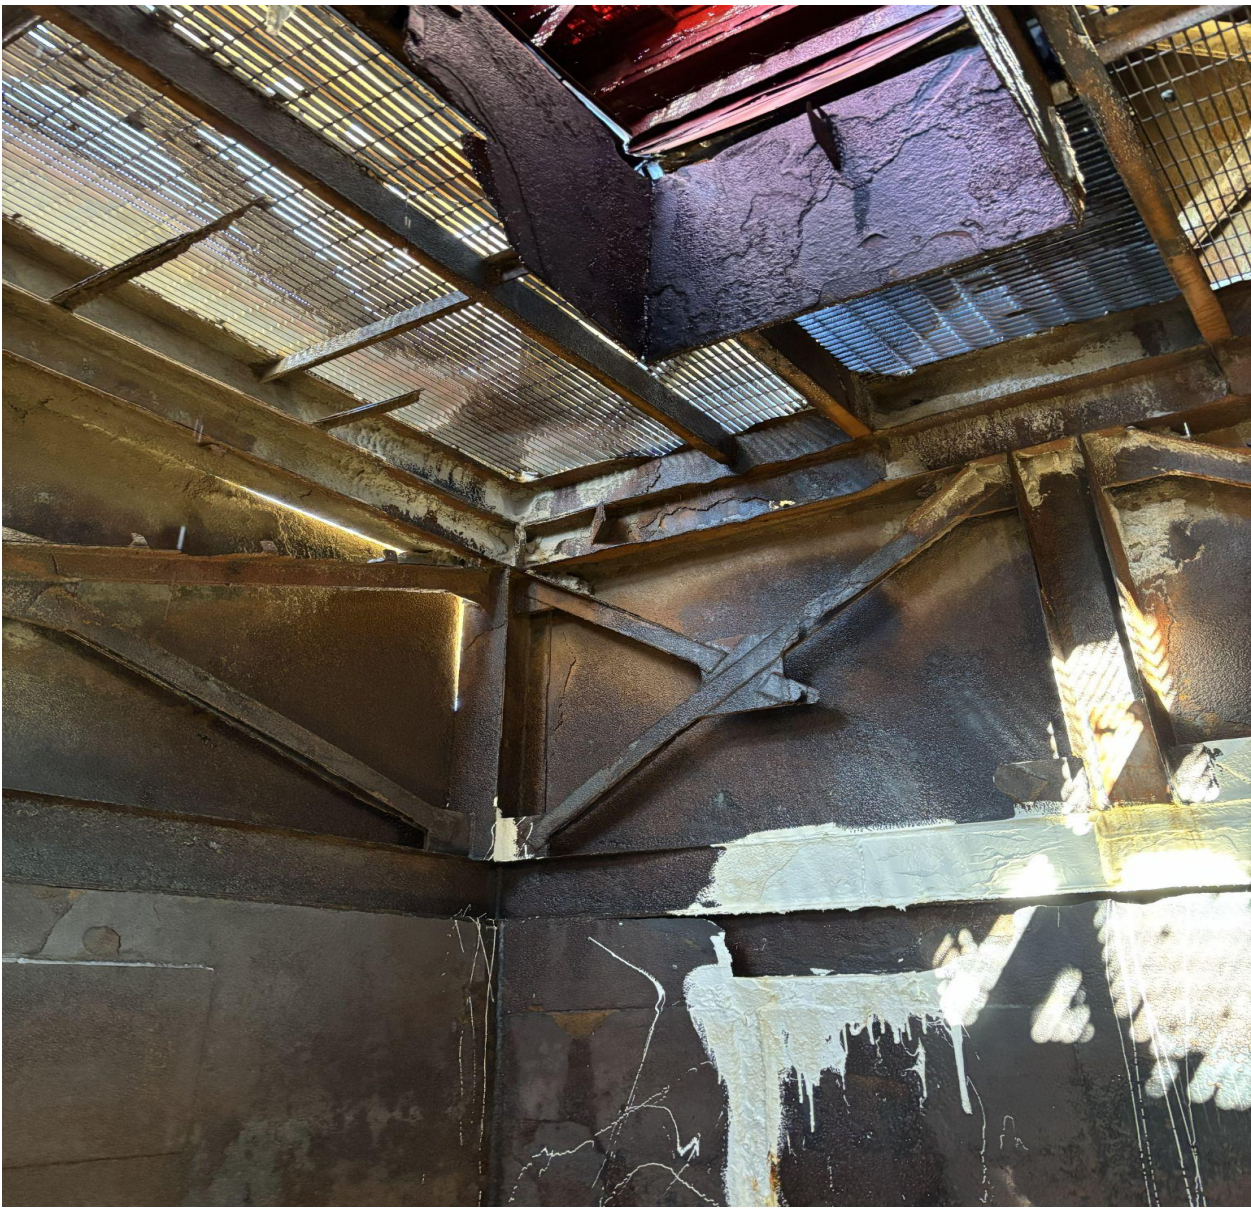
Level three: This section exhibits moderate corrosion and deteriorated structural support members. (Photo D) Floor framing and bar grating appears to be generally intact. Some plates on the hopper are completely corroded thru and missing.

Interior view level 2 looking southwest

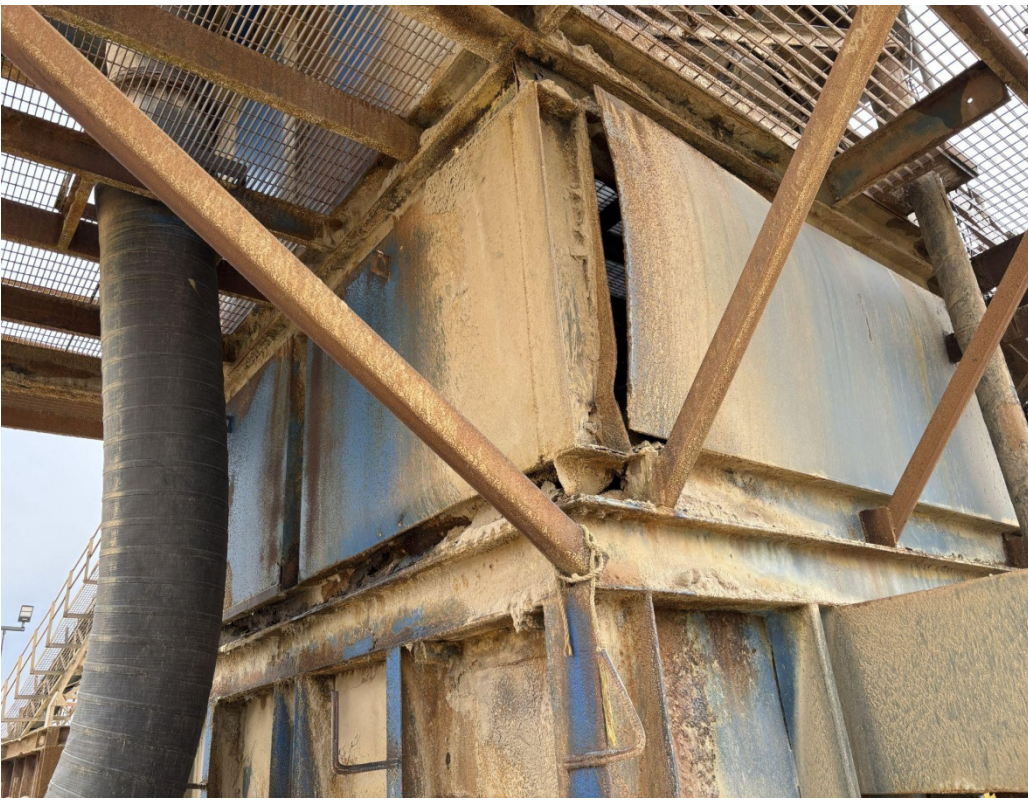
The structure is in imminent state of collapse due to the deteriorated framing between level one and level two.

(Photo E) exterior view level 2 looking north east

It is my recommendation that the structure be completely replaced as soon as possible. Bracing to support the upper level sections will be required to keep the system in operation till a suitable replacement can be installed.

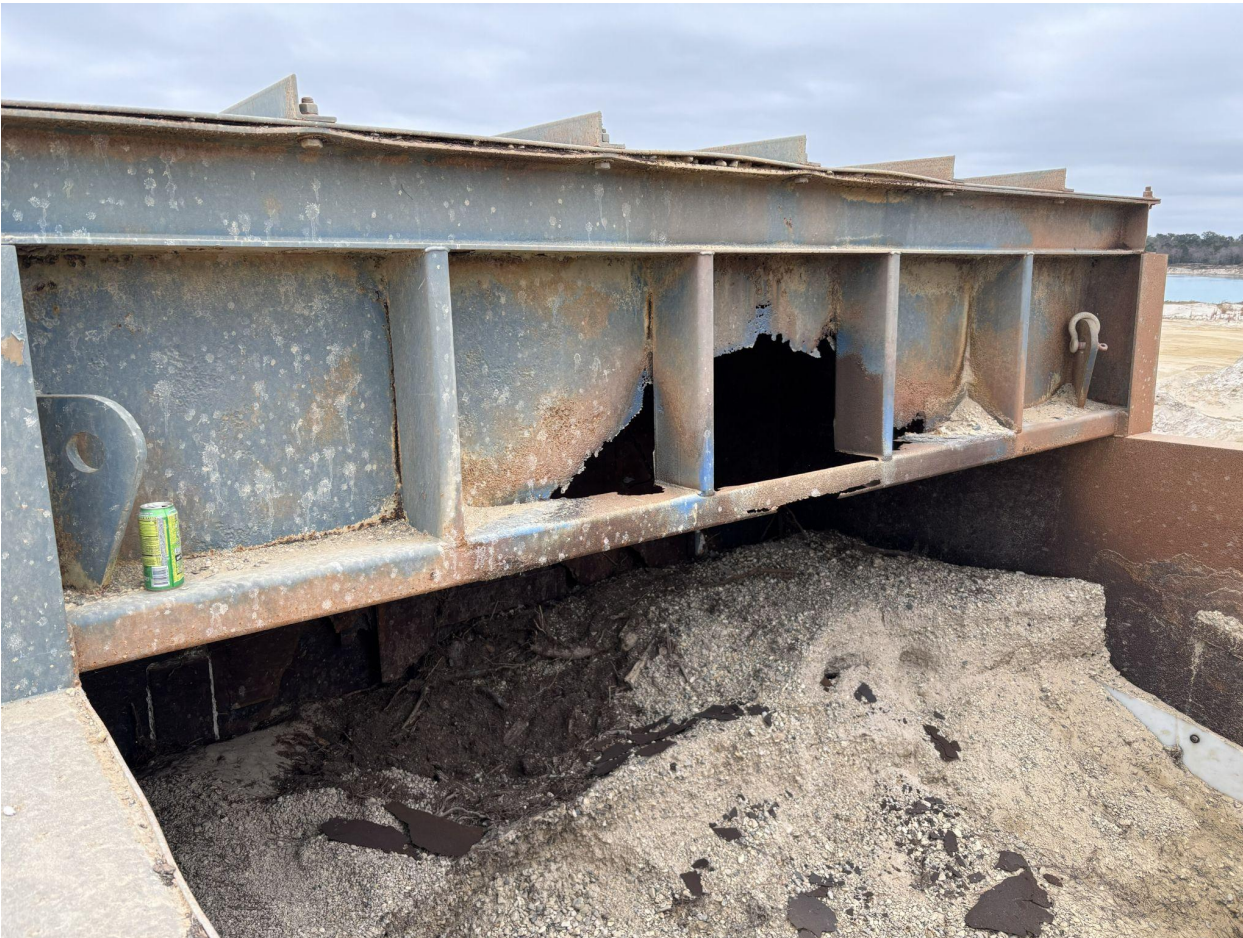
Level four: This section exhibits moderate corrosion and deteriorated structural support members with one cross member completely corroded and missing. (Photo E)

(Photo F) exterior view level 4 looking north west
