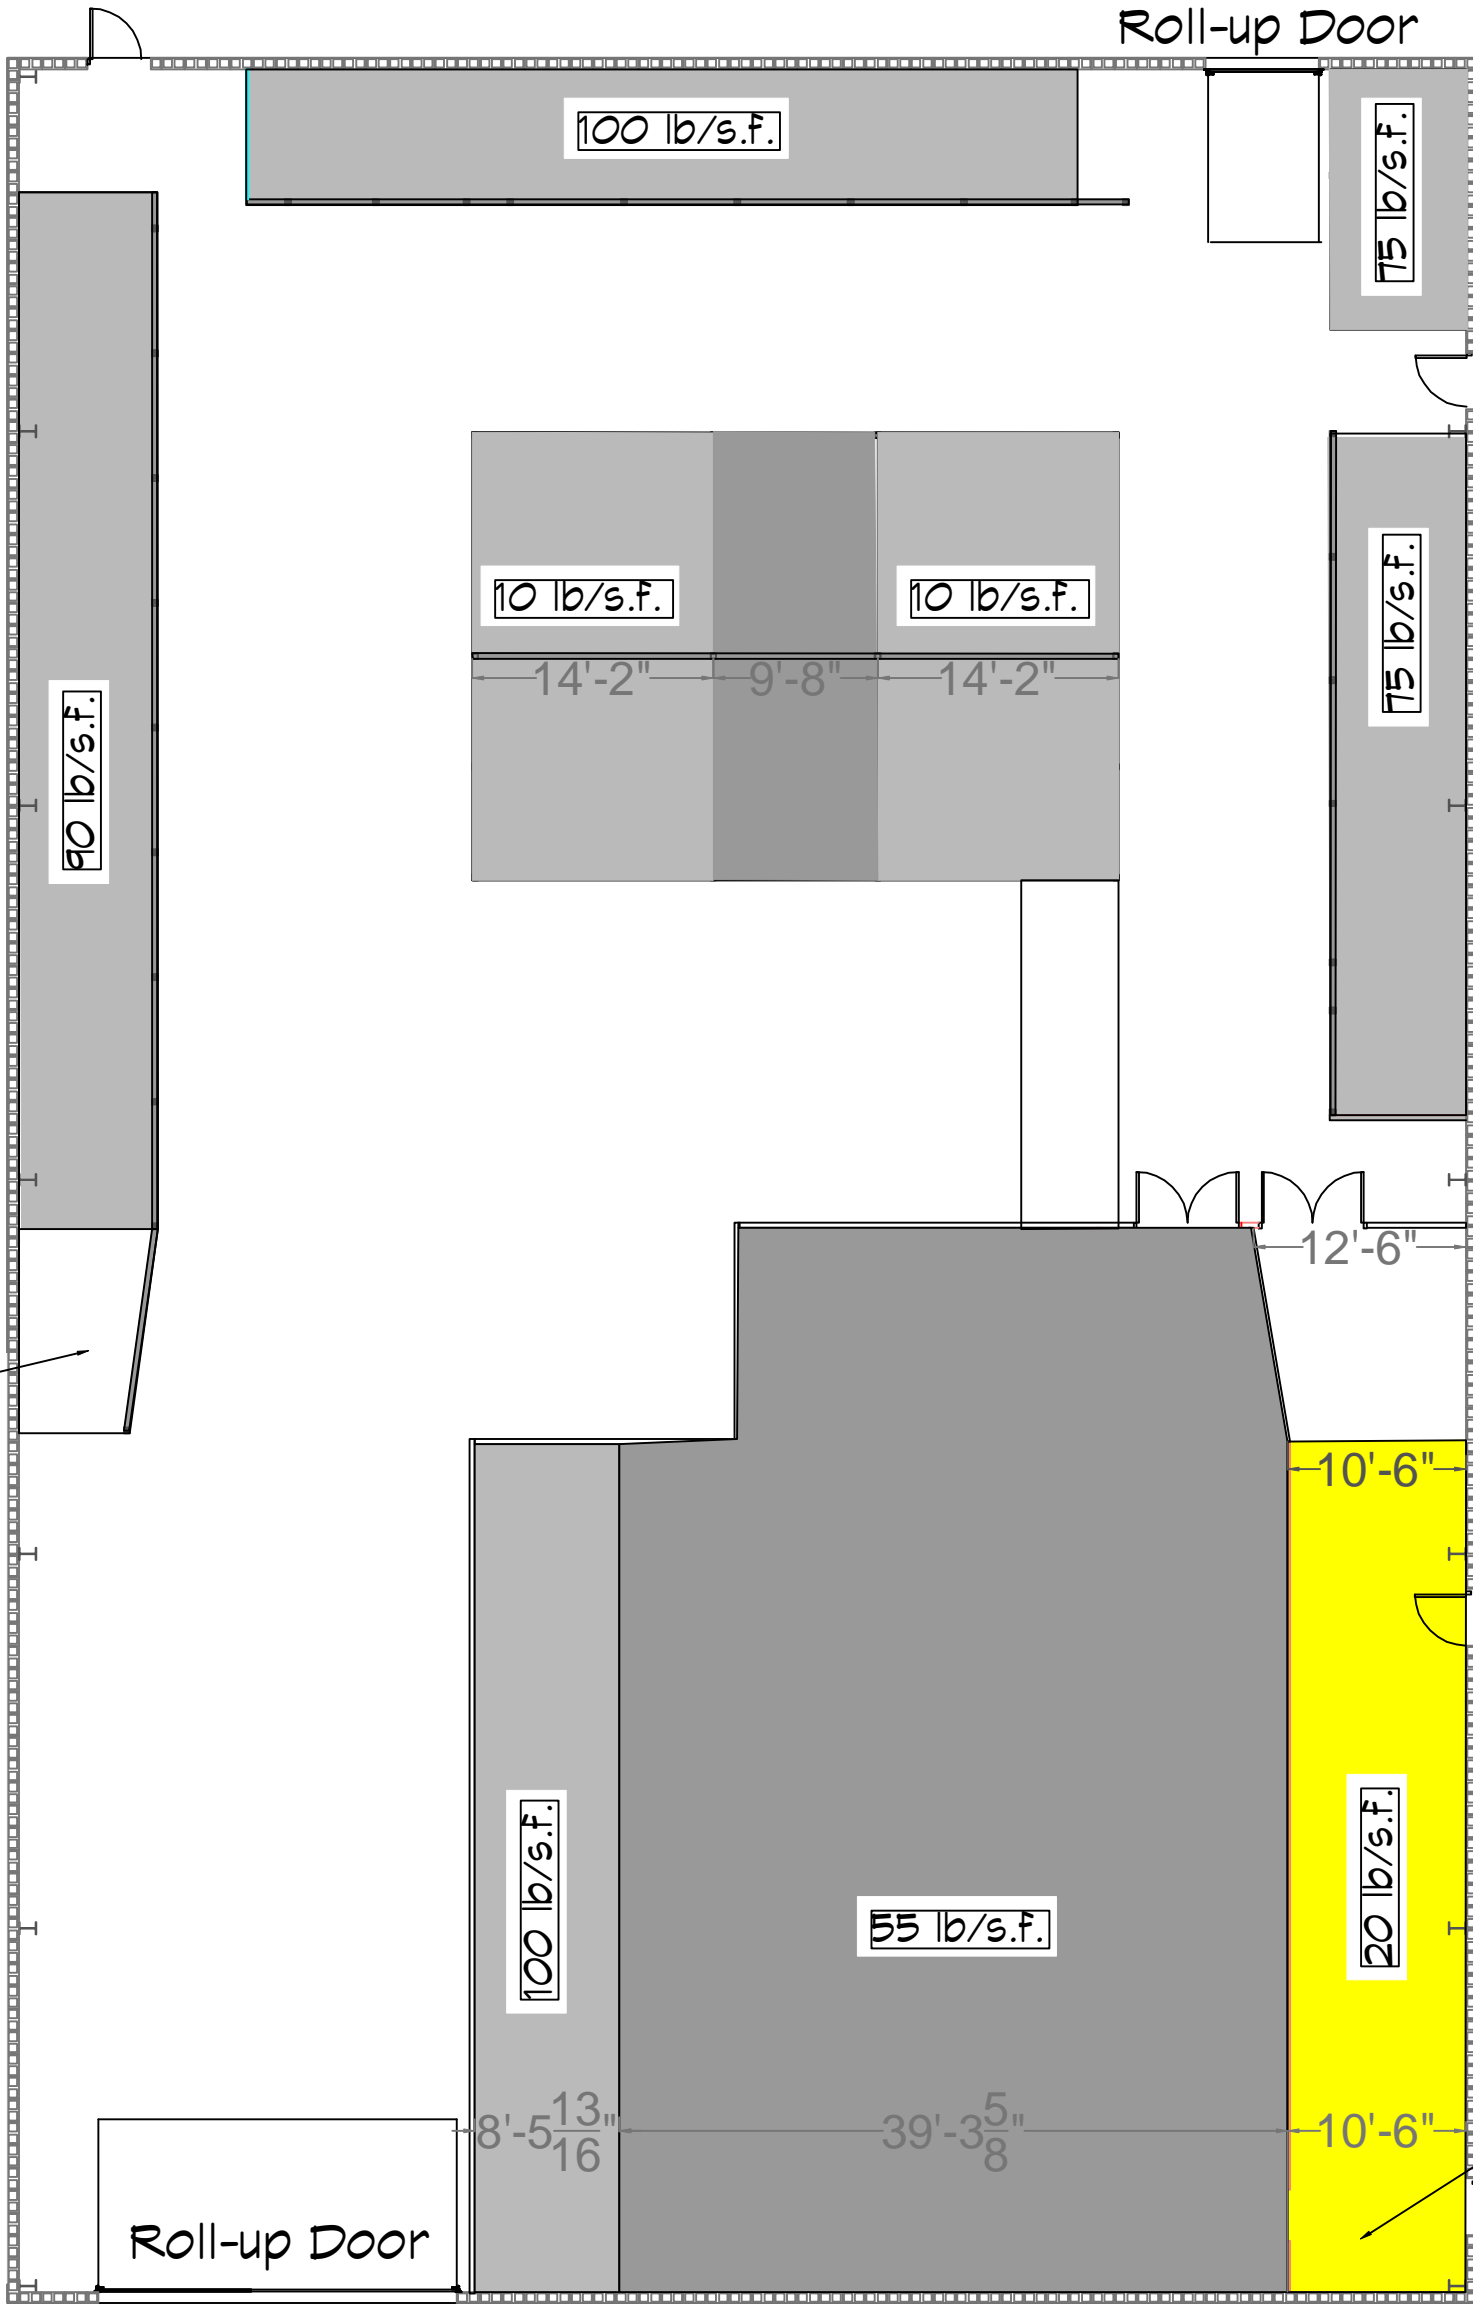
It is not recommended to store anything above this area. Installing a column in the middle of the outside beam will fix this issue. Once corrected it will allow 90 lb/s.f.

This area is limited because of the connection to the CMU wall. If fixed the allowable weight will increase to 90 lb/s.f.
