Acutec Home Inspectors

Home Inspection Report

505 Laurel Oak Drive
Mandeville, La 70471

4/14/2025 4:28:01 PM

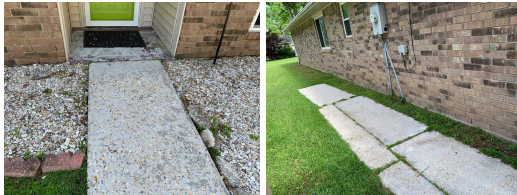
High soil: High soil to foundation noted. The soil should be pulled away from the structure for full evaluation by a licensed termite inspector and to prevent insect and moisture damage. Ideal conditions is having 4 or more inches of visible foundation.

Some areas of foundation were not visible and could not be evaluated.

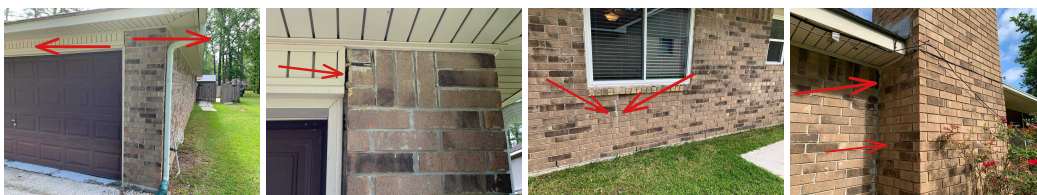
Brick Veneer: One or more bricks are loose with signs of wall movement. These should be secured to prevent further movement, damage or injury.

The corner of the structure appeared to have moved with signs of ongoing sealant separation. Previous repair or improvement noted. Further evaluation and repair by a licensed contractor is recommended.

Cracks were found in one or more sections of brick veneer. A qualified contractor should evaluate to determine the cause of movement and to make necessary repairs or improvements, such as re-pointing mortar to prevent water intrusion and further deterioration in the future. Some areas with tight cracks may need only monitoring for further movement.

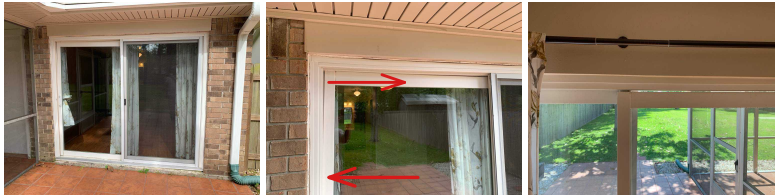
Entry Doors: The sliding door was racked in the jamb. Improvement recommended. This door was not tested.

Moisture damaged components were present on the interior at this location.

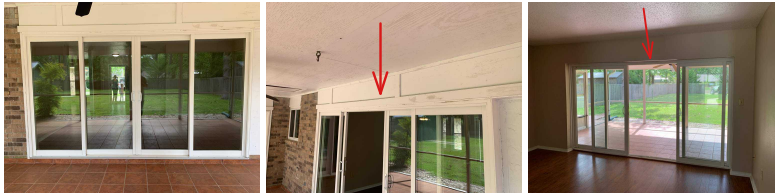
Entry Doors: The wall structure/ visible trim above the door was bowed. The cause was not determined.

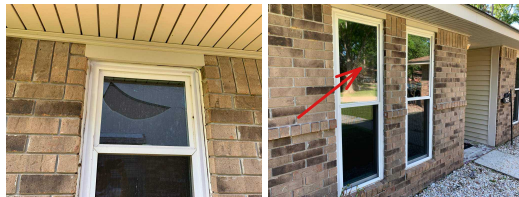
Windows: Broken window noted. Replace as necessary.

The thermal seal appears to be broken on one or more window assemblies as there are signs of moisture visible between the two layers of glass. When the seal is no longer air tight, the unit typically needs to be replaced. Some windows will not show signs until weather conditions change, others may be broken but not visible during inspection.

Included pictures are some of the windows that appeared defective at the time of inspection, but are only a representative of the possible number of windows with bad seals. All should be further evaluated by a qualified window professional.

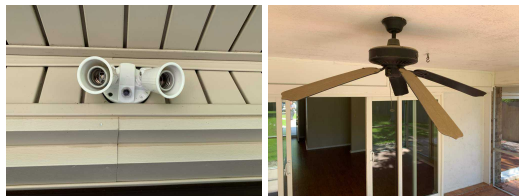
Lighting: Bulbs are broken or missing from one or more fixtures. Replace and test all.

The fan blades were dropped down.

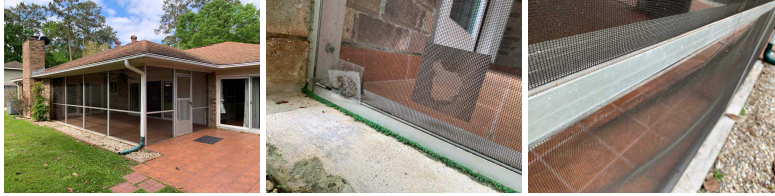
Porch / Patio: Loose and damaged screen noted.

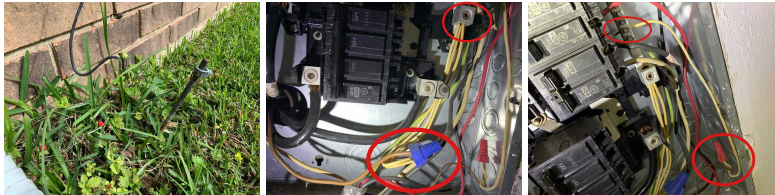
1. **Service Size Amps:** Not determined **Volts:** 110-240 Not verified
2. Marginal **Ground Rod:** Could not verify, further evaluation is recommended. -

A small ground rod was present, but no wires were connected.

Questionable ground connection noted inside the panel. Further evaluation by a licensed electrician is recommended.

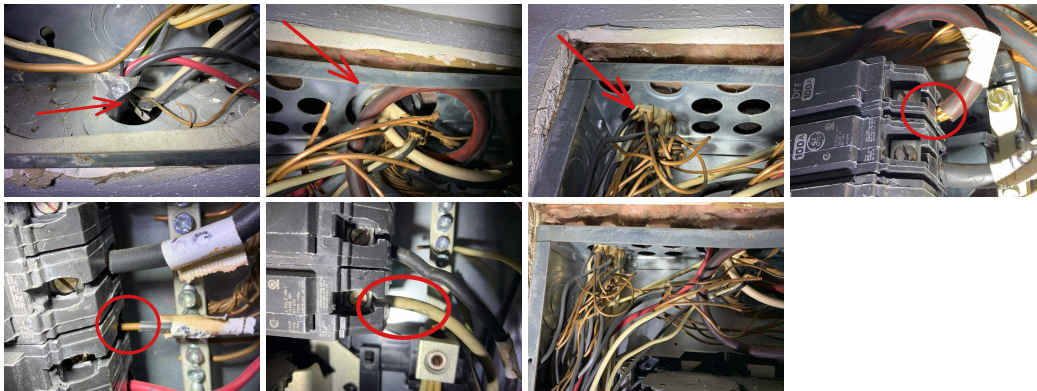
Bushings were missing where wires enter box. Bushings prevent wire damage from metal holes and this helps prevent electrical and fire hazards from wires shorting out.

White wires are neutral and black wires are Hot, which carry live electricity. When white wires are used on the Hot side, they must be marked with black tape or marker to identify being hot and help eliminate electrical hazards. One or more white wires are used as hot wires without proper markings, a qualified contractor should evaluate further.

There were several loose/ cut ground wires present. Further evaluation by a licensed electrician is recommended.

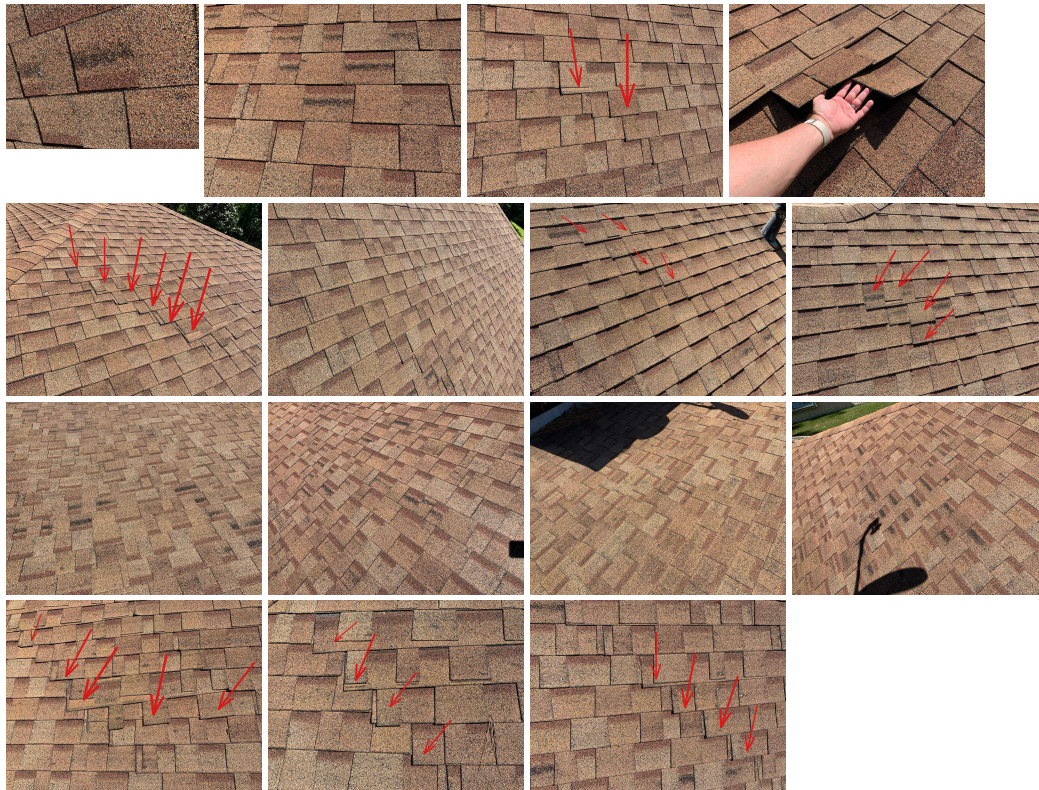
The shingles were loose/ damaged and sliding free from the roof throughout.

Worn and damaged shingles noted.

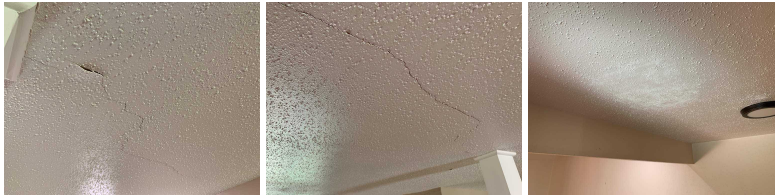
Ceiling: Irregular cracks noted with possible signs of movement.

Previous repairs were noted.

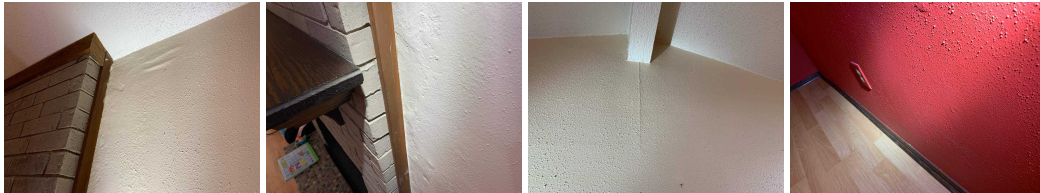
Walls: Damage with previous repairs noted.

Cracks were present in areas with possible signs of movement.

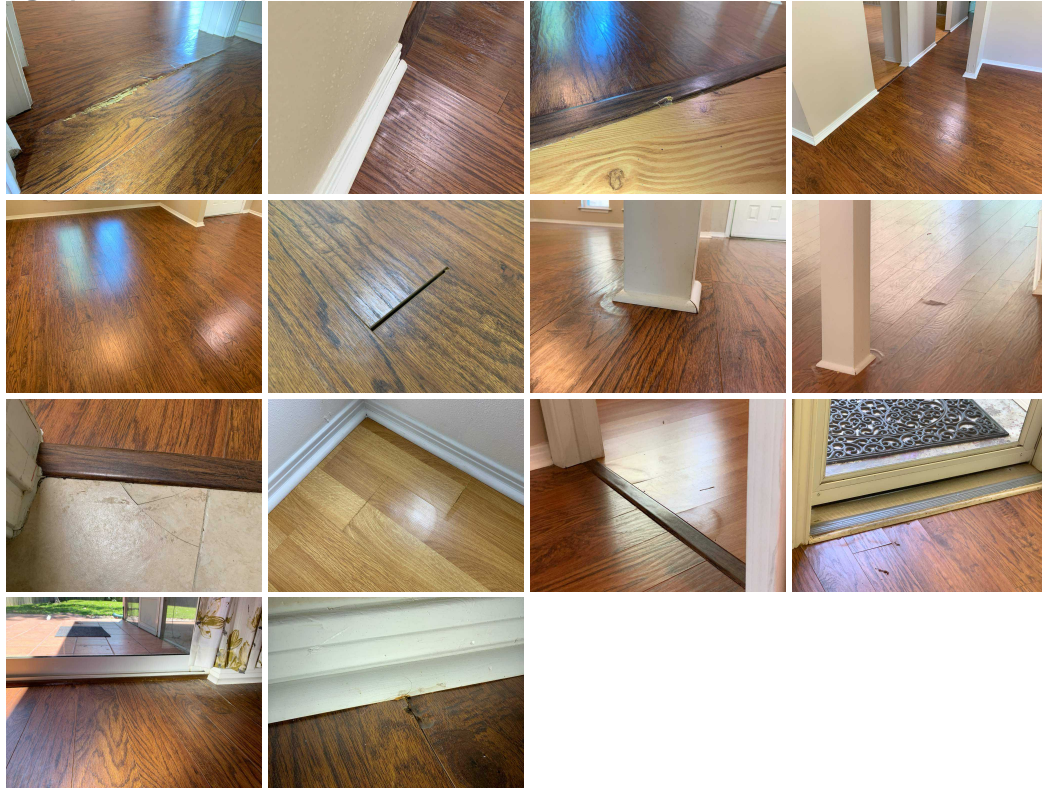
Floor Covering: Damaged flooring and trim noted throughout.

The floor appeared to be floating with open air below in areas. The flooring would drop down with cracking noises when stepped on.

Gaps were visible in flooring, the cause was not determined. Repair as necessary.

Broken tile noted.

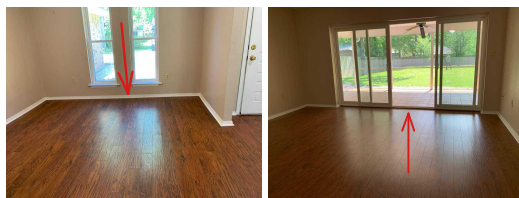
Floor: The floor did not appear to be level throughout. Further evaluation by a qualified contractor is recommended.

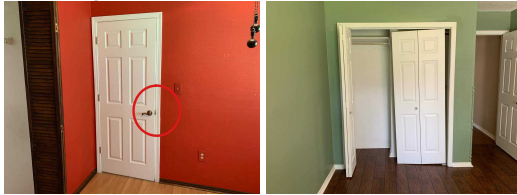
Doors: One or more doors appear to need adjustment as they were difficult to operate or would stick in the jamb during testing. The cause was not determined, but may indicate structural movement. A further evaluation is recommended.

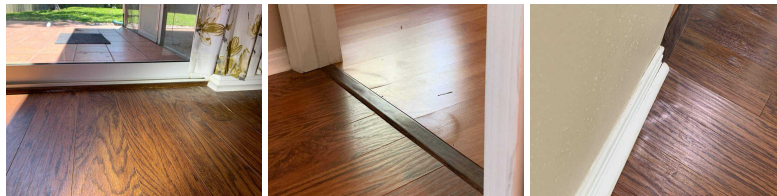
There were one or more areas with visible growth or signs of possible water leaks, which could promote growth, noted inside this structure. Please see pictures showing growth observed and/or possible leaks or stains reported during this inspection, throughout this report.

The details of the growth are unknown and determining it is beyond the scope of this home inspection. All areas of elevated humidity or signs of moisture, stains should be evaluated by a qualified contractor as these can promote growth and adverse conditions.

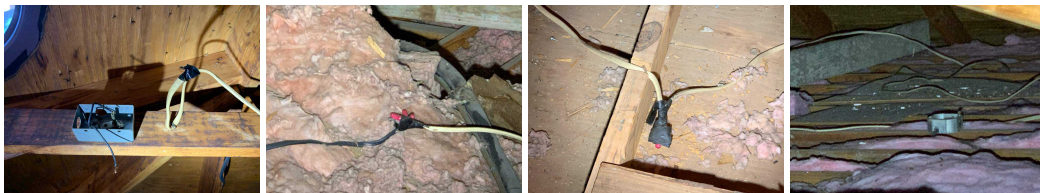
5. Defective **Wiring/Electrical:** Wires terminate in attic. These should be in a junction box to prevent electrical and fire hazards.

Exposed wire splices/ connections visible. These should be made inside a junction box.

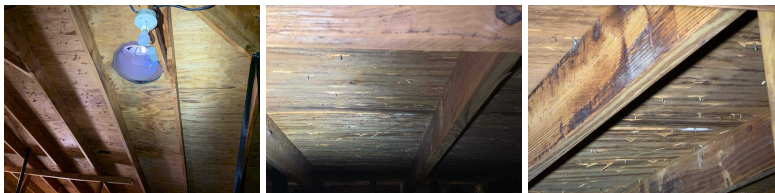
8. Marginal **Sheathing:** Plywood, partially visible
- Water stains/damage present in one or more areas. Further evaluation required.

There were no visible H clips between decking boards in areas. Uneven decking noted.
