Summary of Findings of our Site Inspection, Plans and Specifications Review and Design Responsibilities as it Relates to Trusses Supplied by Clearspan Components, Inc.

For the
LaQuinta Inn 957 Cedar Lake Rd, Biloxi, MS

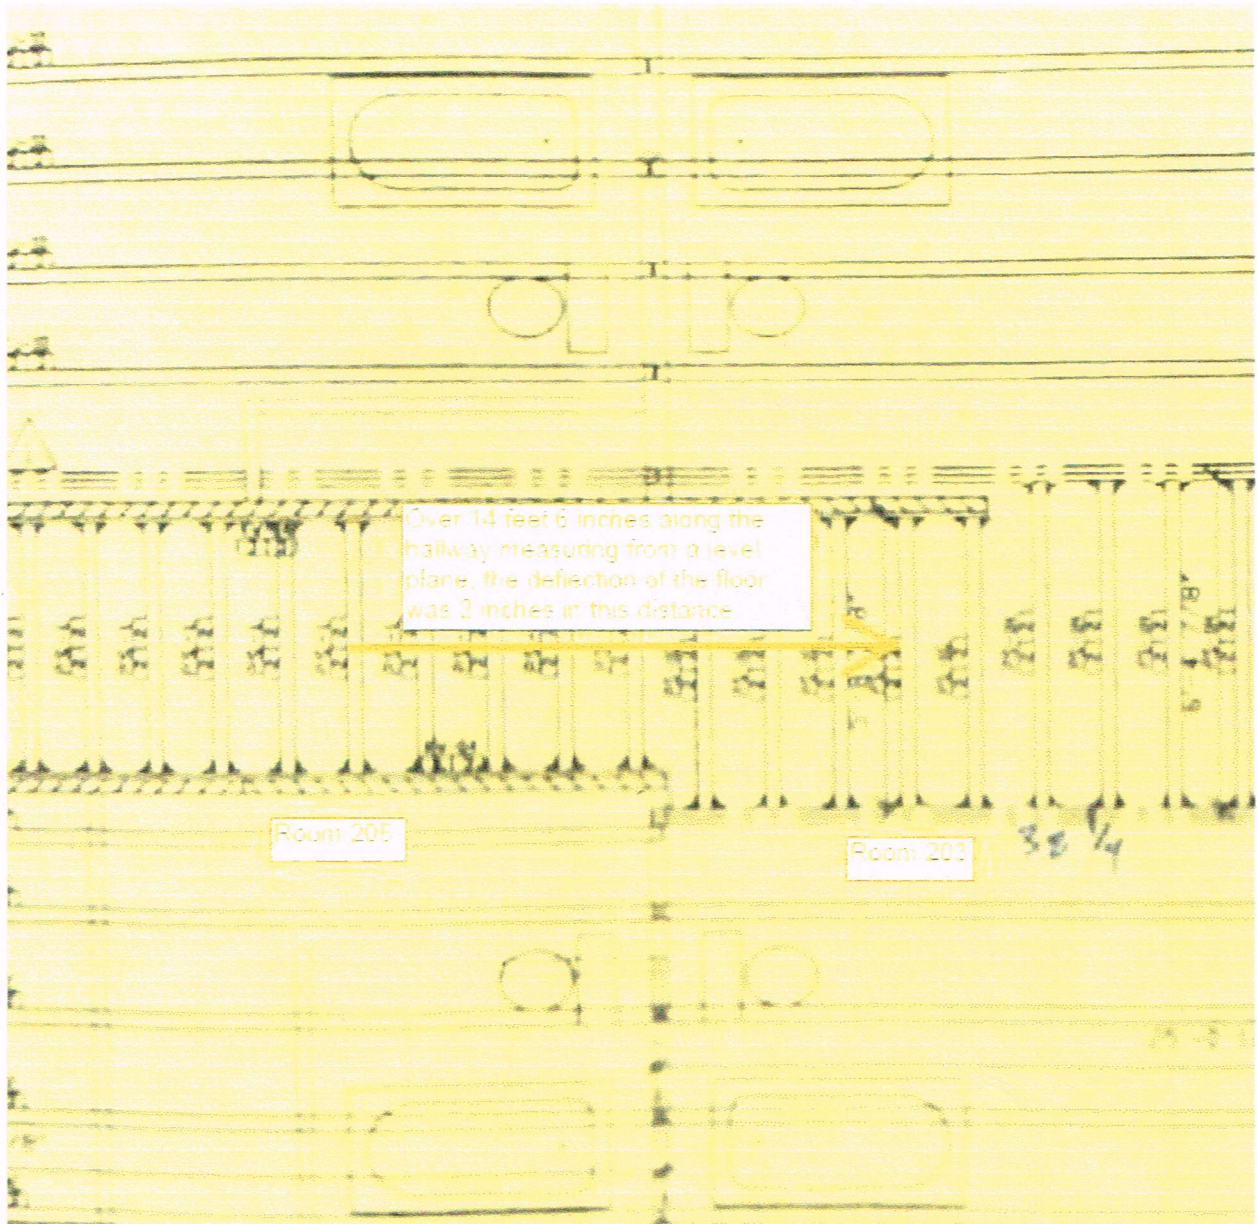
Figure 2: Truss Layout and Laser Level Deflection Measurements in the Hallway near rooms 203, 204, 205 and 206.
 Case: 24CI2:08-cv-00277 Document #: 86-1 Filed: 02/01/2013 Page 6 of 31 Page 6 of 31

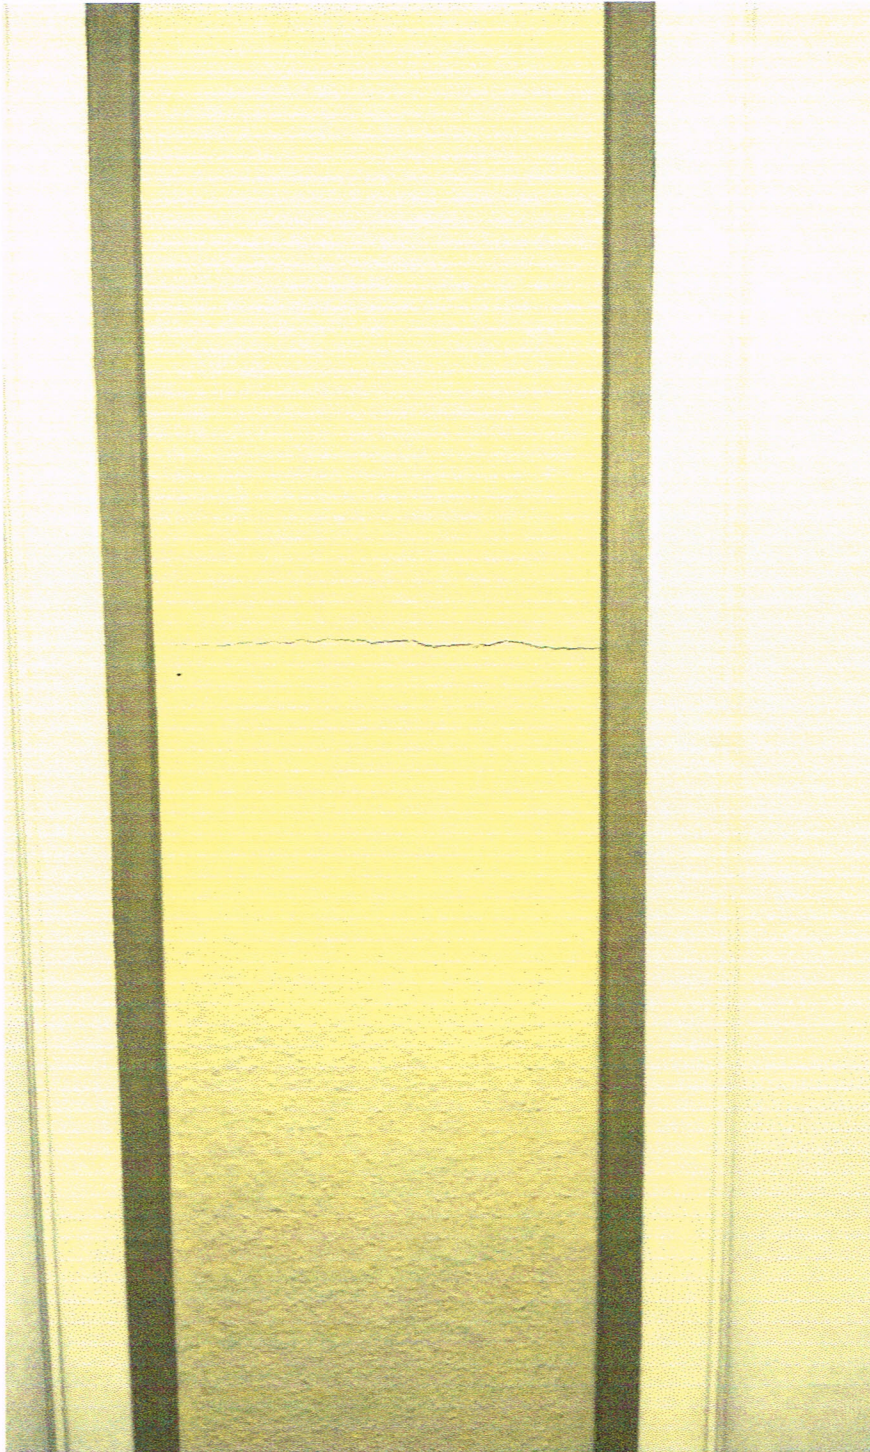
Photograph 1: Hallway gypsum wallboard cracking near rooms 203 and 205.

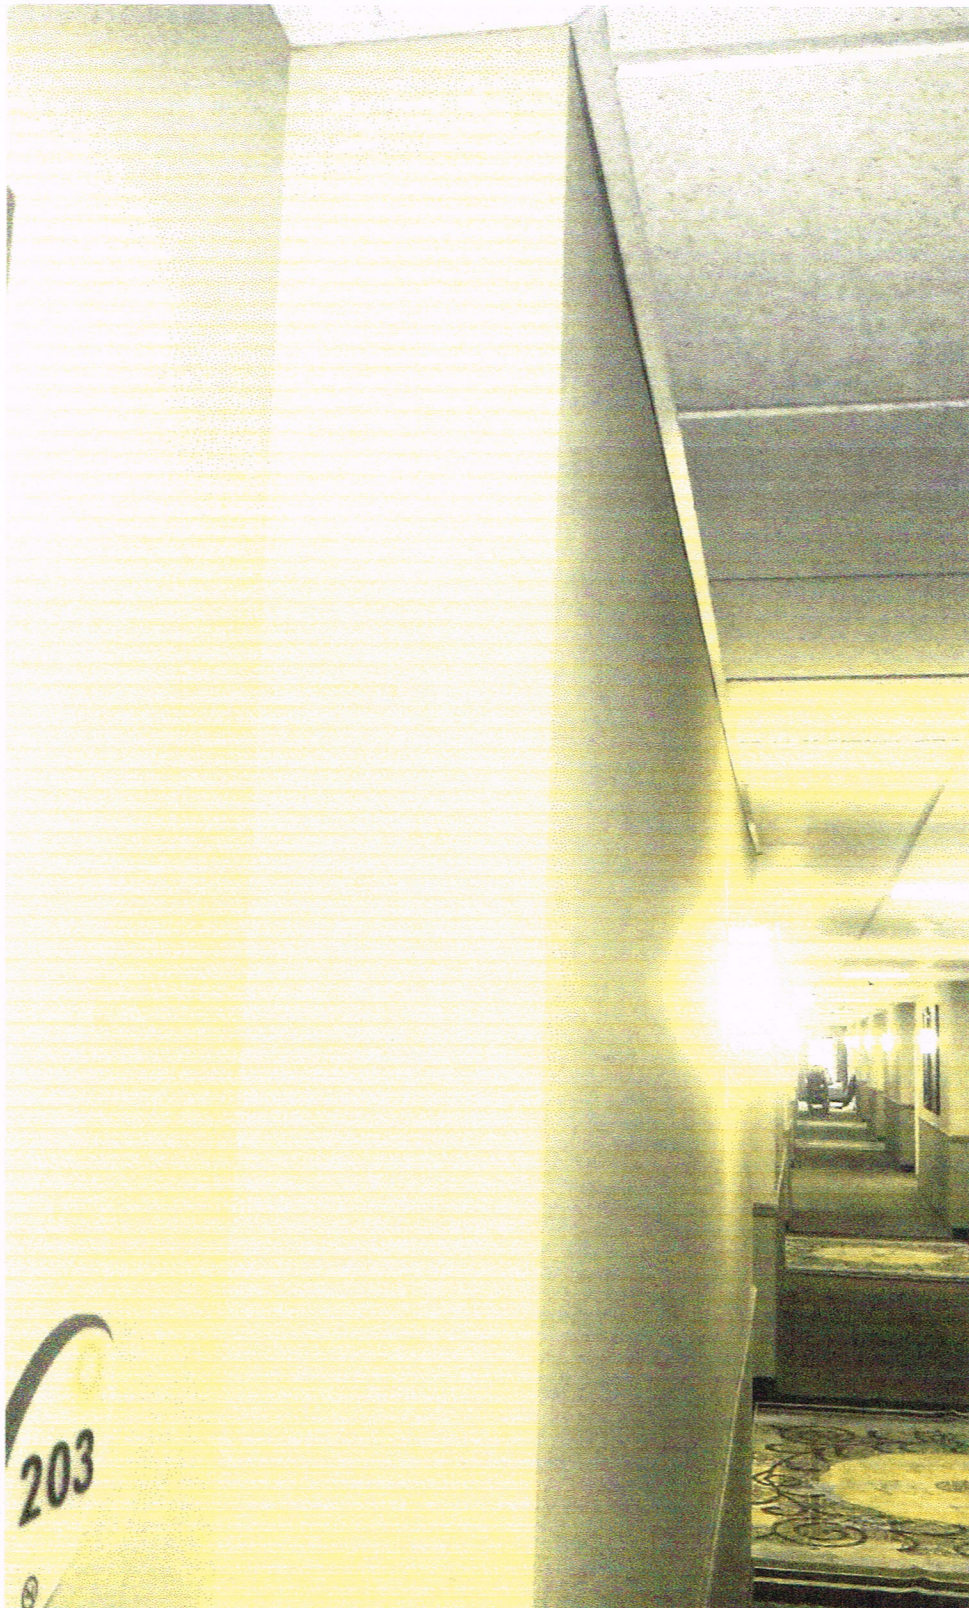
Photograph 2: Hallway gypsum wallboard cracking near room 203.

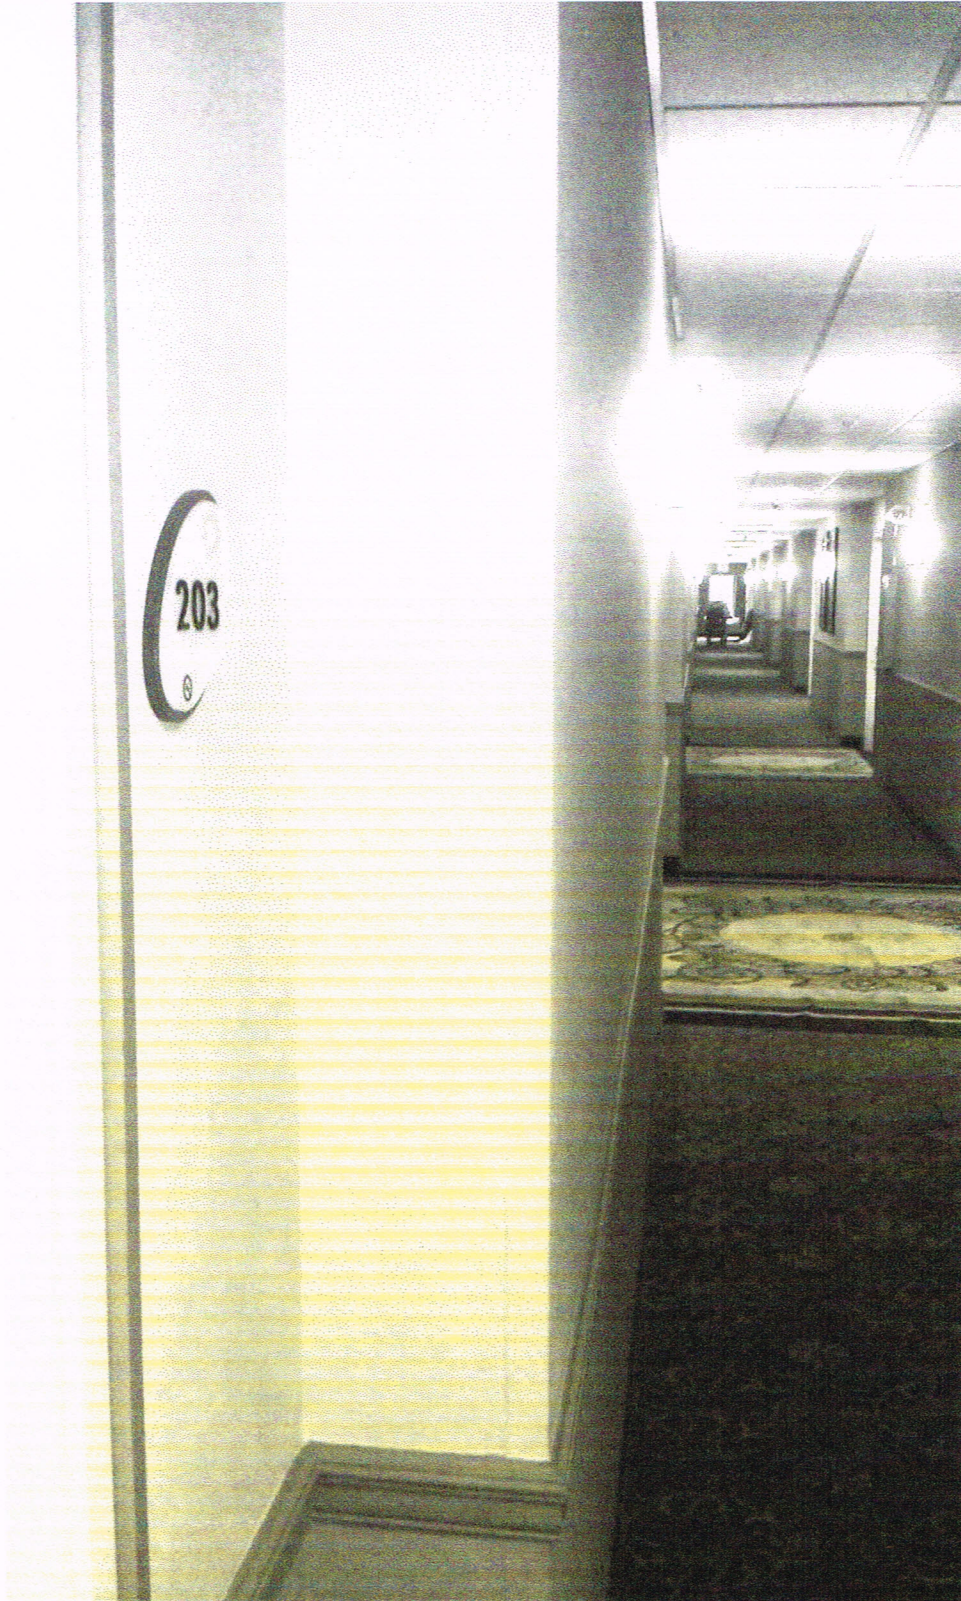
Photograph 3: Hallway gypsum wallboard cracking near room 203.

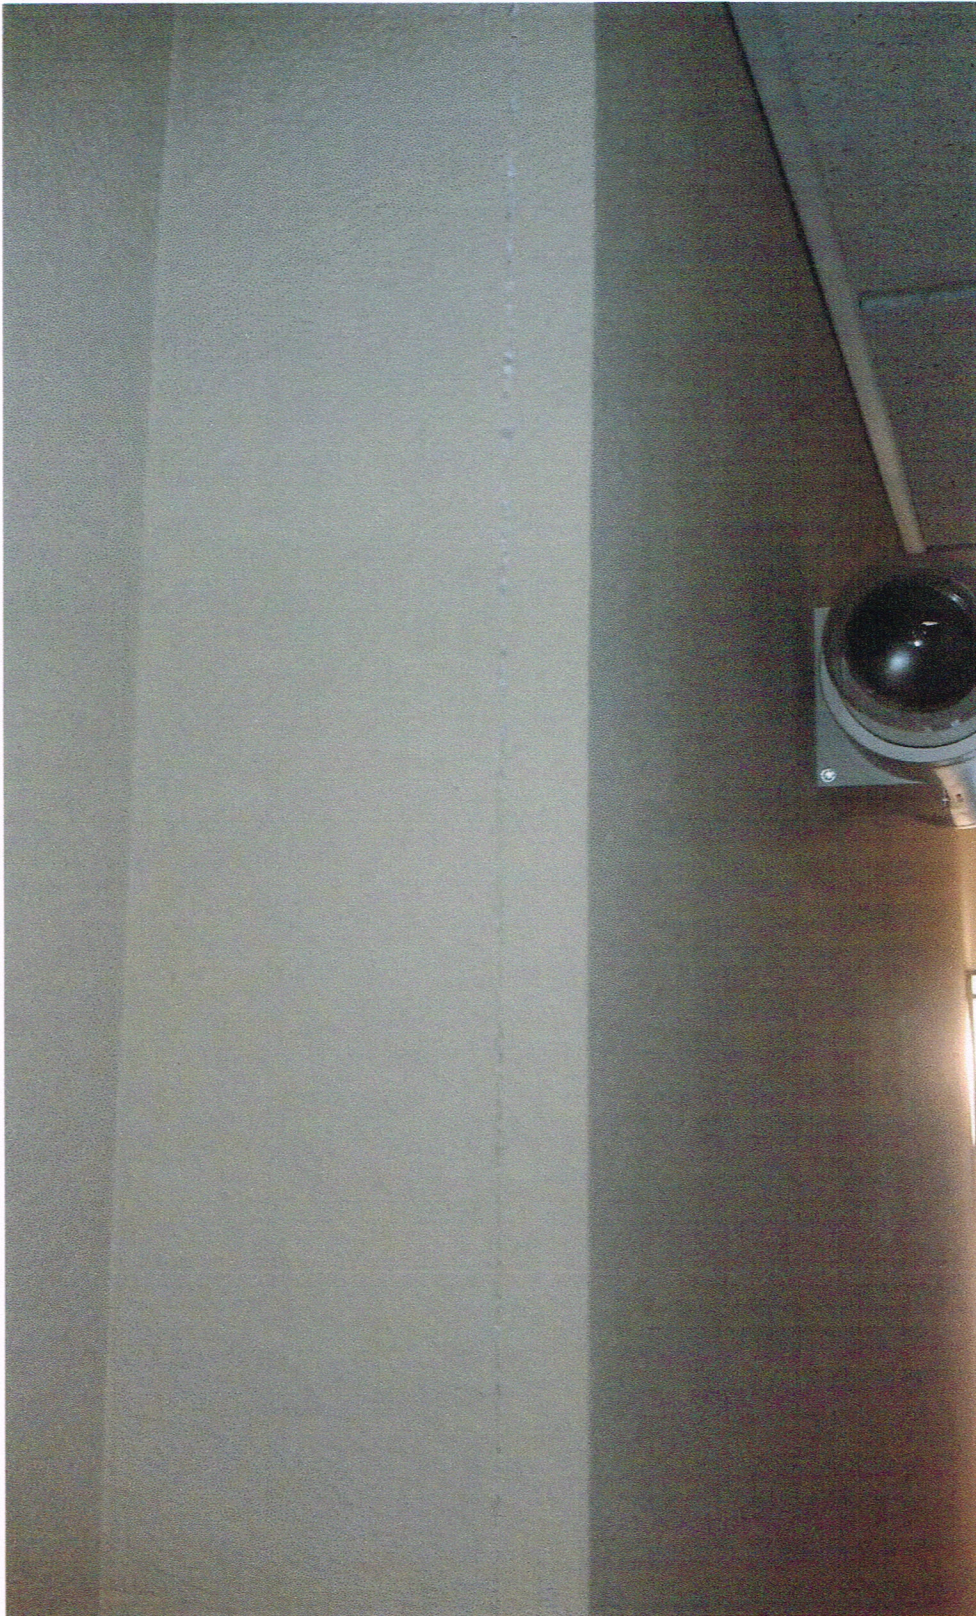
Photograph 4: Hallway gypsum wallboard cracking near room 204.

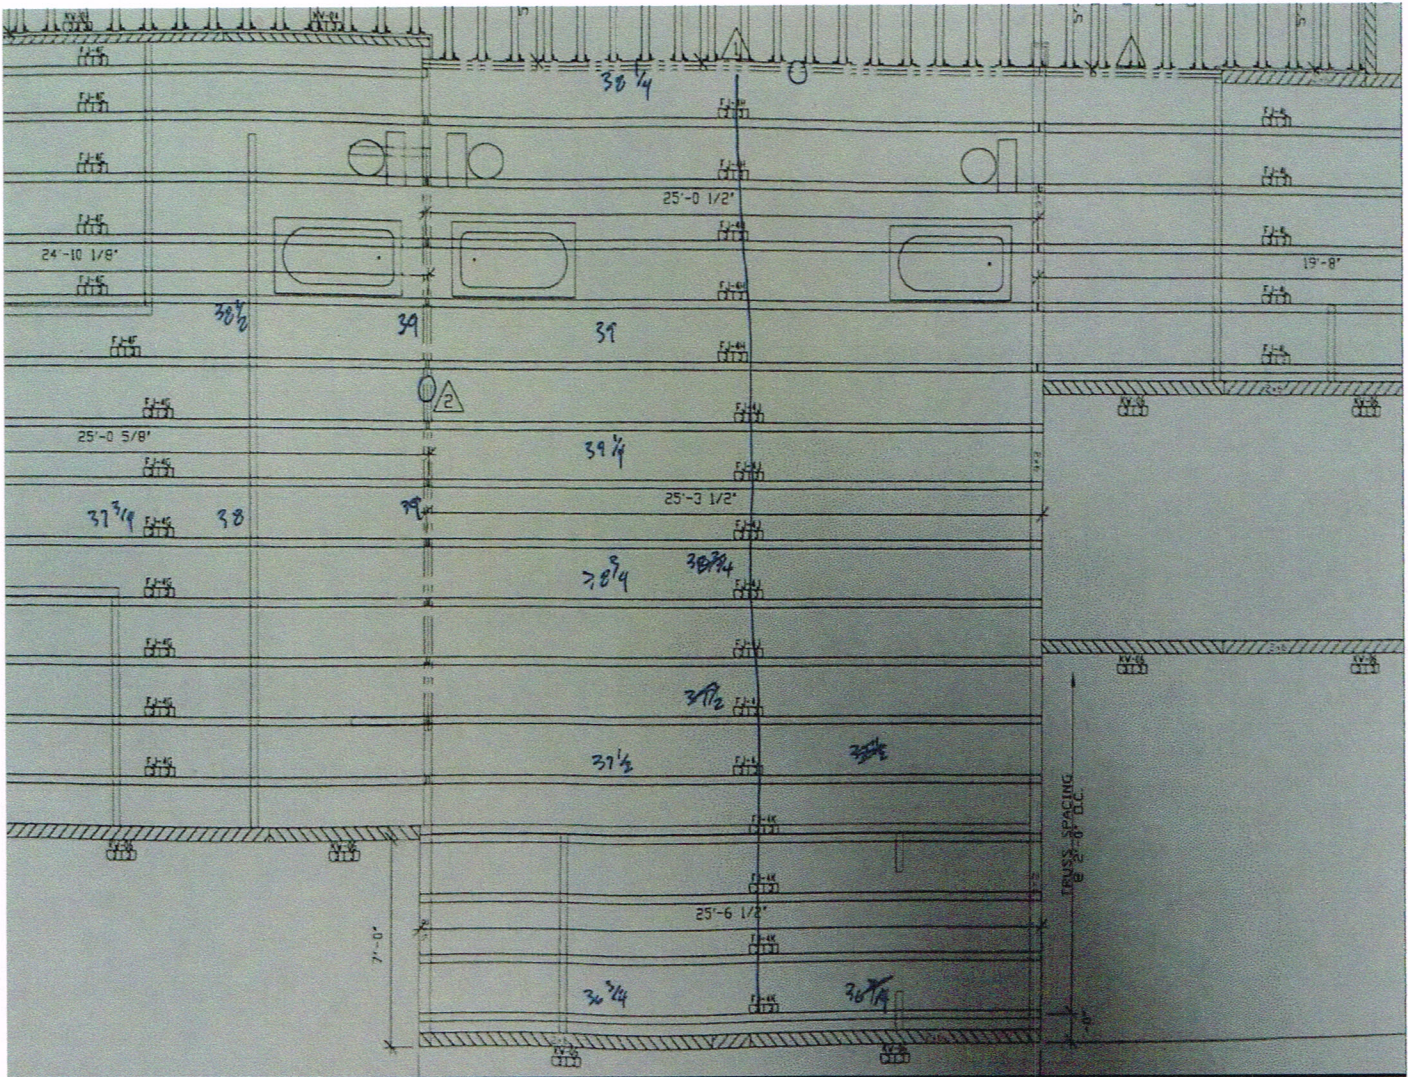
Figure 3: Truss layout and laser level deflection measurements as originally taken inside rooms 203 and 205.

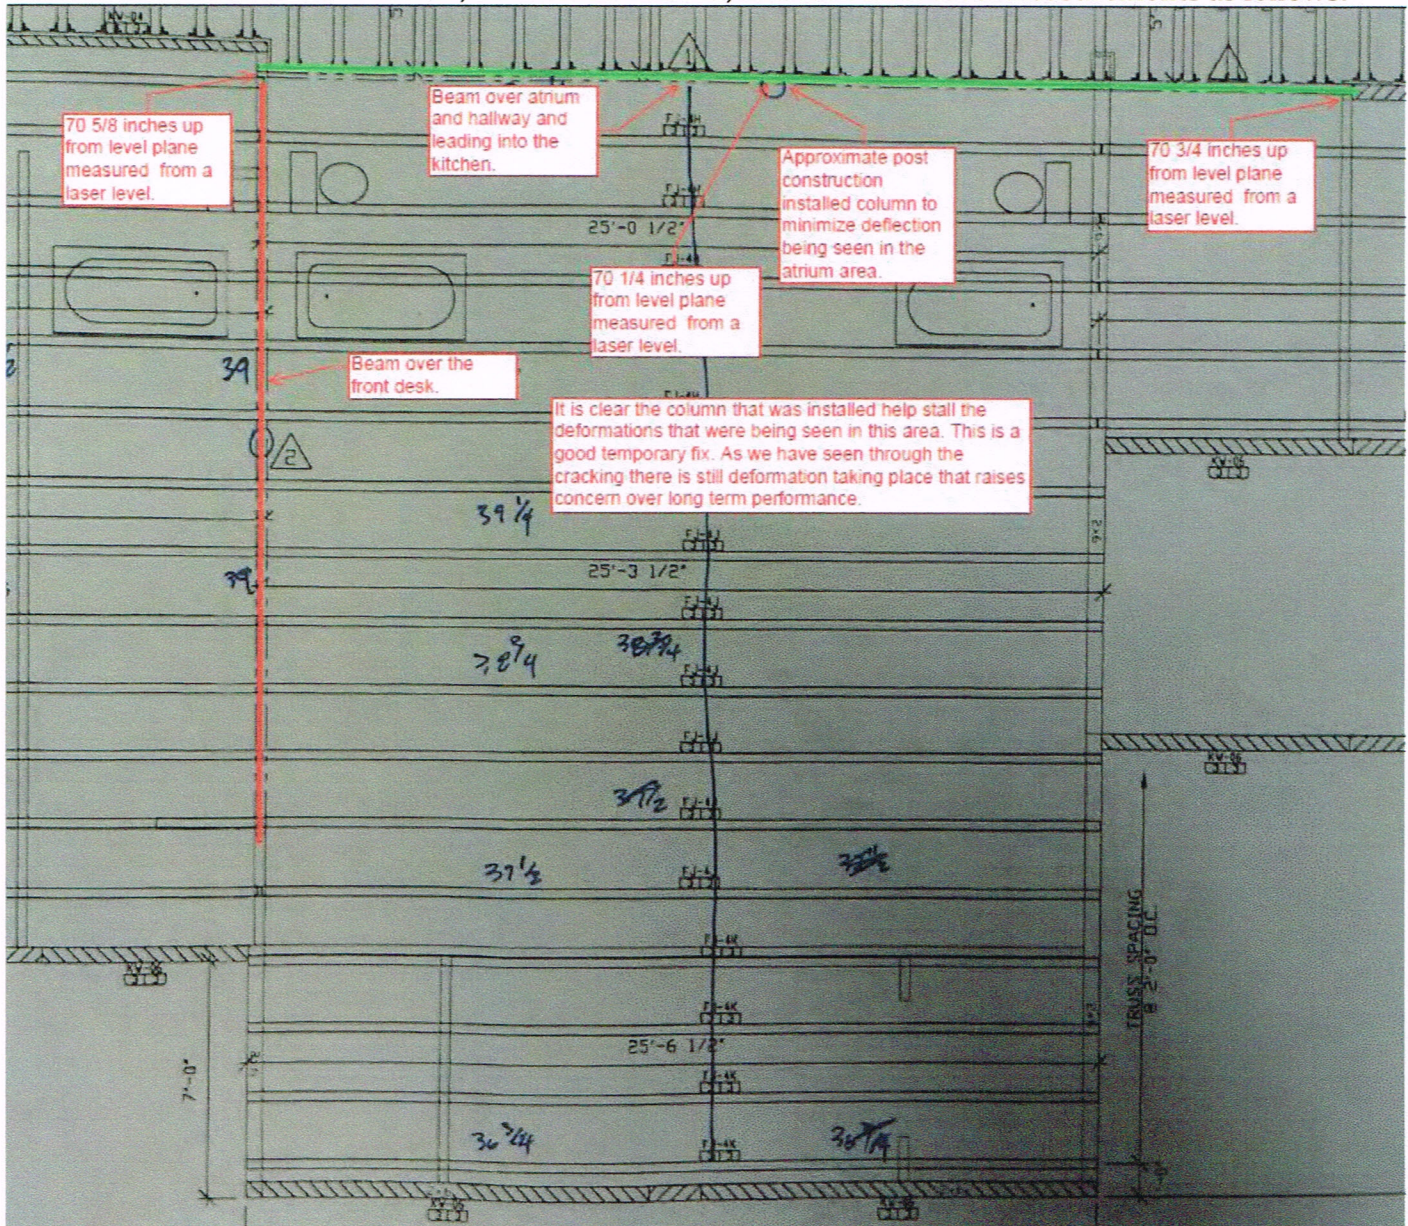
Figure 6: Truss layout and laser level deflection measurement in the atrium area below the hallway and rooms 203, 204, 205 and 206.

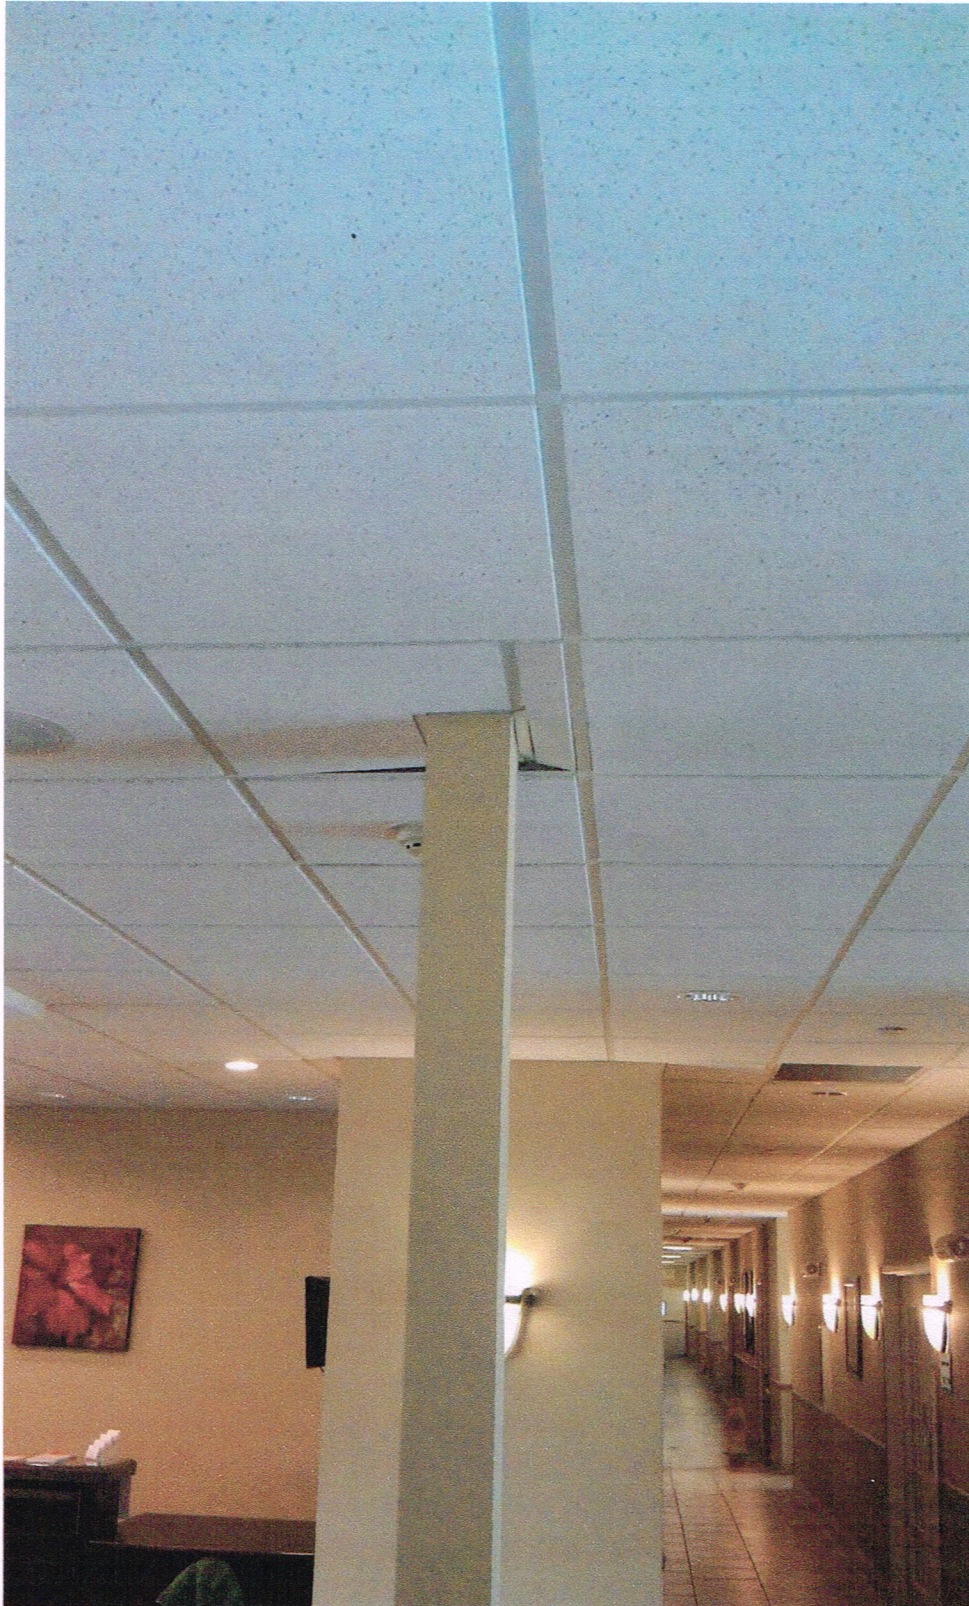
Photograph 5: Column in the atrium placed approximately below Room 203/ 201 to support the beam that provides support to the floor trusses in the hallway and the walls above it to provide the clear opening in the atrium below. The ceiling tile is reflecting movement of the structural framing surrounding the column.

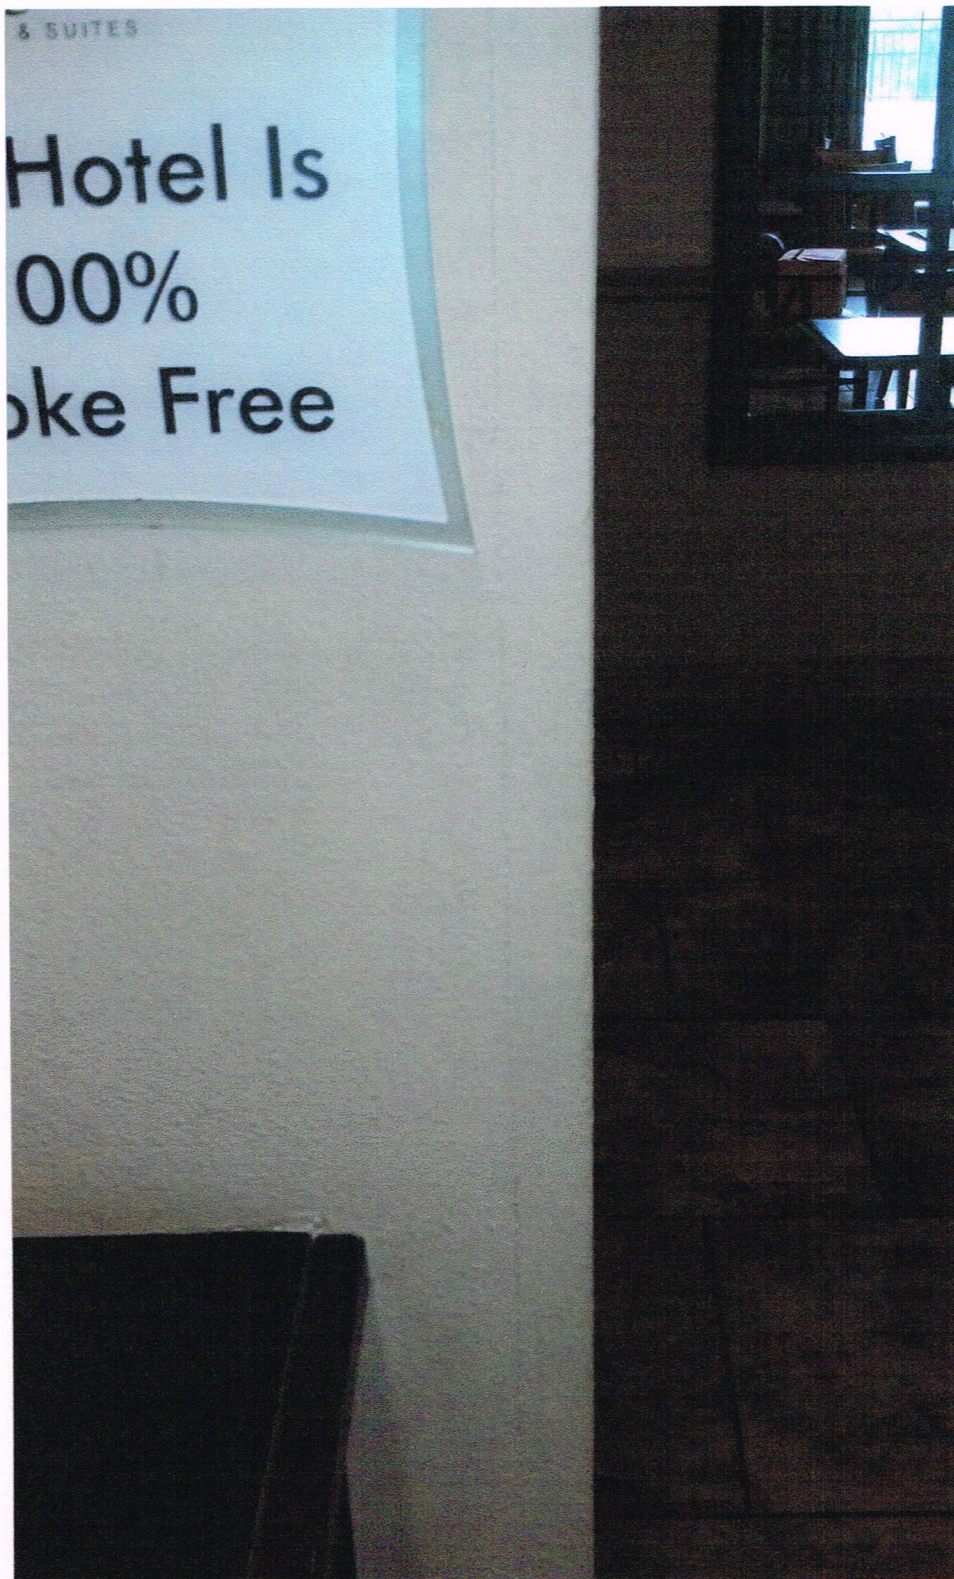
Photograph 6: Gypsum wallboard cracking near the front desk.

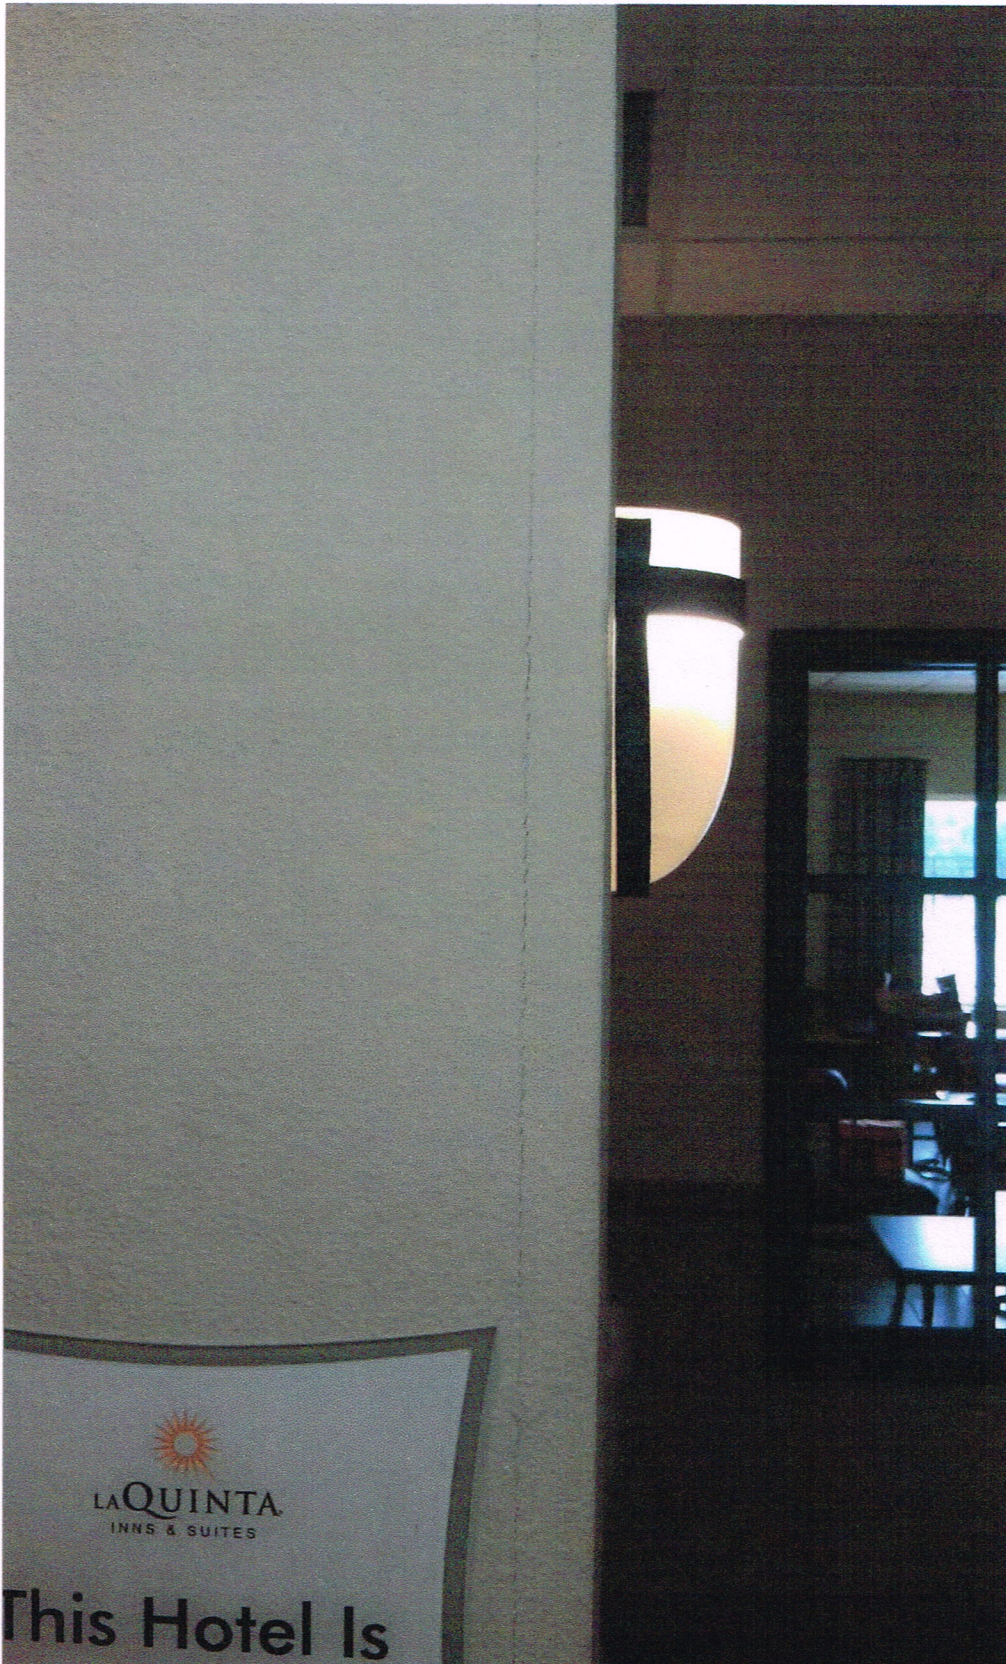
Photograph 7: Another view of the gypsum wallboard cracking near the front desk.

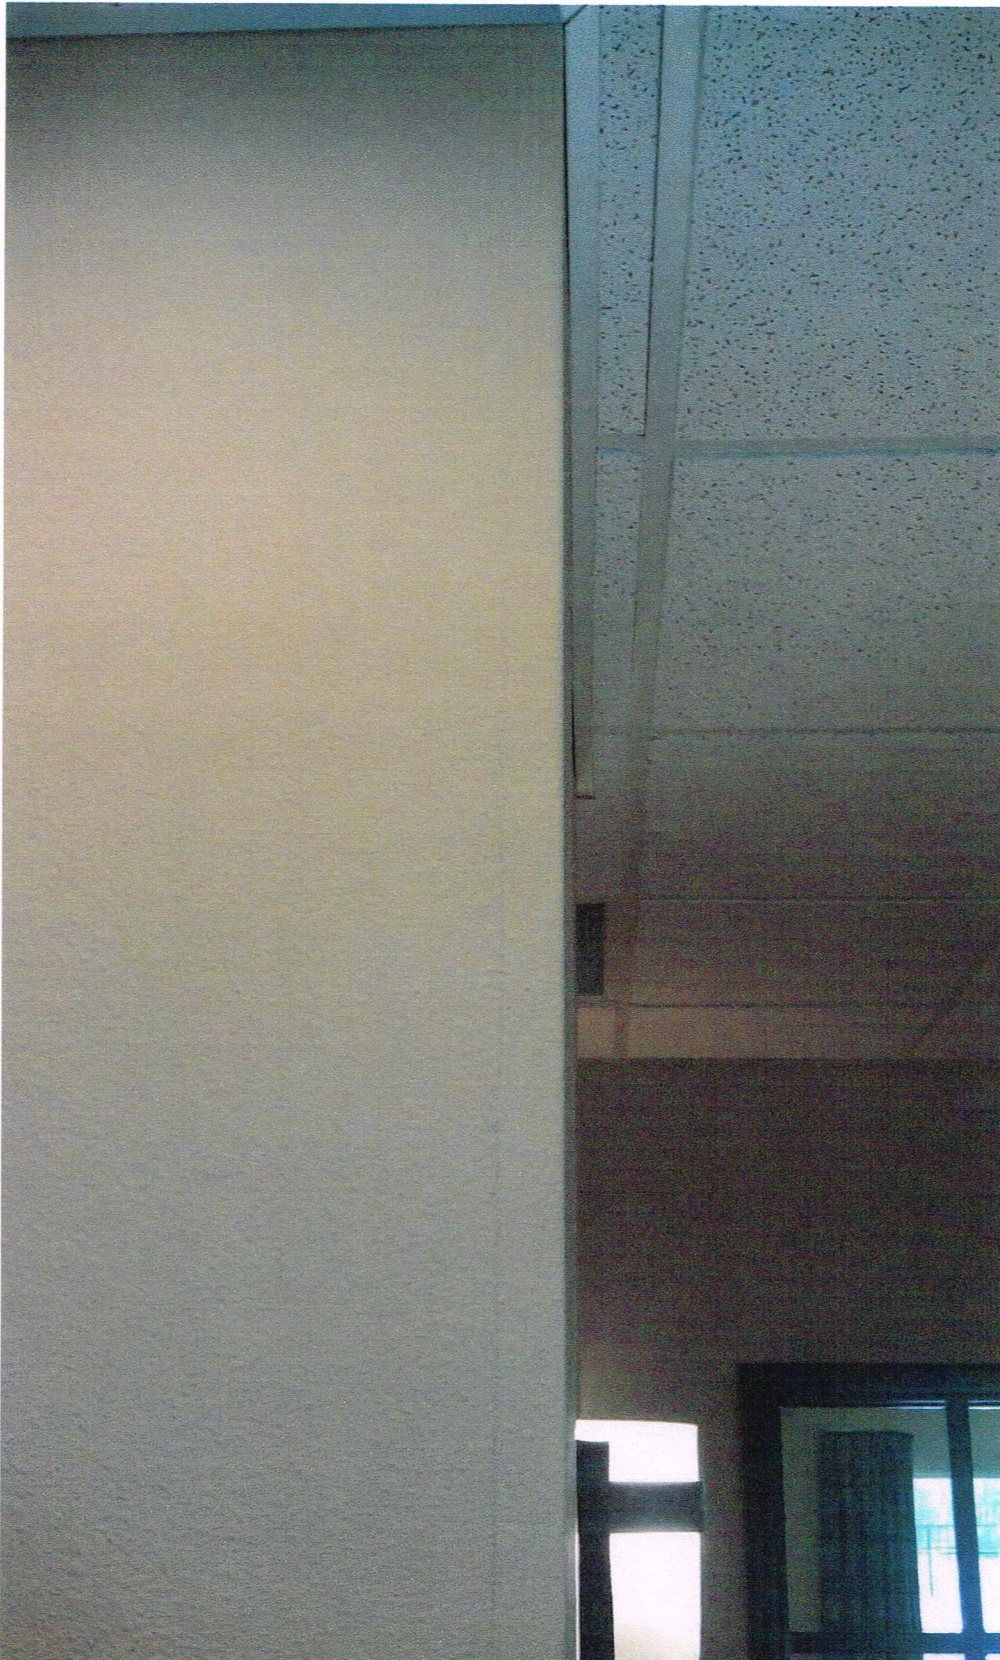
Photograph 8: A view of the gypsum wallboard cracking near the front desk and a view toward the ceiling tile.

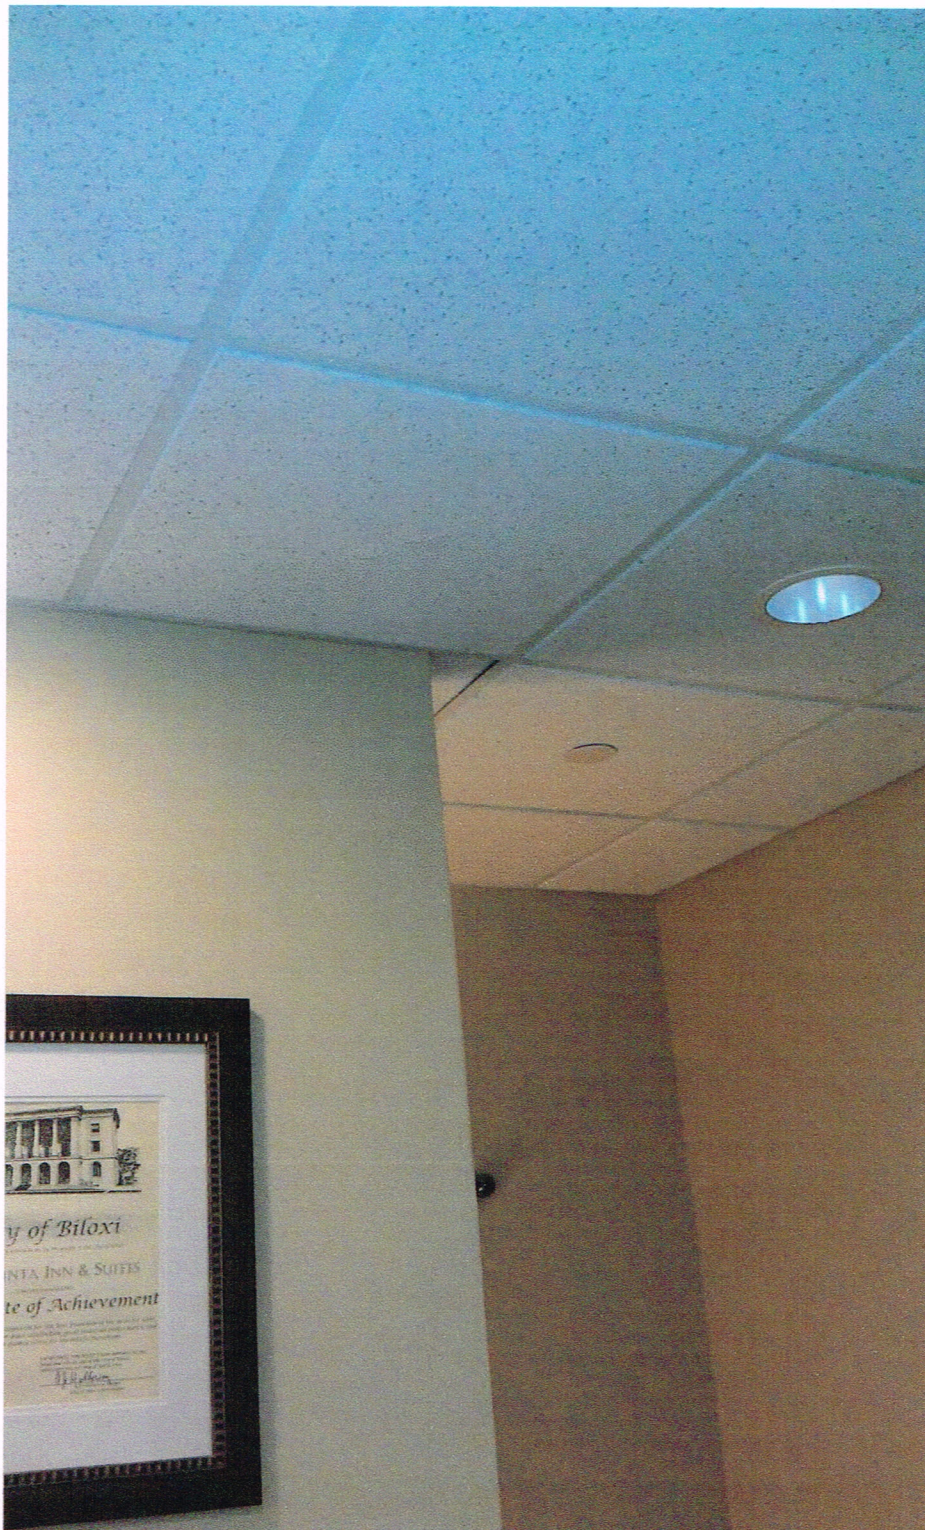
Photograph 9: Ceiling tile movement at the front entry way corner near the backside of the front desk.
