## Structural Inspection

June 24, 2024

Michelle Atwood  
248 Clara Drive  
Slidell, La. 70458

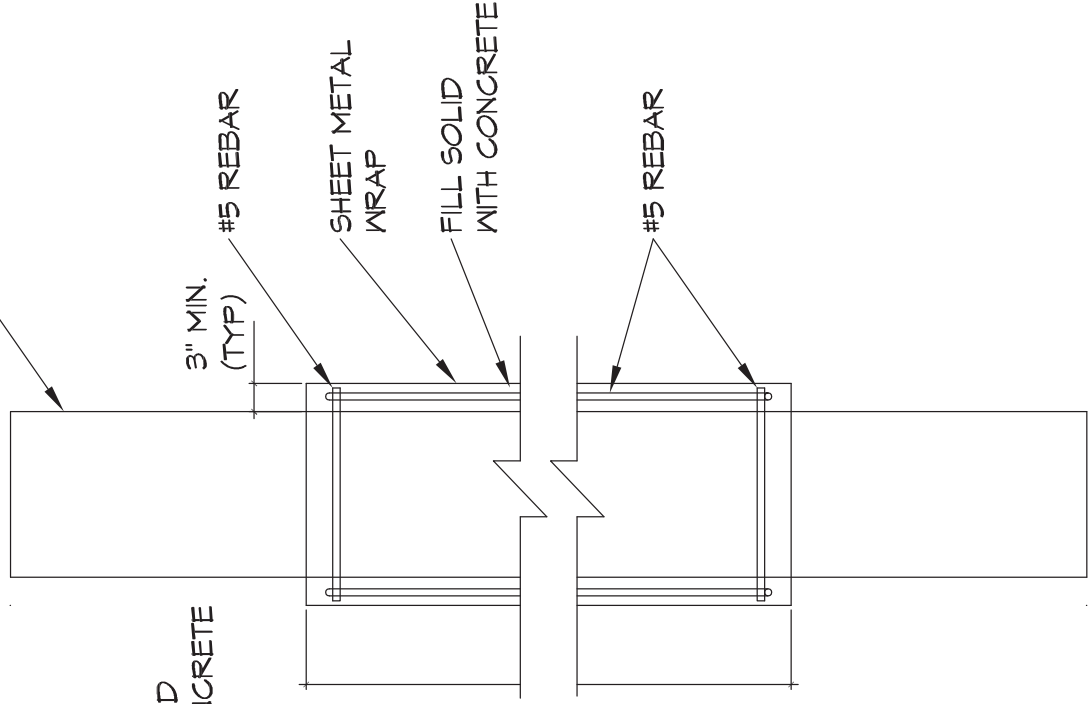
EXISTING HOUSE PILING

FIELD VERIFY HEIGHT, COVER SHALL BE  
2' ABOVE AND 2' BELOW ROTTEN WOOD.

- 1) Secure the existing pilings with a concrete wrap as noted in the attached dwg.
- 2) Seal the concrete with a non-shrinking grout to prevent insects and water from entering the home.
- 3) Install proper drainage around the home to keep the foundation dry.

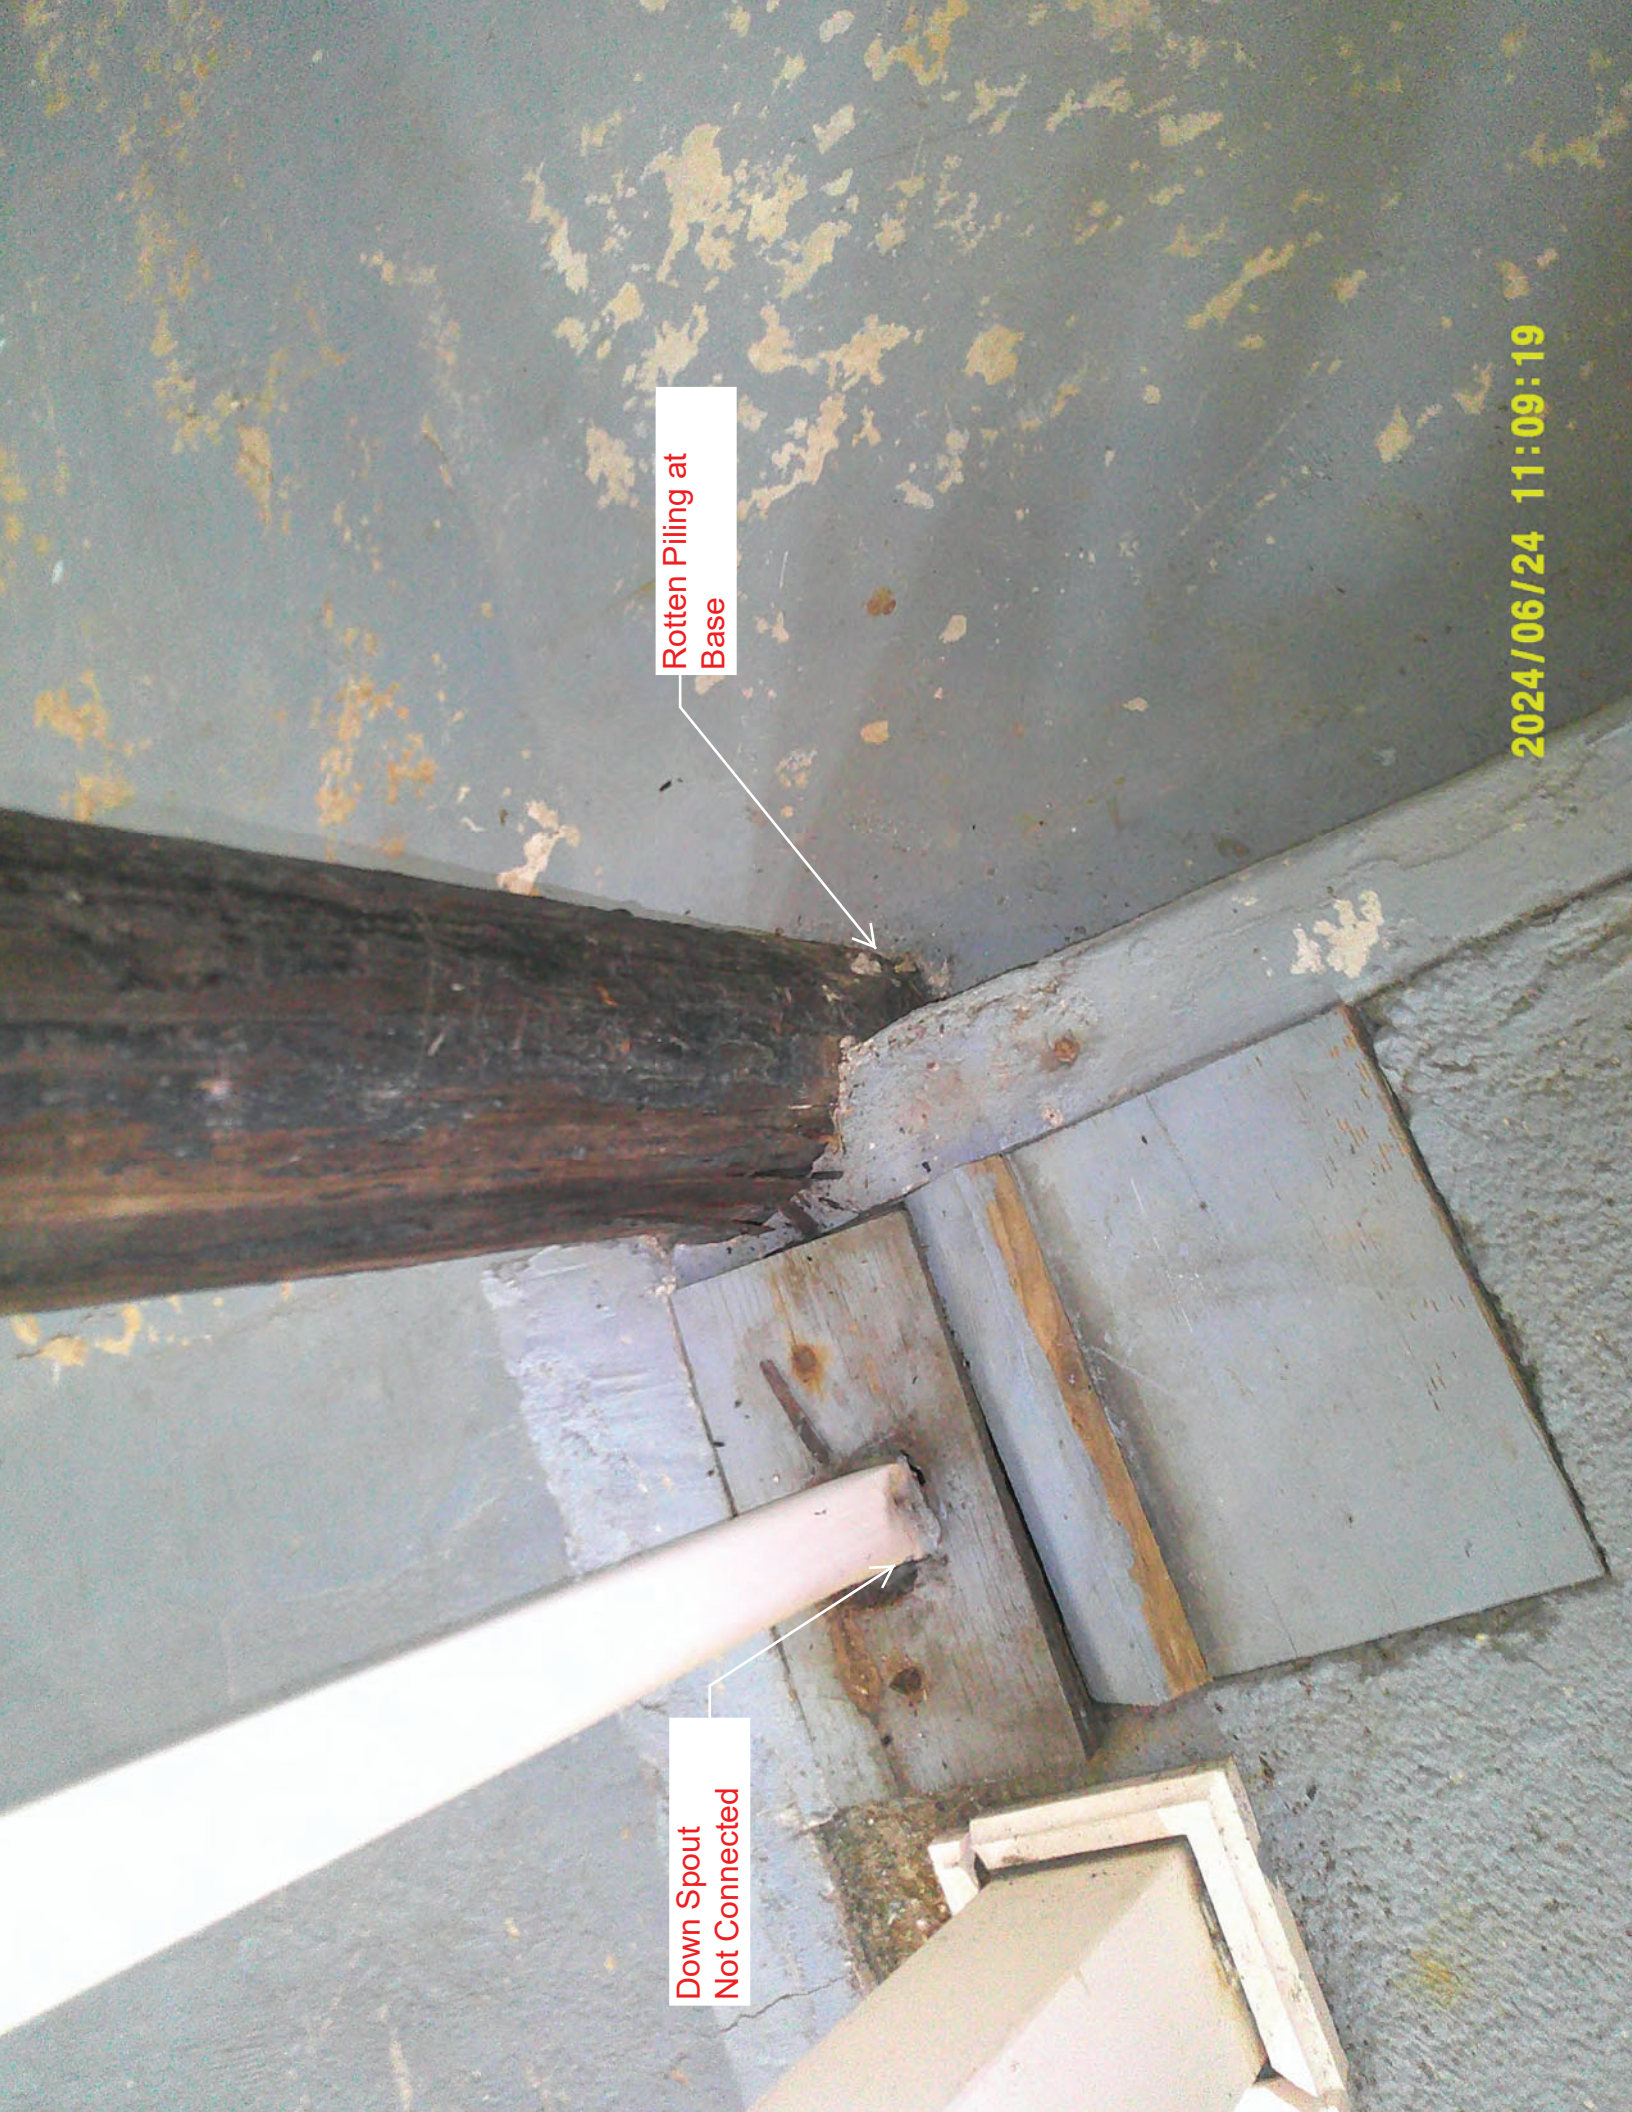
The support pilings have deteriorated over time at the base due to water intrusion. This is typical when the bases of the pilings are not sealed airtight. The foundation has cracked over time due to the shifting soil. The gutters and down spouts are not connected to properly route the water around the home and into the bayou.

Rotten Piling at Base

Down Spout  
Not Connected

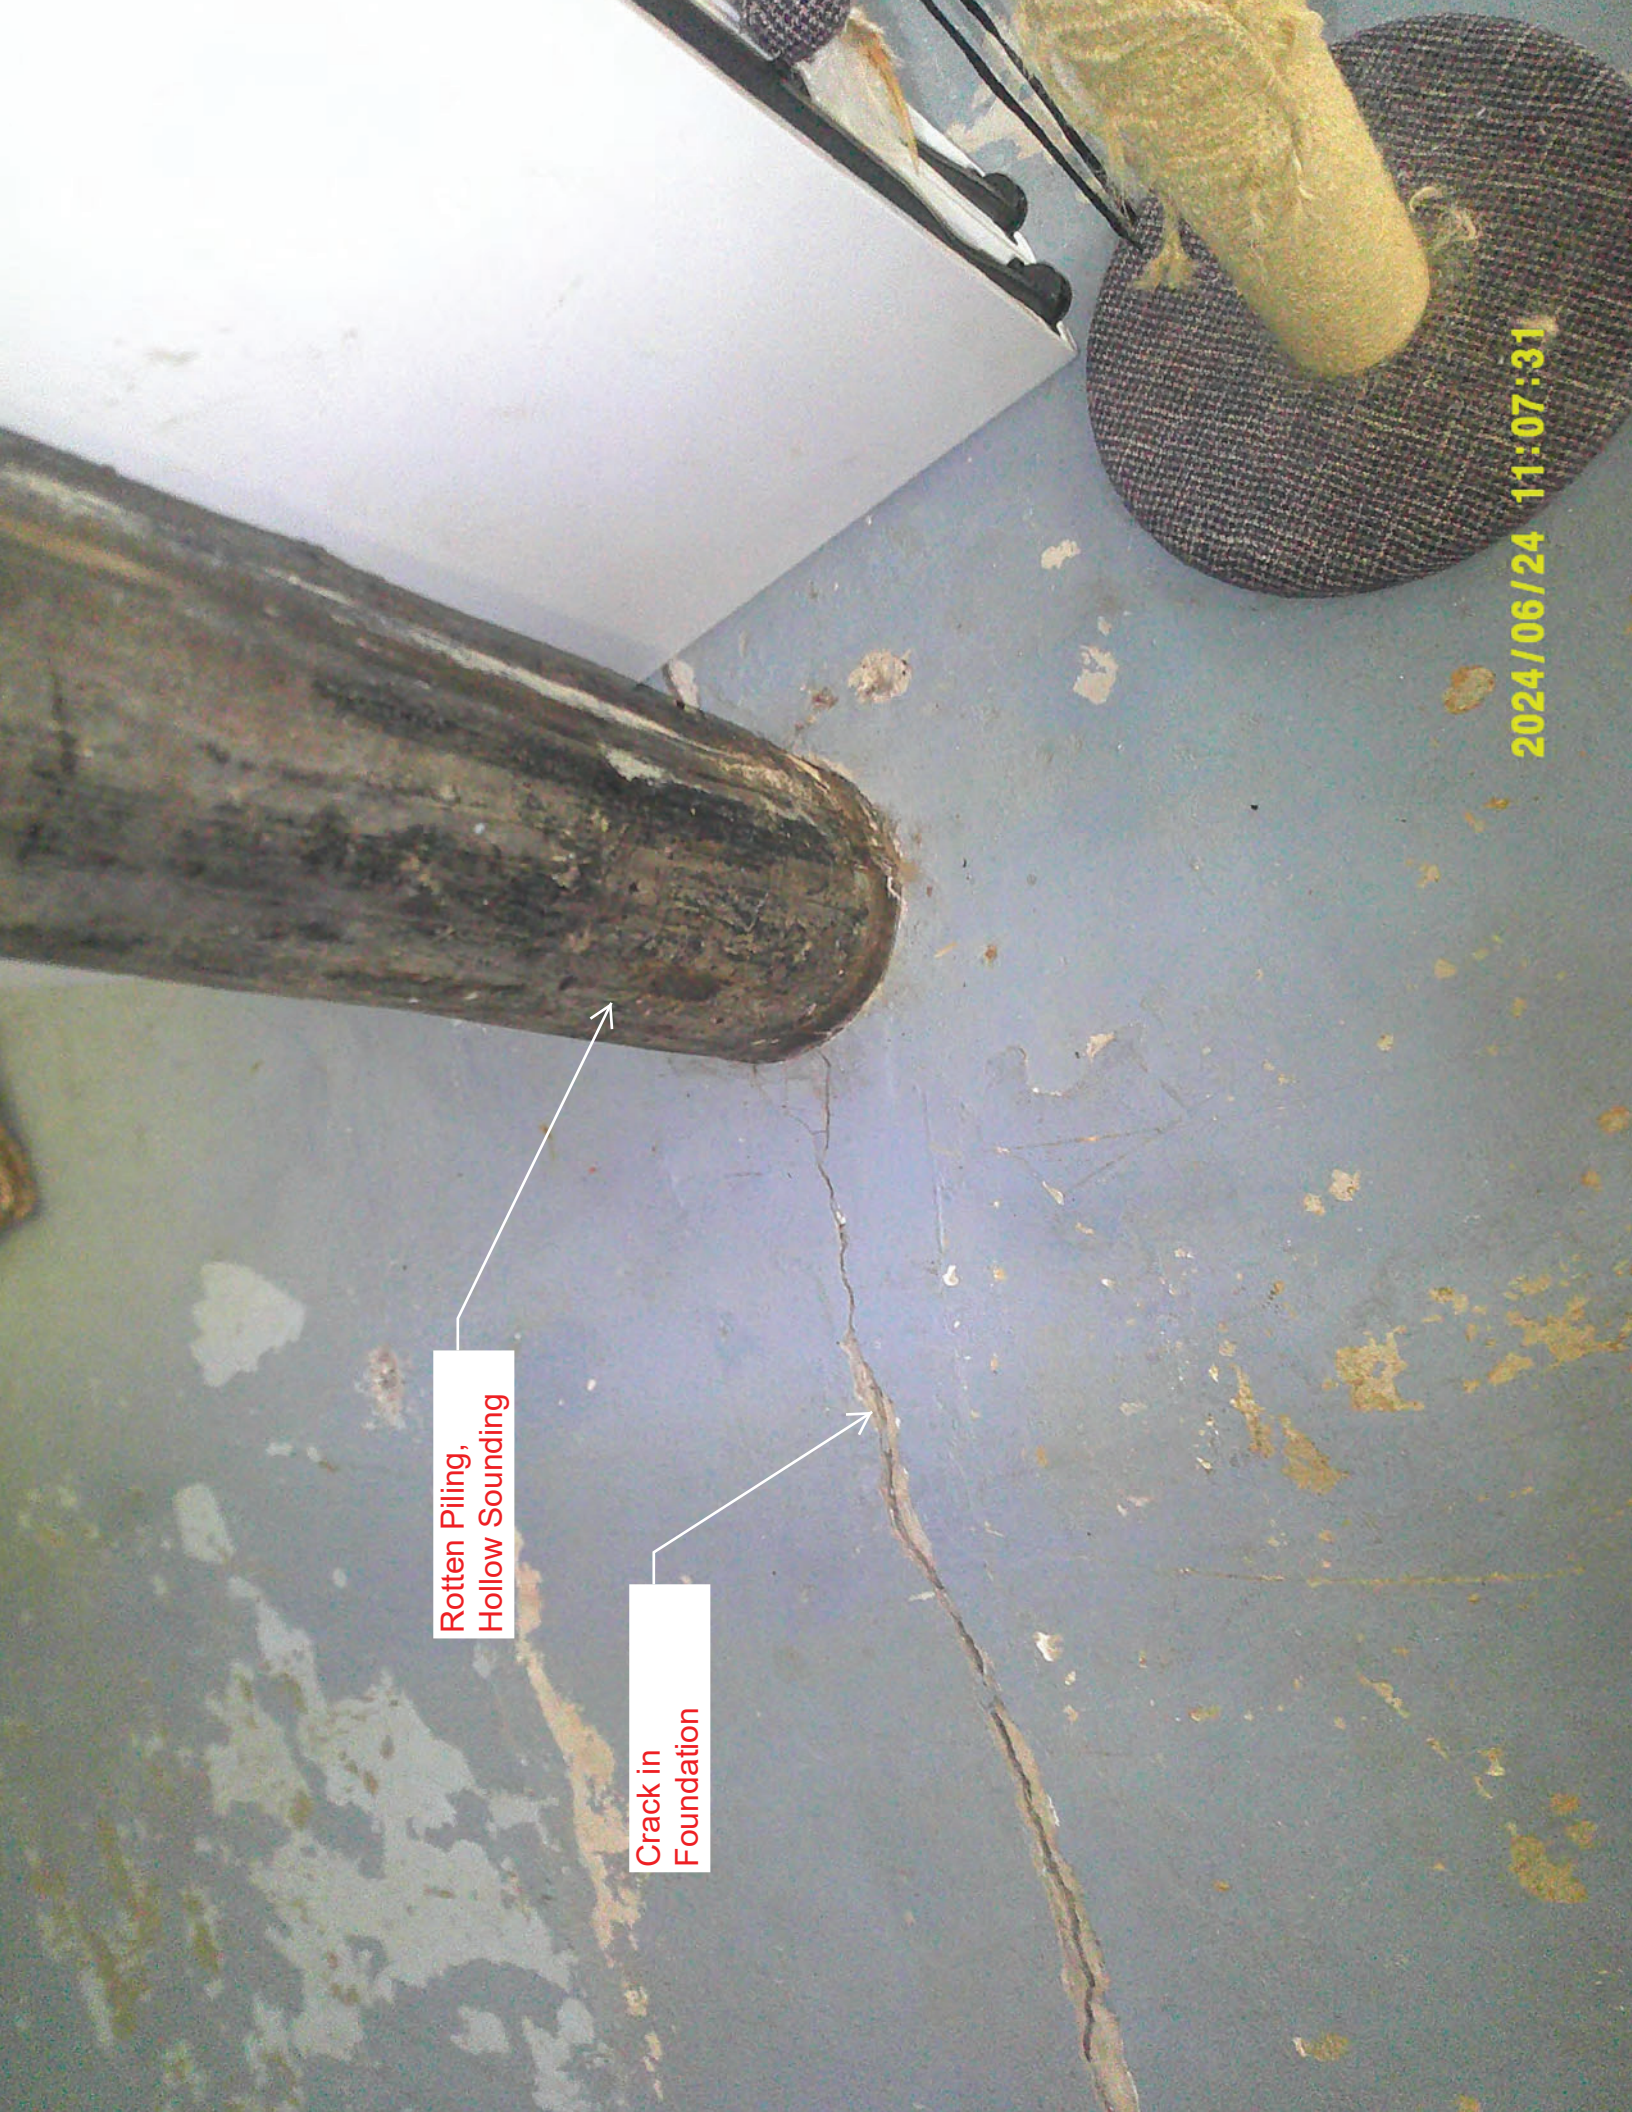
Rotten Piling,  
Hollow Sounding

Crack in  
Foundation

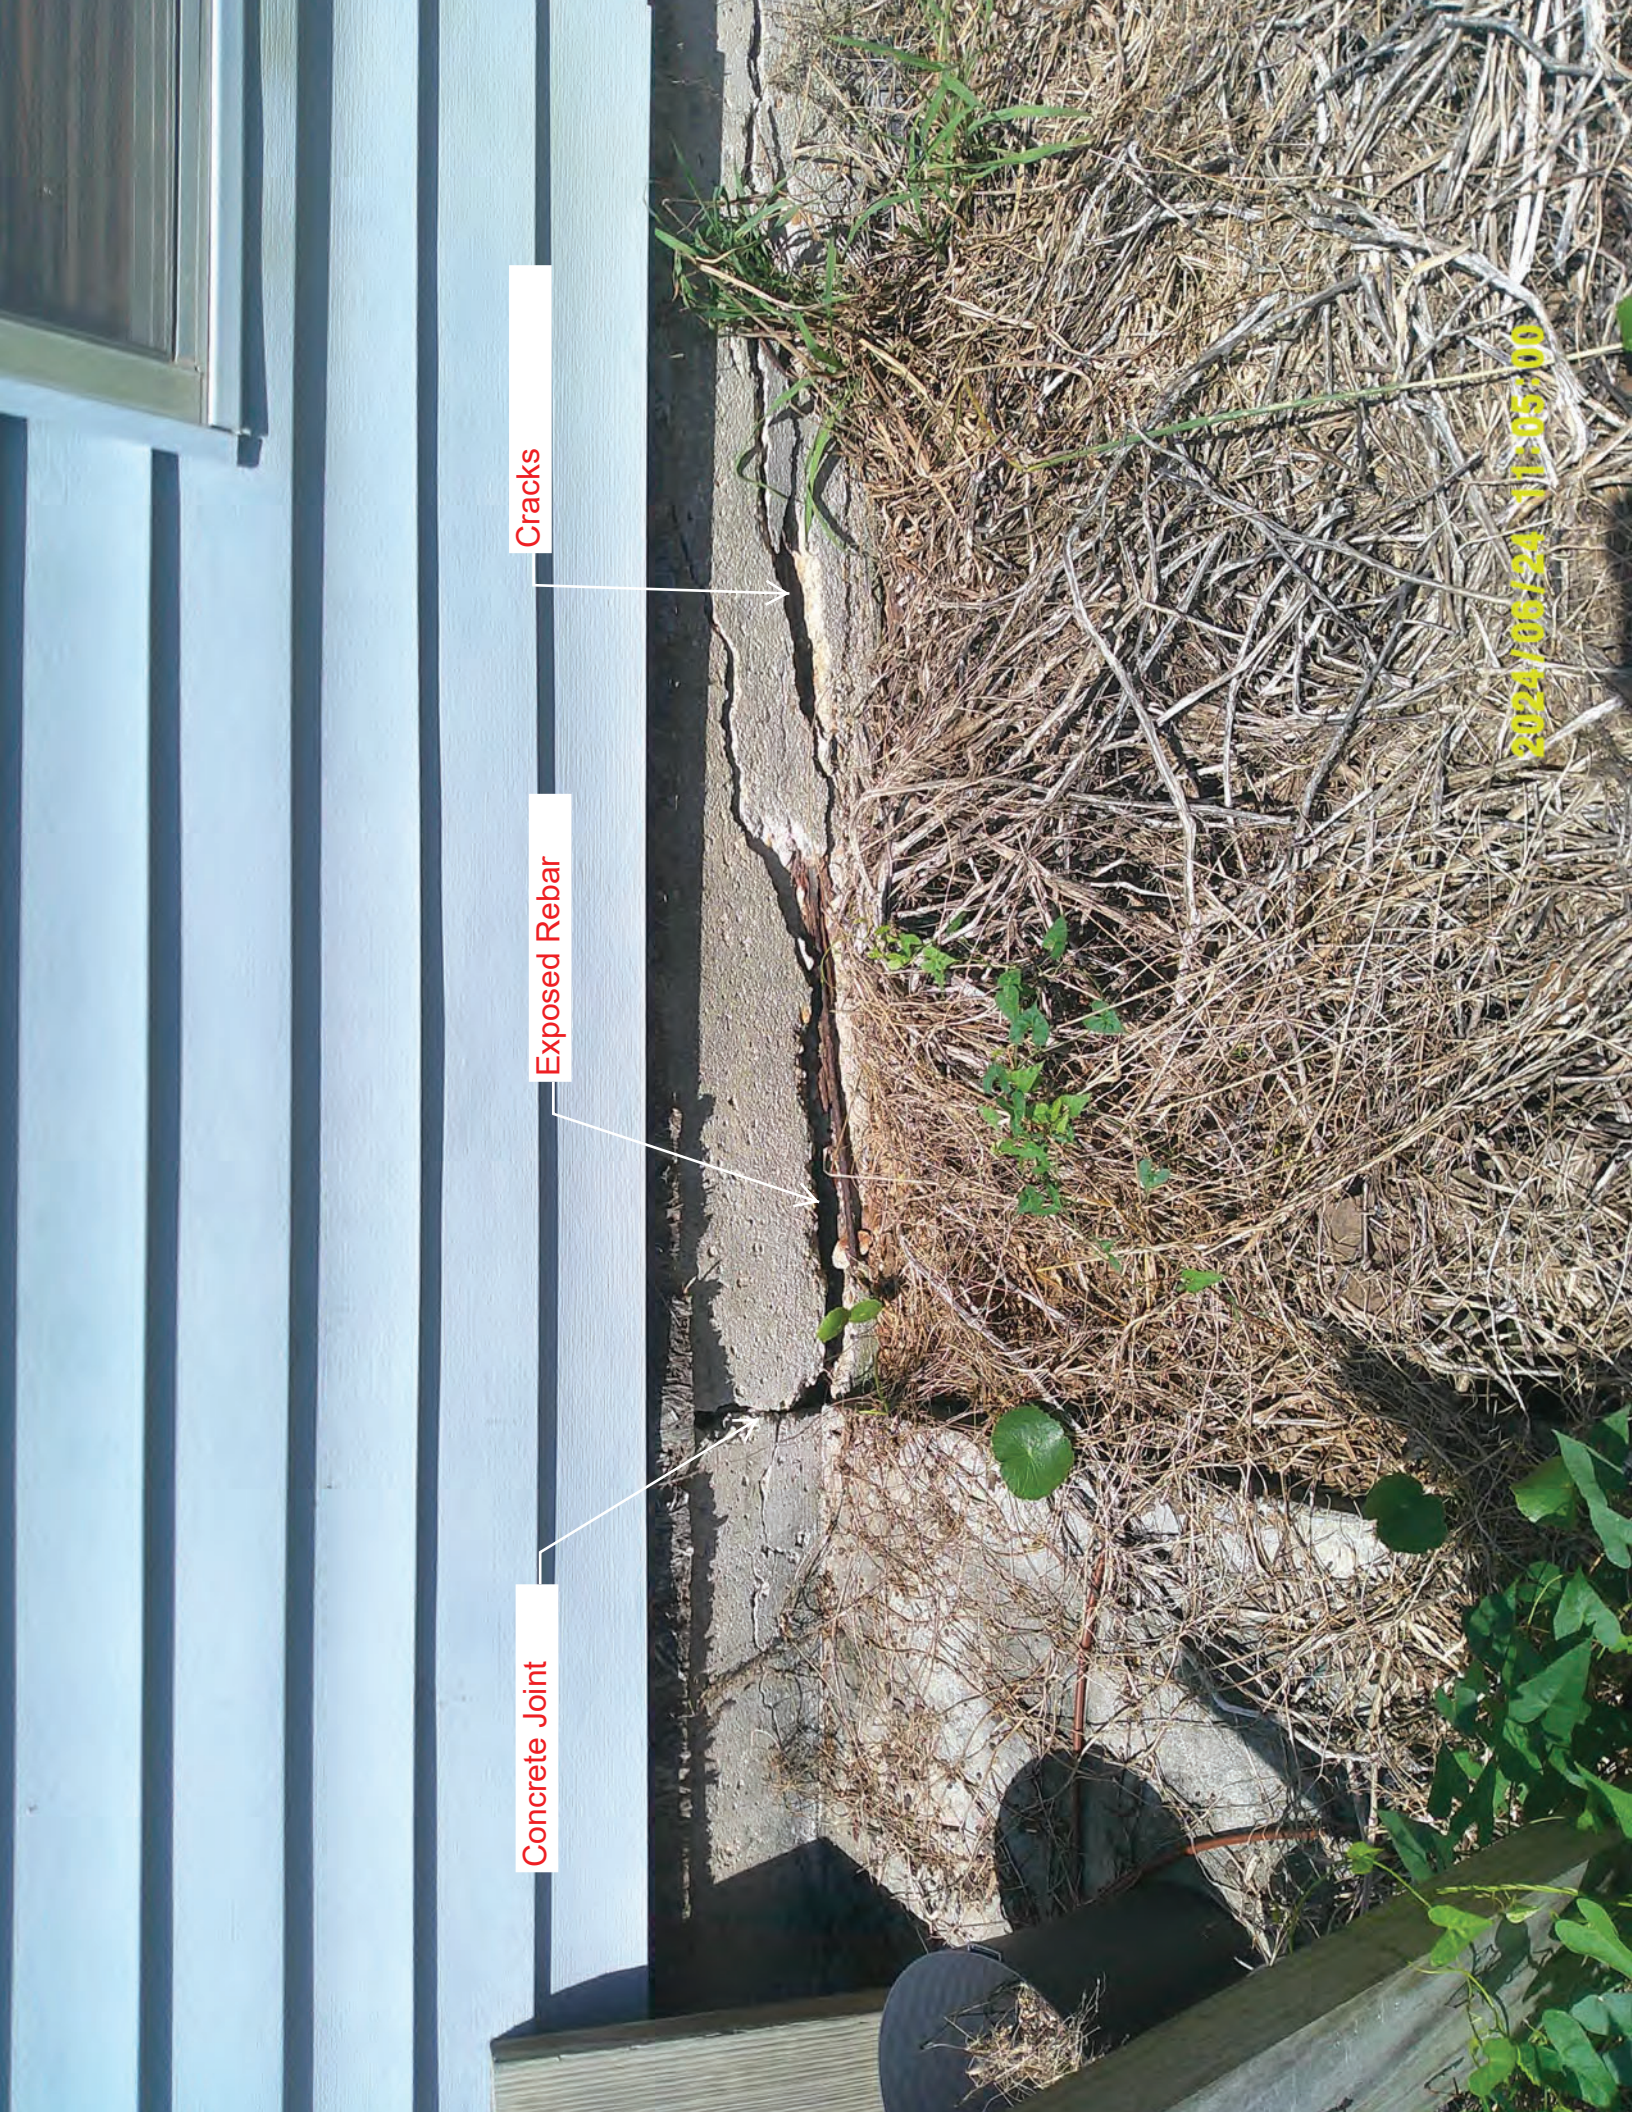
Concrete Joint

Exposed Rebar

Cracks
