Structural Inspection

July 28, 2025

Hailey Florane
1569 Susan Lane
Slidell, La. 70458

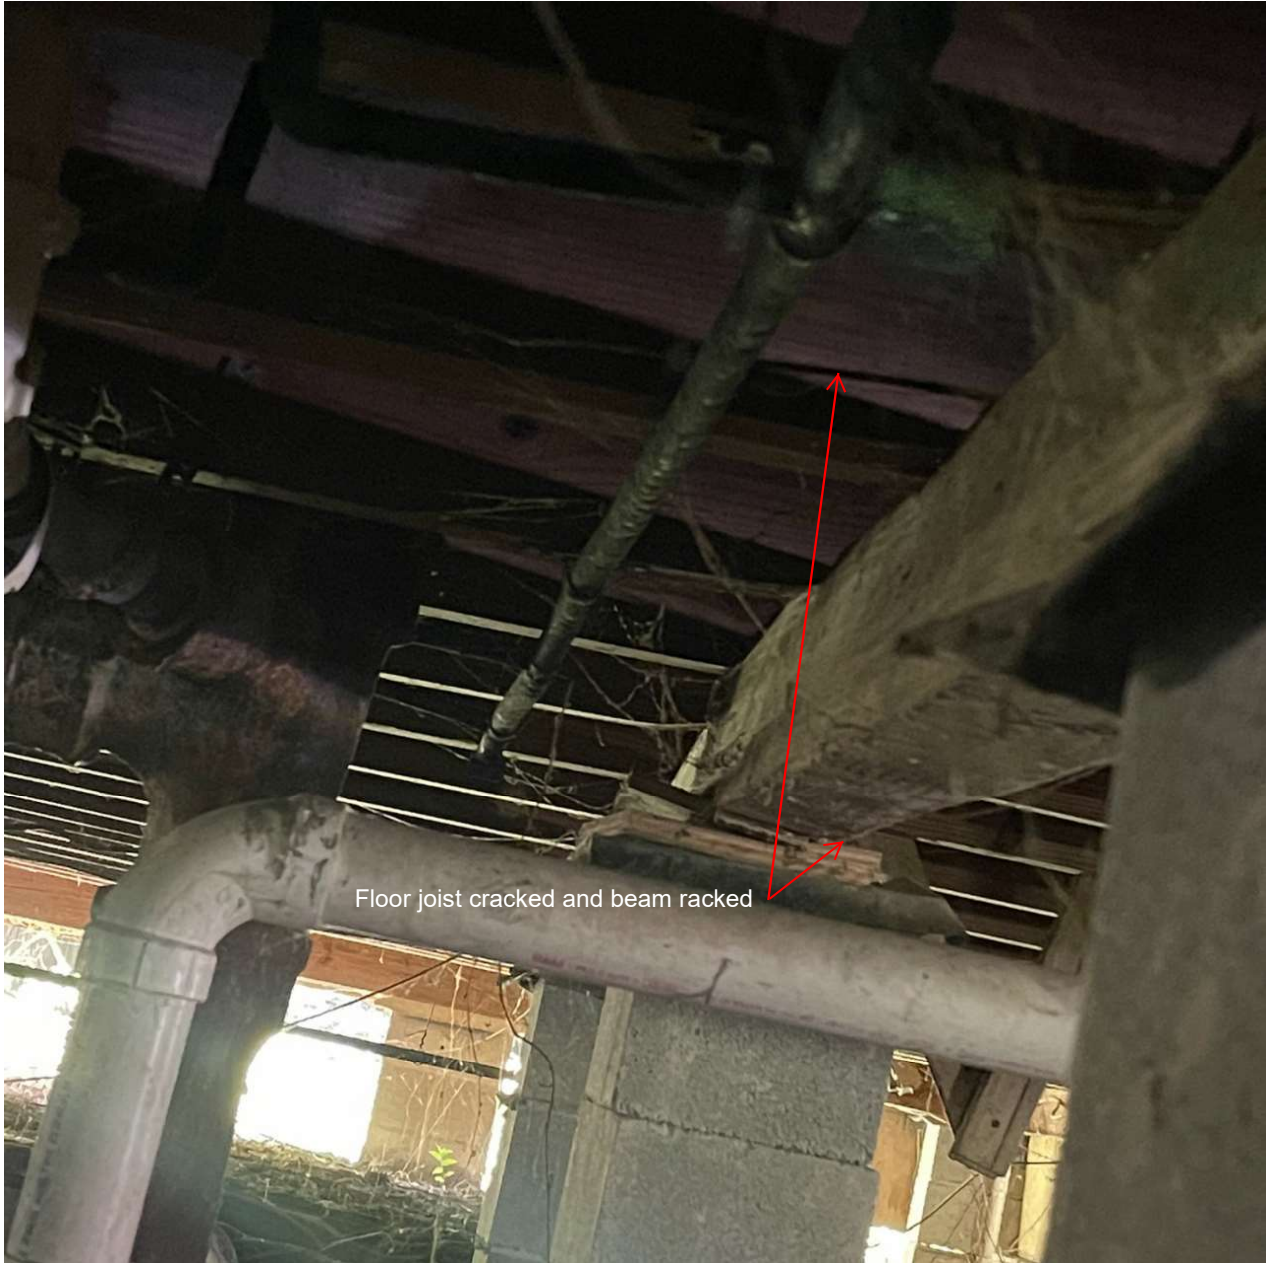
Floor joist cracked and beam racked

Replace beam supporting floor joist

Replace floor joist

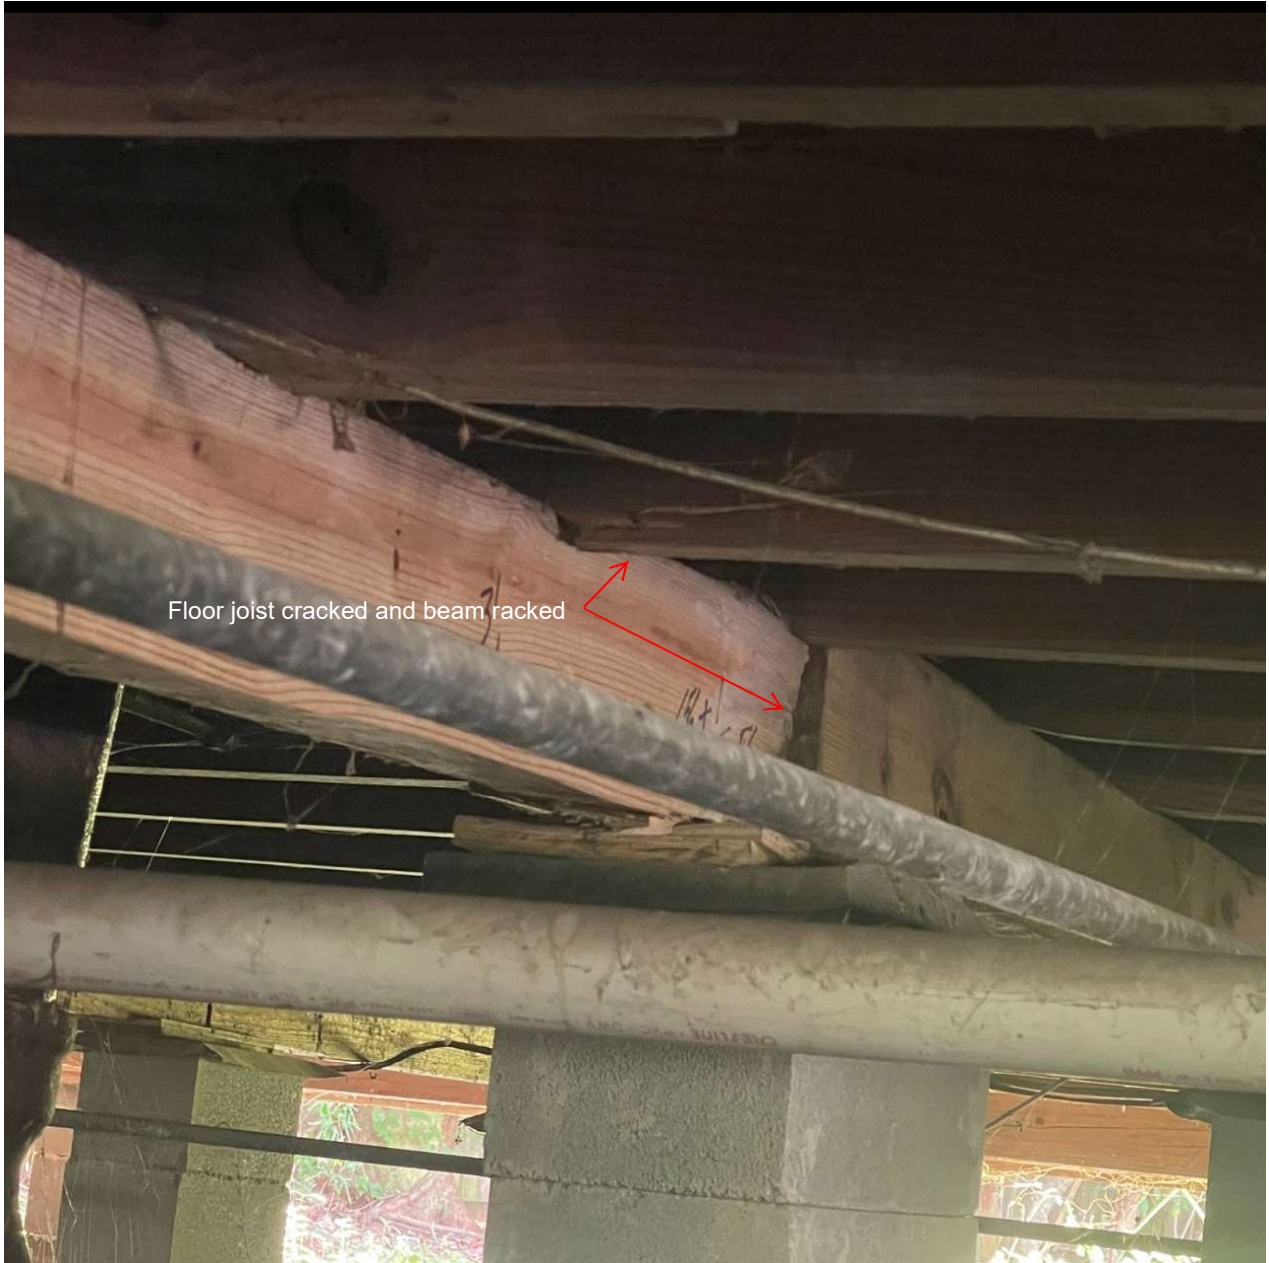
Floor joist cracked and beam racked

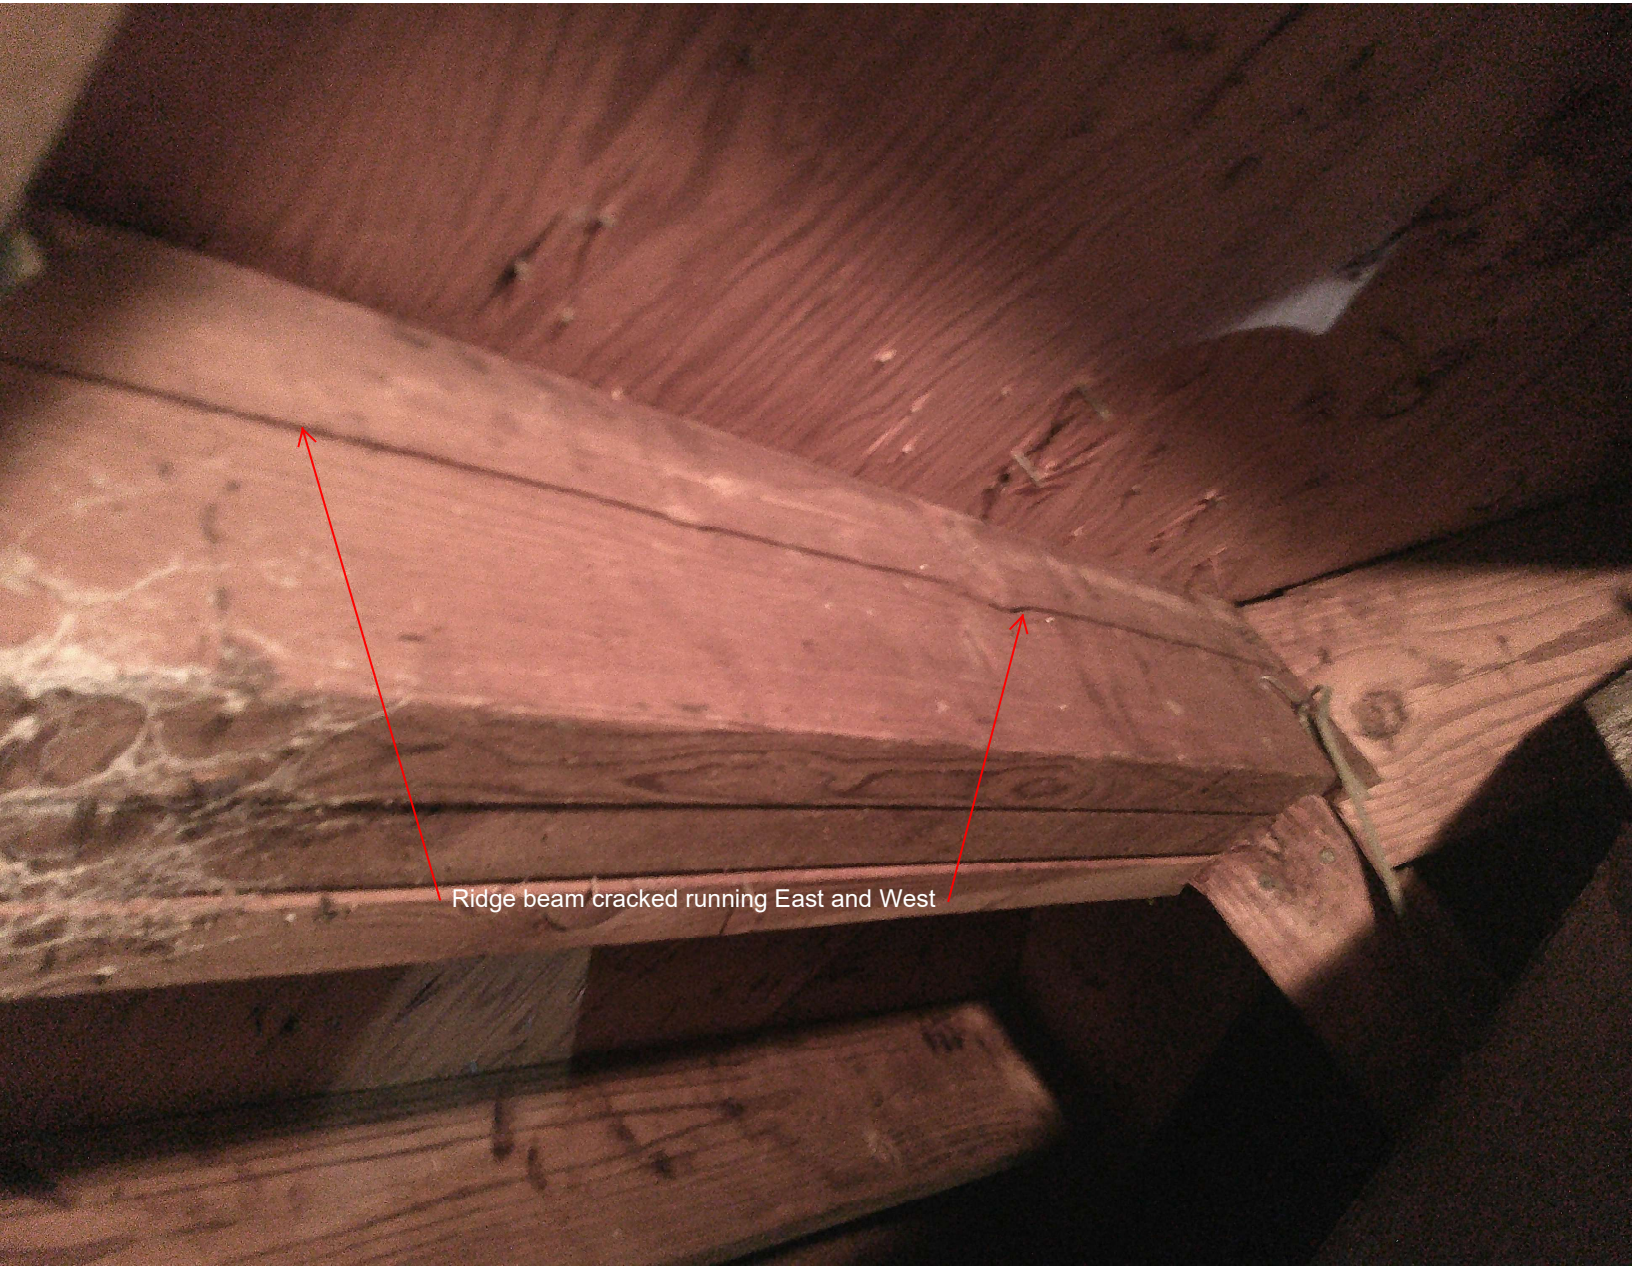
Ridge beam cracked running East and West

Replace cracked ridge beams in attic

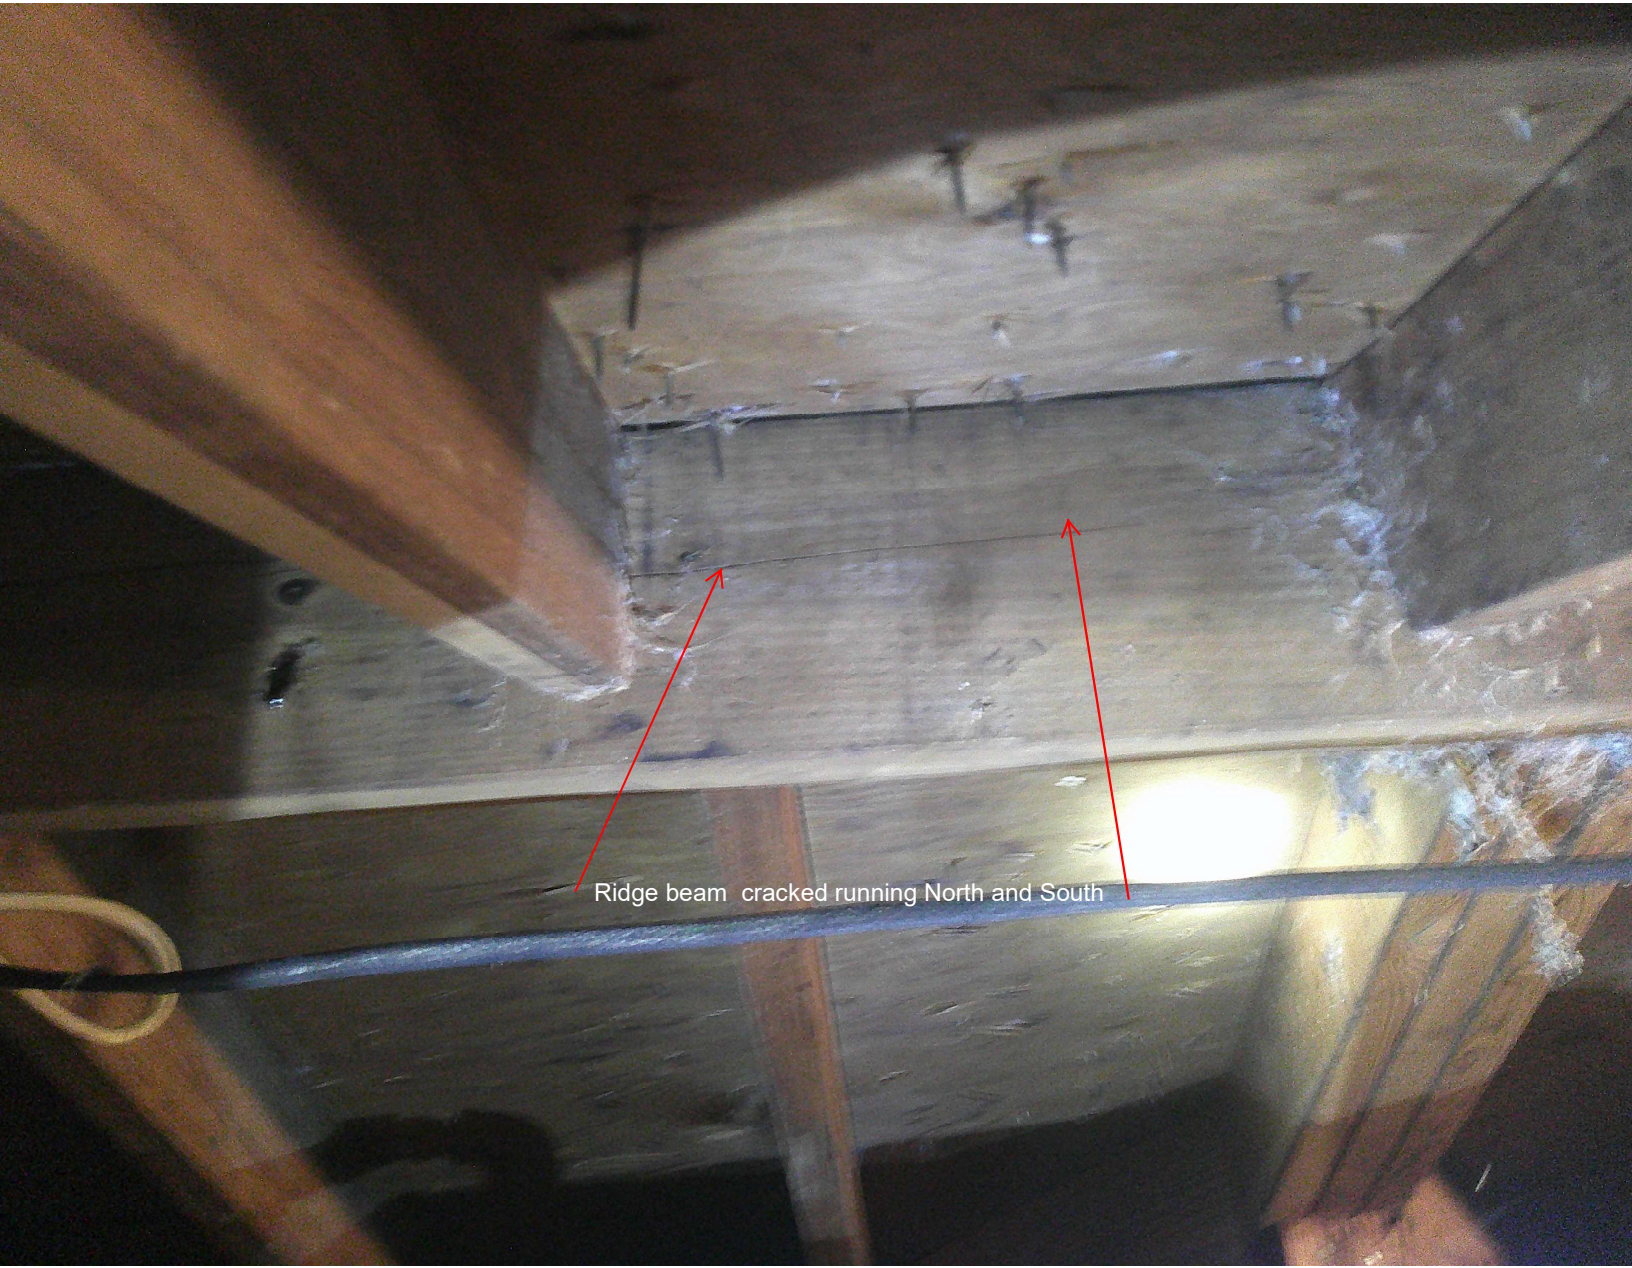
Ridge beam cracked running North and South

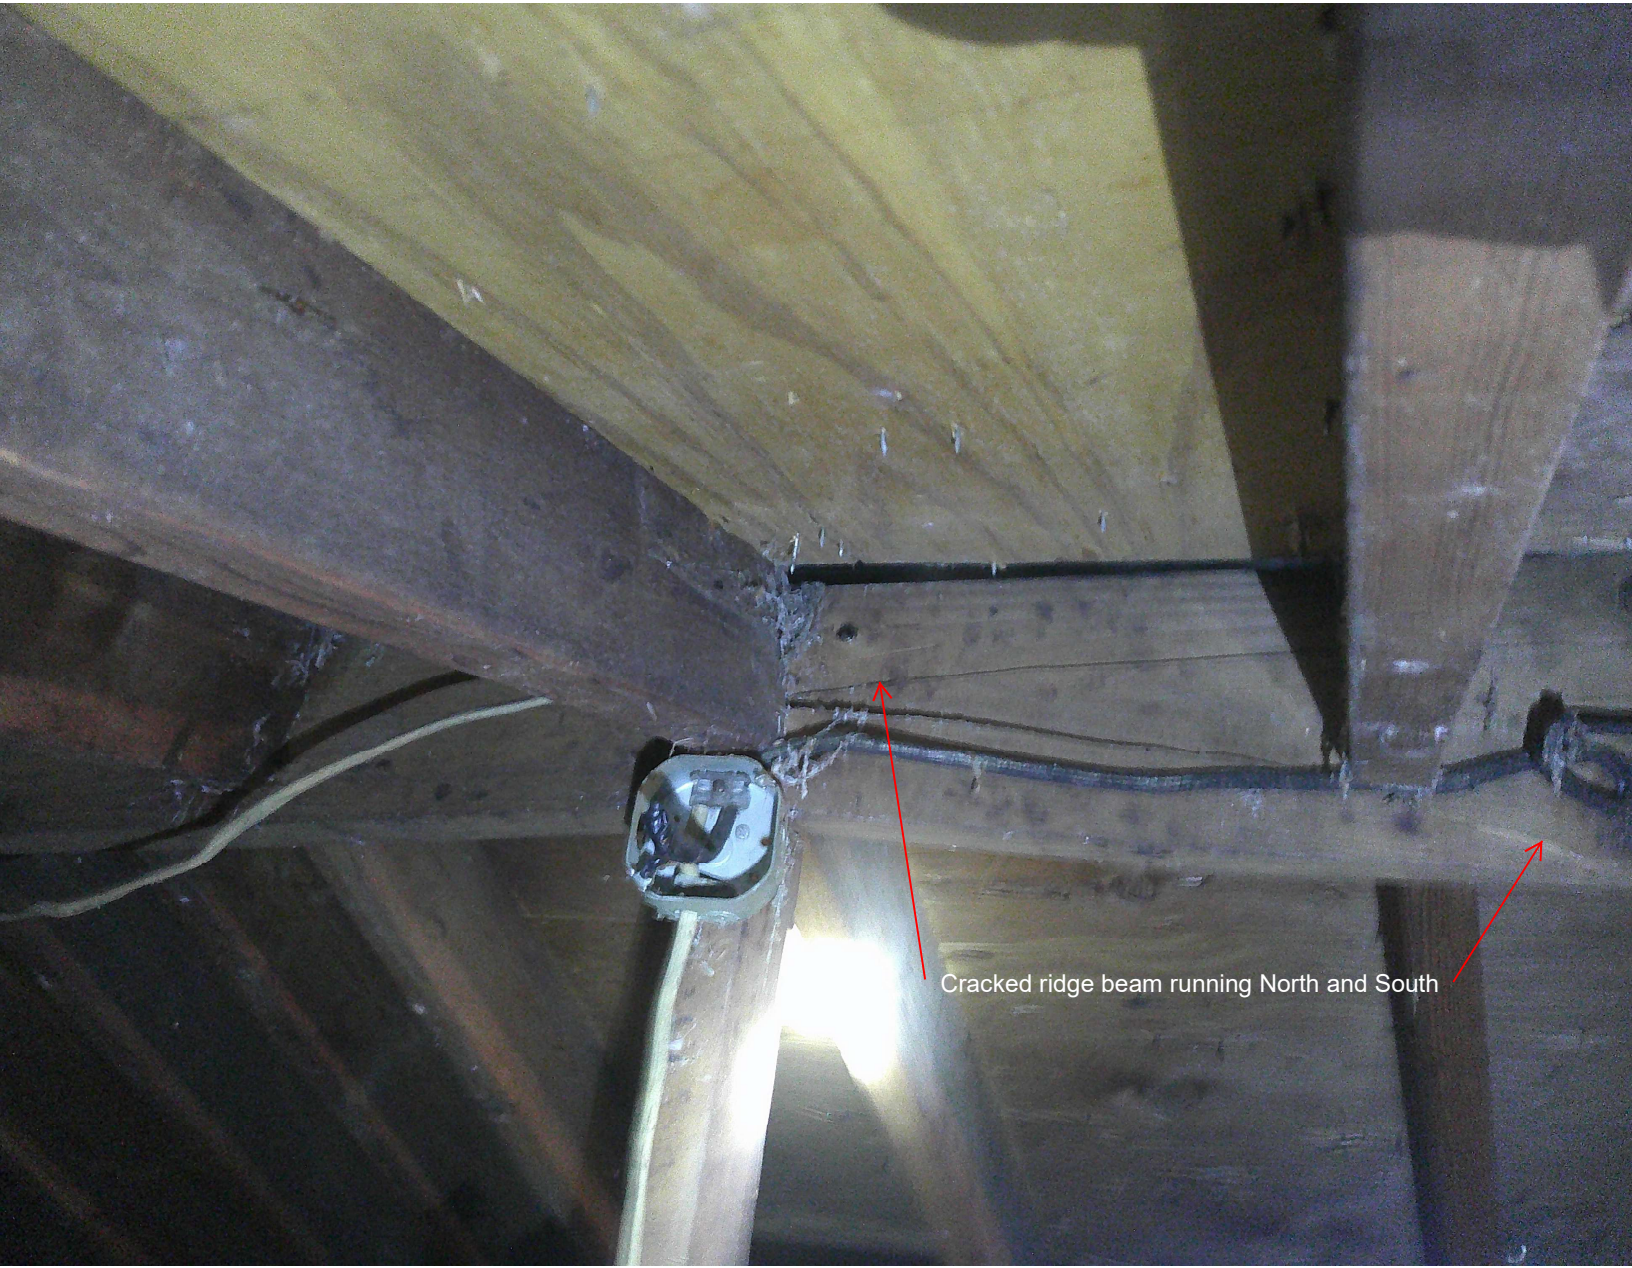
Cracked ridge beam running North and South

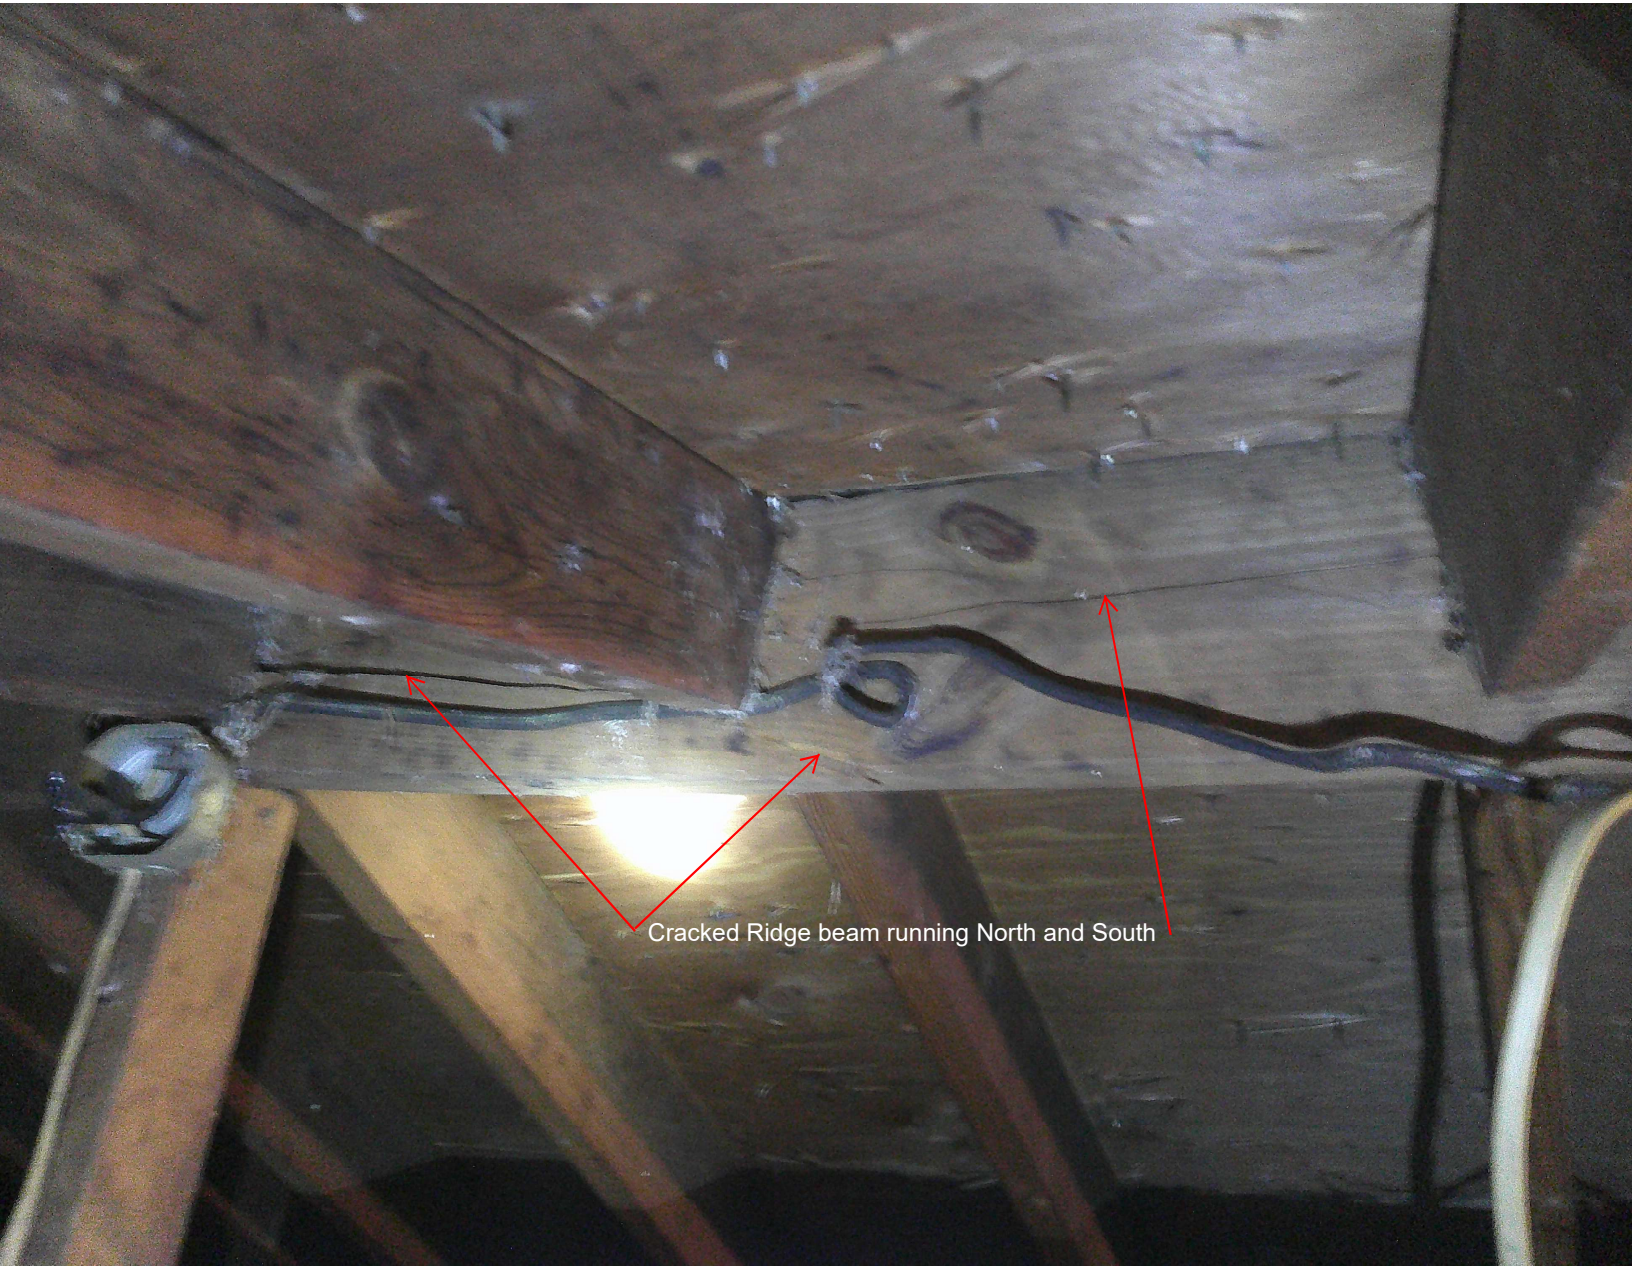
Cracked Ridge beam running North and South
