310 Lakeland C. Suite E
Flowood, MS 39232
Tel: 601-956-1590

Engineering Report

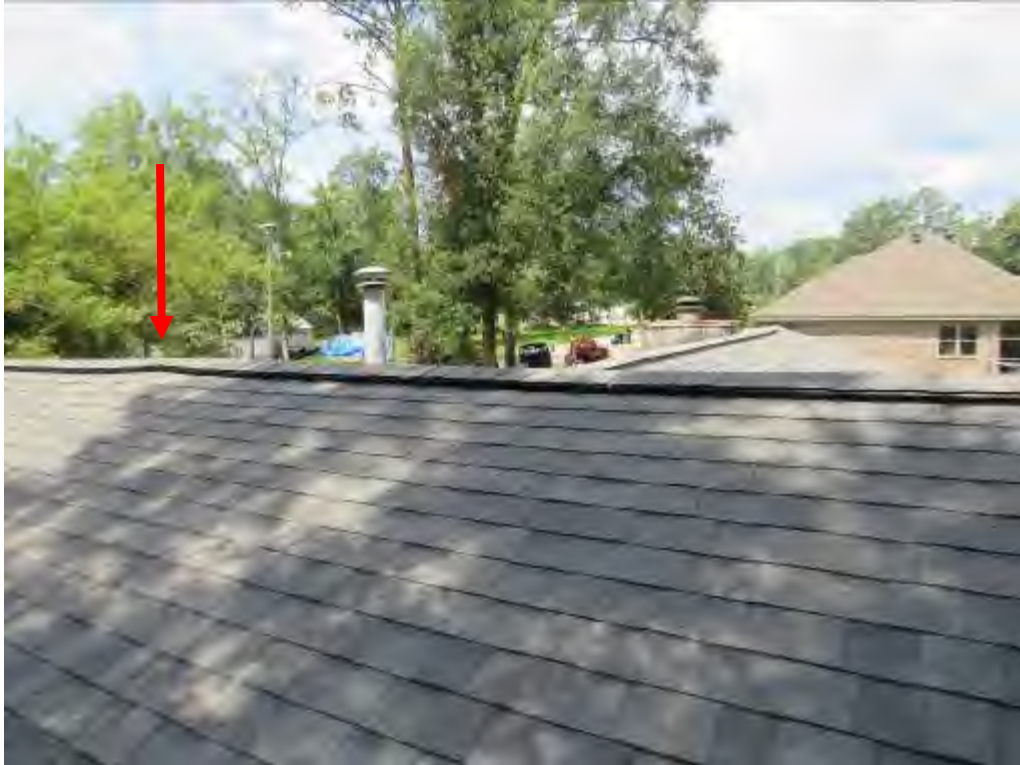
Photo No. 13: A high-point was noted near the middle of the roof.

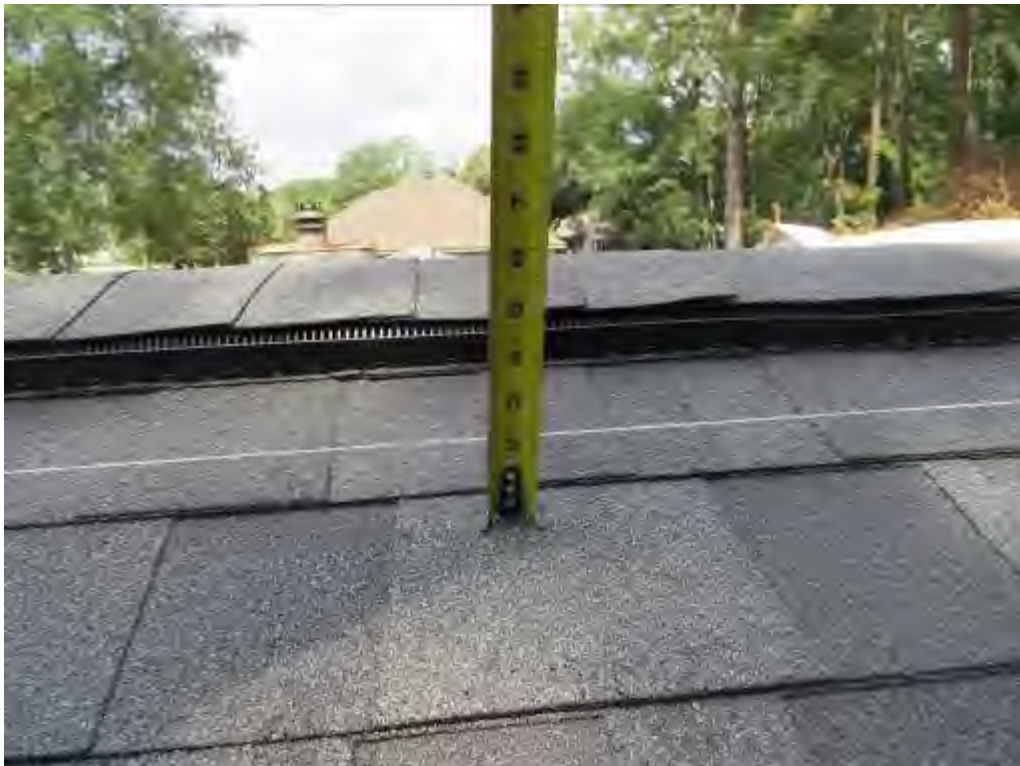
Photo No. 14: Low-point at north-side ridgeline.

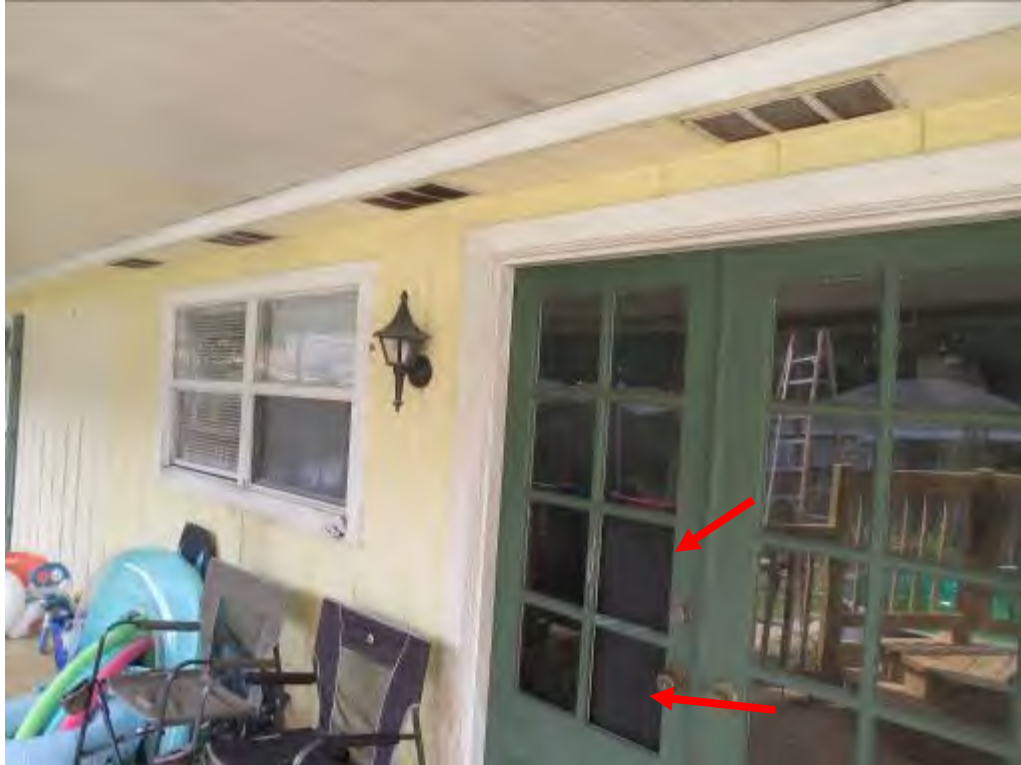
Photo No. 15: Two of the rear door's window panes were missing.

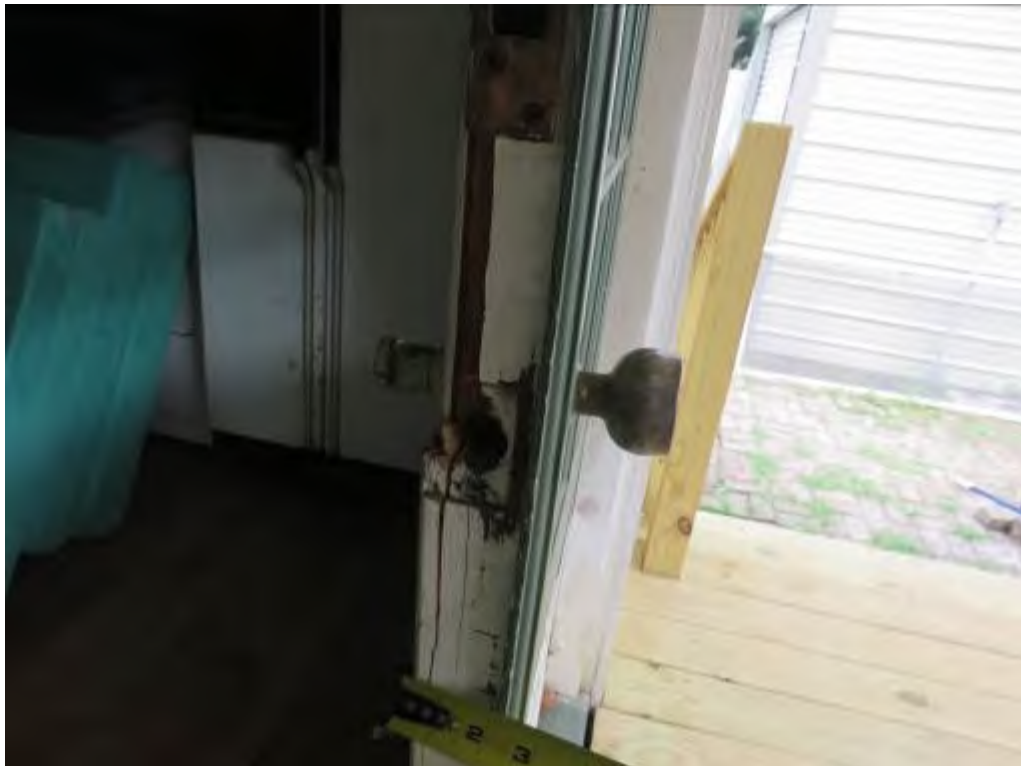
Photo No. 16: The rear door was broken.

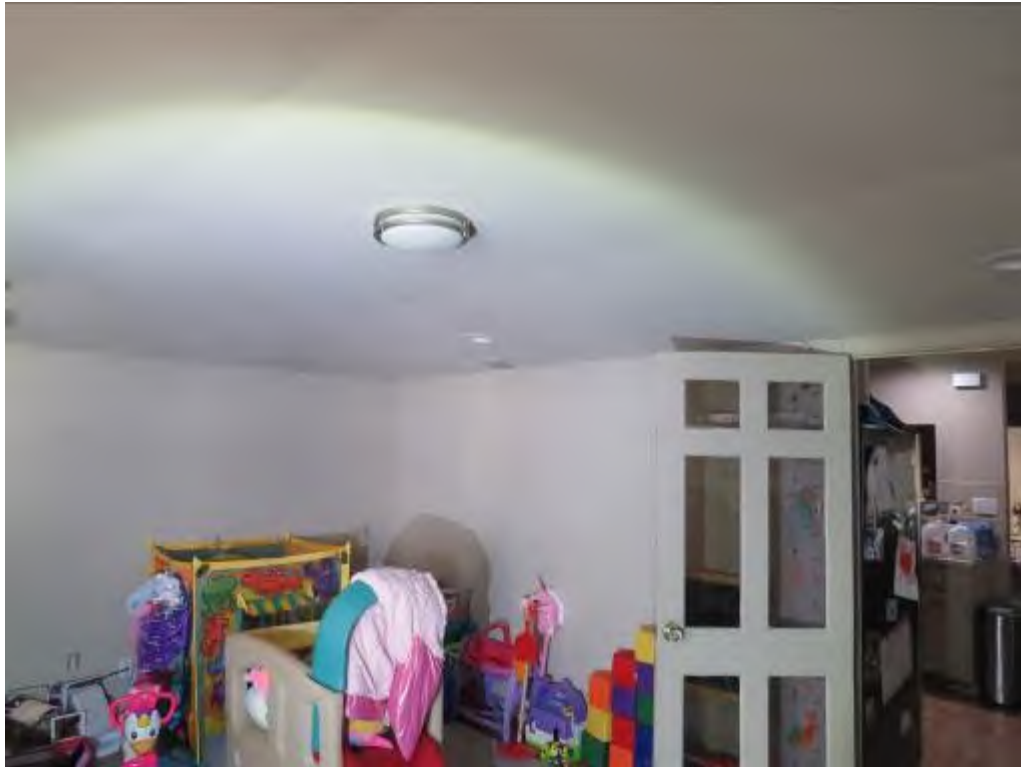
Photo No. 17: No cracks or stains were noted on the playroom's ceiling or walls.

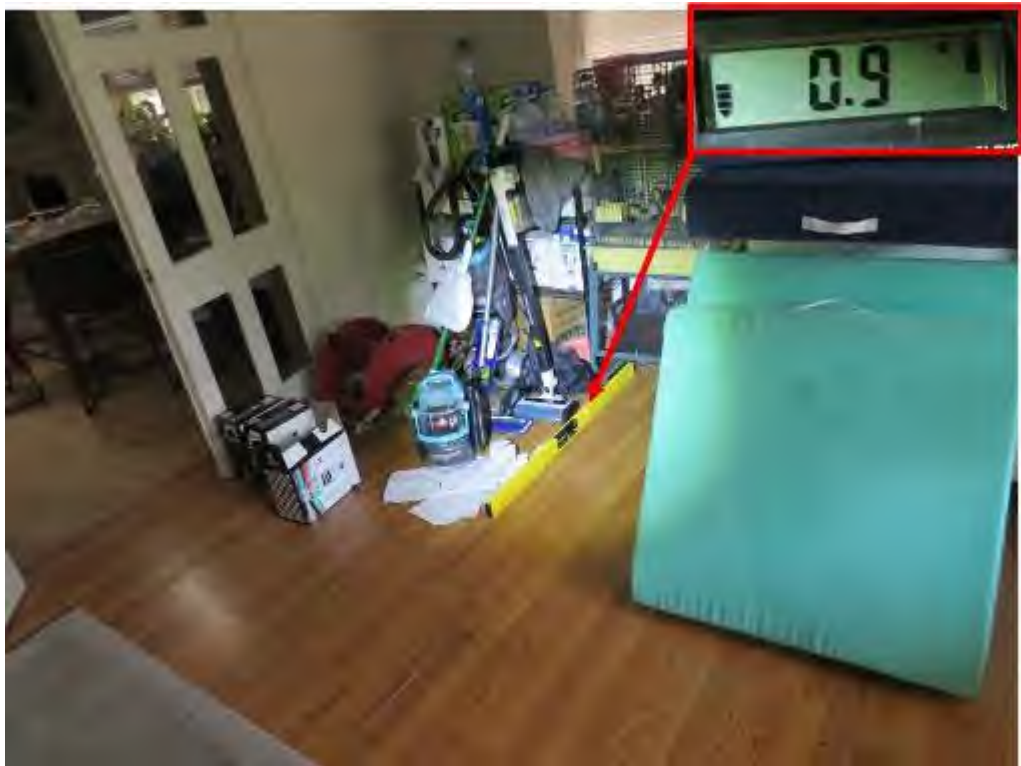
Photo No. 18: The playroom's west-side floors sloped down toward the west.

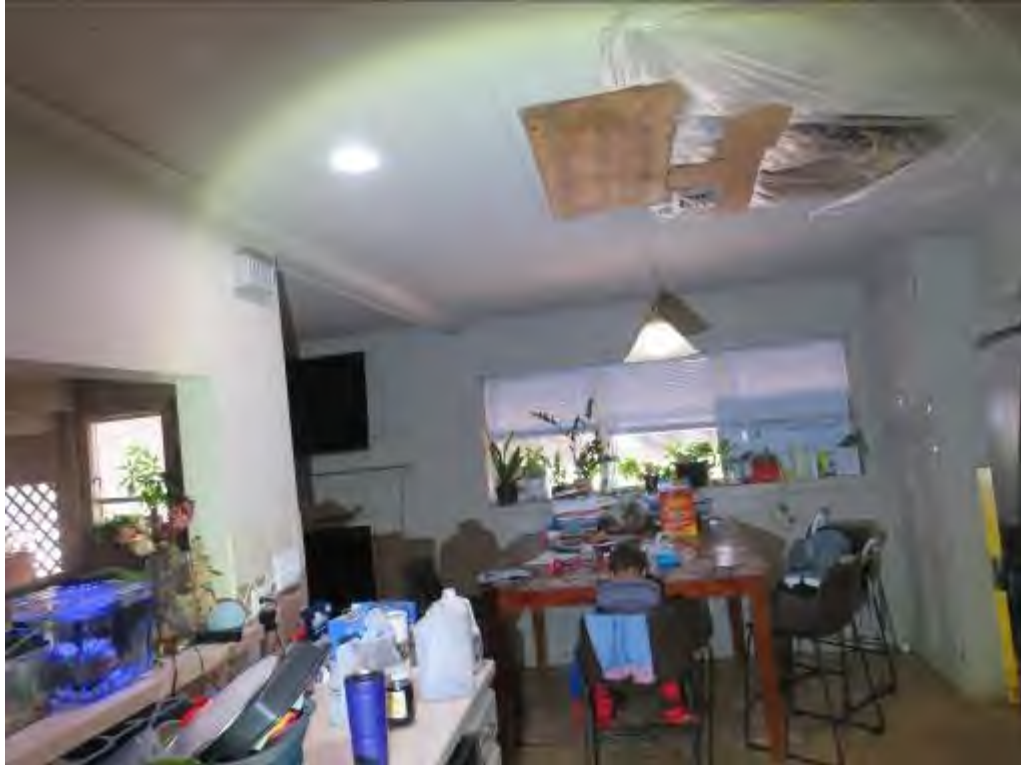
Photo No. 21: A section of the kitchen's ceiling drywall was missing.

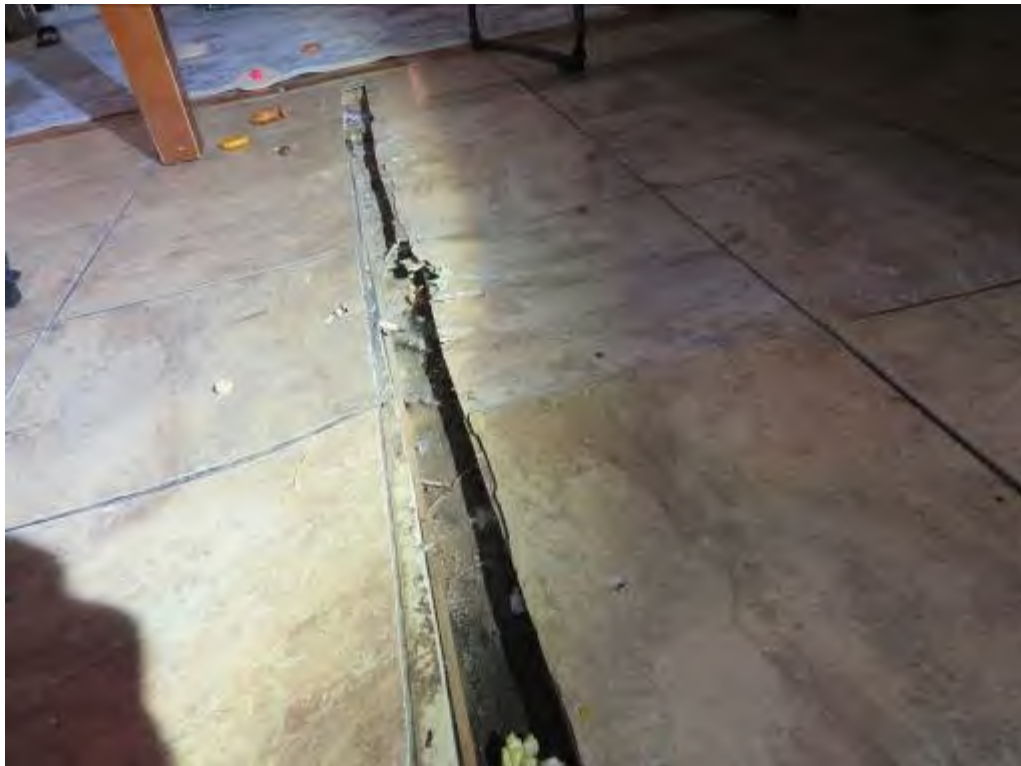
Photo No. 22: Dirt and debris were noted within the missing area

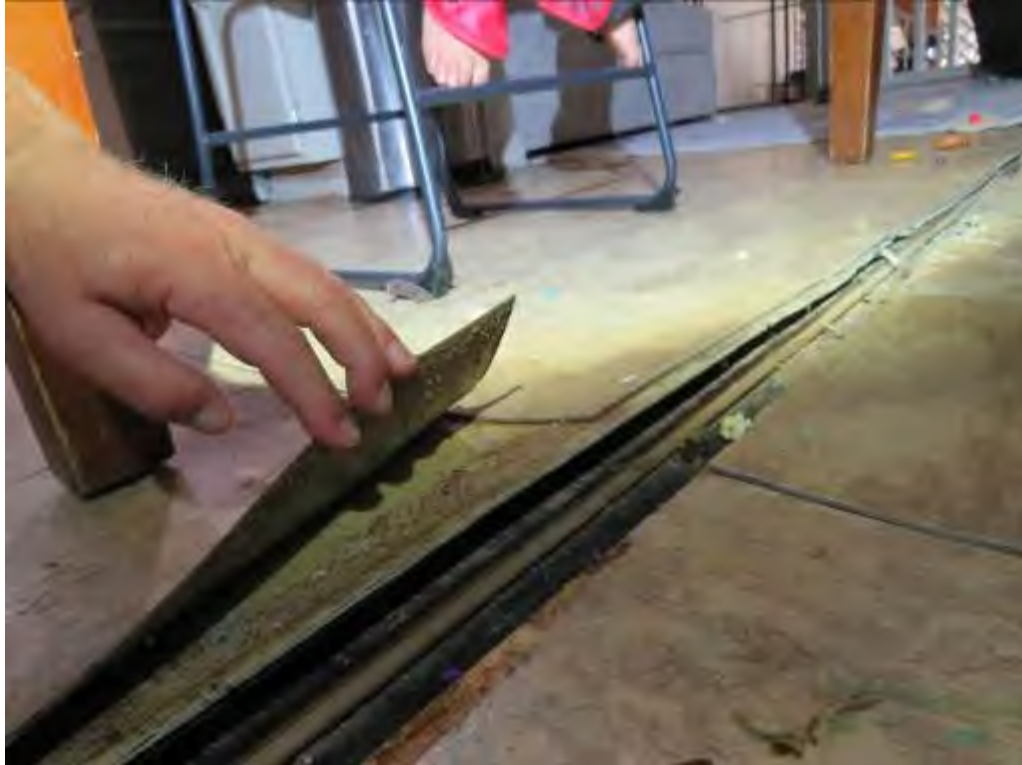
Photo No. 23: The hardwood flooring was covered by laminate sheeting and laminate tiles

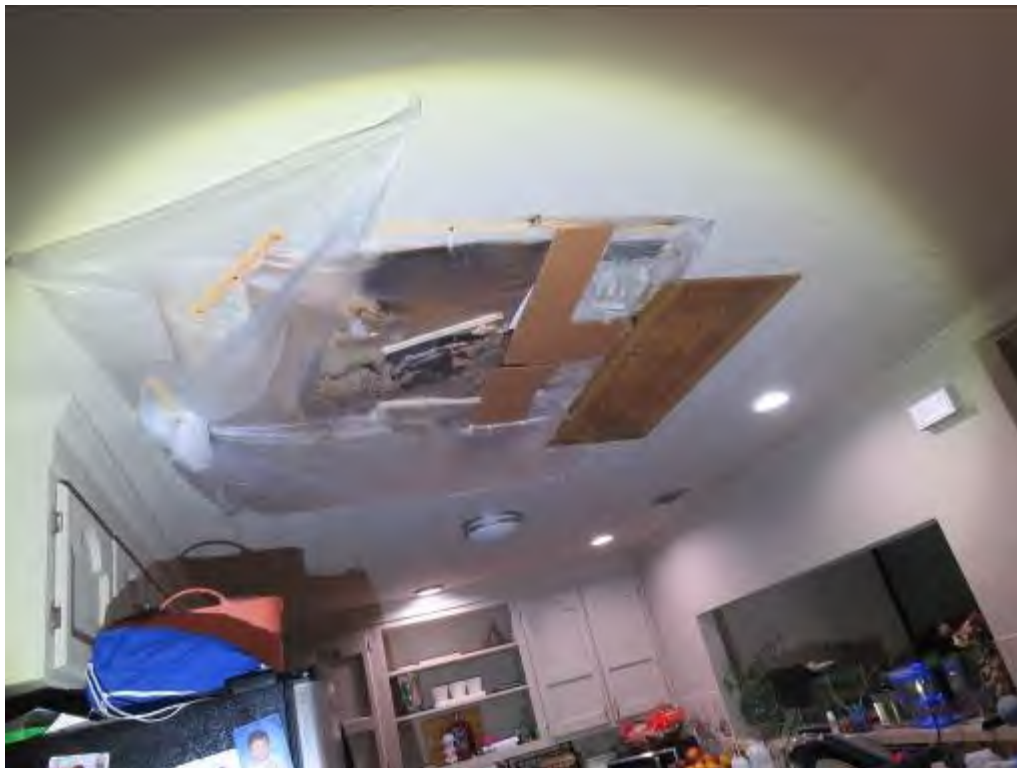
Photo No. 26: No cracks were noted in the remainder of the kitchen's ceiling or walls.

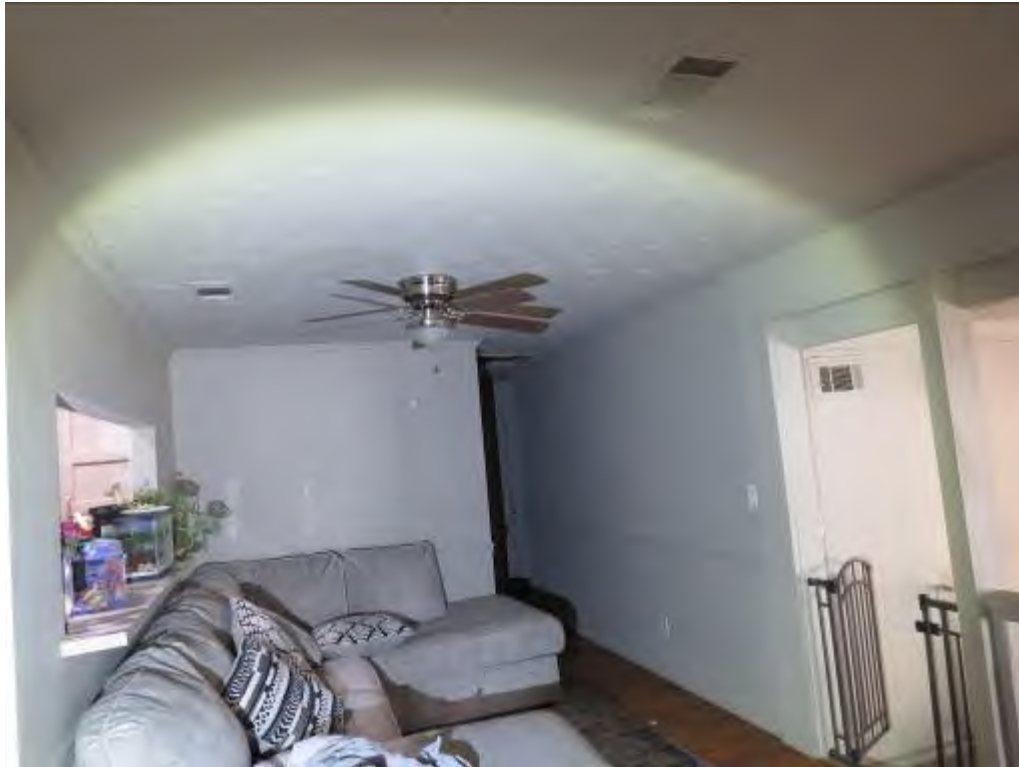
Photo No. 27: No cracks or stains were noted in the living room's ceiling or walls.

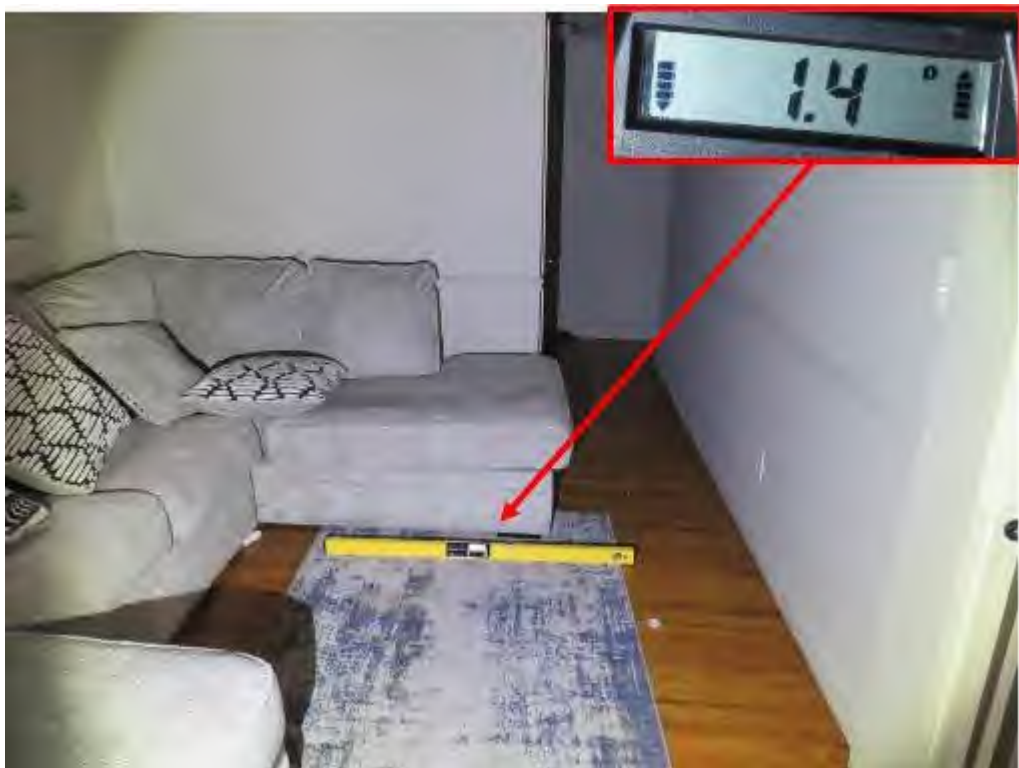
Photo No. 28: The living room's floors were not level.

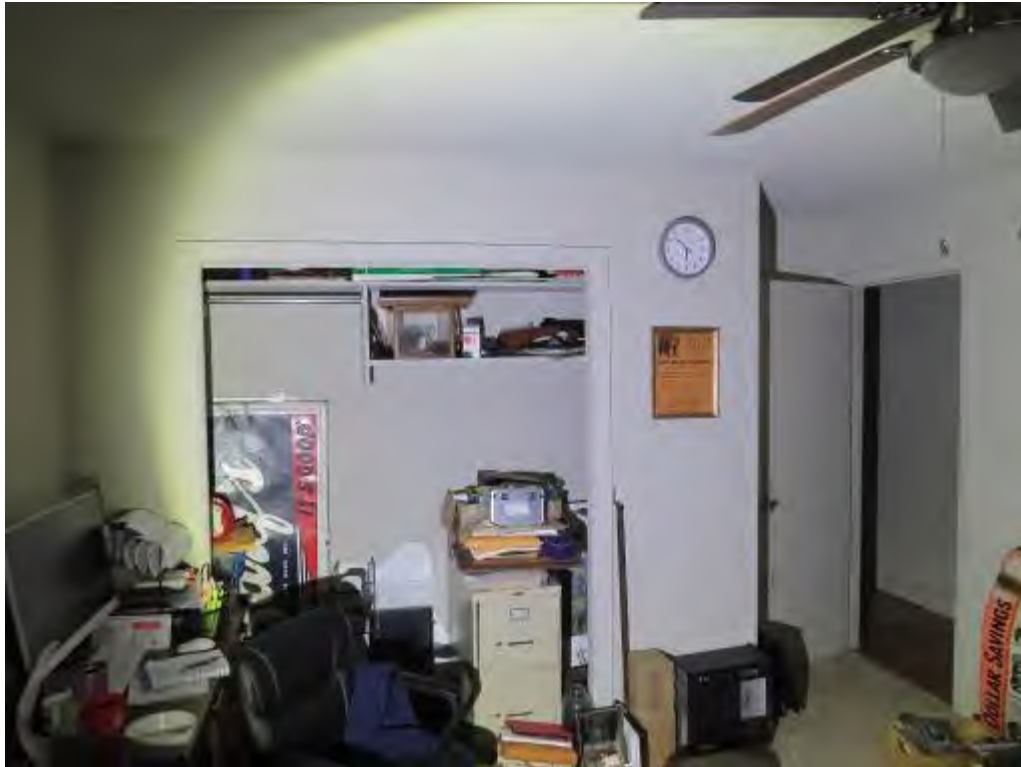
Photo No. 31: No stains were noted on the bedroom's ceiling or walls.

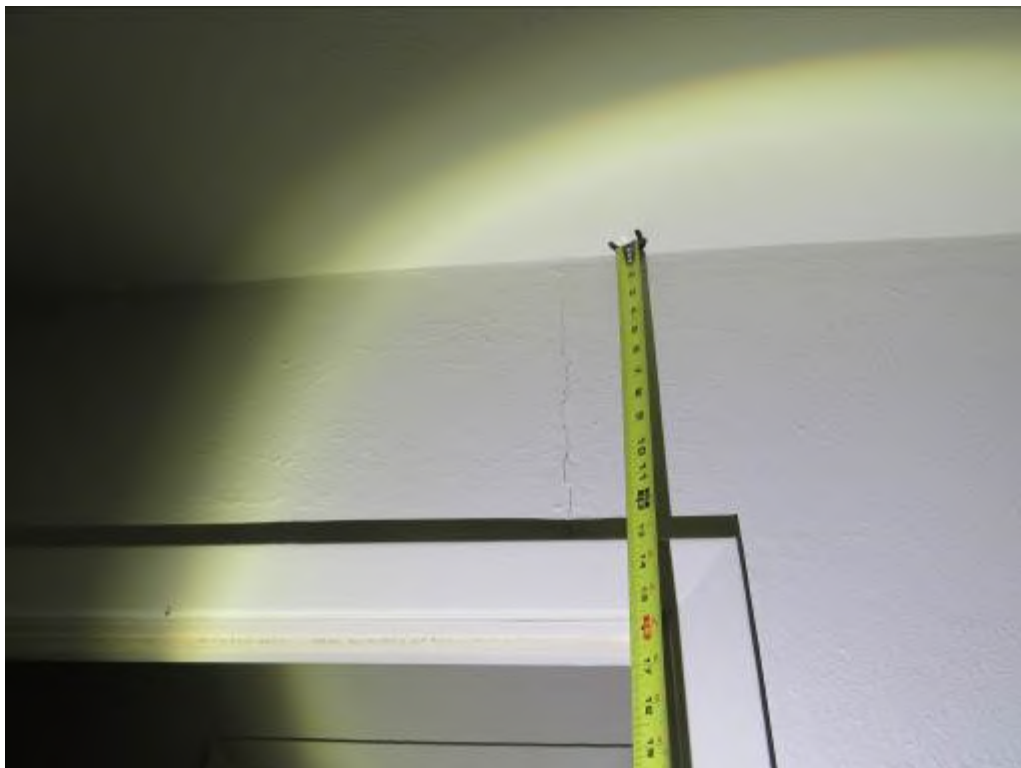
Photo No. 32: A crack was noted in the drywall above the door.

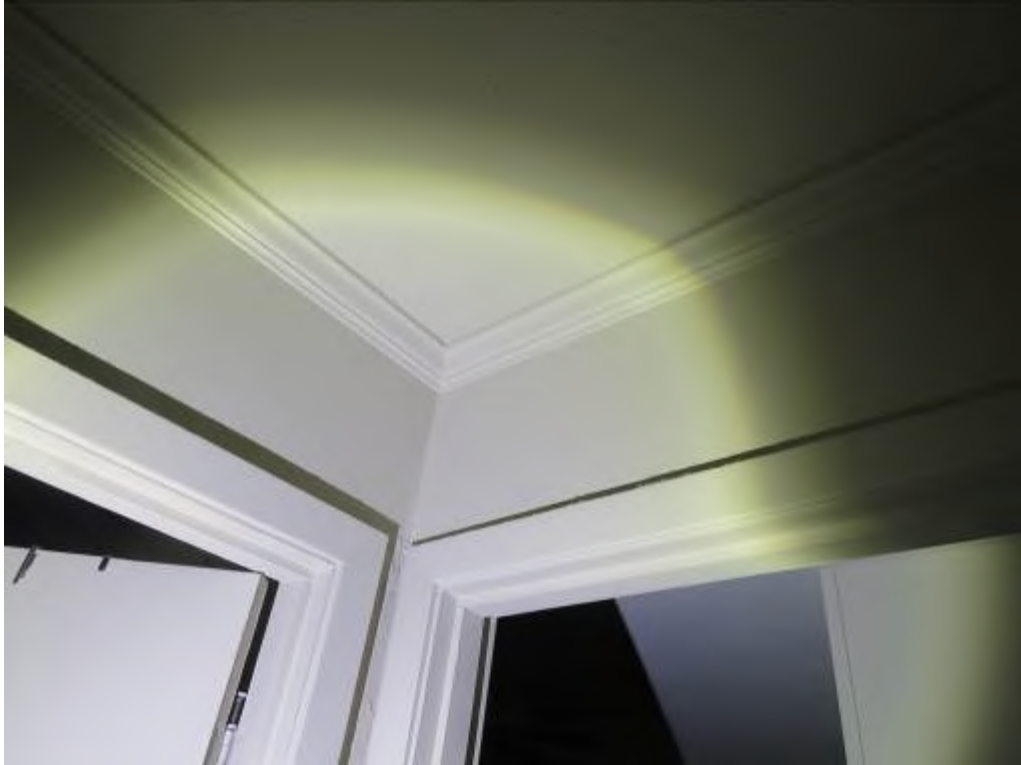
Photo No. 33: No cracks were noted in the adjacent hallway's drywall.

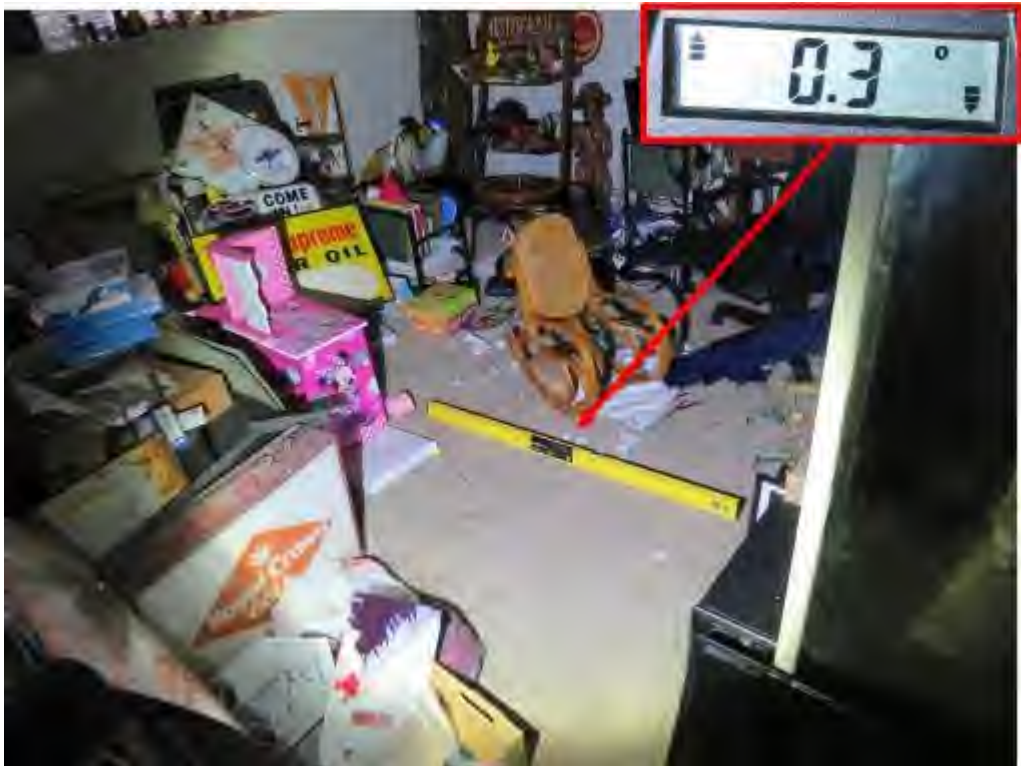
Photo No. 34: The bedroom's floors were near level.

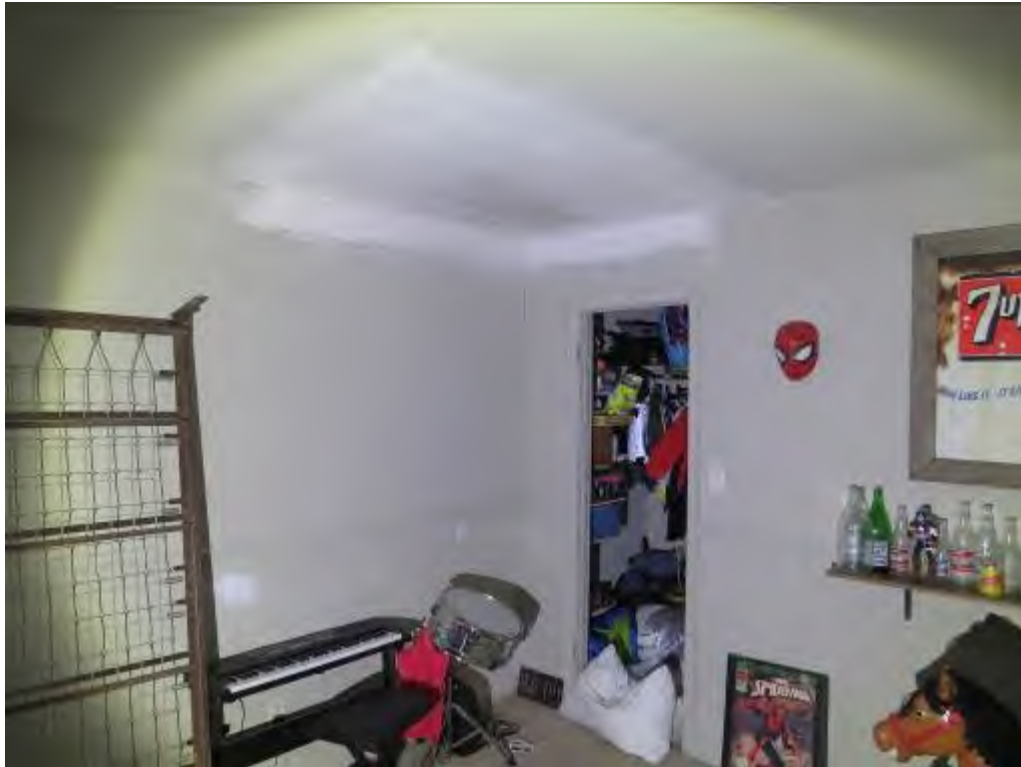
Photo No. 35: On-going repair activities were noted in the southeast bedroom's ceiling.

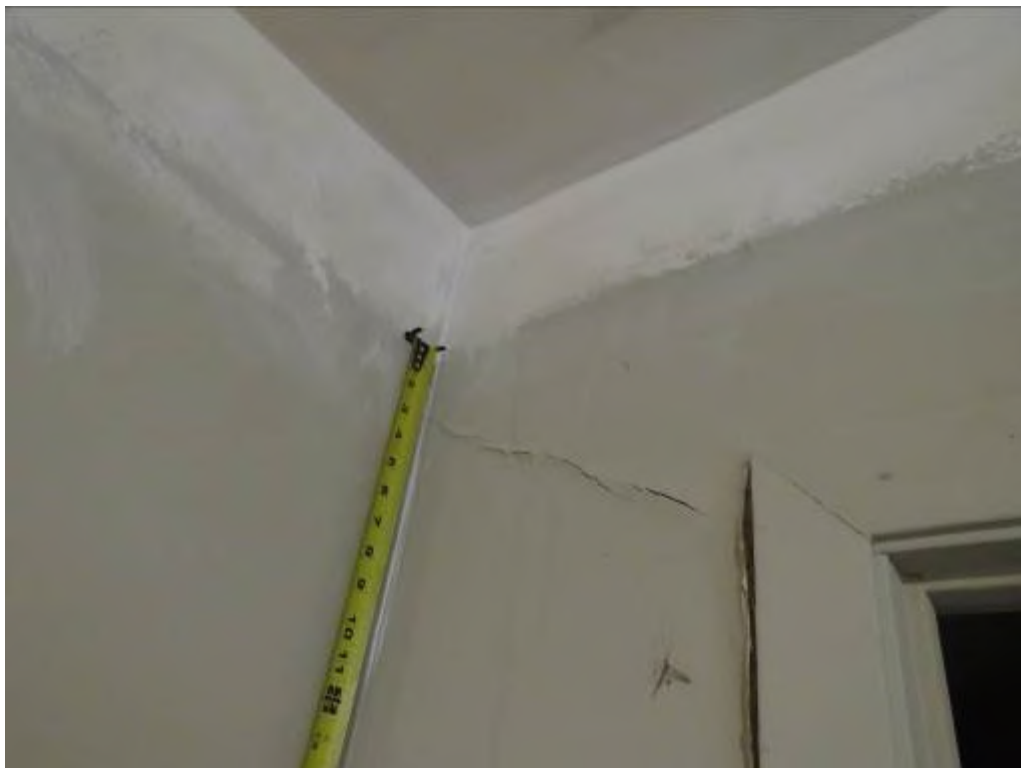
Photo No. 36: The room's east-side wall paint was cracked and delaminated.

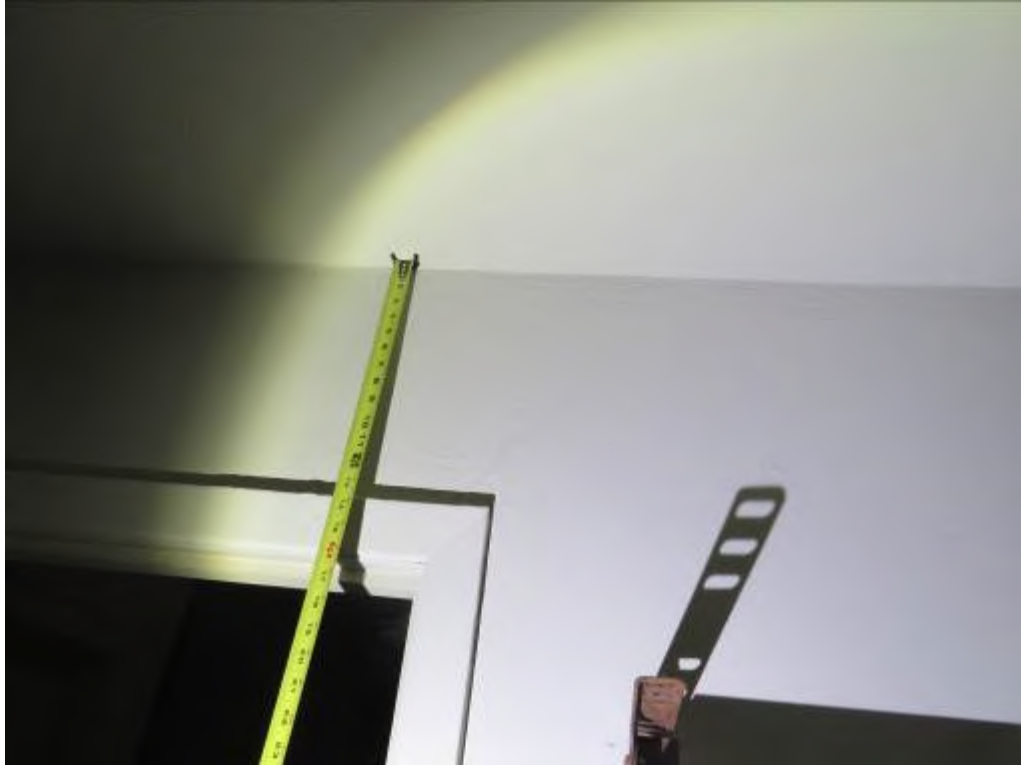
Photo No. 37: A crack was noted above the door to the bedroom.

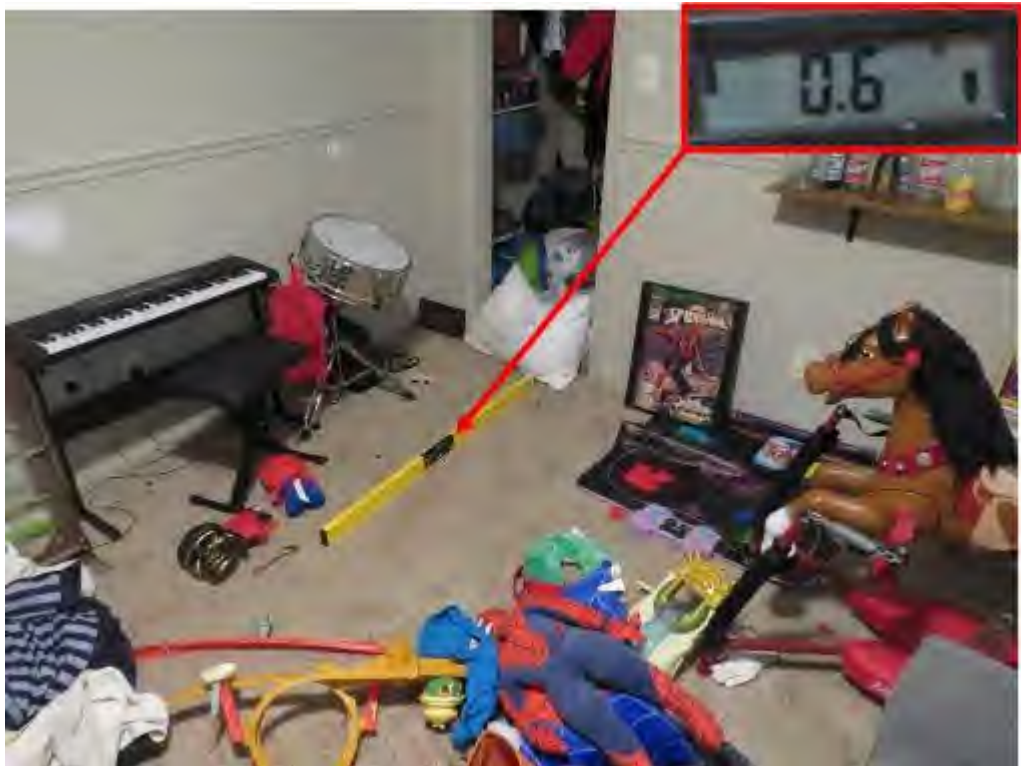
Photo No. 38: The bedroom's floors were not level.

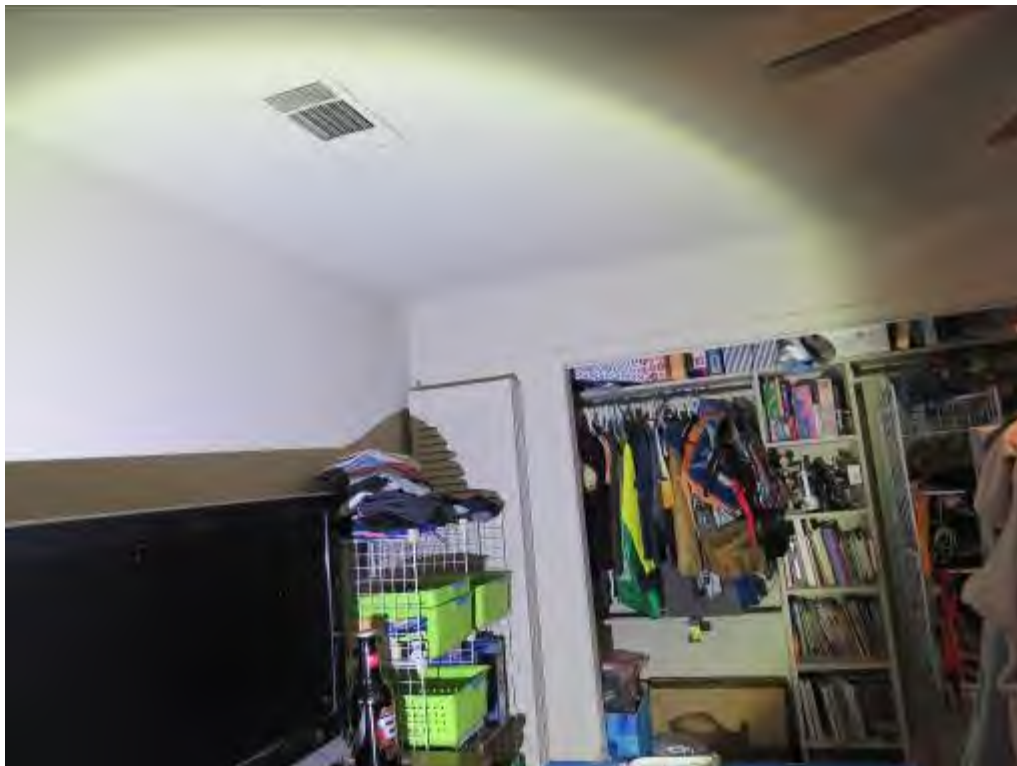
Photo No. 40: No stains or cracks were noted on the bedroom's ceilings or walls.

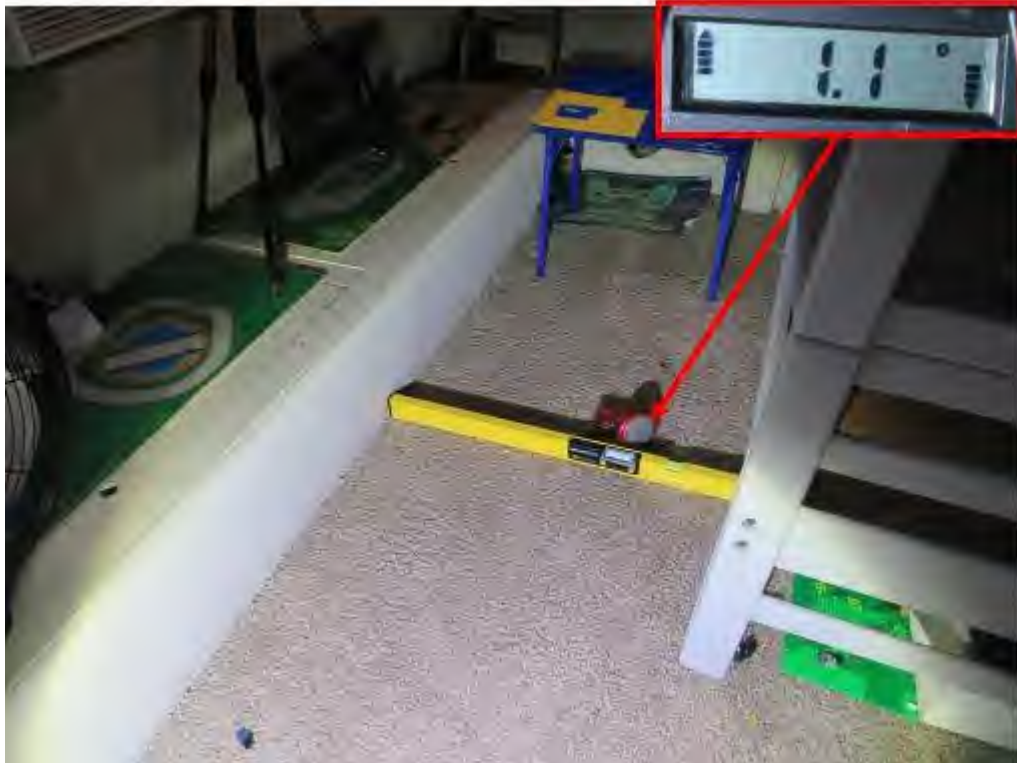
Photo No. 41: The bedroom's floors were not level.

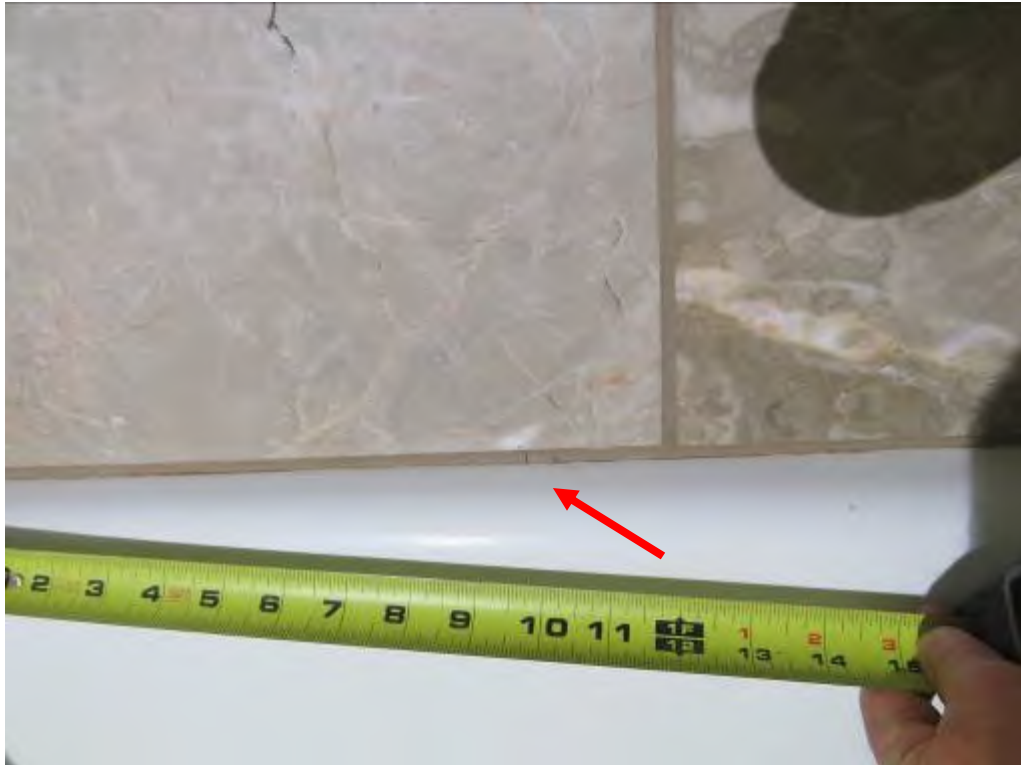
Photo No. 43: Cracks were noted in the ceramic tile's grout.

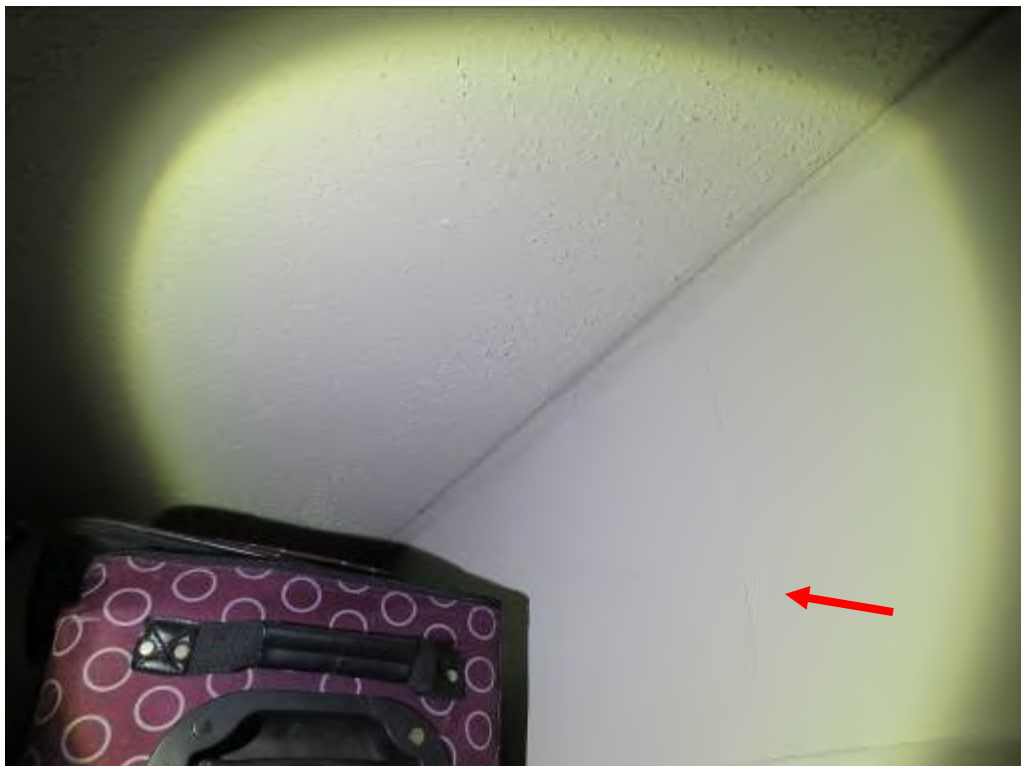
Photo No. 44: A crack was noted in the closet's drywall, above the door.

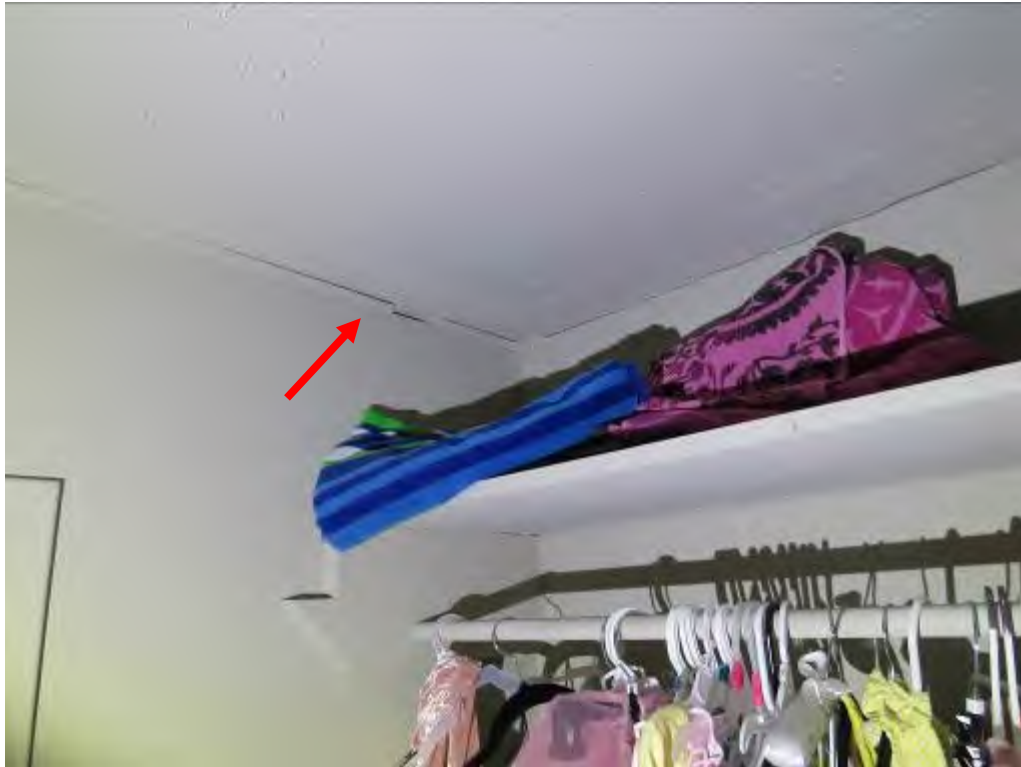
Photo No. 45: The drywall tape at the ceiling wall interface, above the door was delaminated.

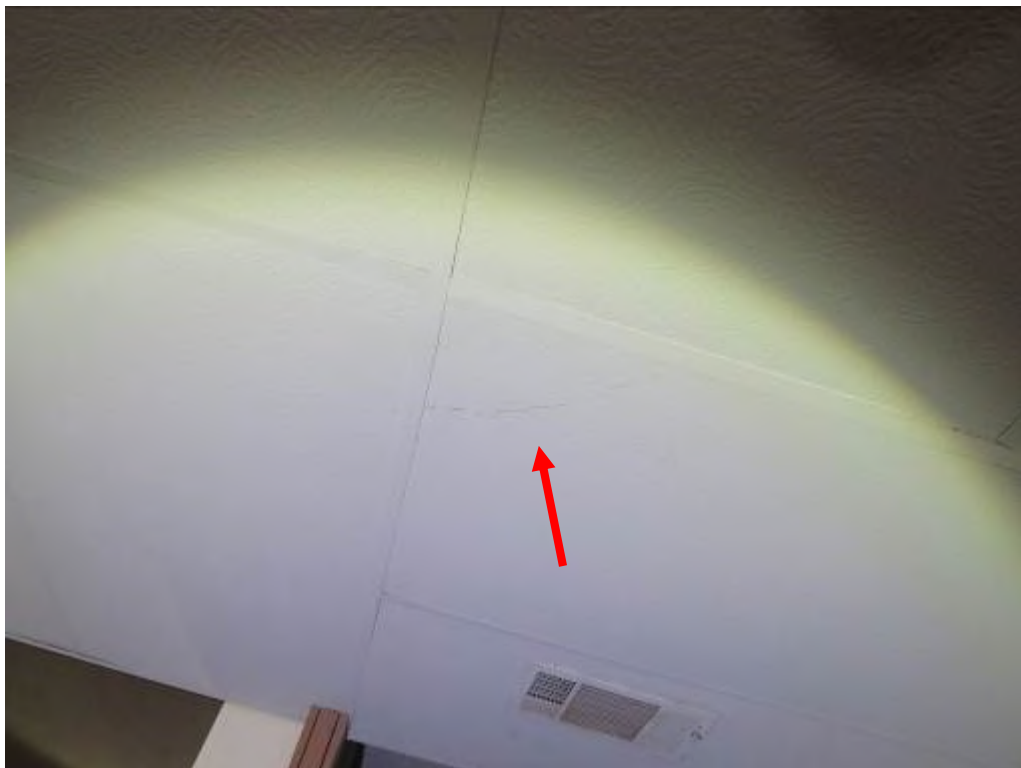
Photo No. 46: One of the tiles was broken.

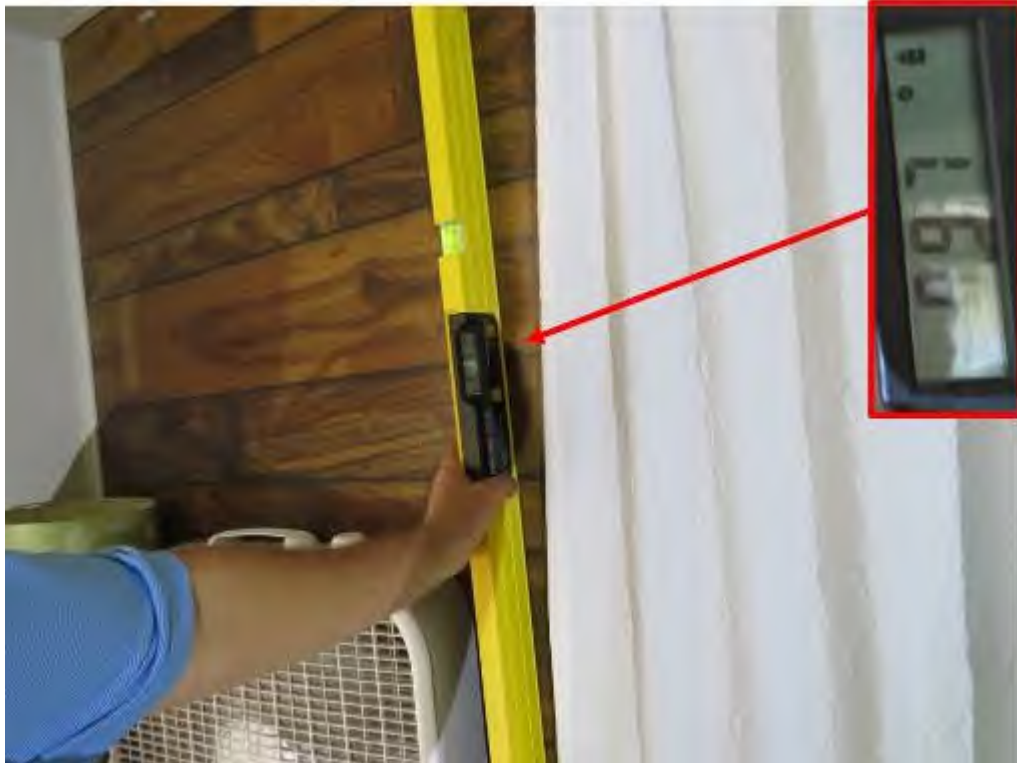
Photo No. 47: The bedroom's walls were plumb or near plumb.

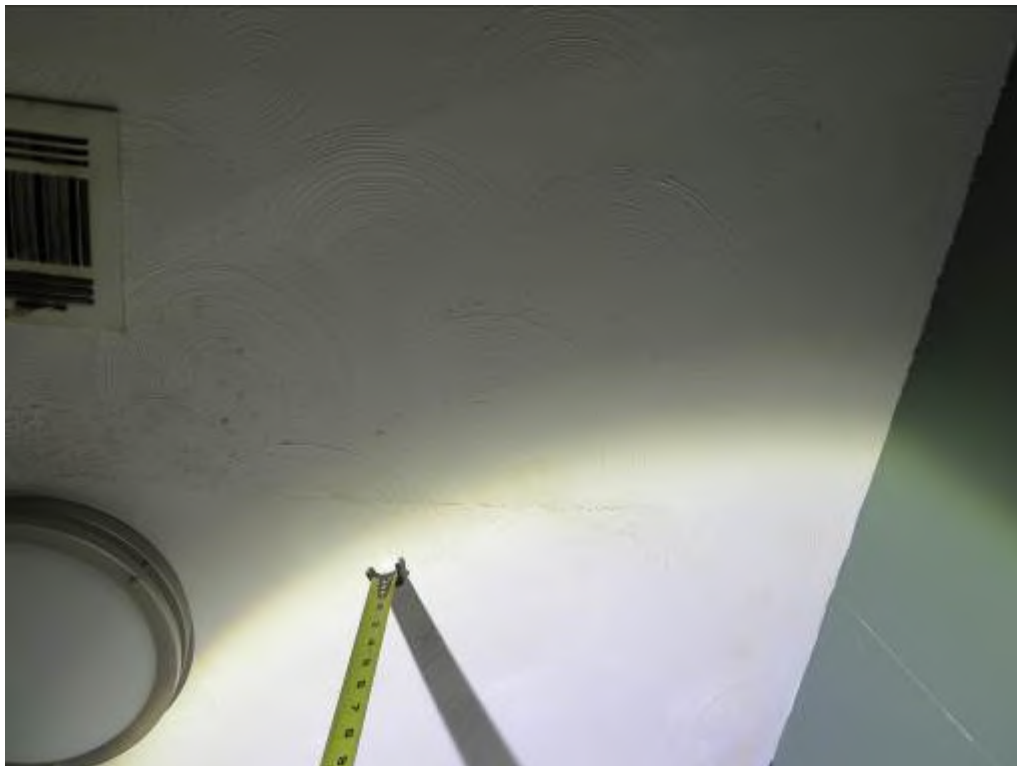
Photo No. 48: The ceiling drywall was cracked.

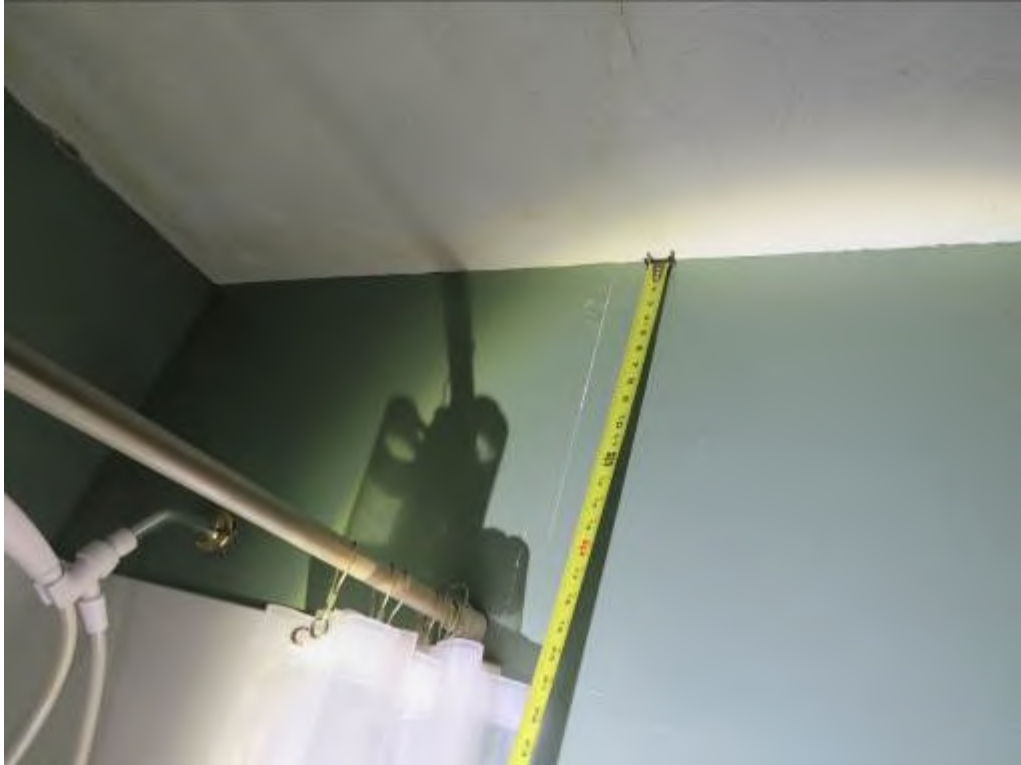
Photo No. 49: The wall drywall was cracked.
