310 Lakeland C. Suite E
Flowood, MS 39232
Tel: 601-956-1590

Engineering Report

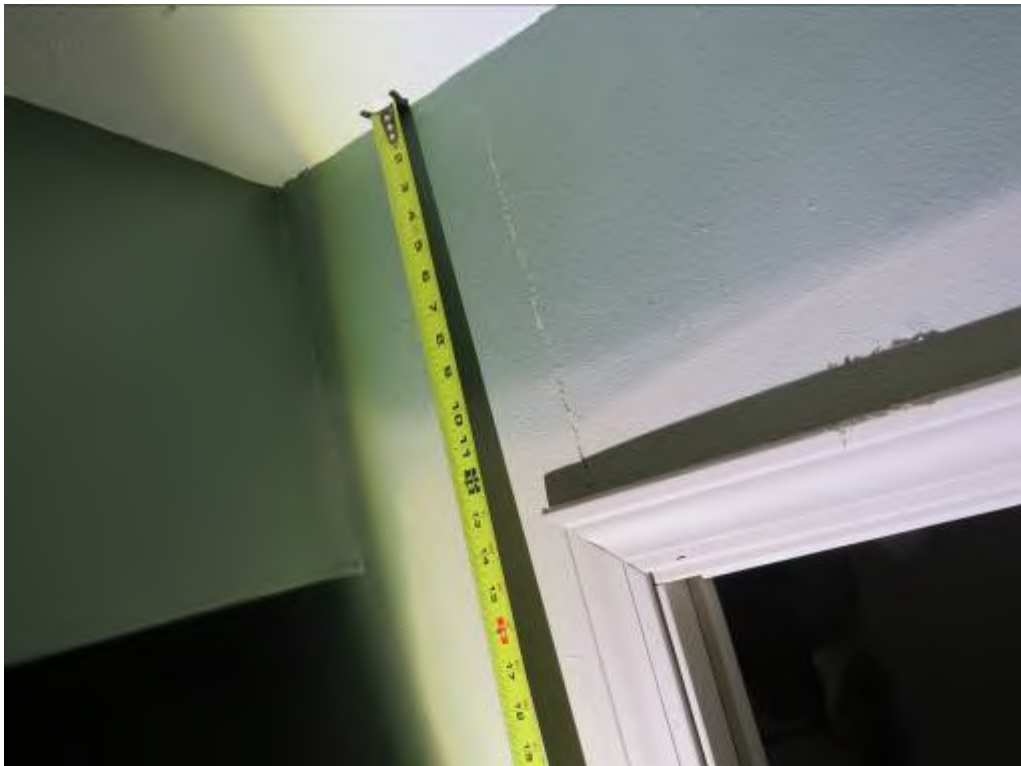
Photo No. 50: The cracks were vertical on the walls.

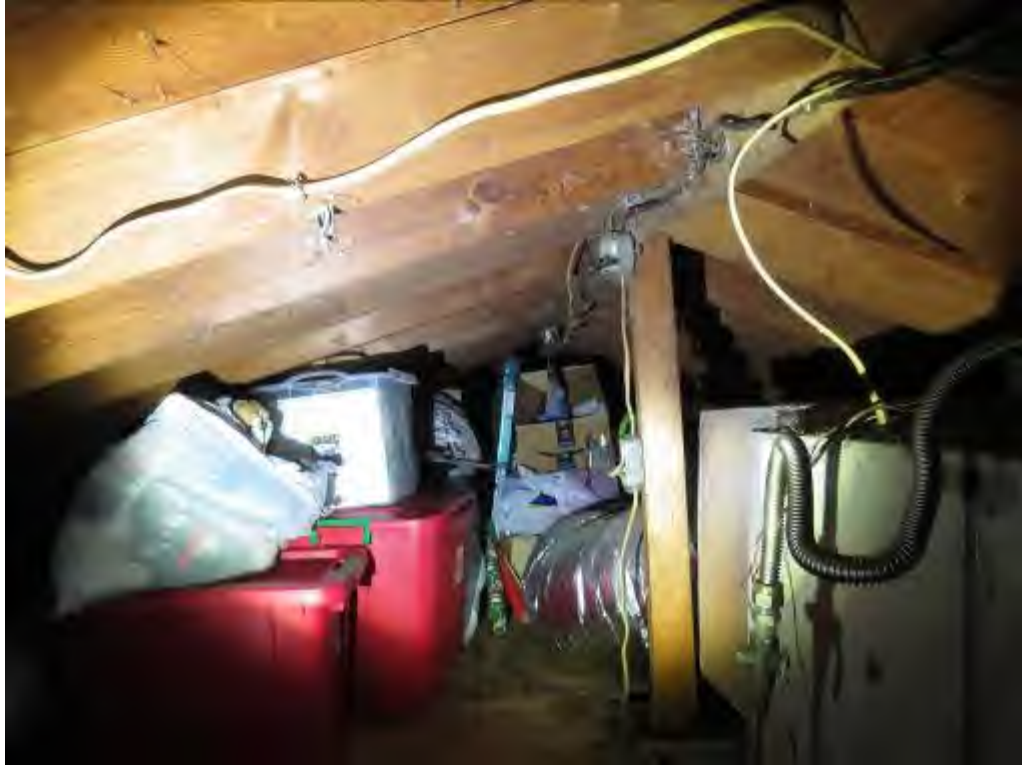
Photo No. 51: The north-south ridge beam was supported by one (1) king post.

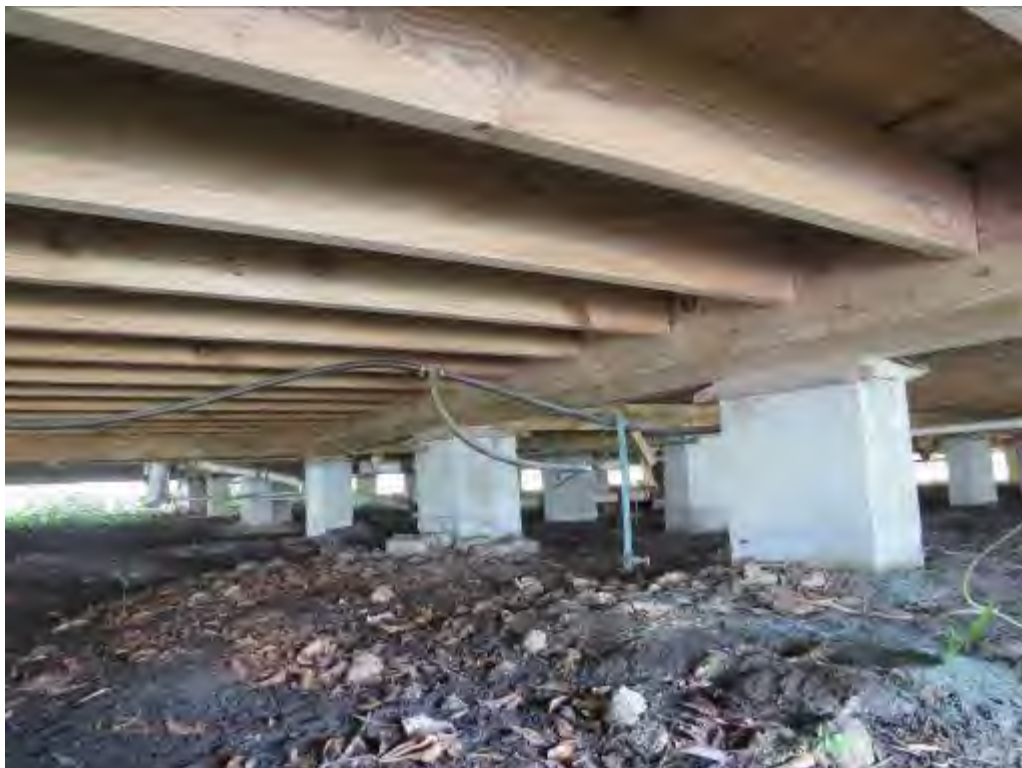
Photo No. 52: The residence was supported by a pier-and-beam foundation system.

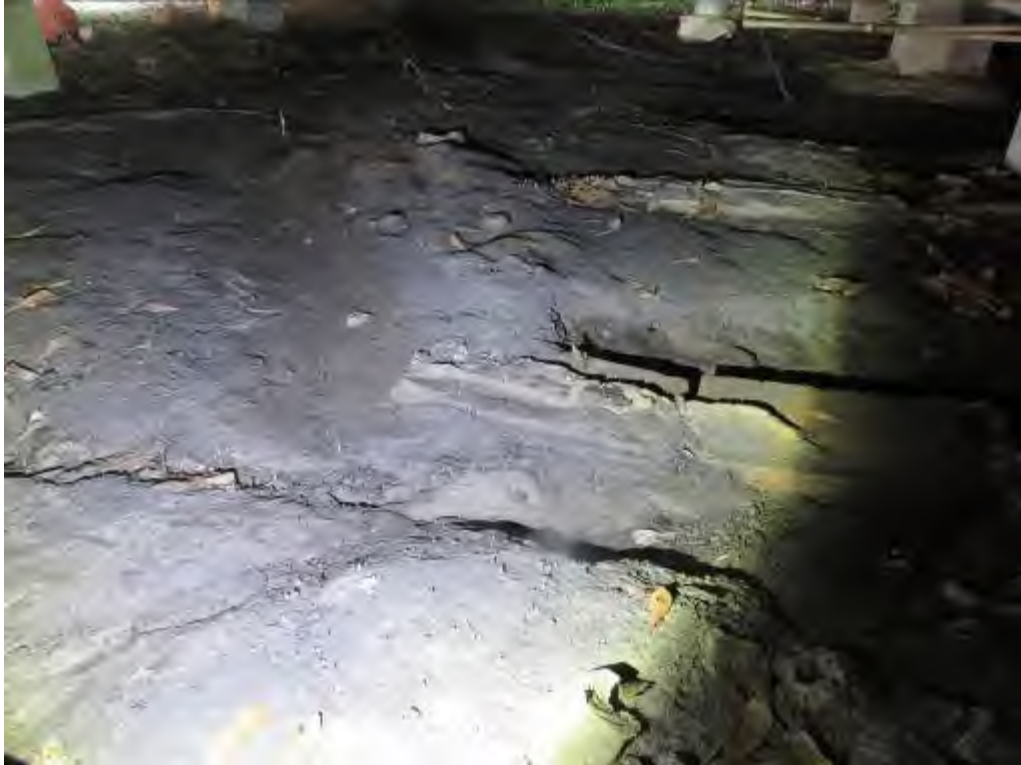
Photo No. 53: Several trenches were noted in the crawlspace floor.

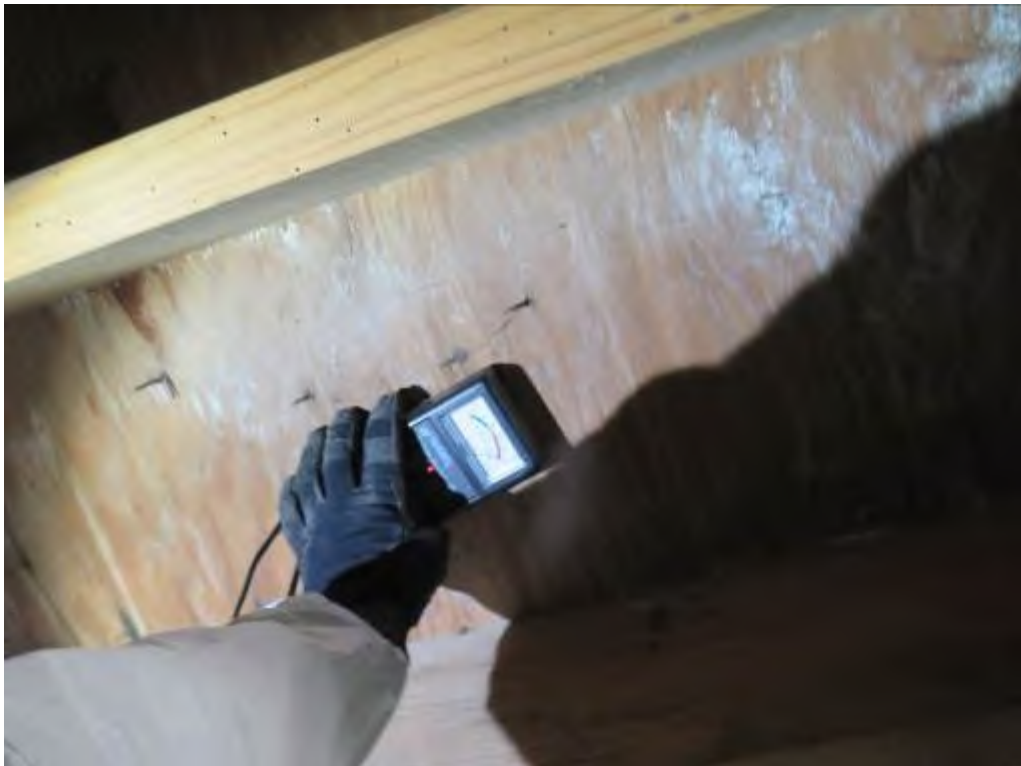
Photo No. 54: The subfloor's moisture content was elevated above 30%.

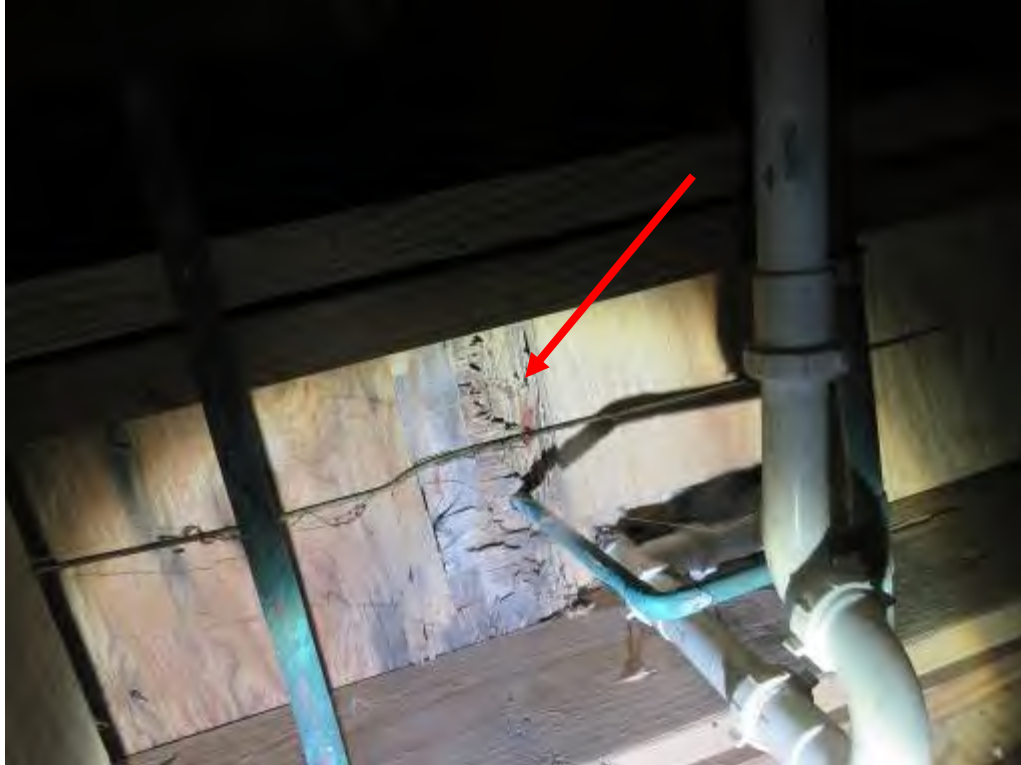
Photo No. 55: Deteriorated subfloor was noted under the bathrooms area.

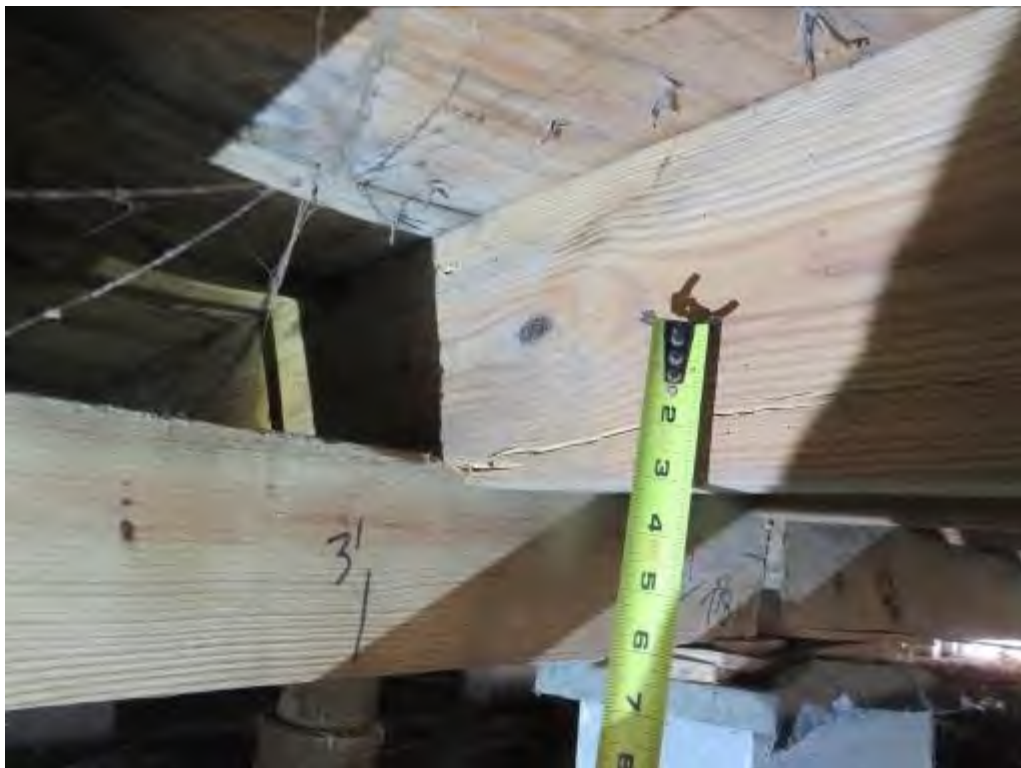
Photo No. 56: One broken floor framing member was noted adjacent to the repair location.

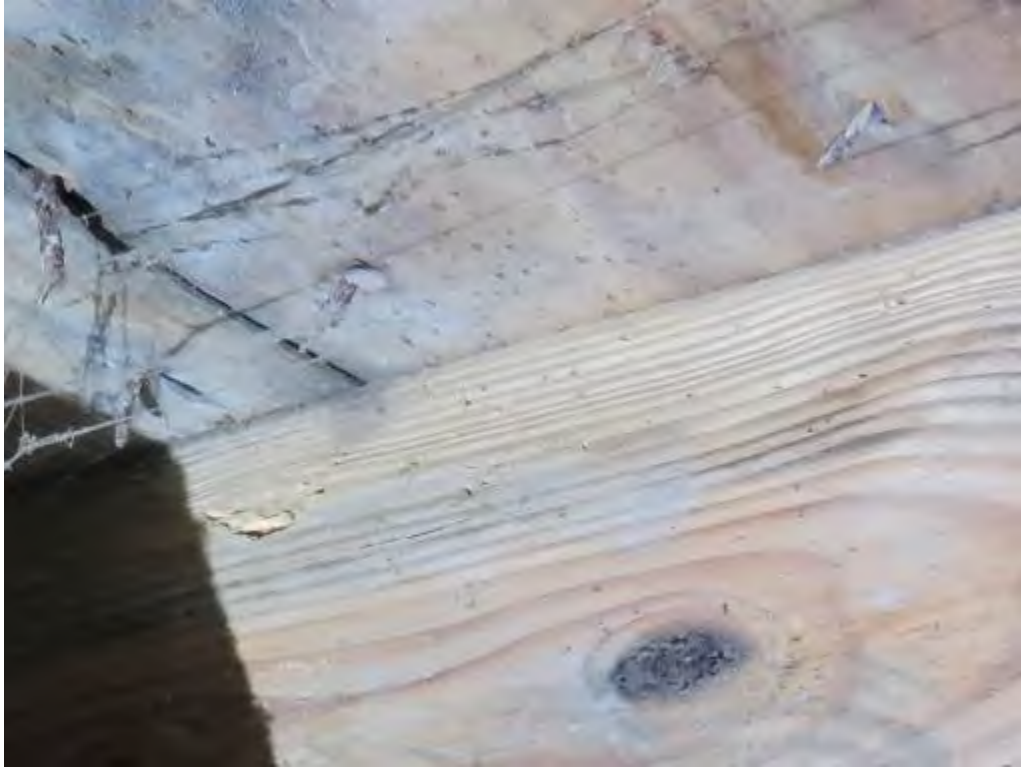
Photo No. 57: Numerous small holes were noted in the framing member.

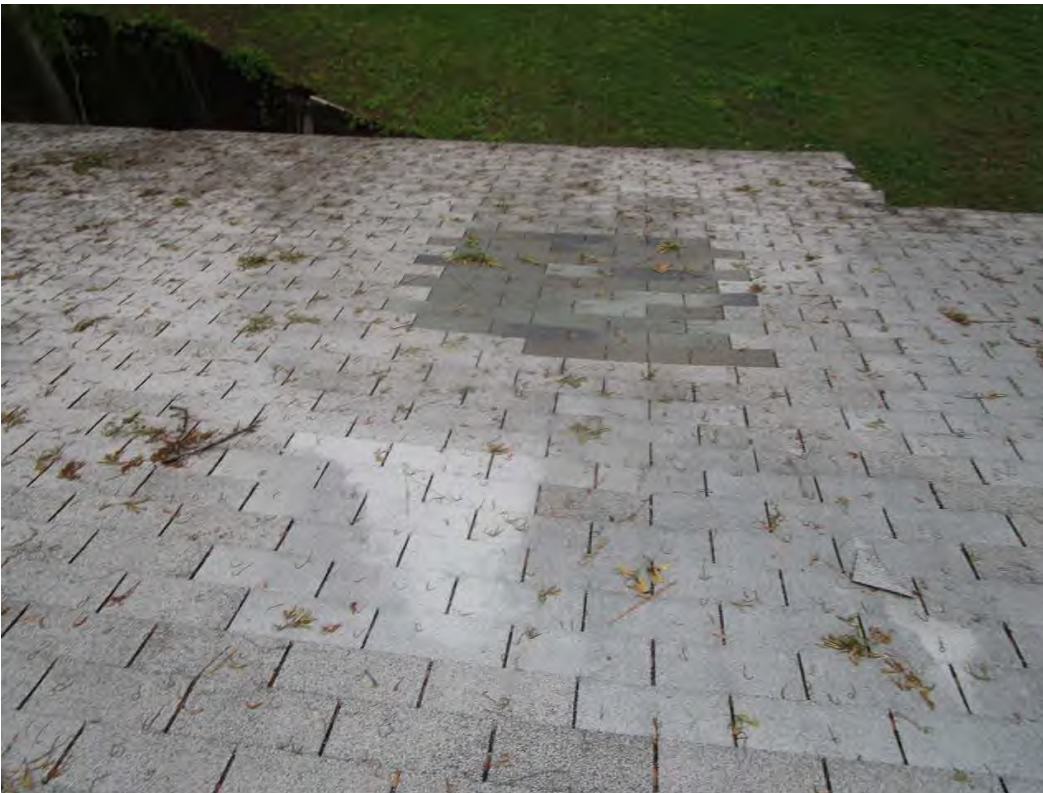
Dwelling/Shingled Roof - 8-

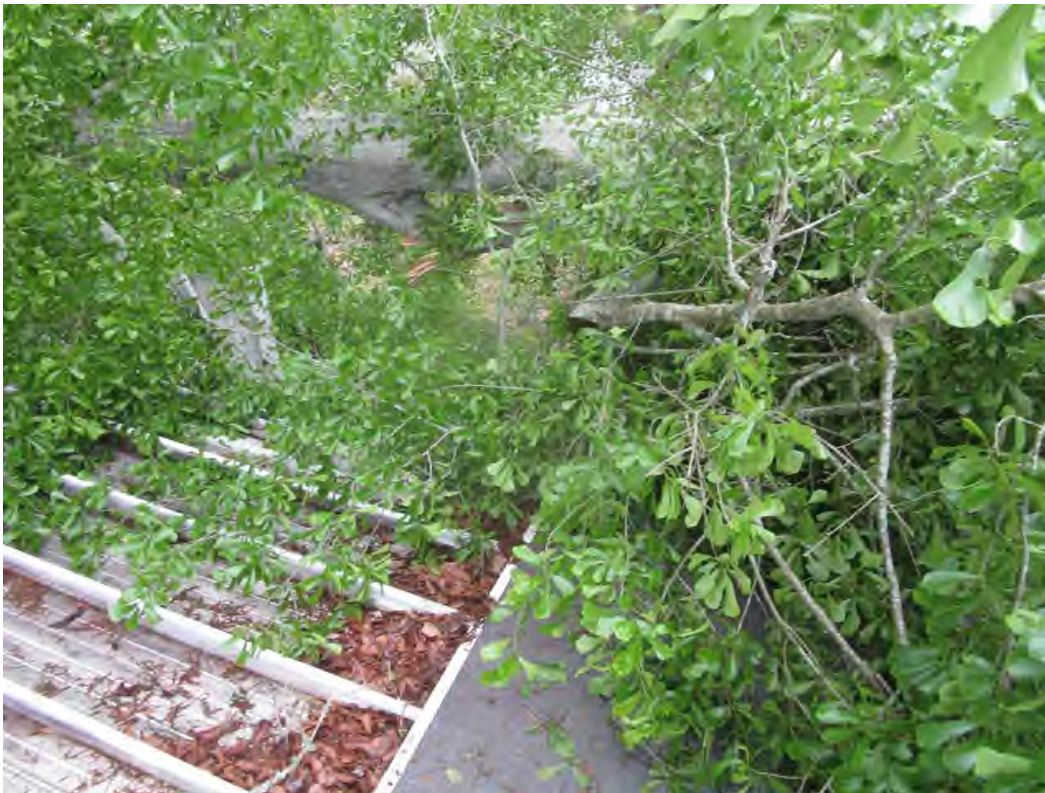
Dwelling/Shingled Roof - 14-

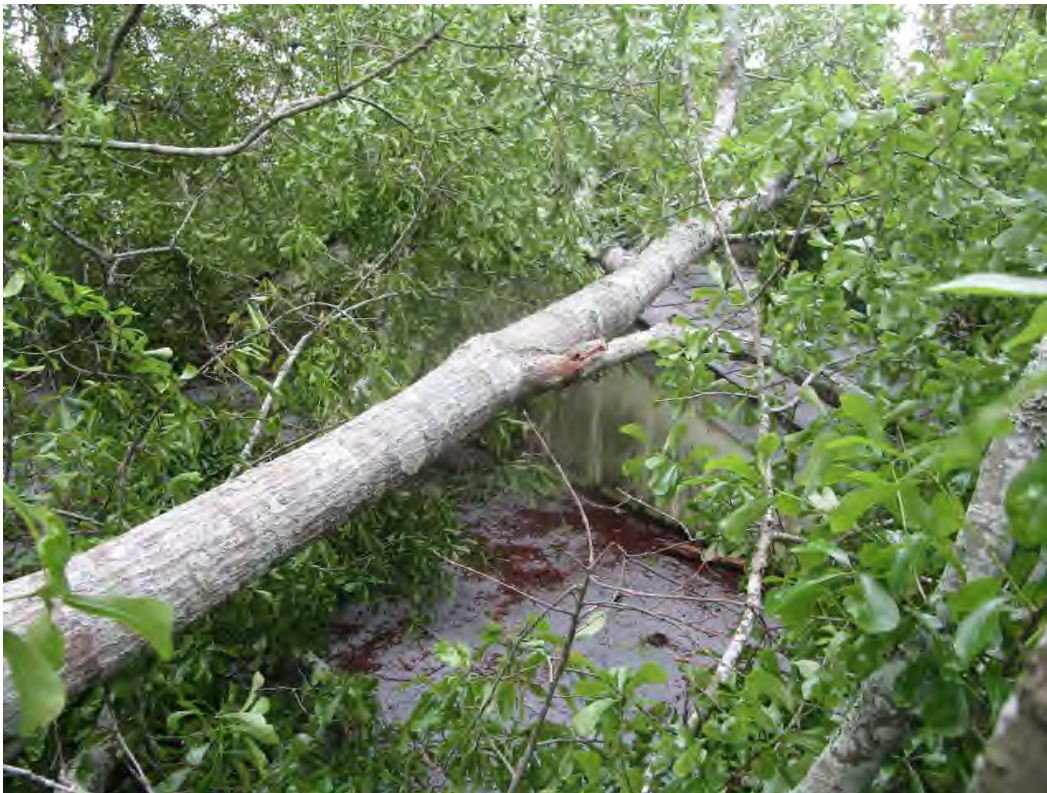
Dwelling/Shingled Roof - 16-

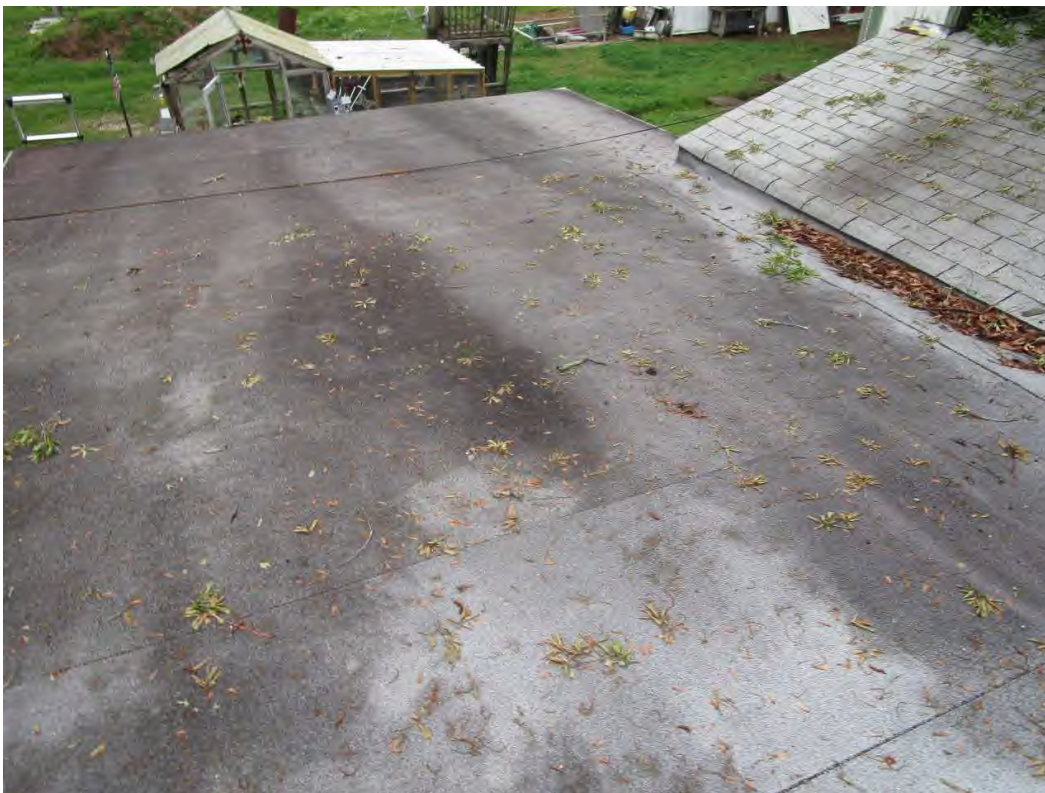
Dwelling/Front Flat Roof - 22-

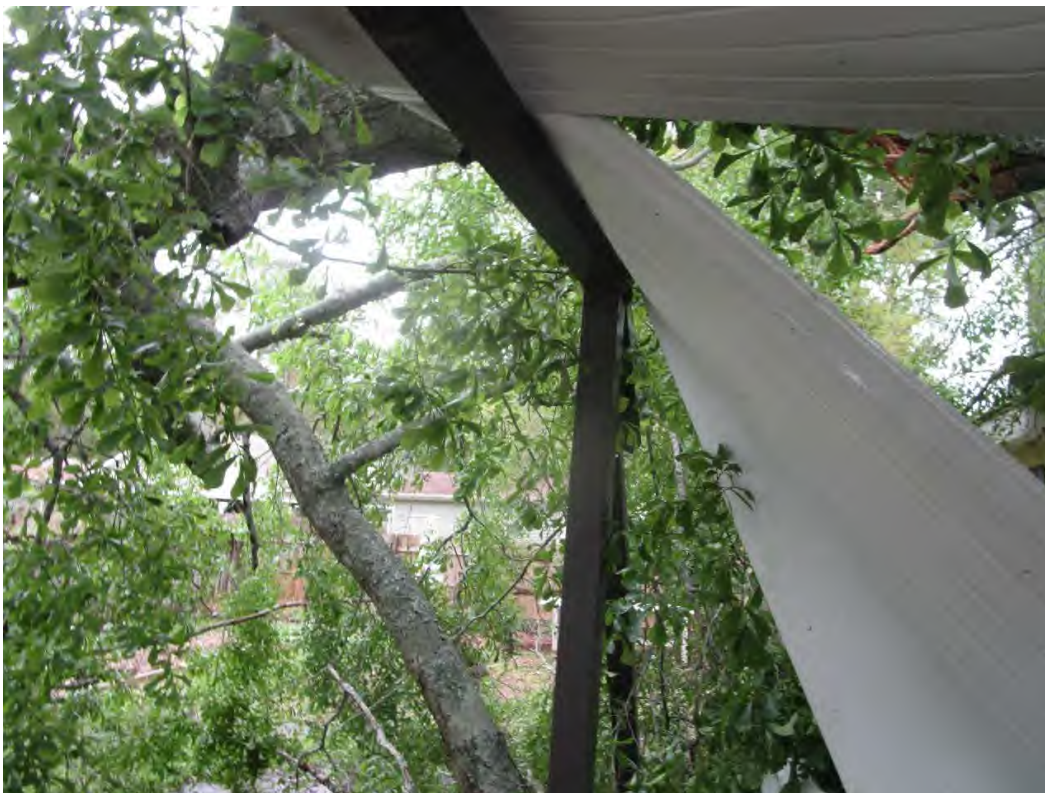
**Dwelling/Exterior/Rear
Elevation - 26-**

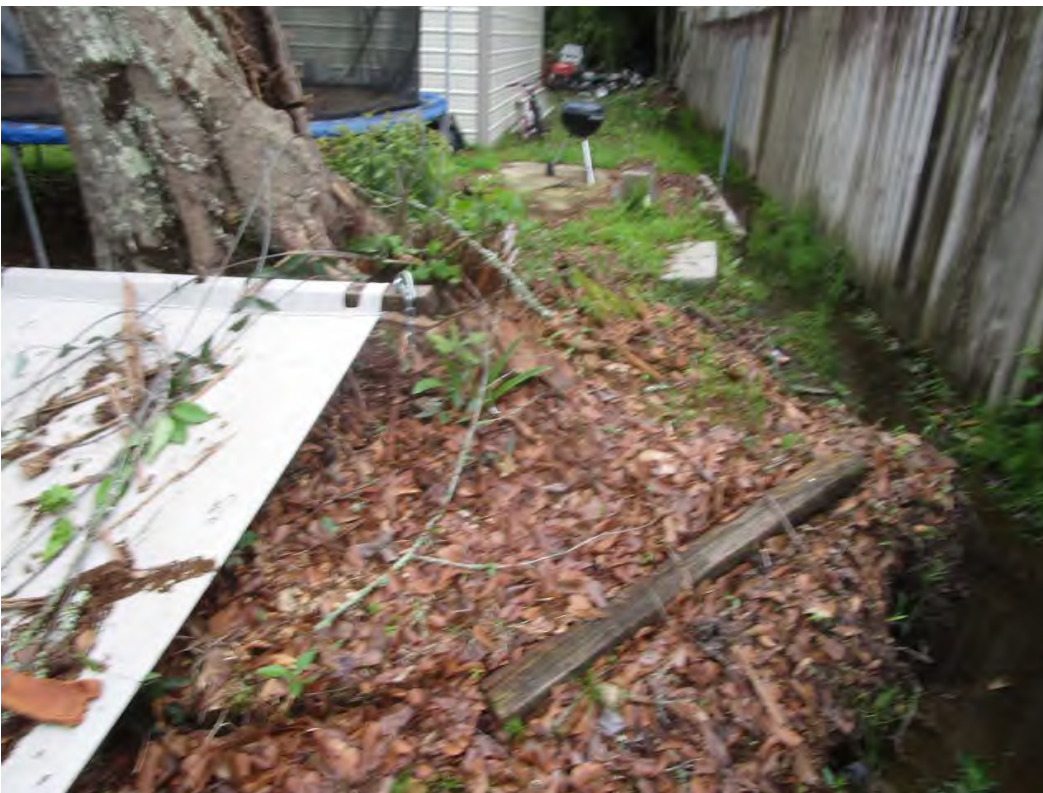
**Dwelling/Exterior/Rear
Elevation - 28-**

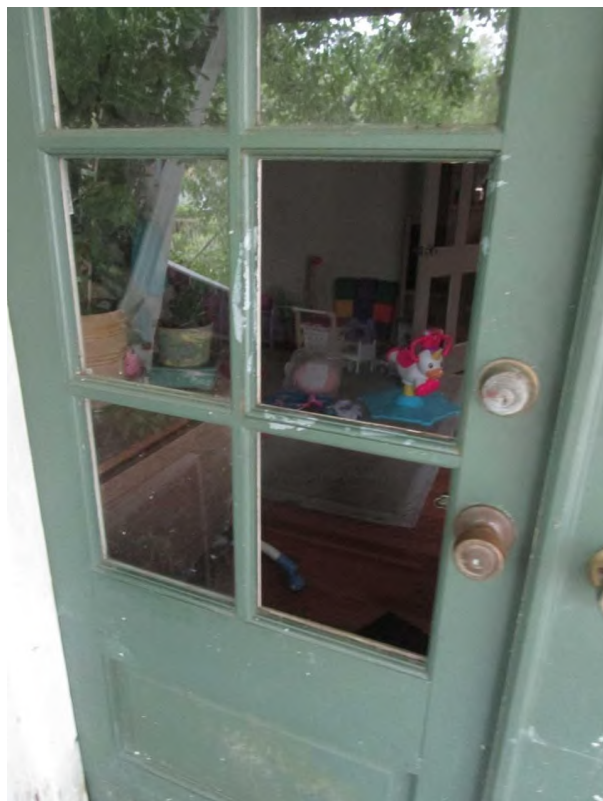
**Dwelling/Exterior/Rear
Elevation - 36-**

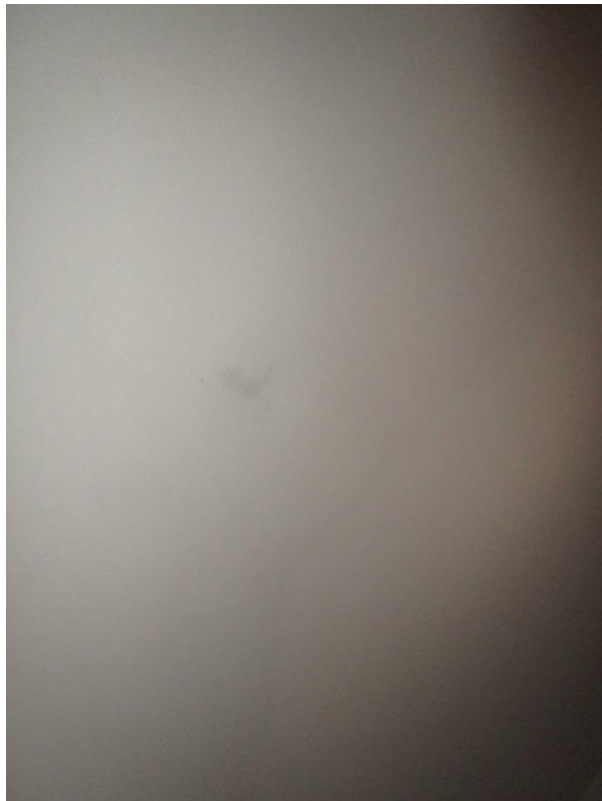
Interior/Sun Room - 44-

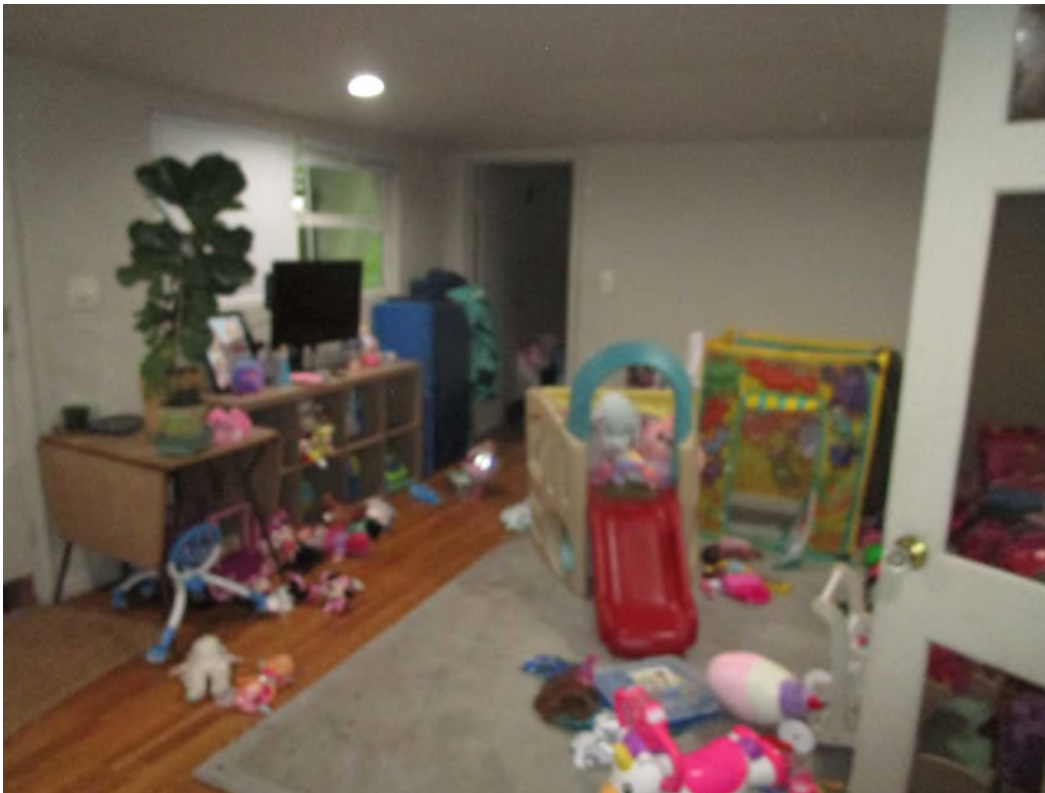
Interior/Sun Room - 46-

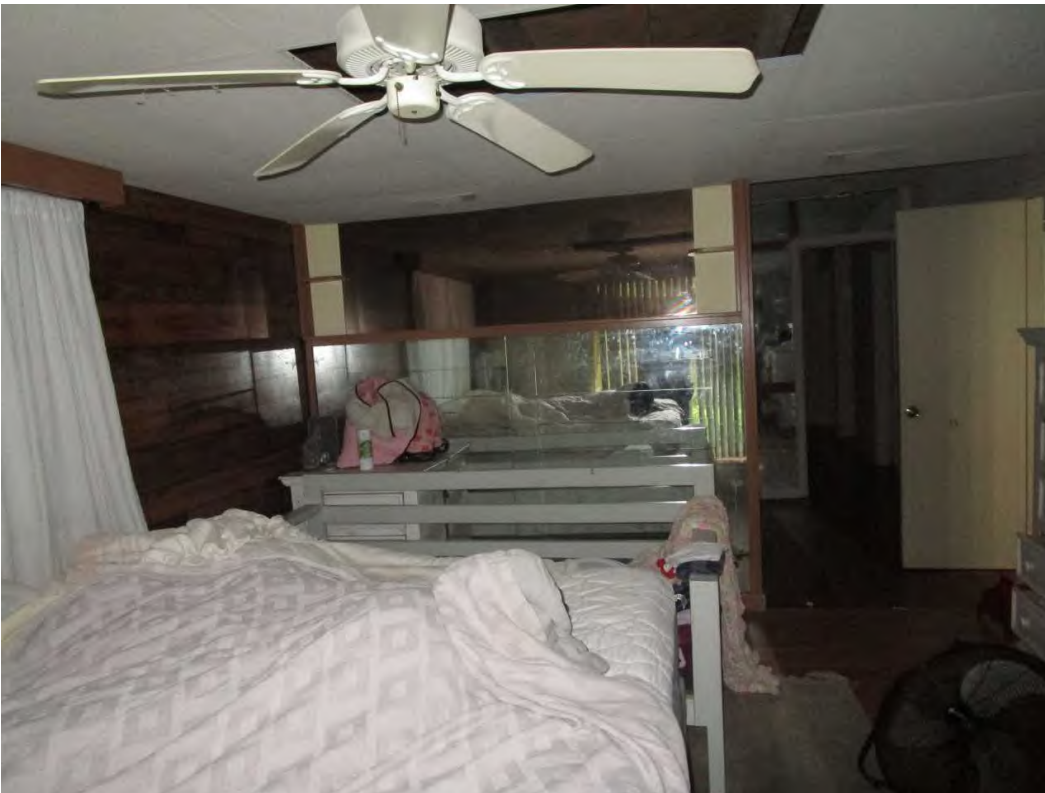
Interior/Rear Bedroom - 50-

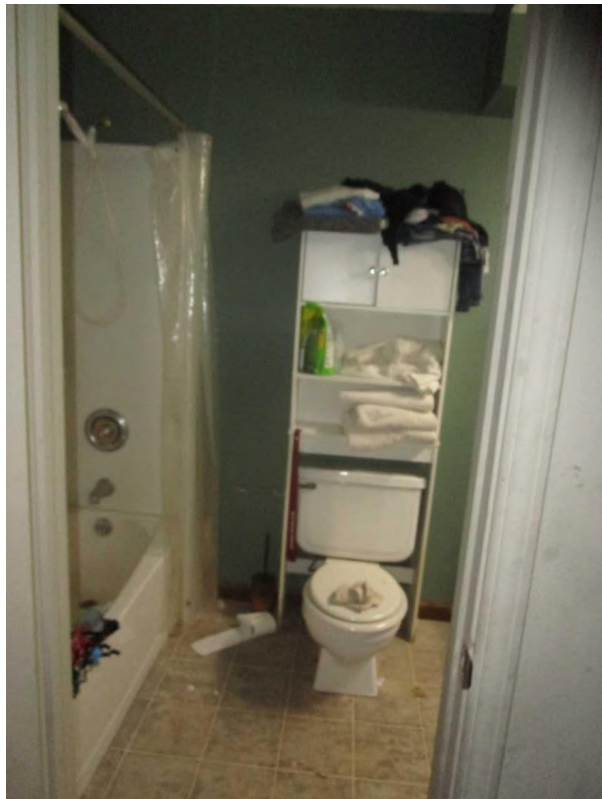
Interior/Hall Bathroom - 56-

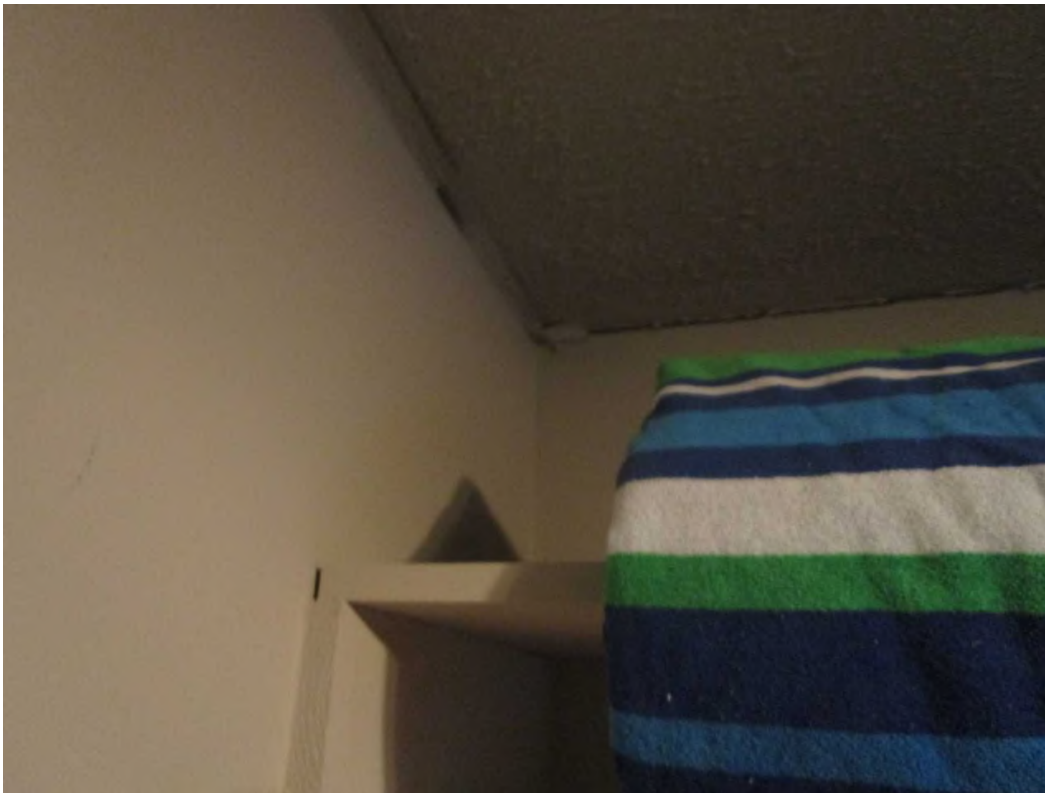
Interior/Rear Bedroom Closet - 58-

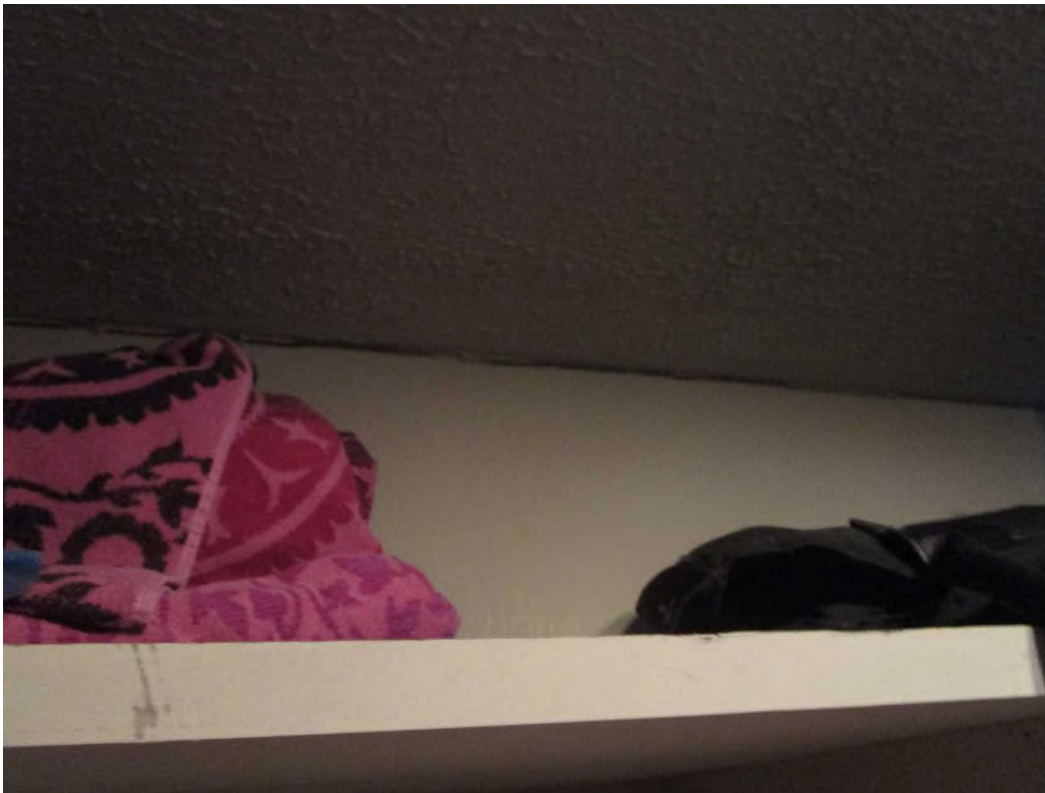
Interior/Rear Bedroom Closet - 60-

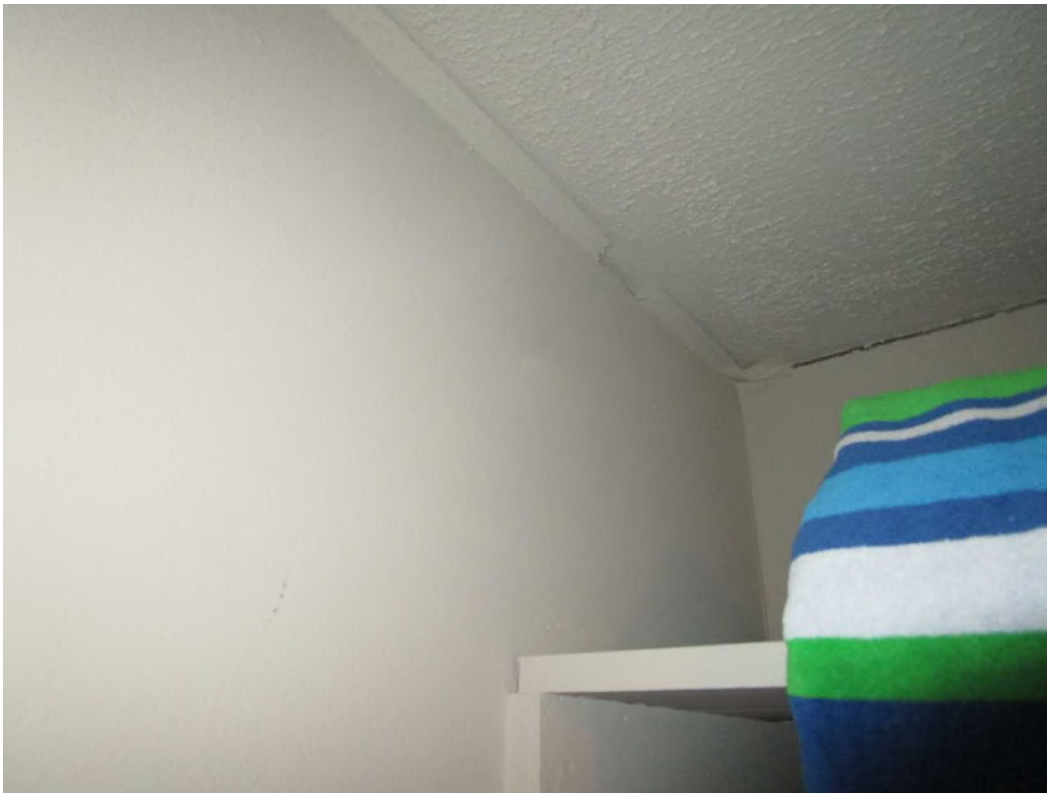
Interior/Rear Bedroom Closet - 62-

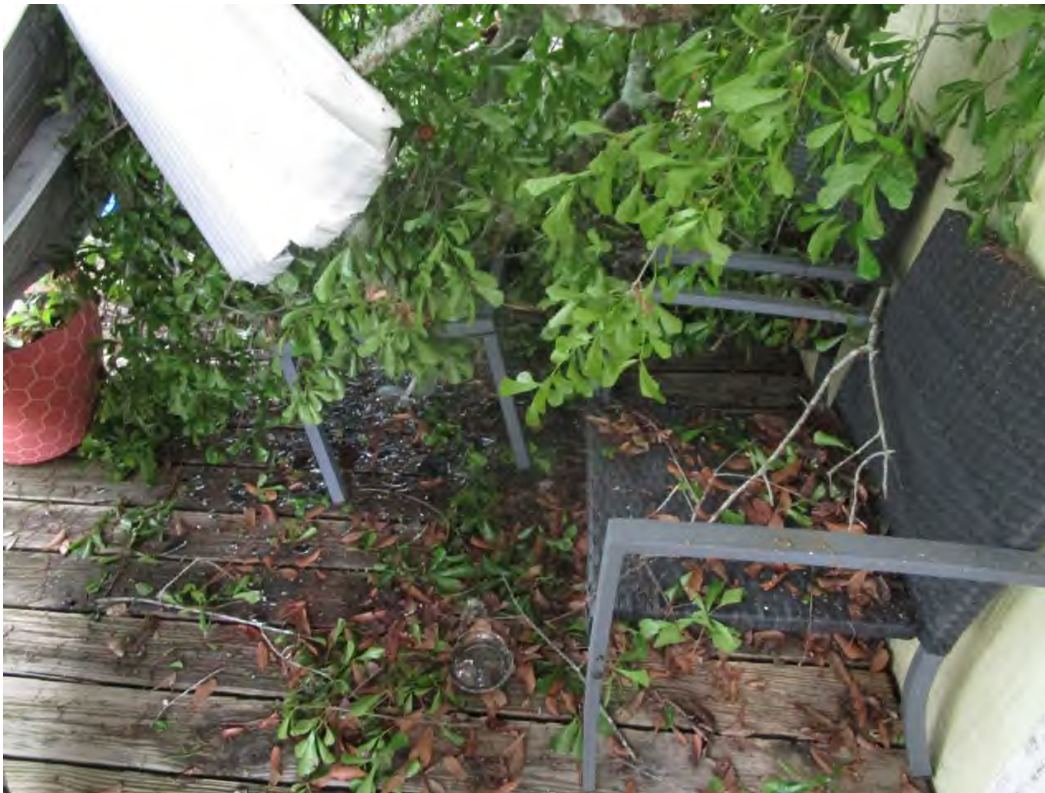
Mattress was replaced.
