Structural Inspection

June 24, 2024

Michelle Atwood
248 Clara Drive
Slidell, La. 70458

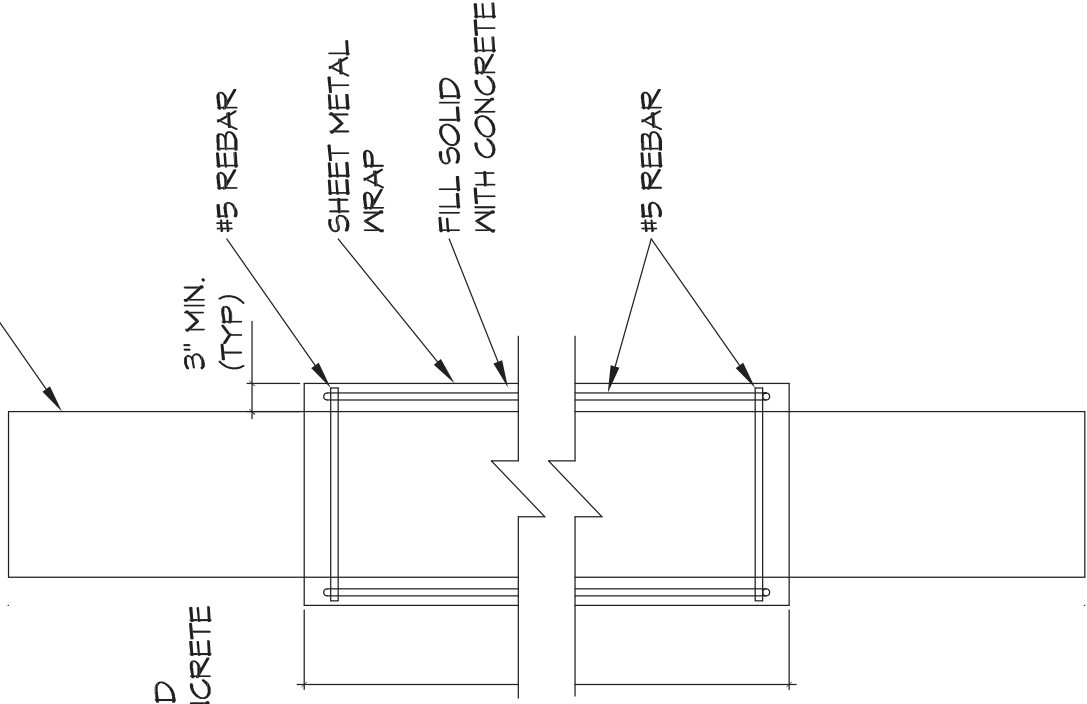
EXISTING HOUSE PILING

FIELD VERIFY HEIGHT, COVER SHALL BE
2' ABOVE AND 2' BELOW ROTTEN WOOD.

- 1) Secure the existing pilings with a concrete wrap as noted in the attached dwg.
- 2) Seal the concrete with a non-shrinking grout to prevent insects and water from entering the home.
- 3) Install proper drainage around the home to keep the foundation dry.

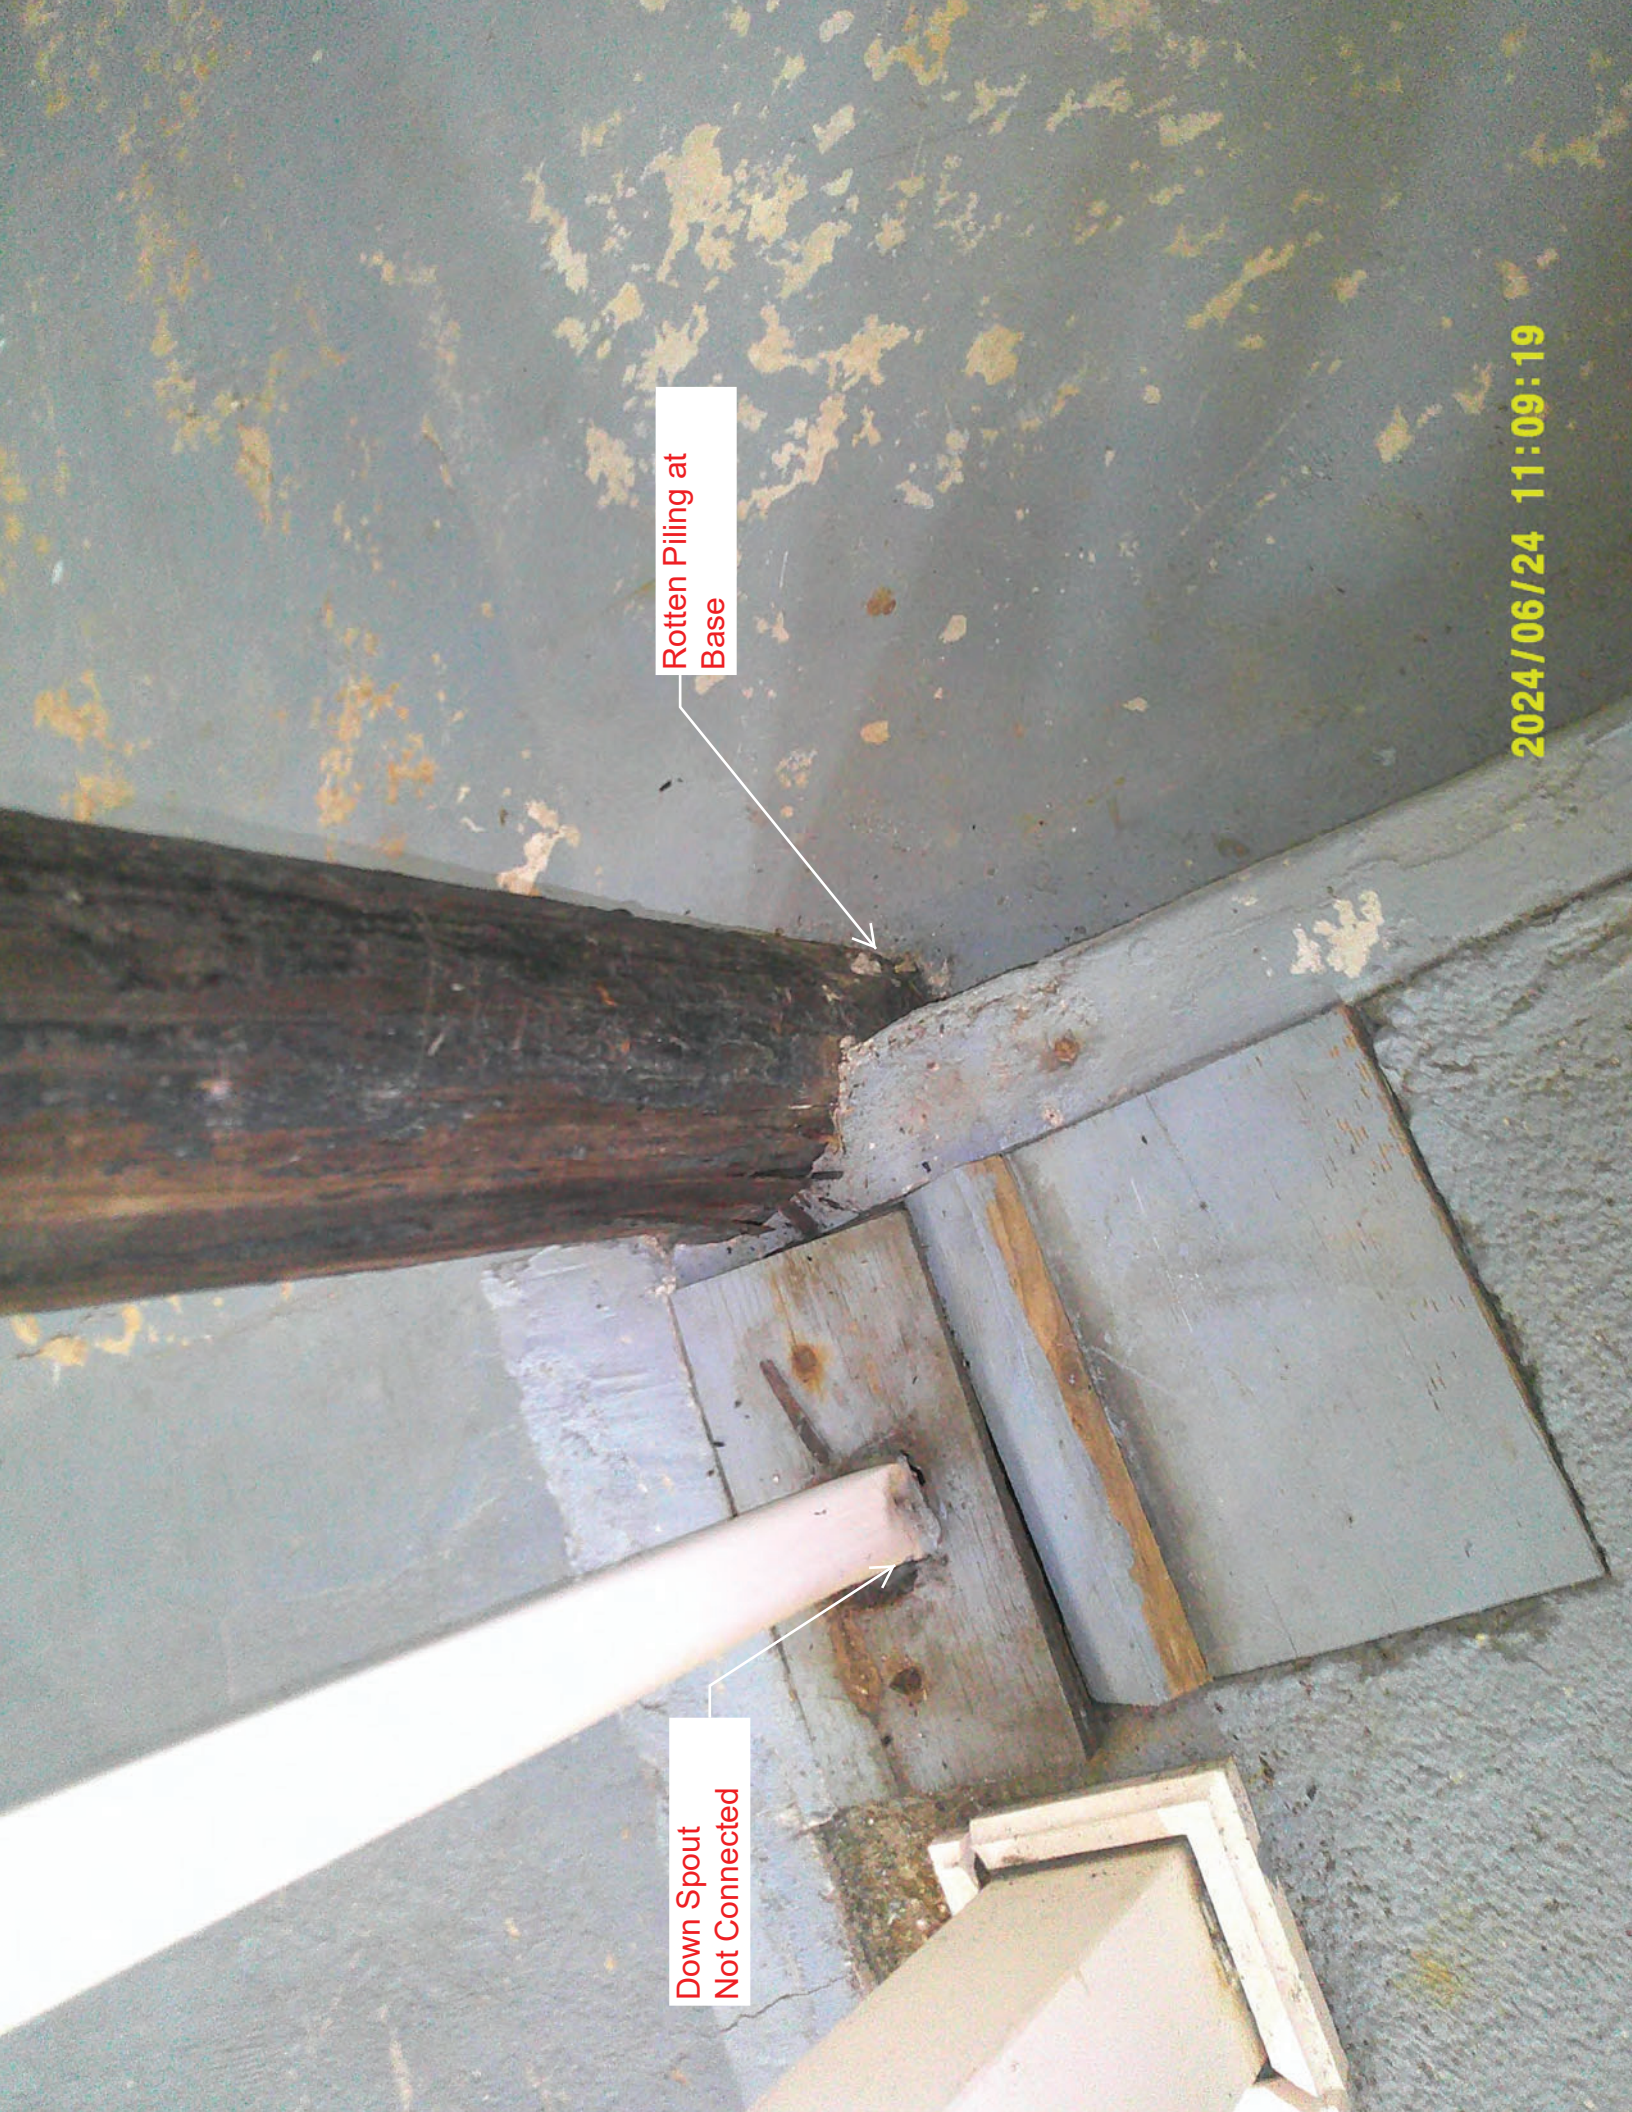
Rotten Piling at Base

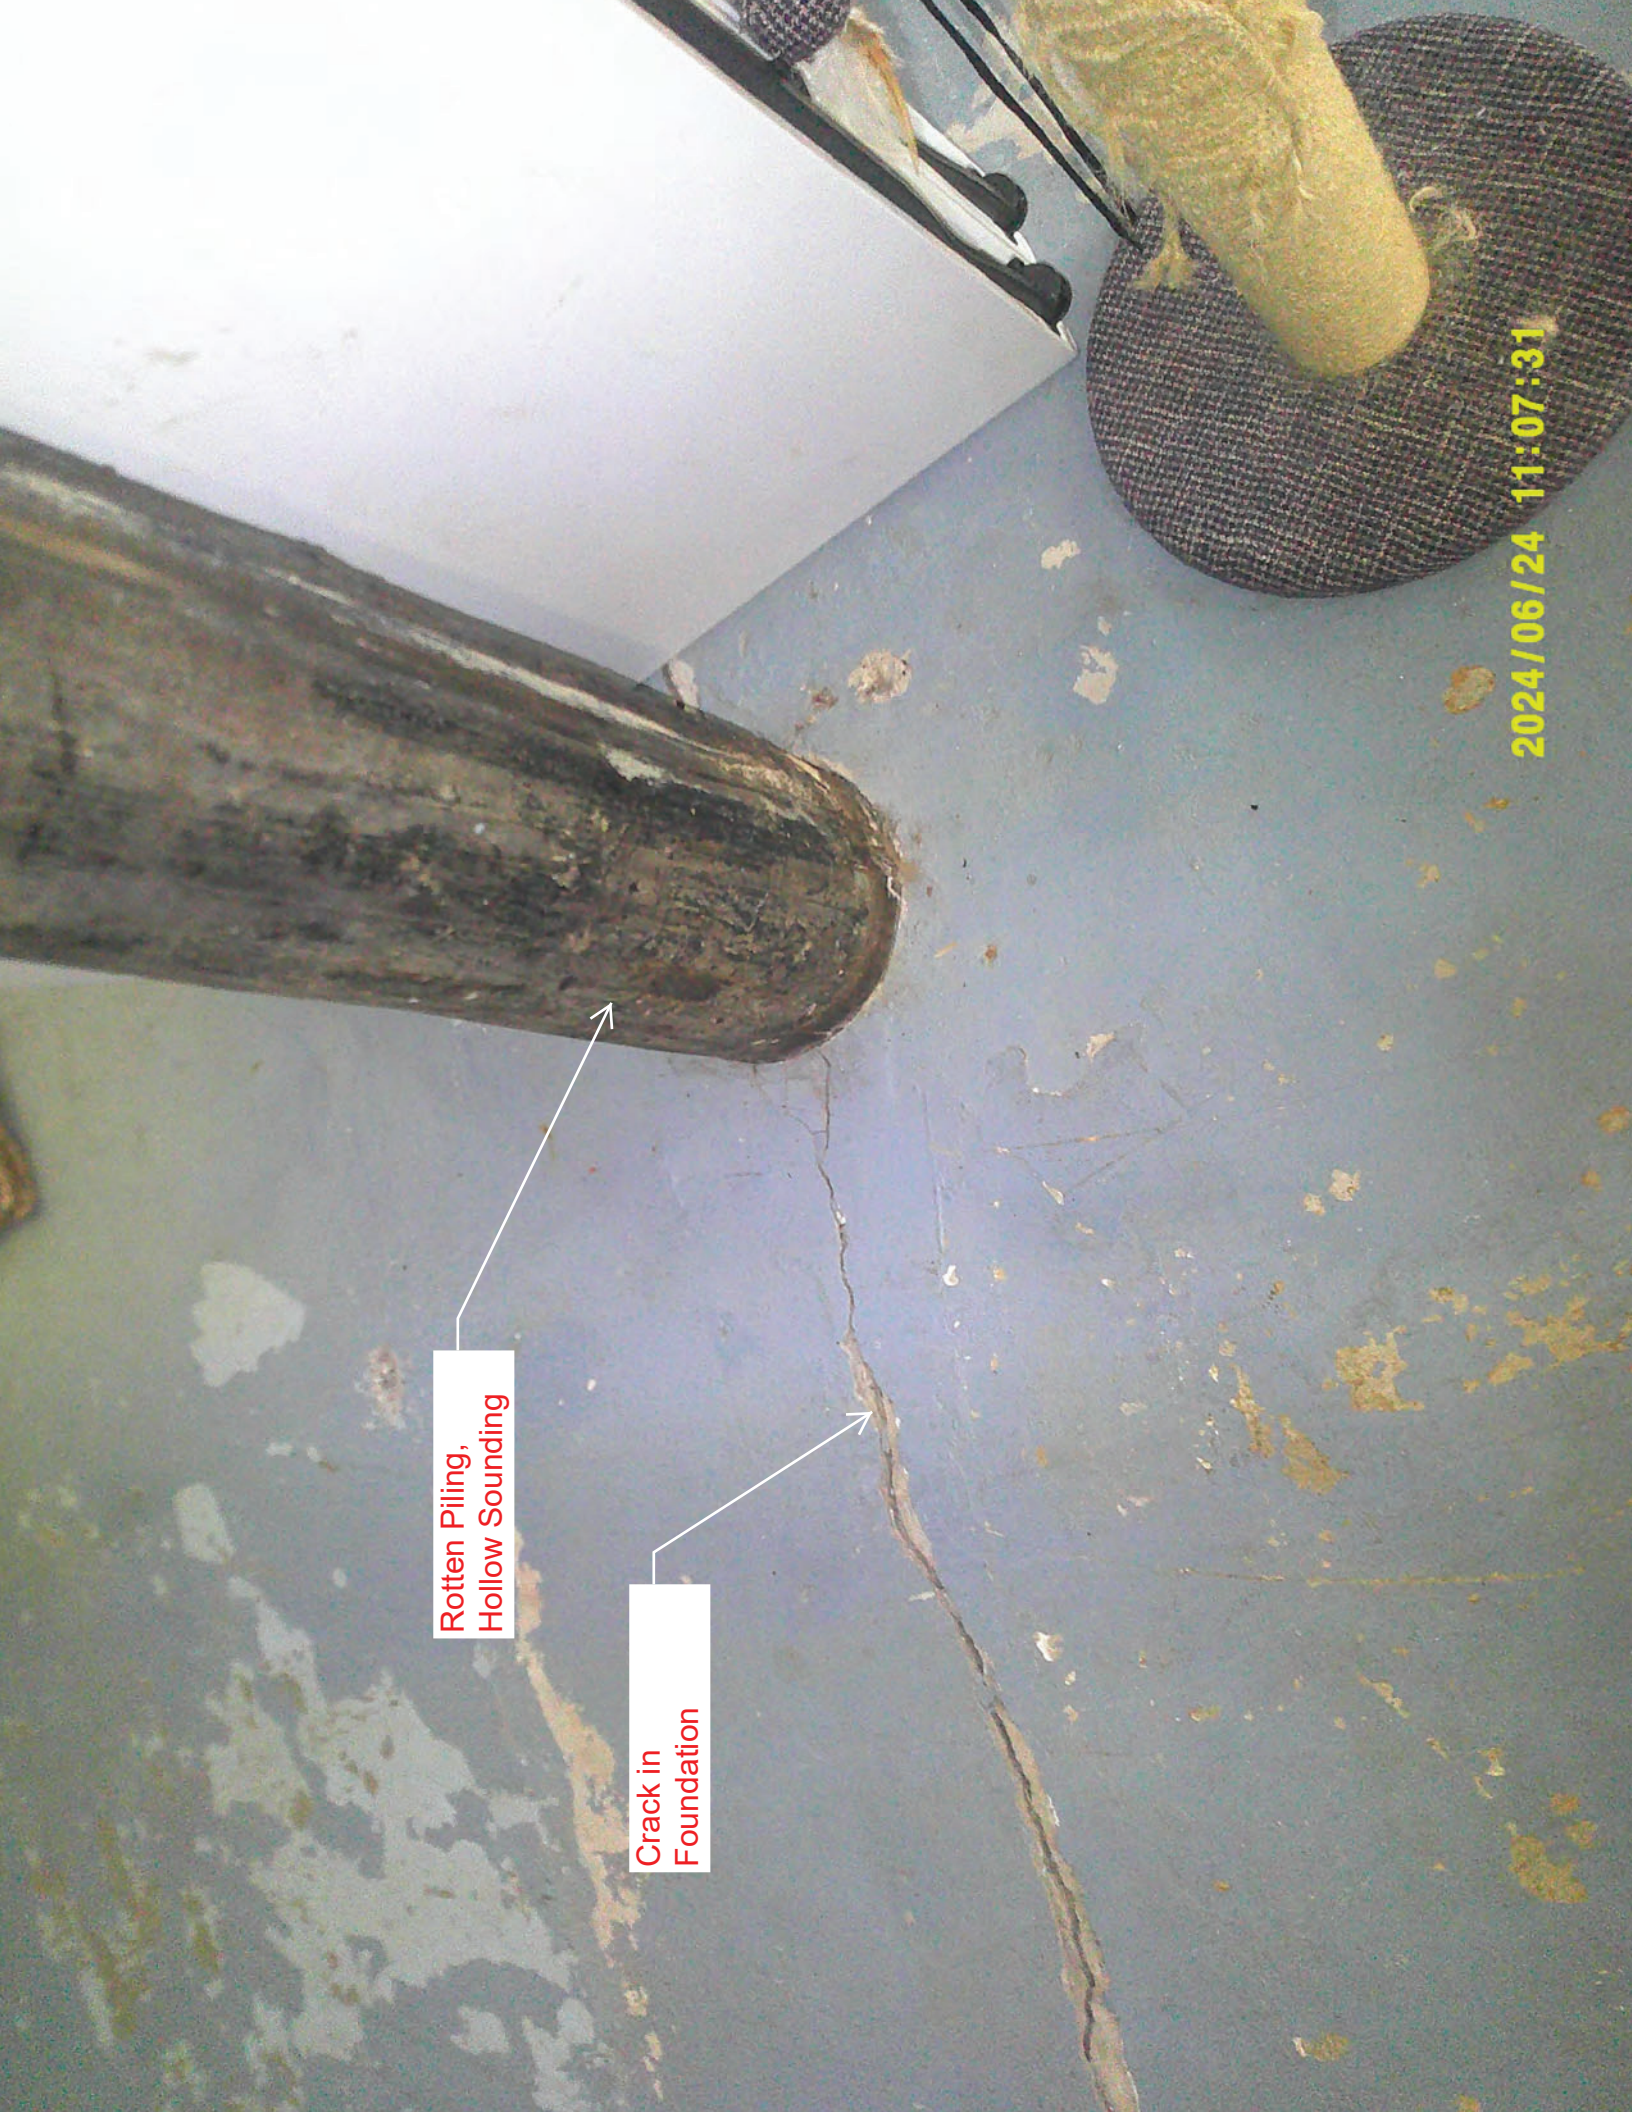
Down Spout Not Connected

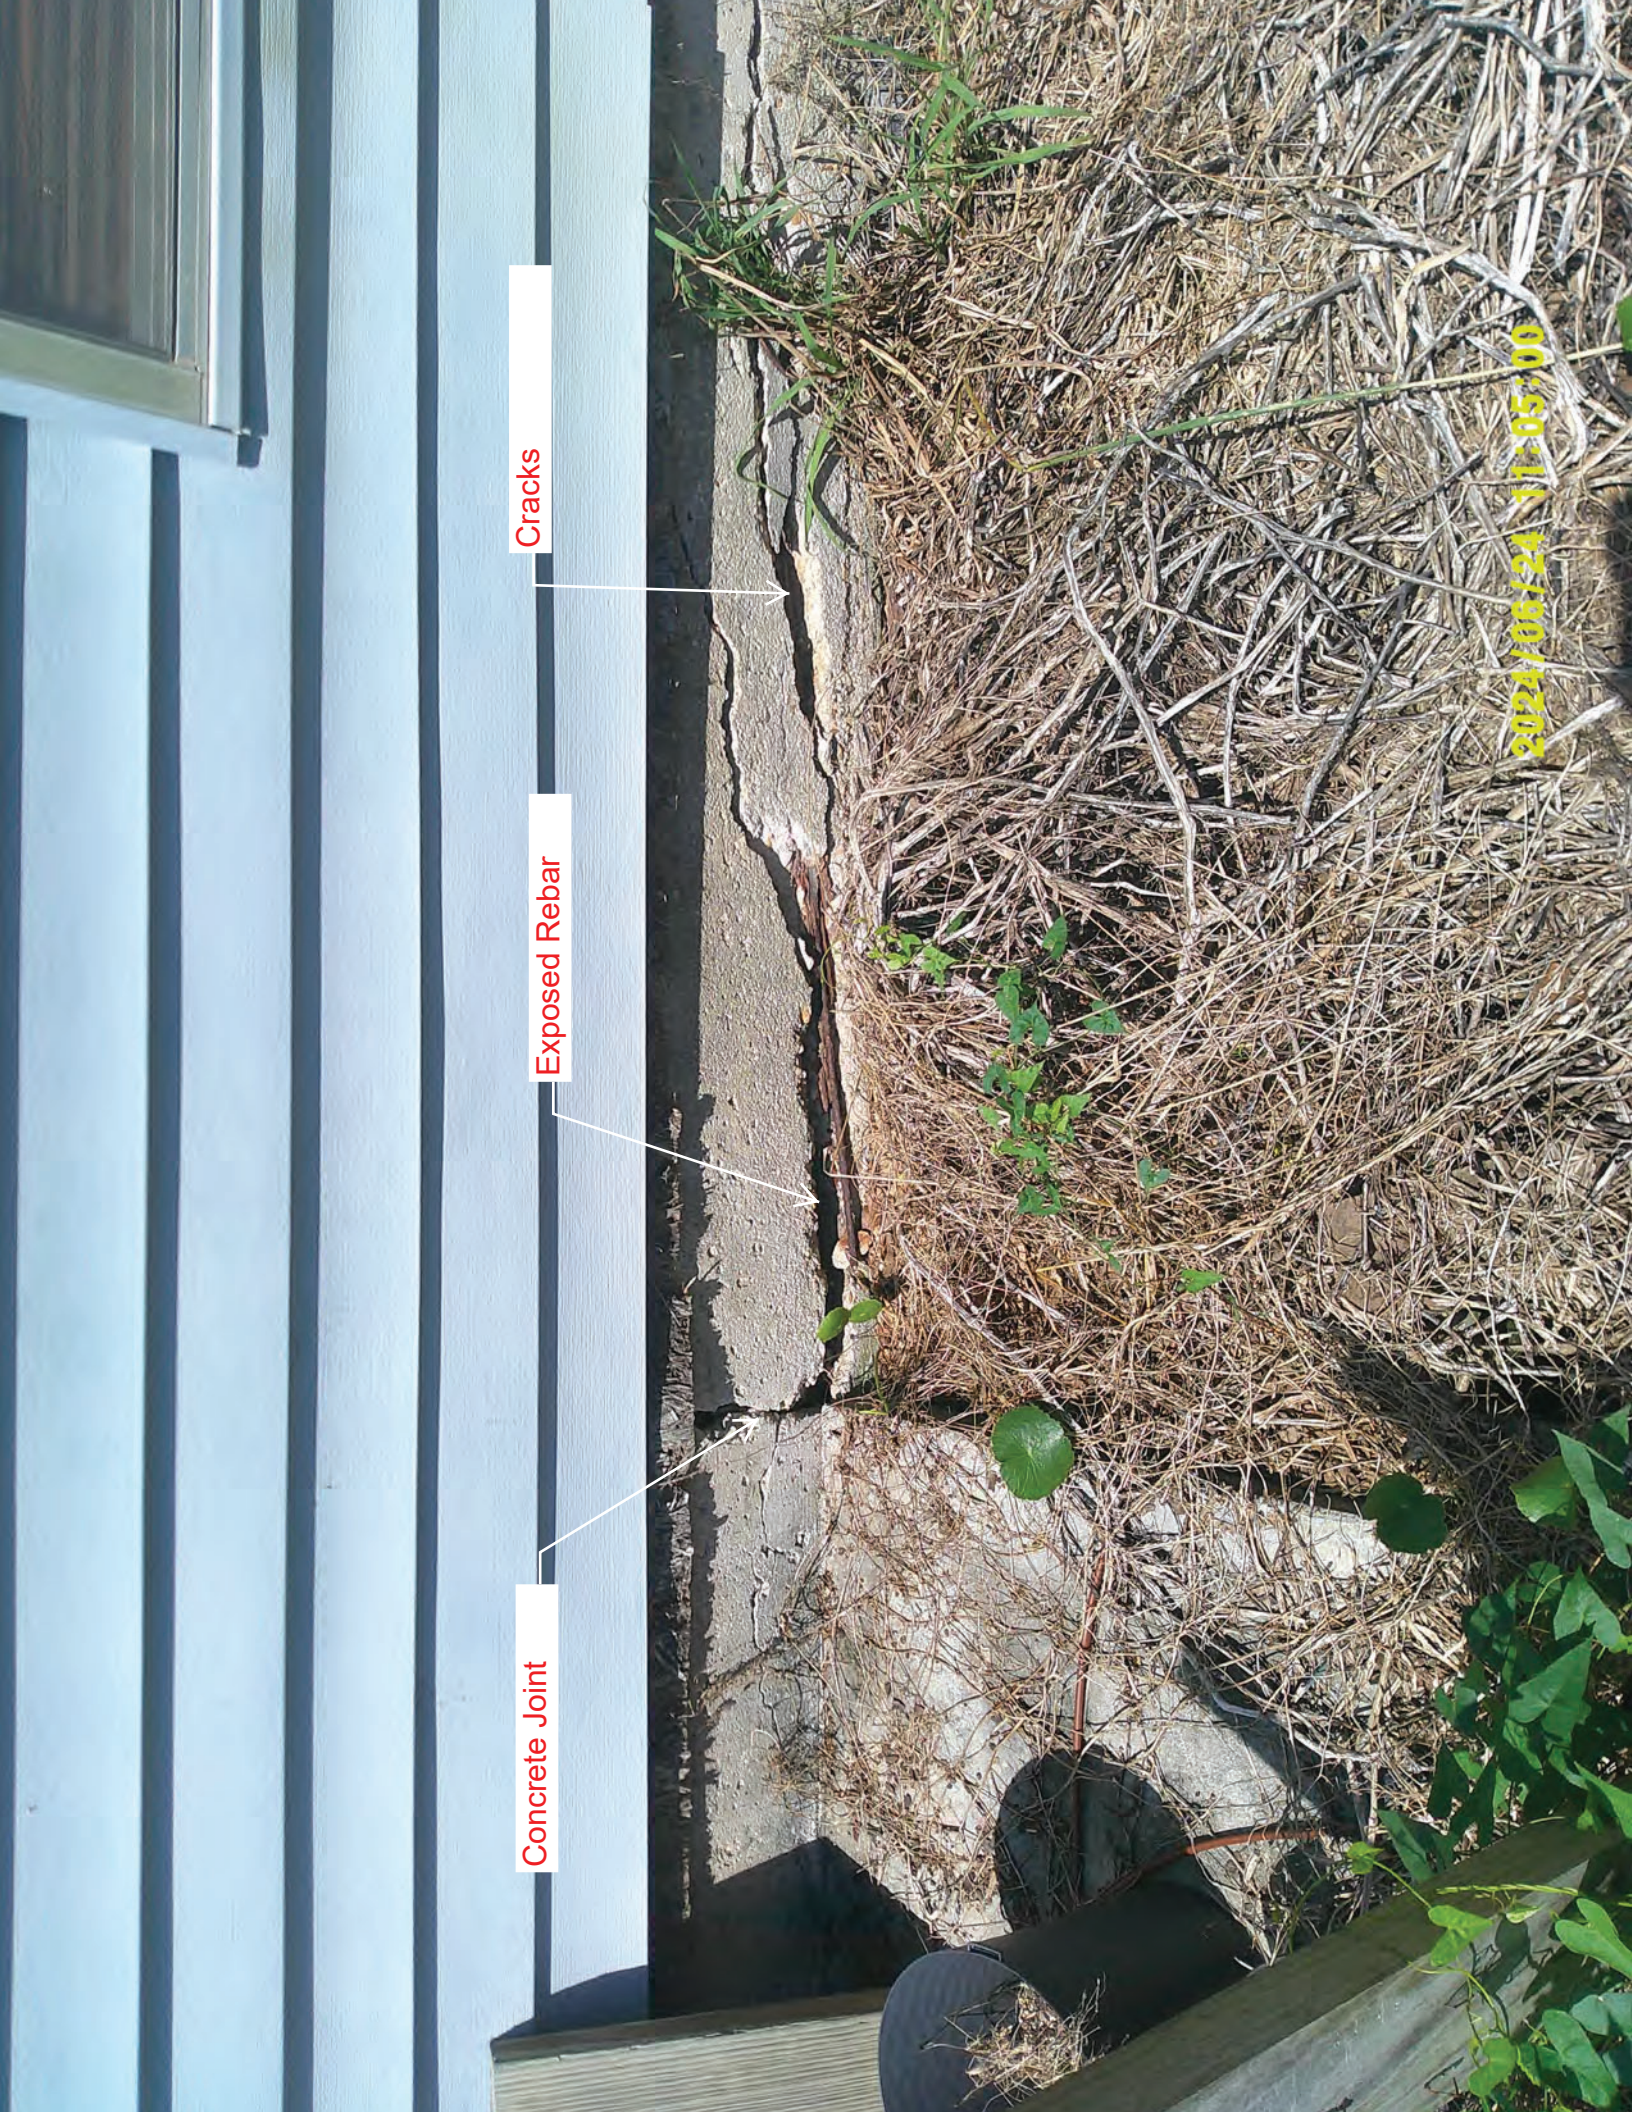
Rotten Piling,
Hollow Sounding

Crack in
Foundation

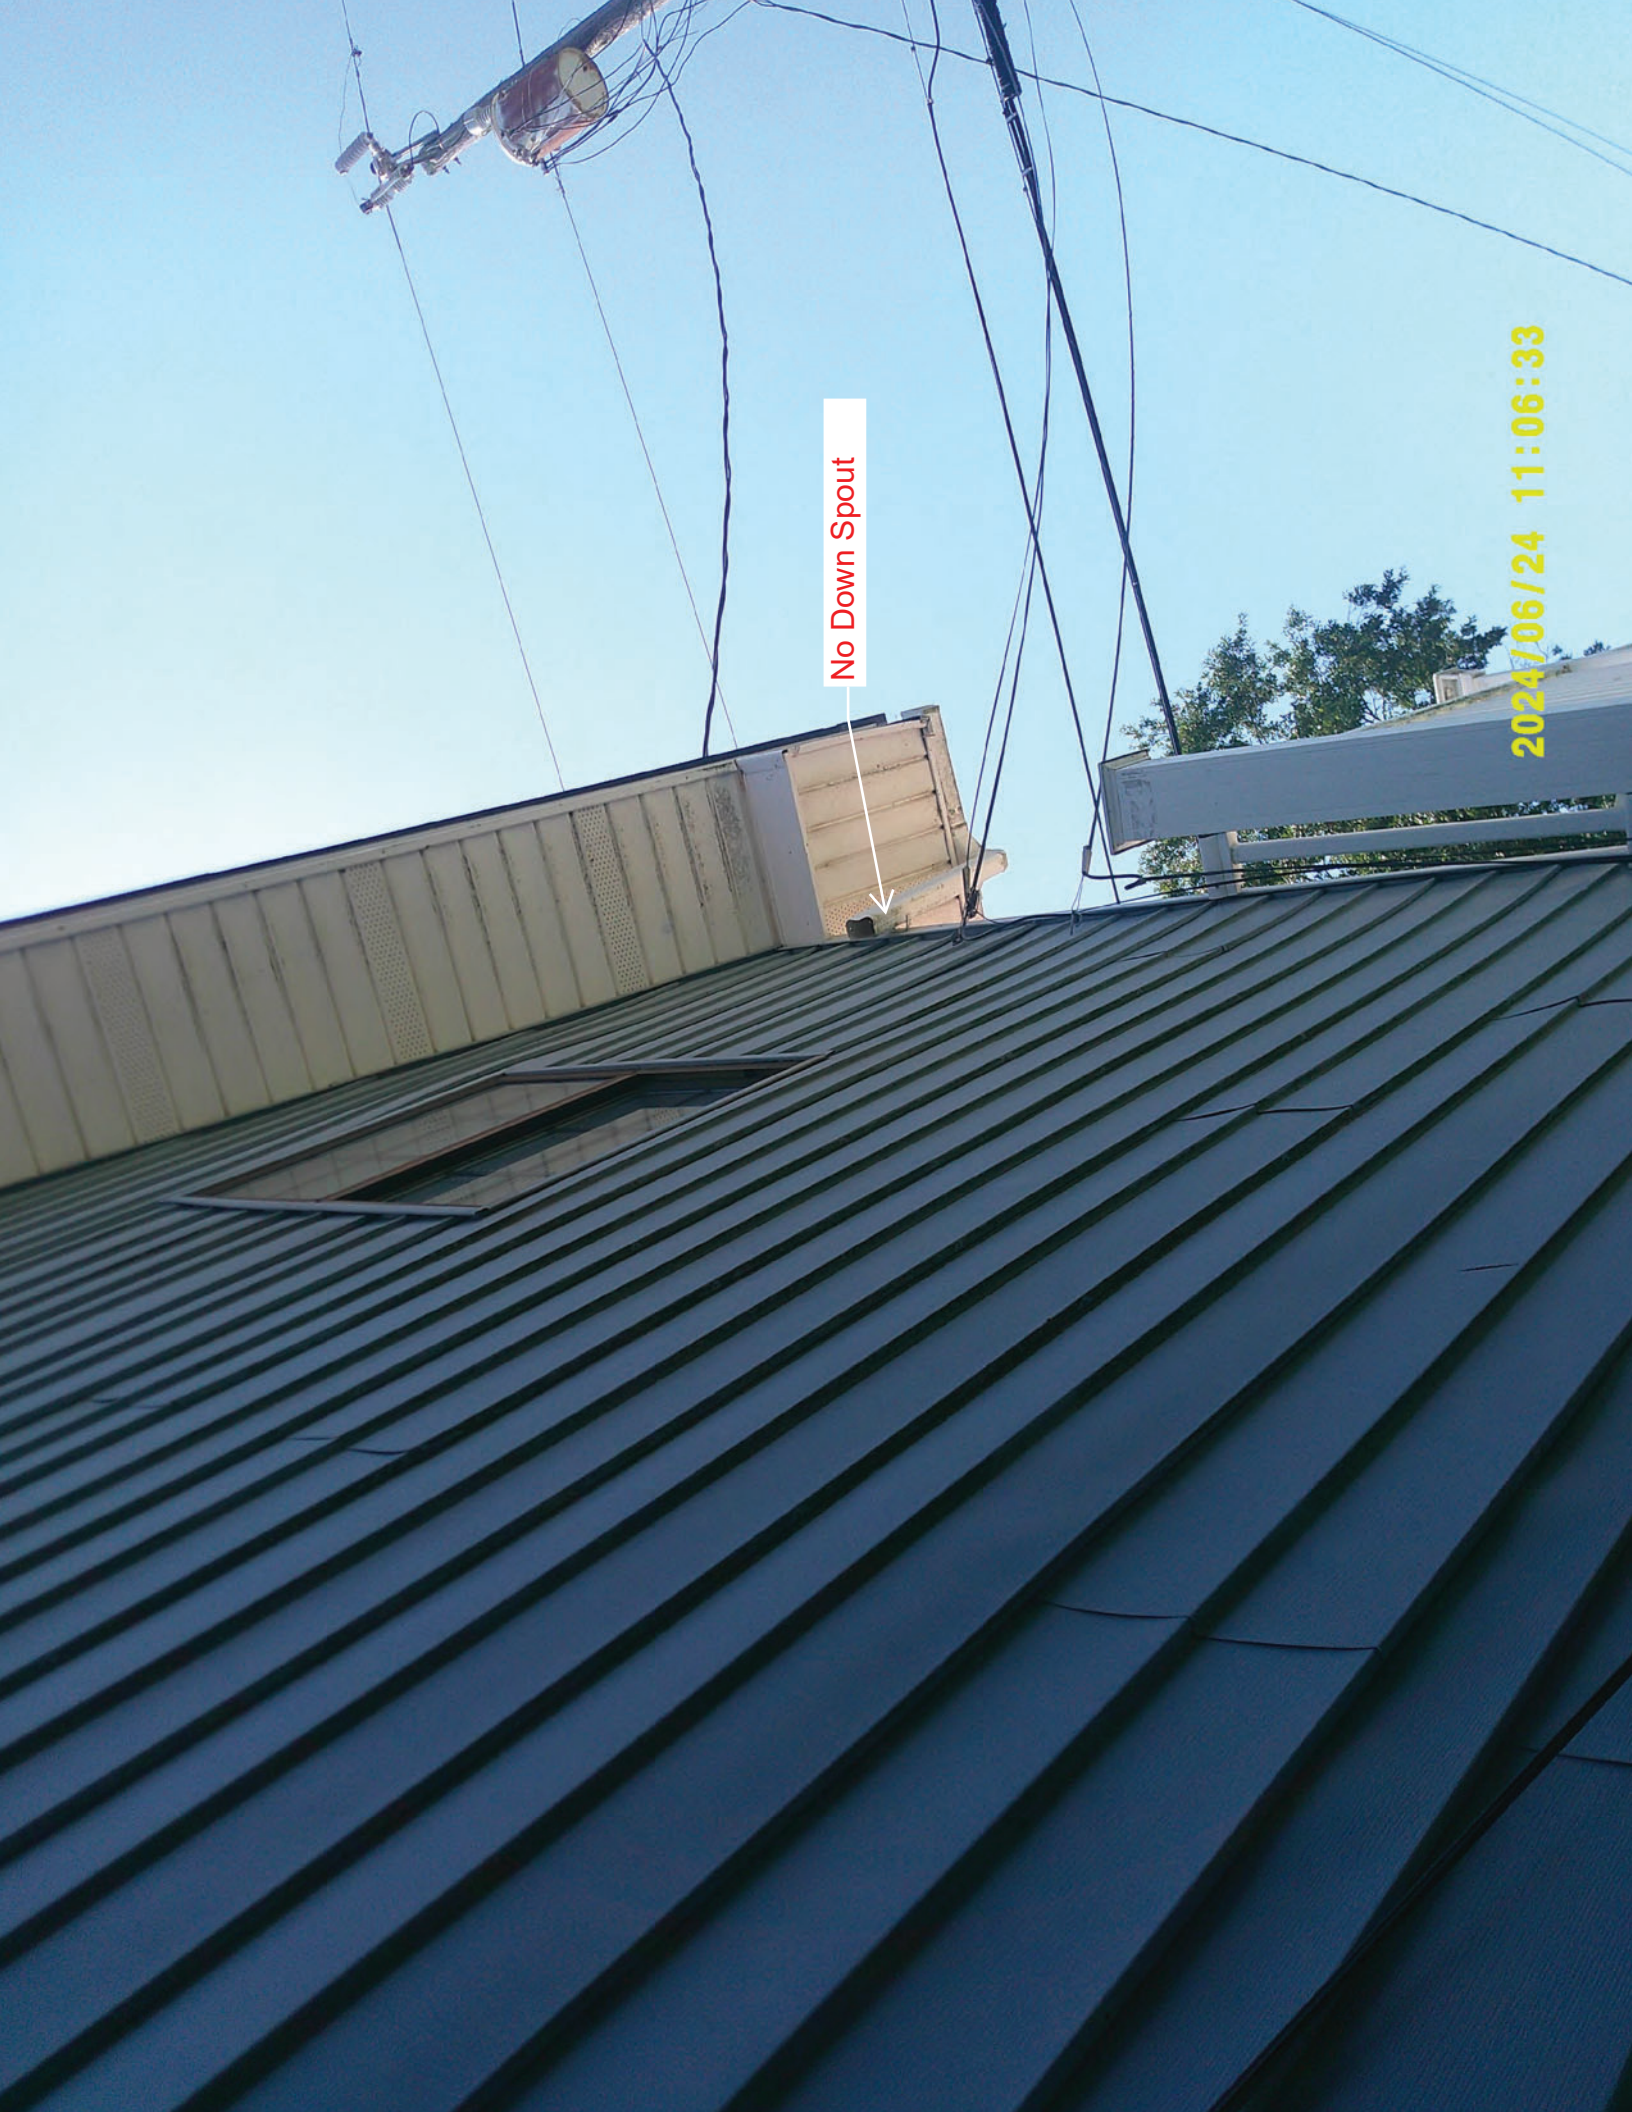
No Down Spout
